Kia Motors America
Consumer Affairs Department

Kia Case Type Lvl4: Windshield/Rear Glass(Breakaway)

Broken Sunroof Report

TF – Field Investigation Analysis Report

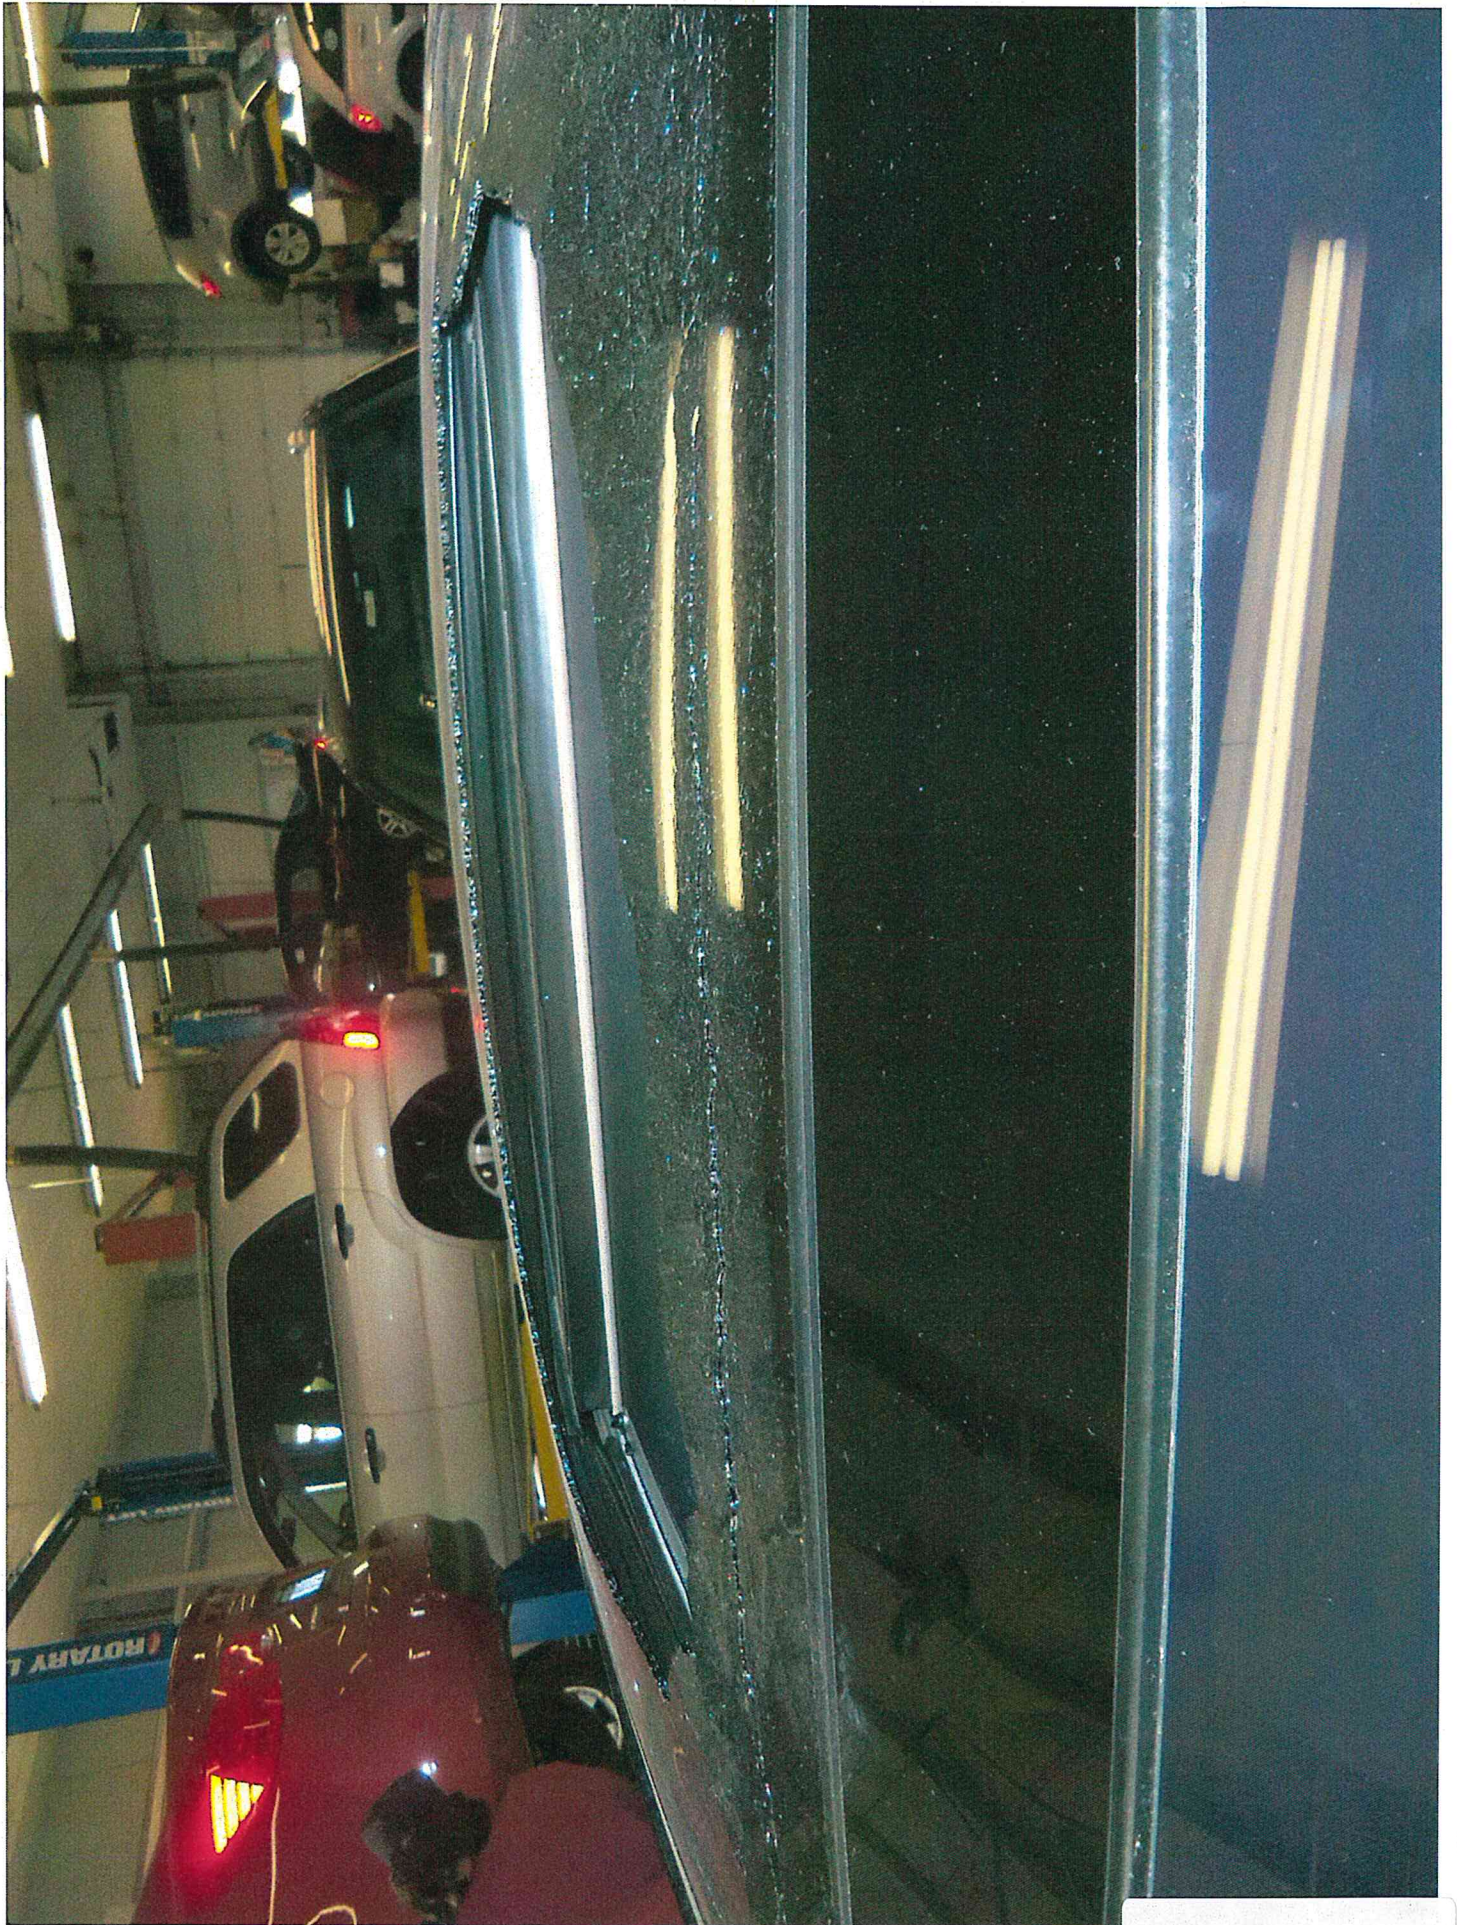
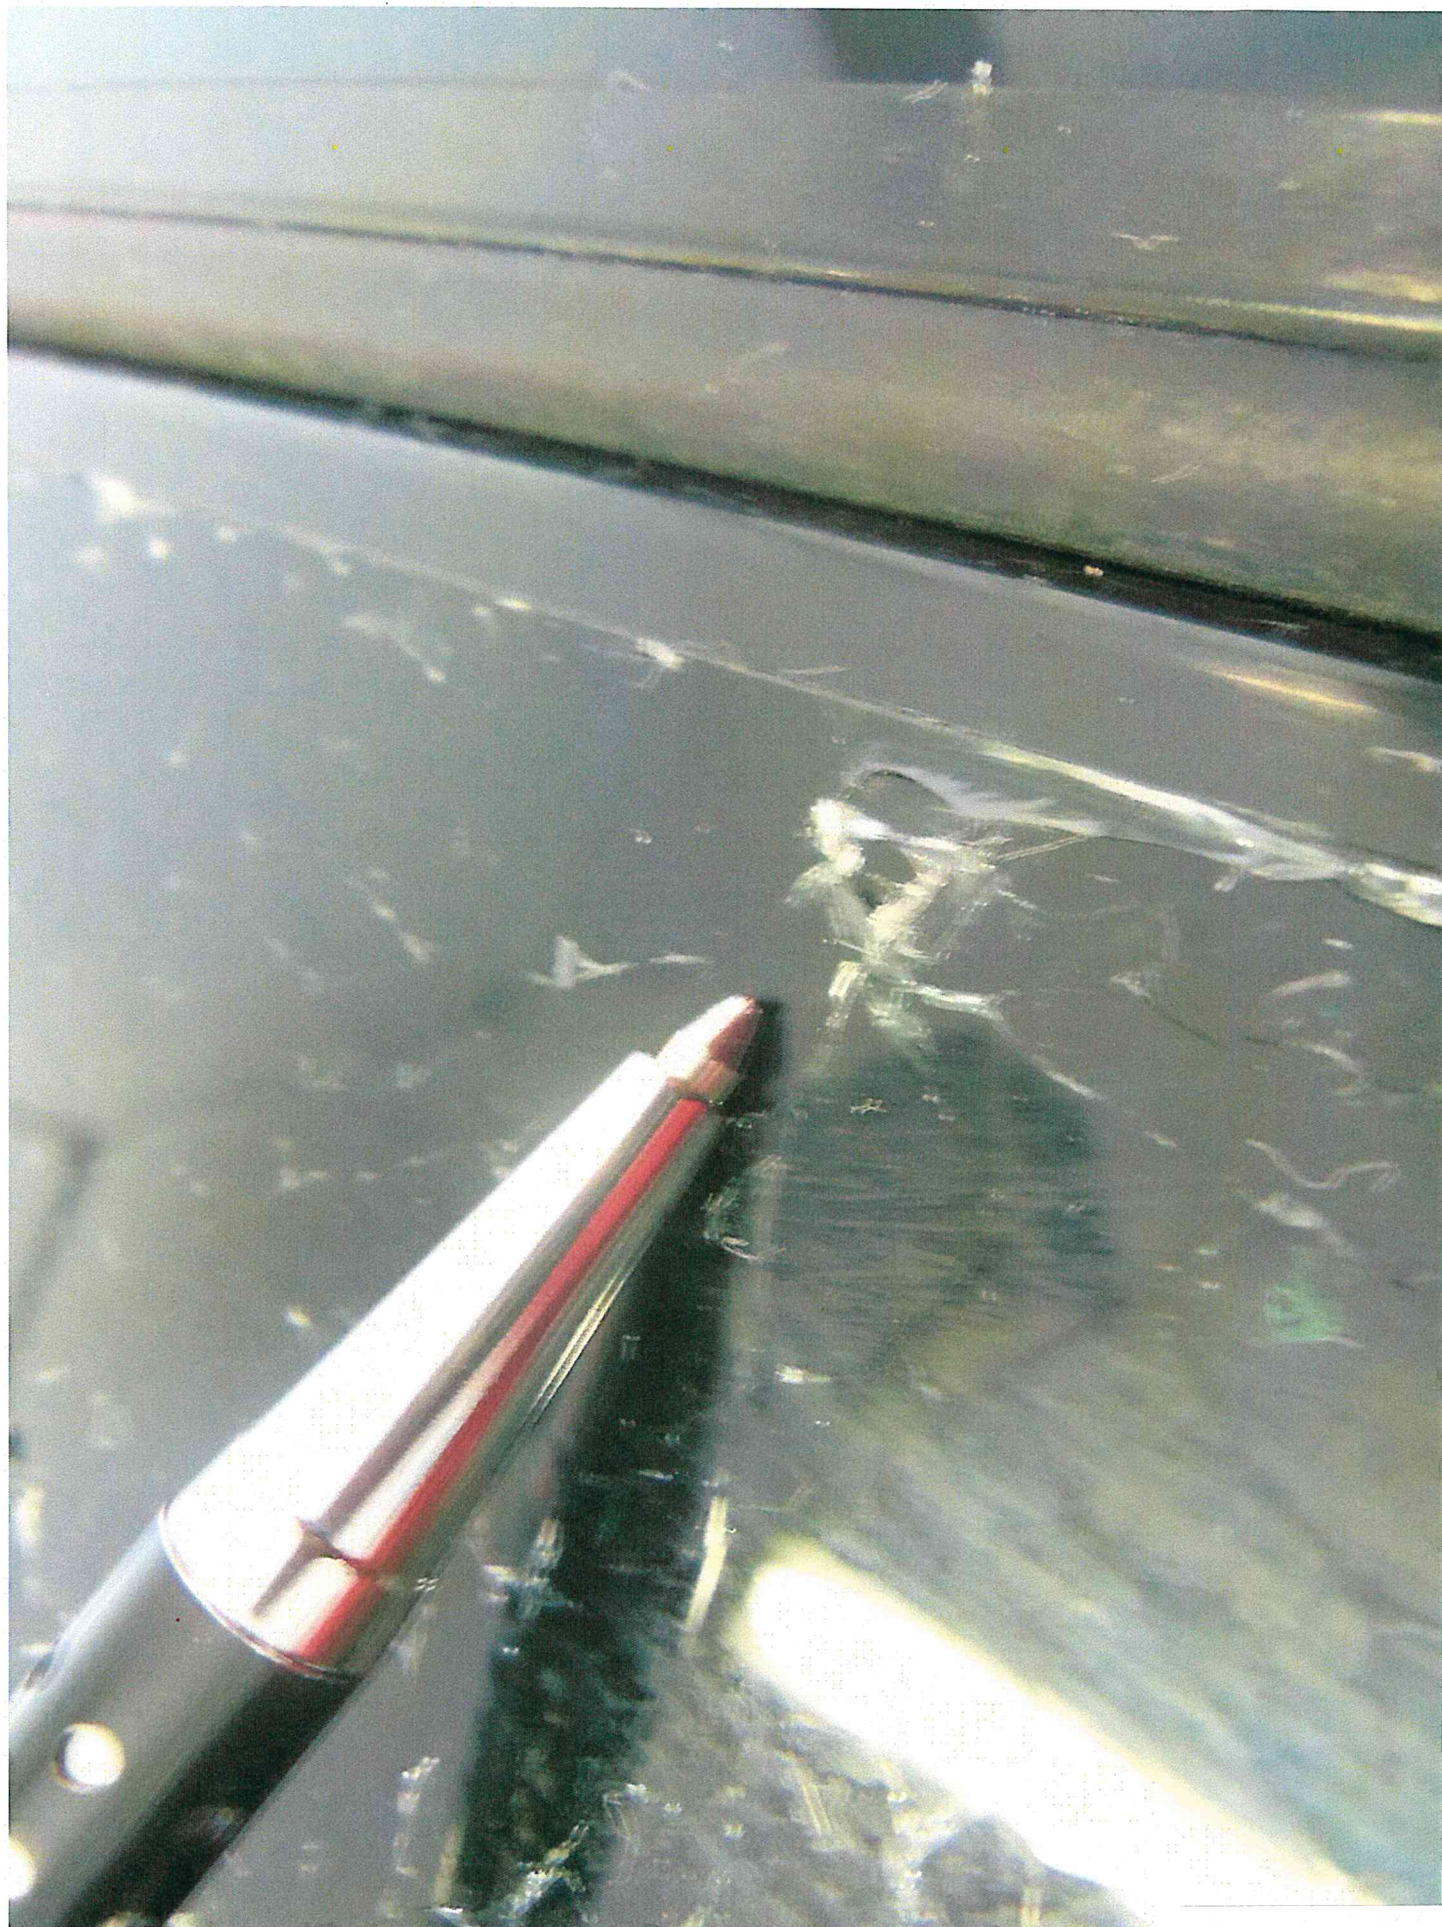
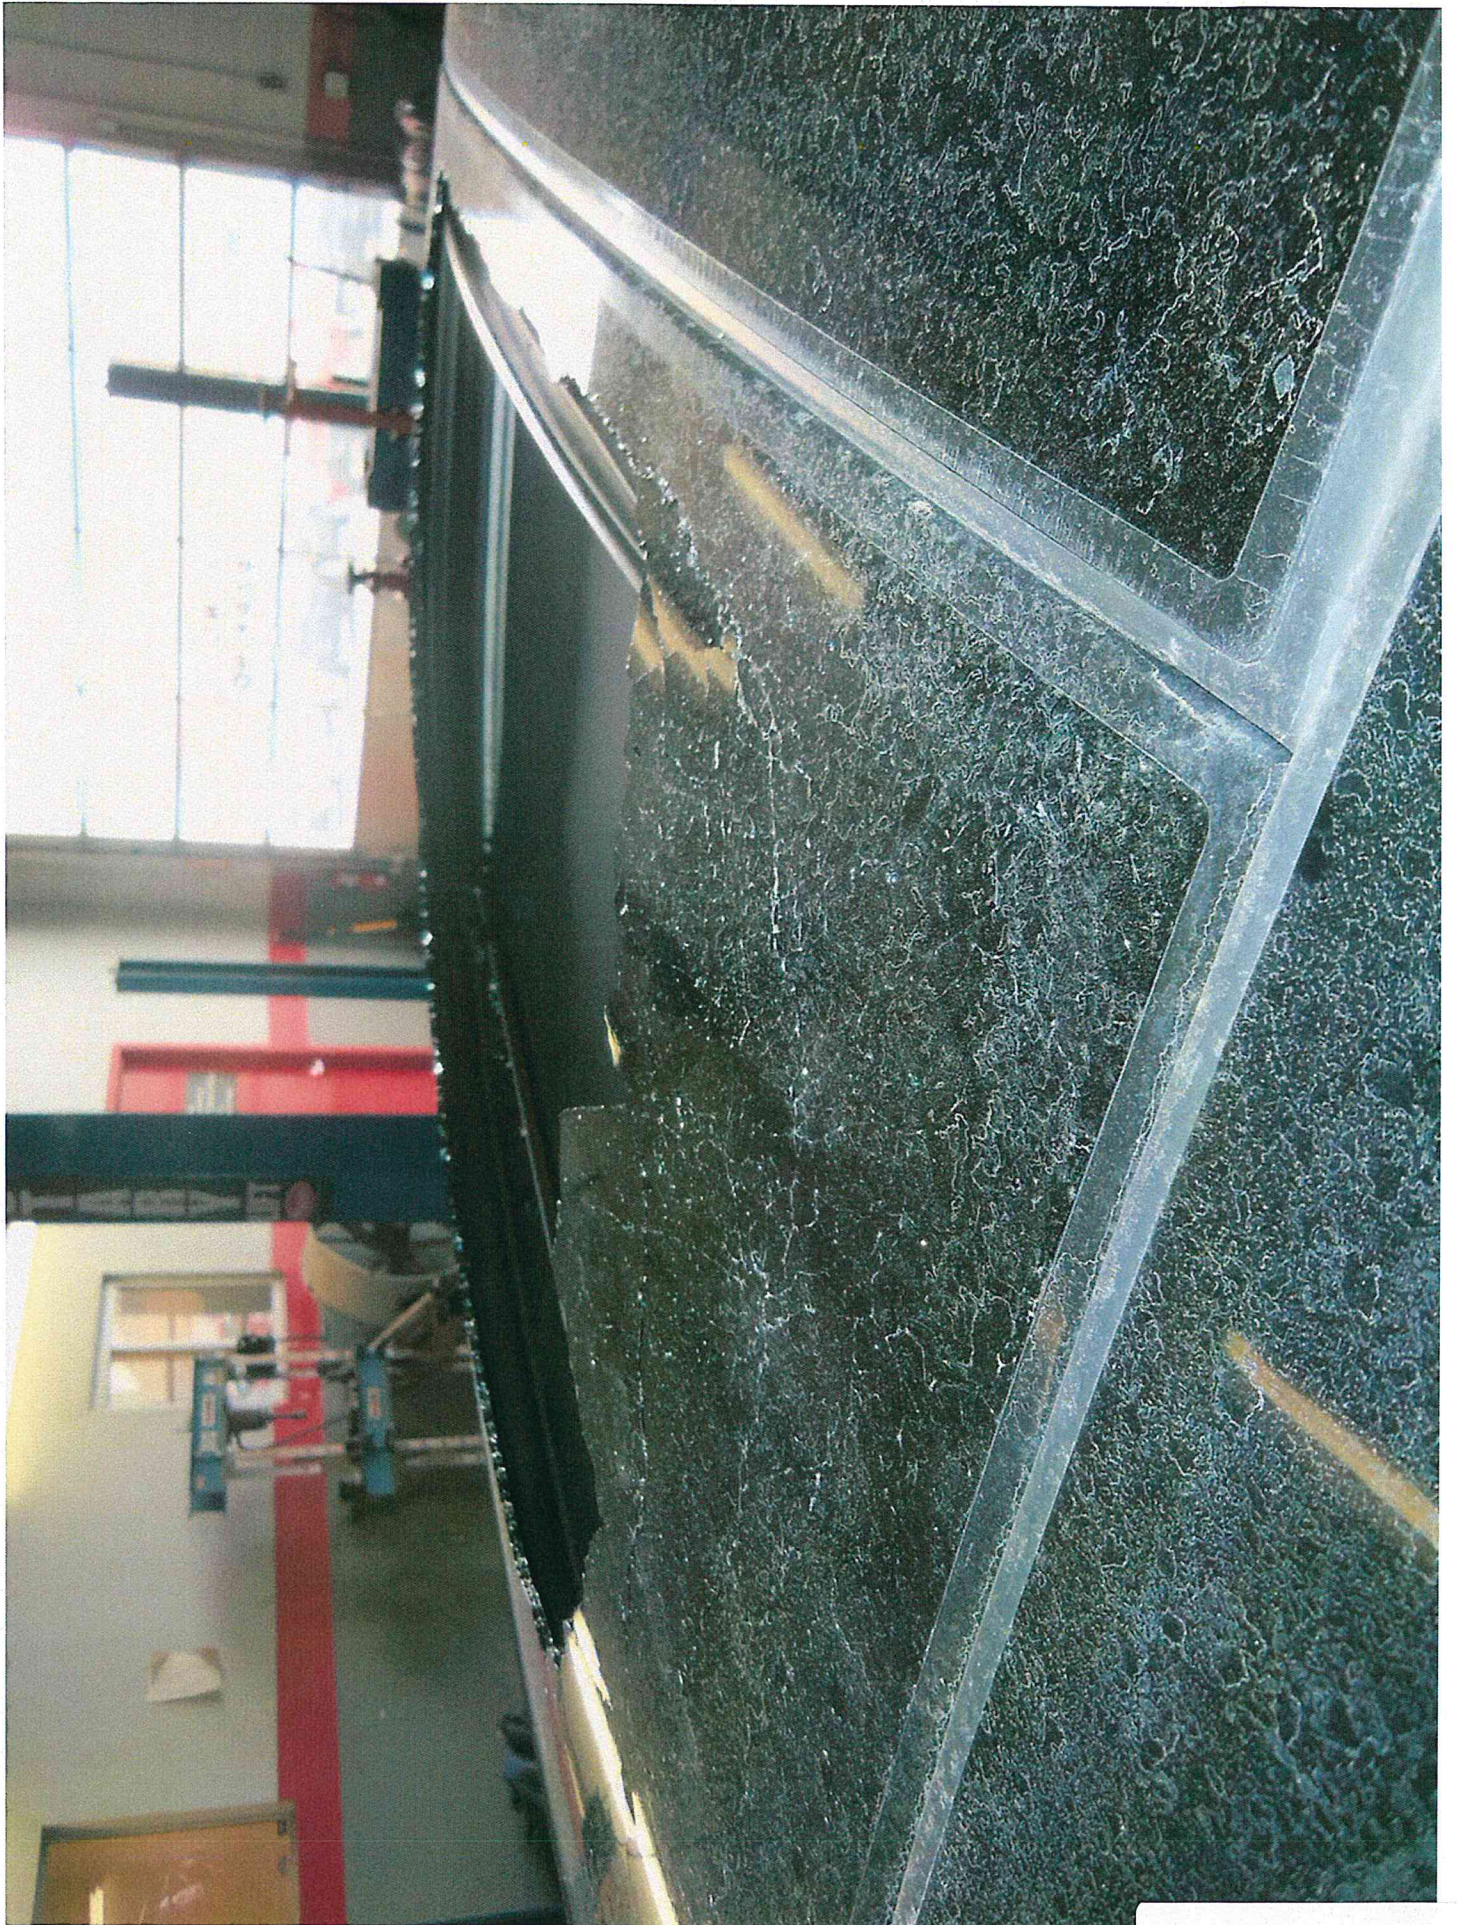
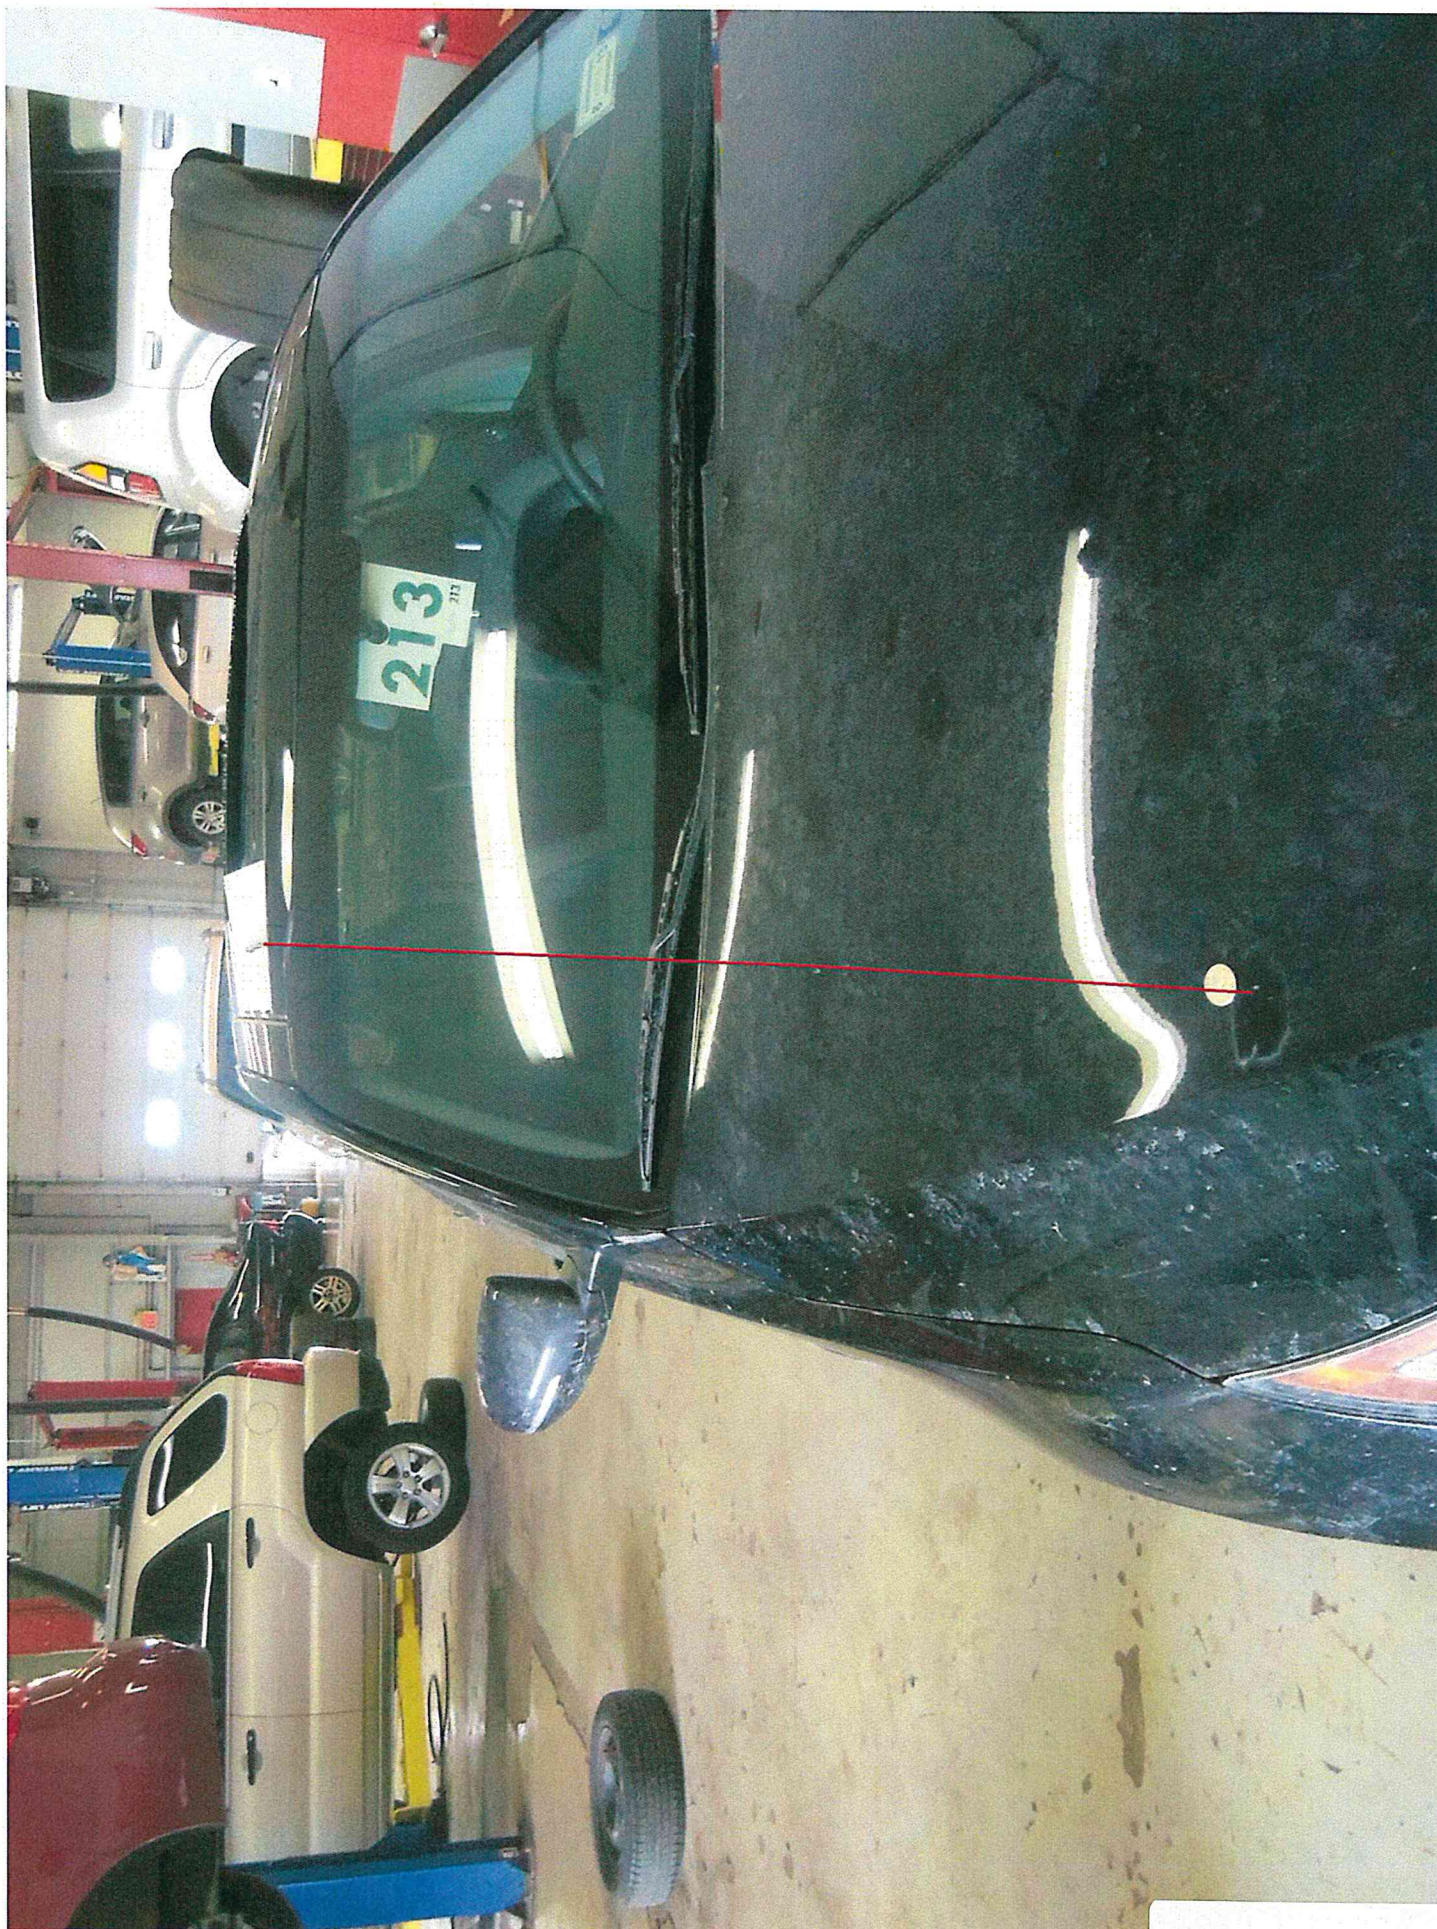
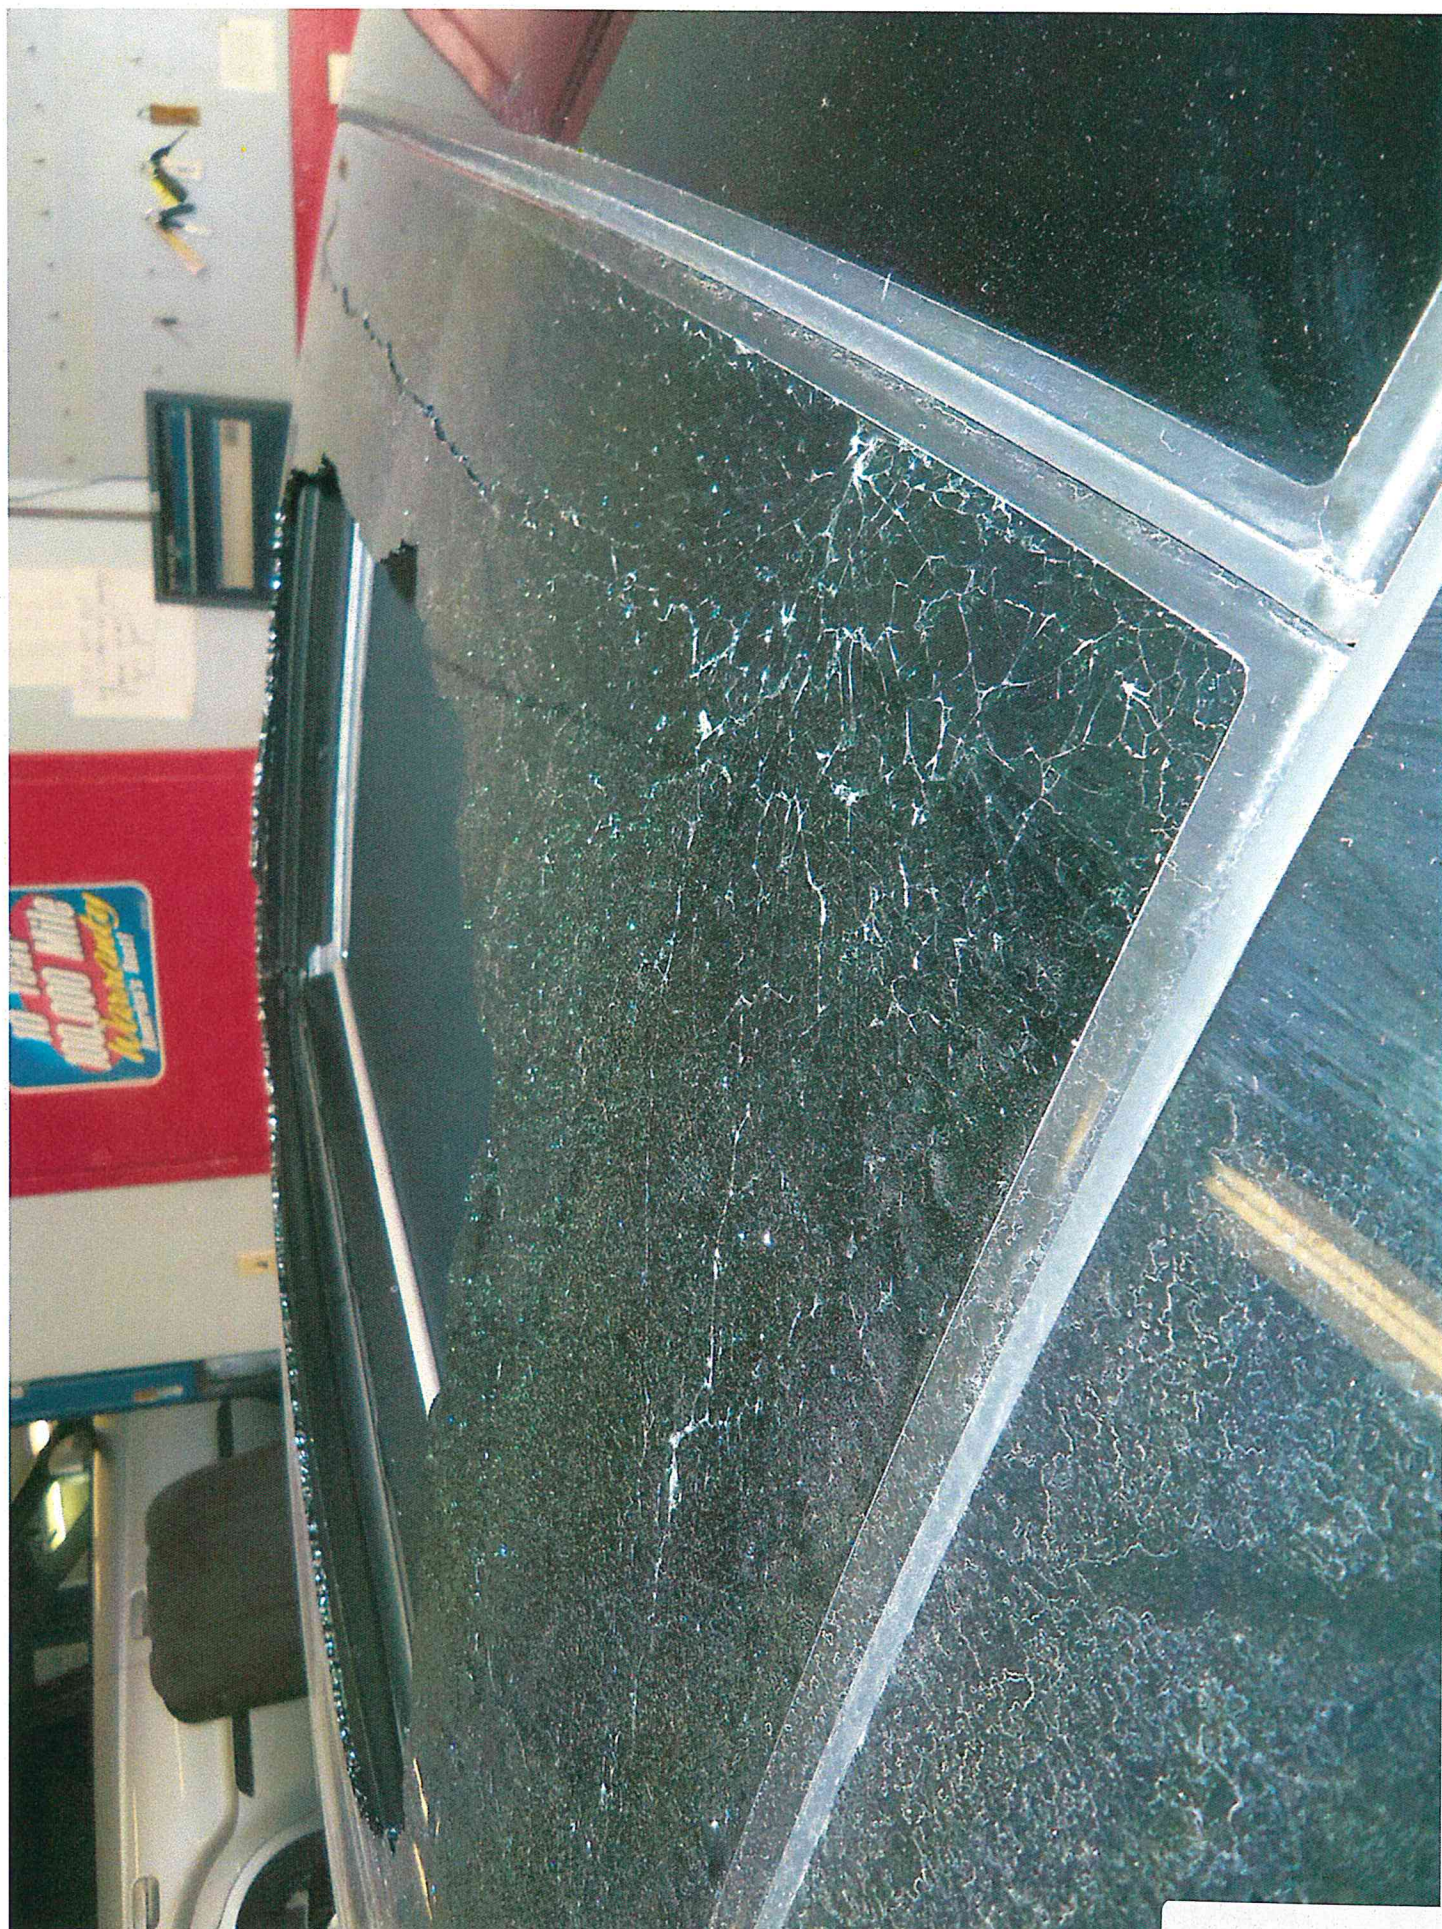
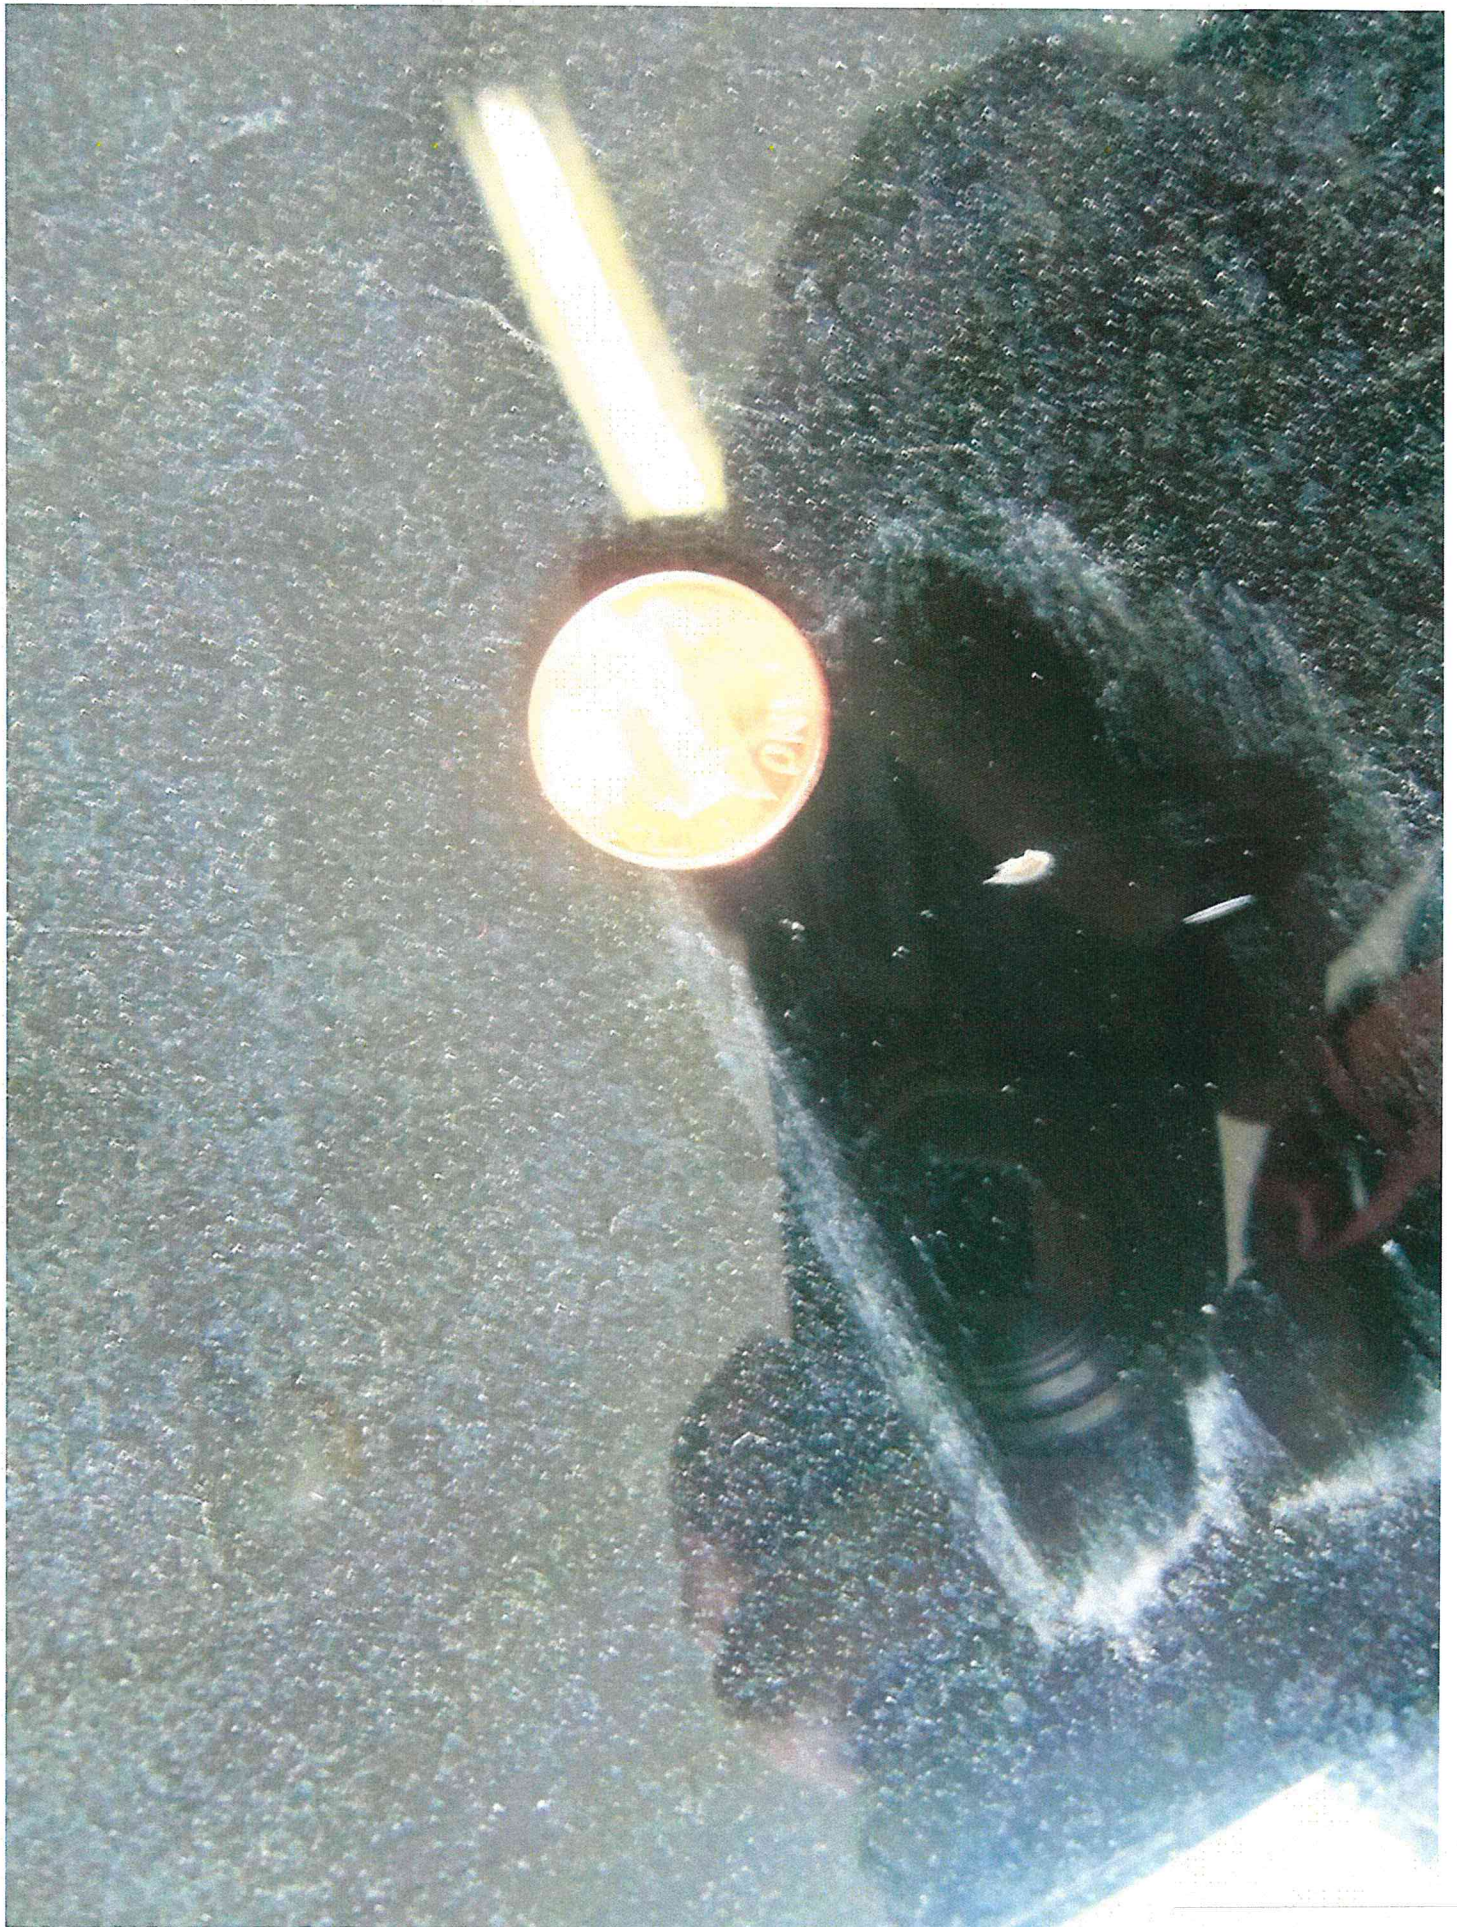
F2485282

FTR inspected vehicle. Roof glass was broken. Inspected glass area for impact. Impact mark was evident on the RF leading edge of the glass (see pics). Inspected the hood and front grill area for any stone chips and initial impact points. There were several stone chips on the hood area. One stone impact on the RF hood area was in direct line of the impact on the leading edge of the sunroof glass. No evidence of defect was found on the glass or sunroof during the inspection. Outside influence by a rock or road debris seems to be the cause of glass failure.

Outside influence by a rock or road debris seems to be the cause of glass failure.

Replacement of the sunroof glass assembly

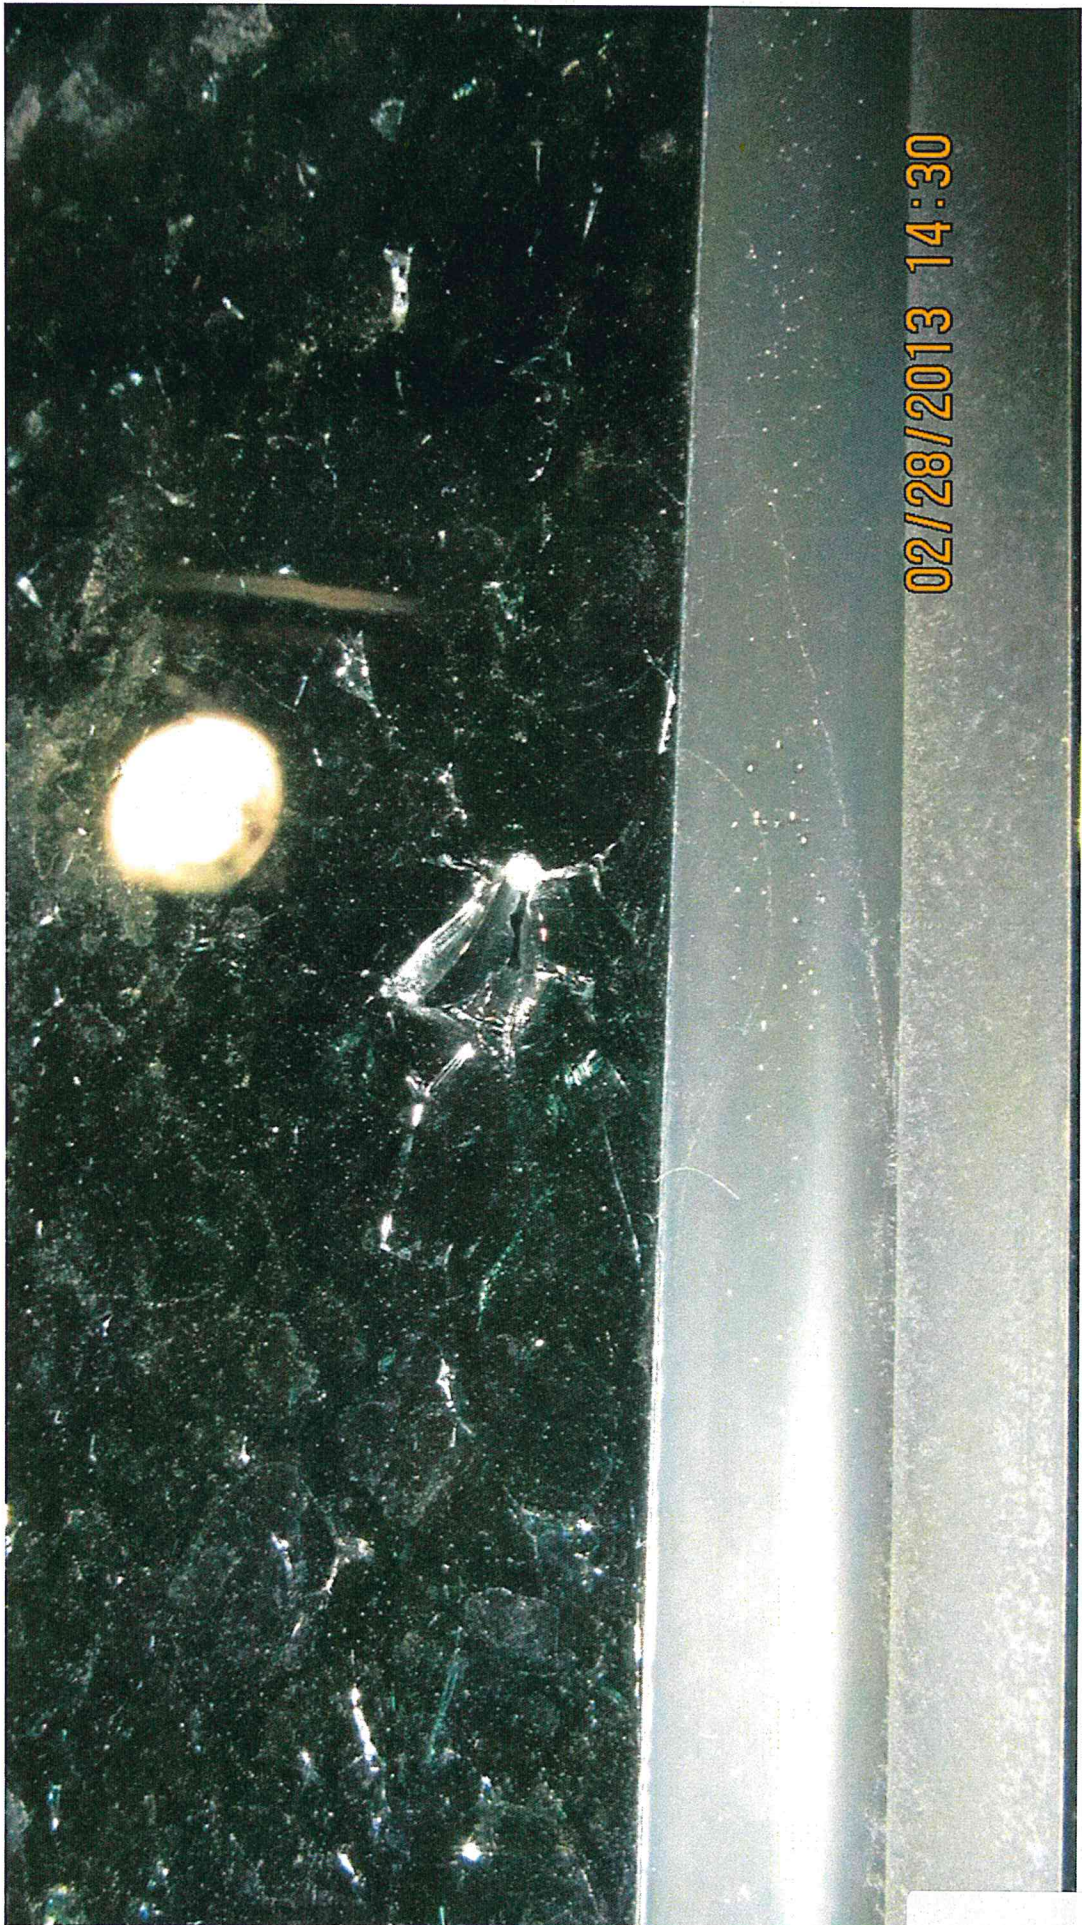
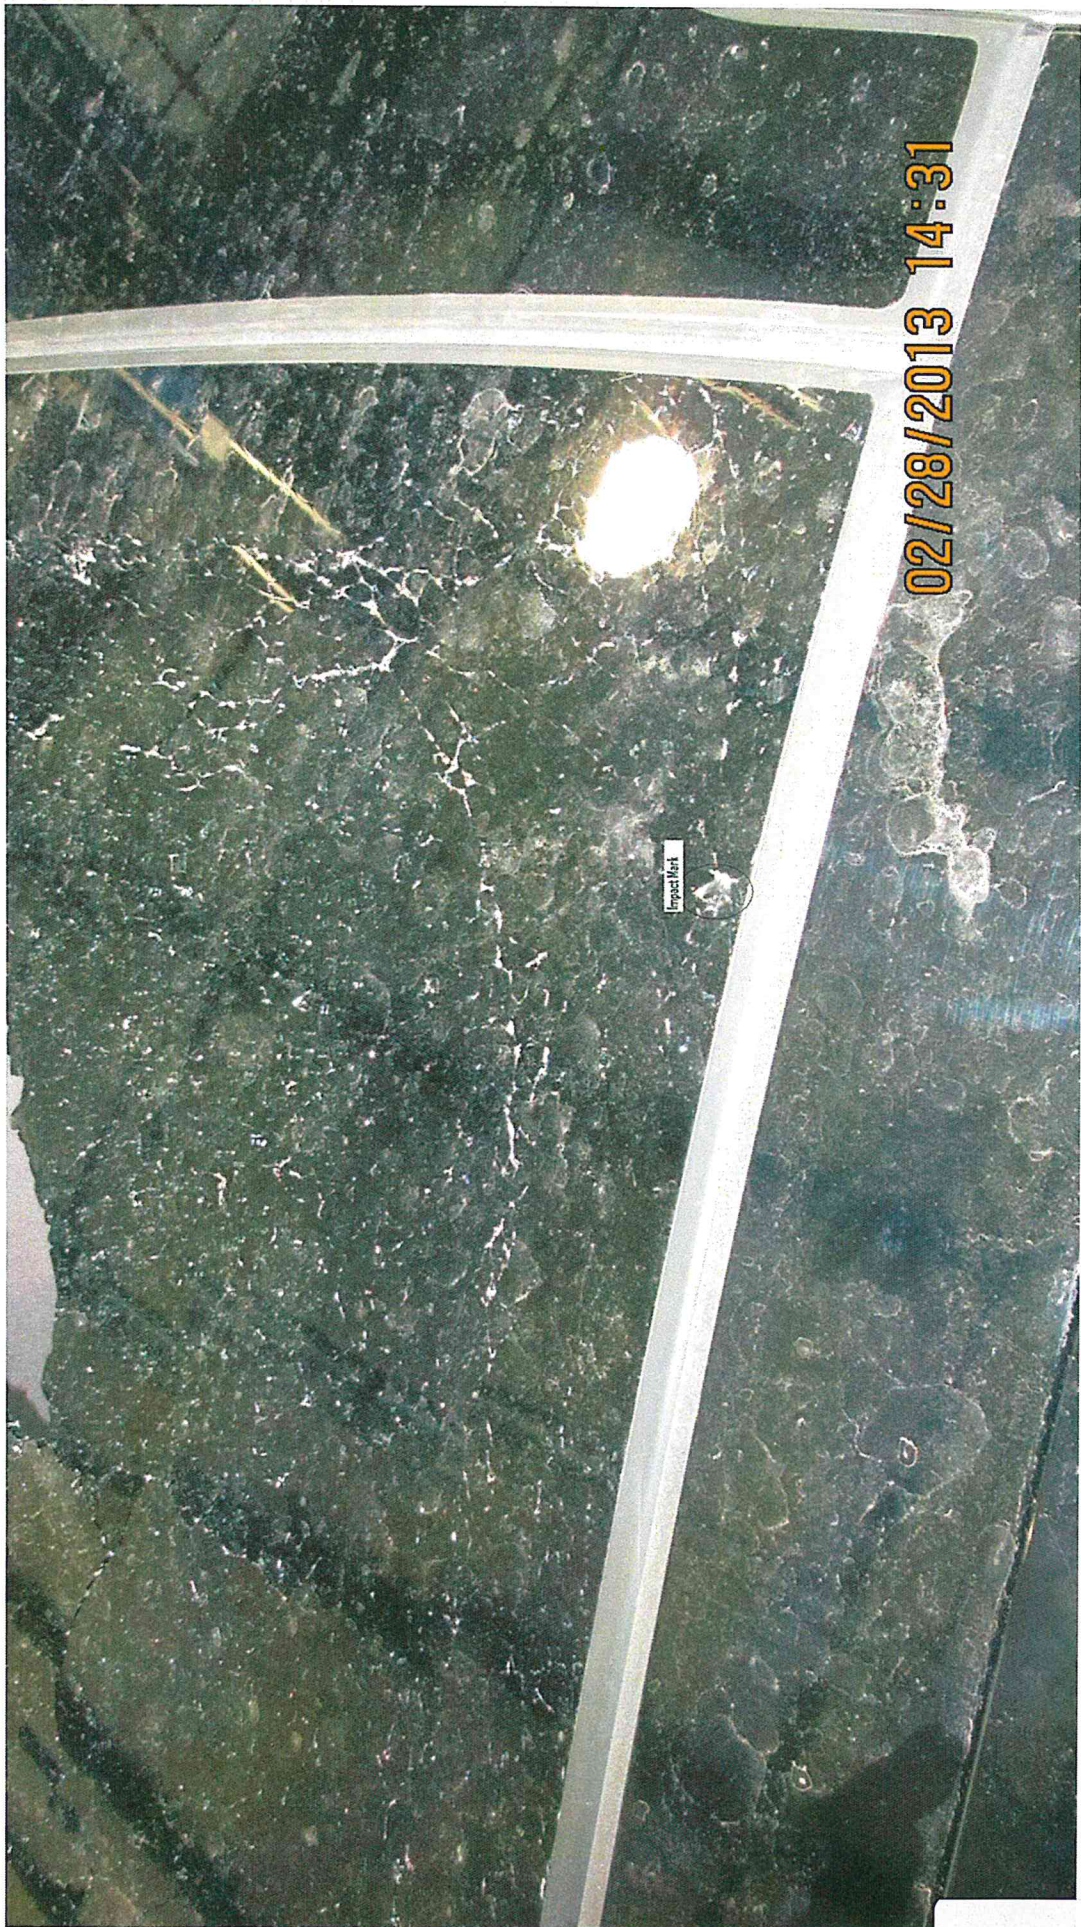
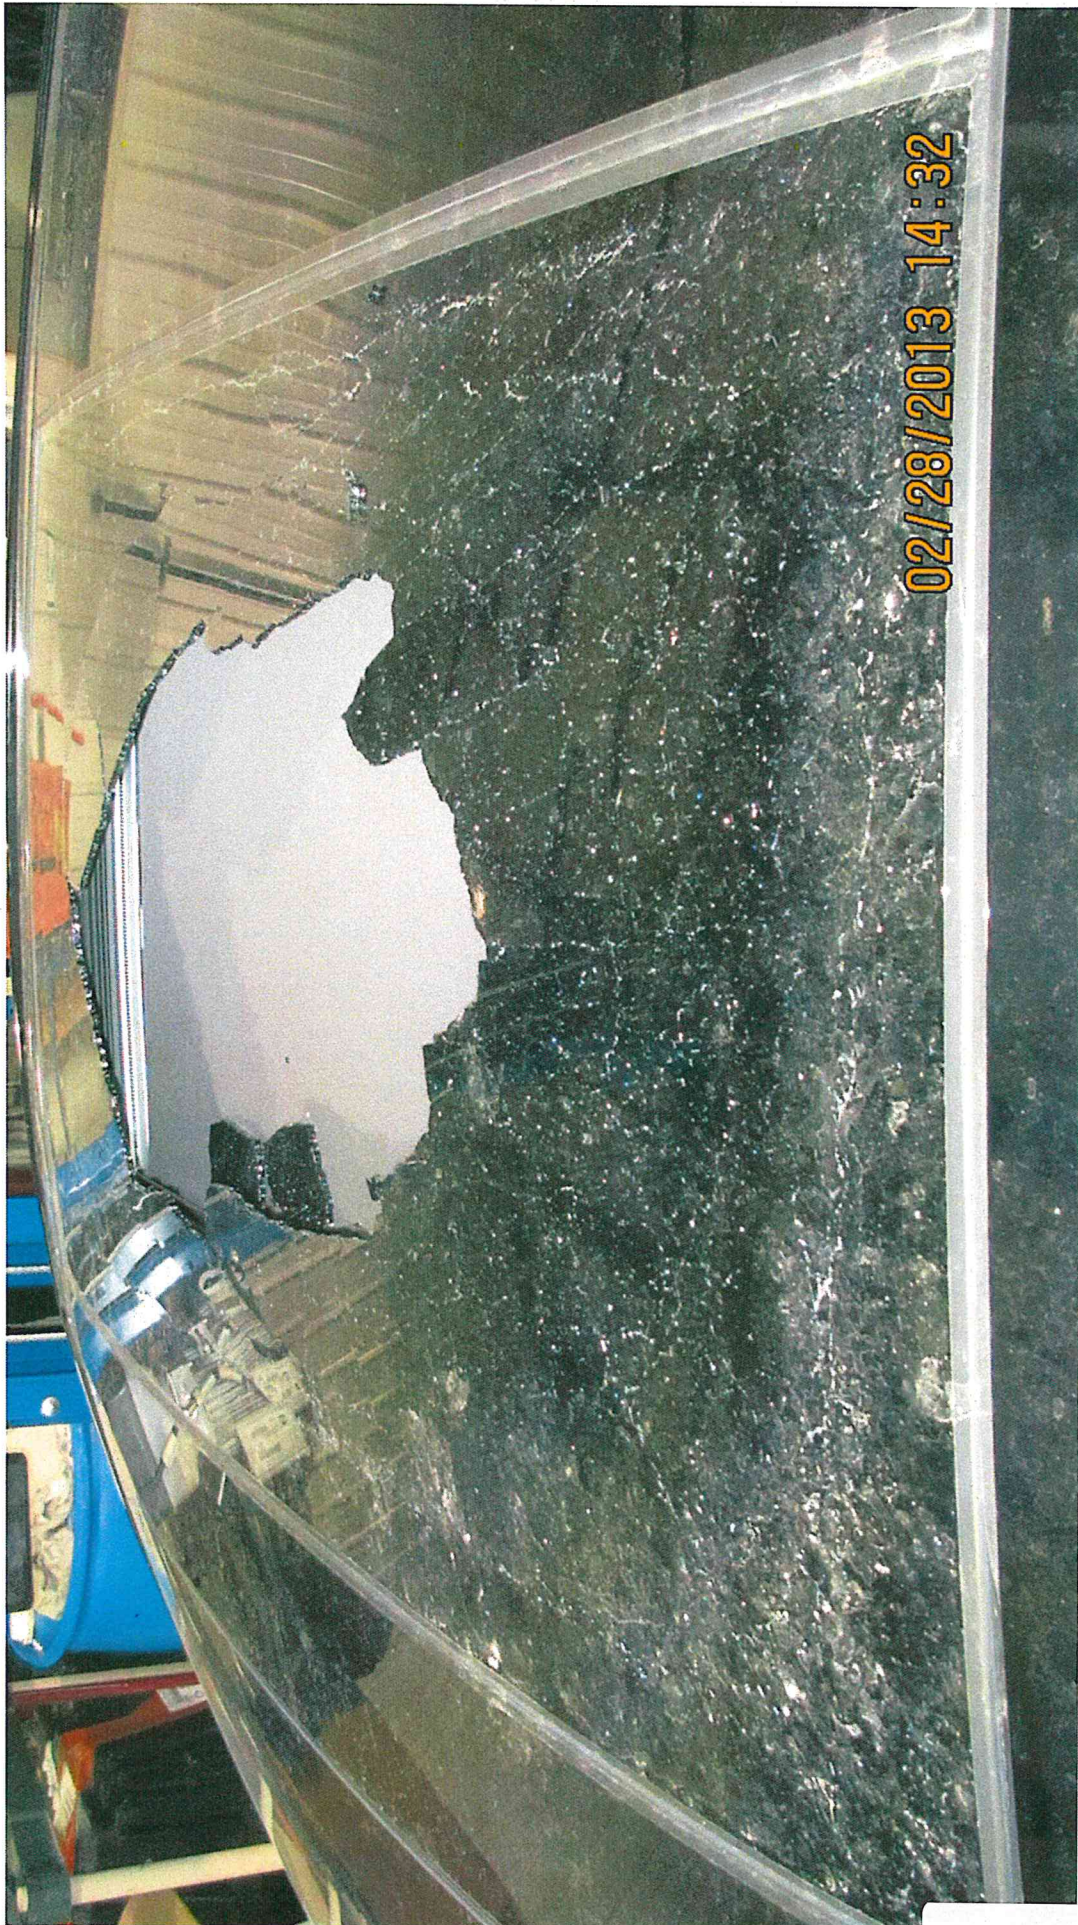
F2485284

Found that the glass had fragmented, and there was a chip, in the glass near the edge at the RF of the sunroof

Replace sunroof glass assembly, clean area of glass. Shipped fragmented glass to Product Quality.
