Kia Motors America
Consumer Affairs Department

Kia Case Type Lvl4: Windshield/Rear Glass(Breakaway)

Broken Sunroof Report

TF – Field Investigation Analysis Report

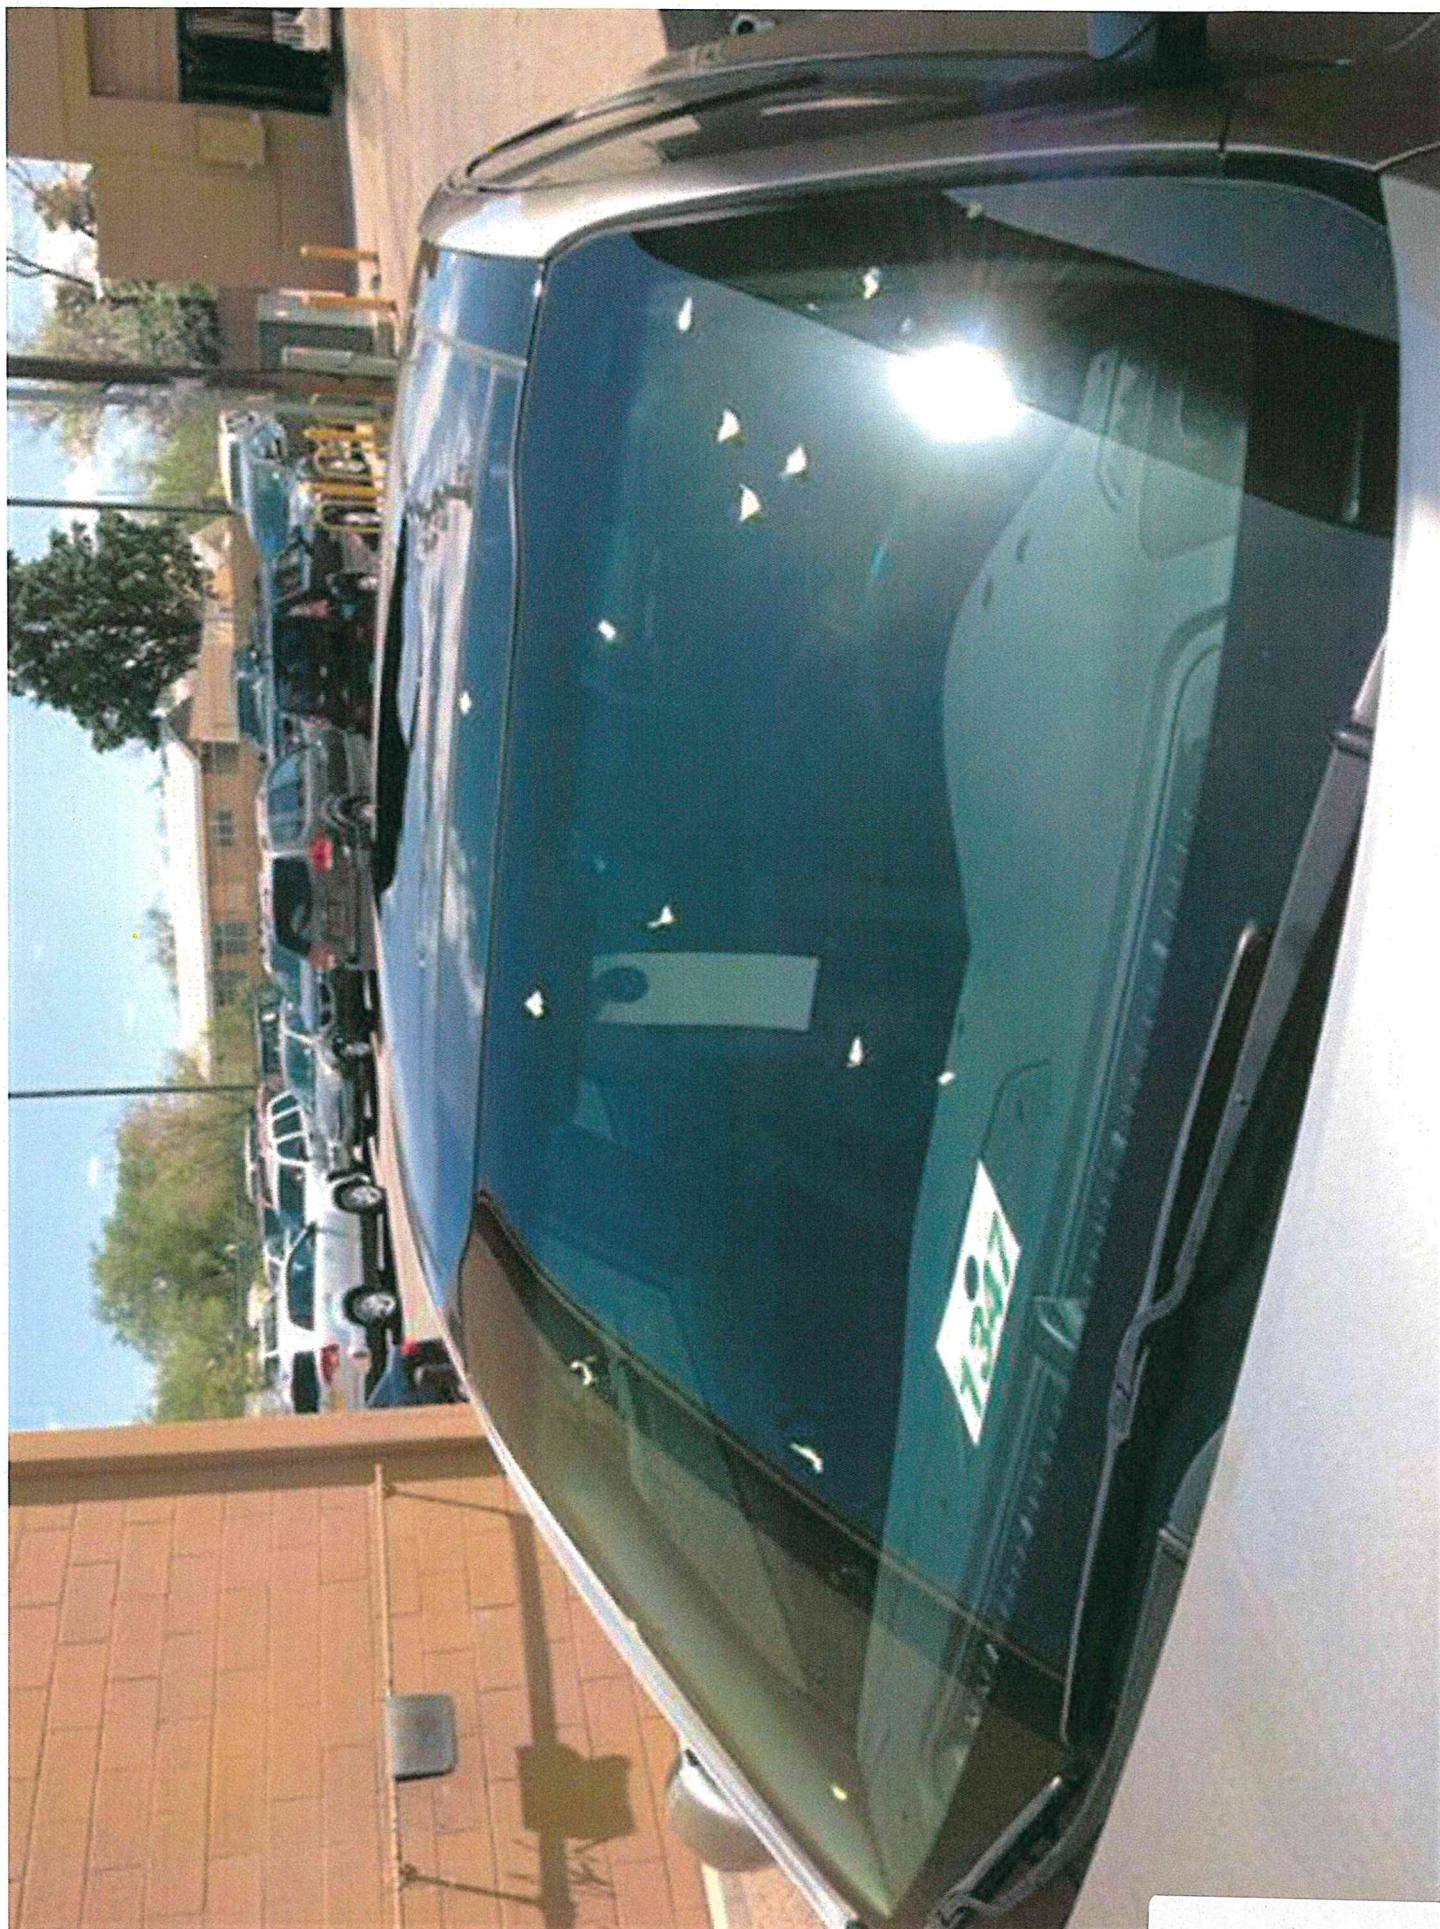
F2486234

POSSIBLE CAUSE

Panoramic sunroof glass assembly was replaced

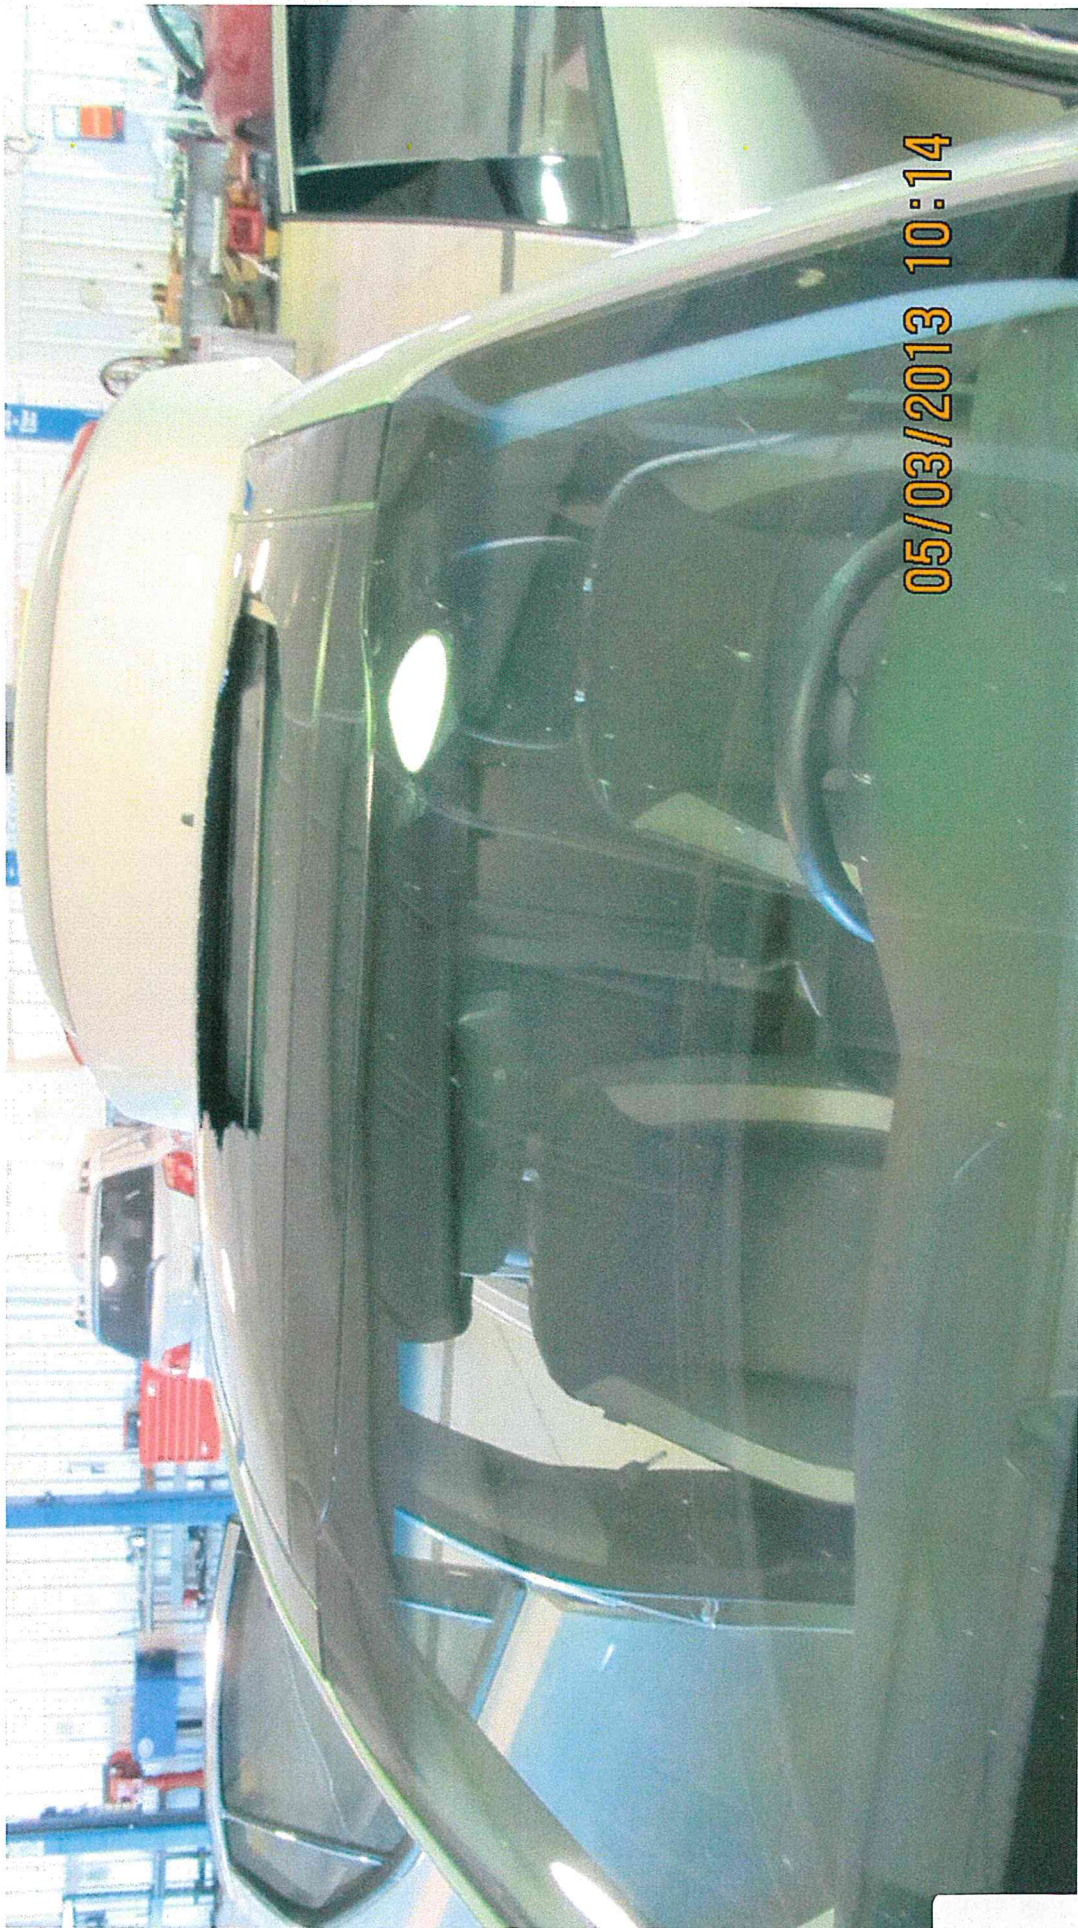
F2486235

Found that the sunroof had shattered while driving. Found scratches on the trunk lid from glass debris.

Replace the sunroof glass.

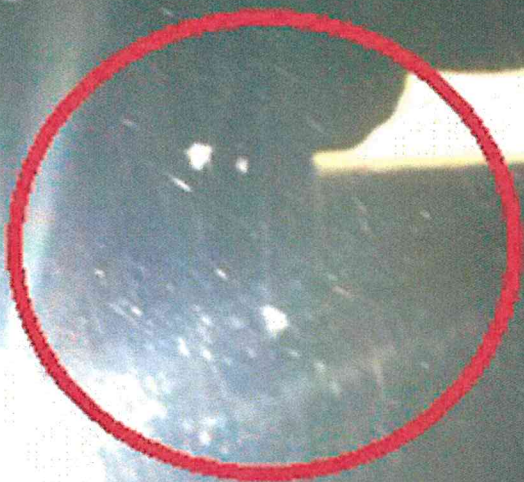
FTR investigated concern. When vehicle was inspected - there was a hole in the movable sunroof glass. The sunroof glass was taped with packing tape on the outside and blue painters tape on the broken hole area. The glass had a hole approximately the size of a basketball. The glass appeared to have an upward bow. There was some residual glass on the inside of the vehicle - but I was informed that a majority of the glass in the interior was cleaned by the customer. The outside of the vehicle was inspected and a rock chip was found on the hood. There was also cuts and gouges in the rear deck lid surface. I was informed by the service manager that the customer stated that they were traveling on the highway (Route 80 in NJ) and the sunroof was in the "vent" position. They then heard a loud "Gunshot" type sound and glass began to fall. The drivers window was also in the open position.

Rock Chip in hood

Repair and refinish the rear deck lid surface - replace panoramic sunroof movable glass - clean interior of vehicle.
Techline case - T2480594

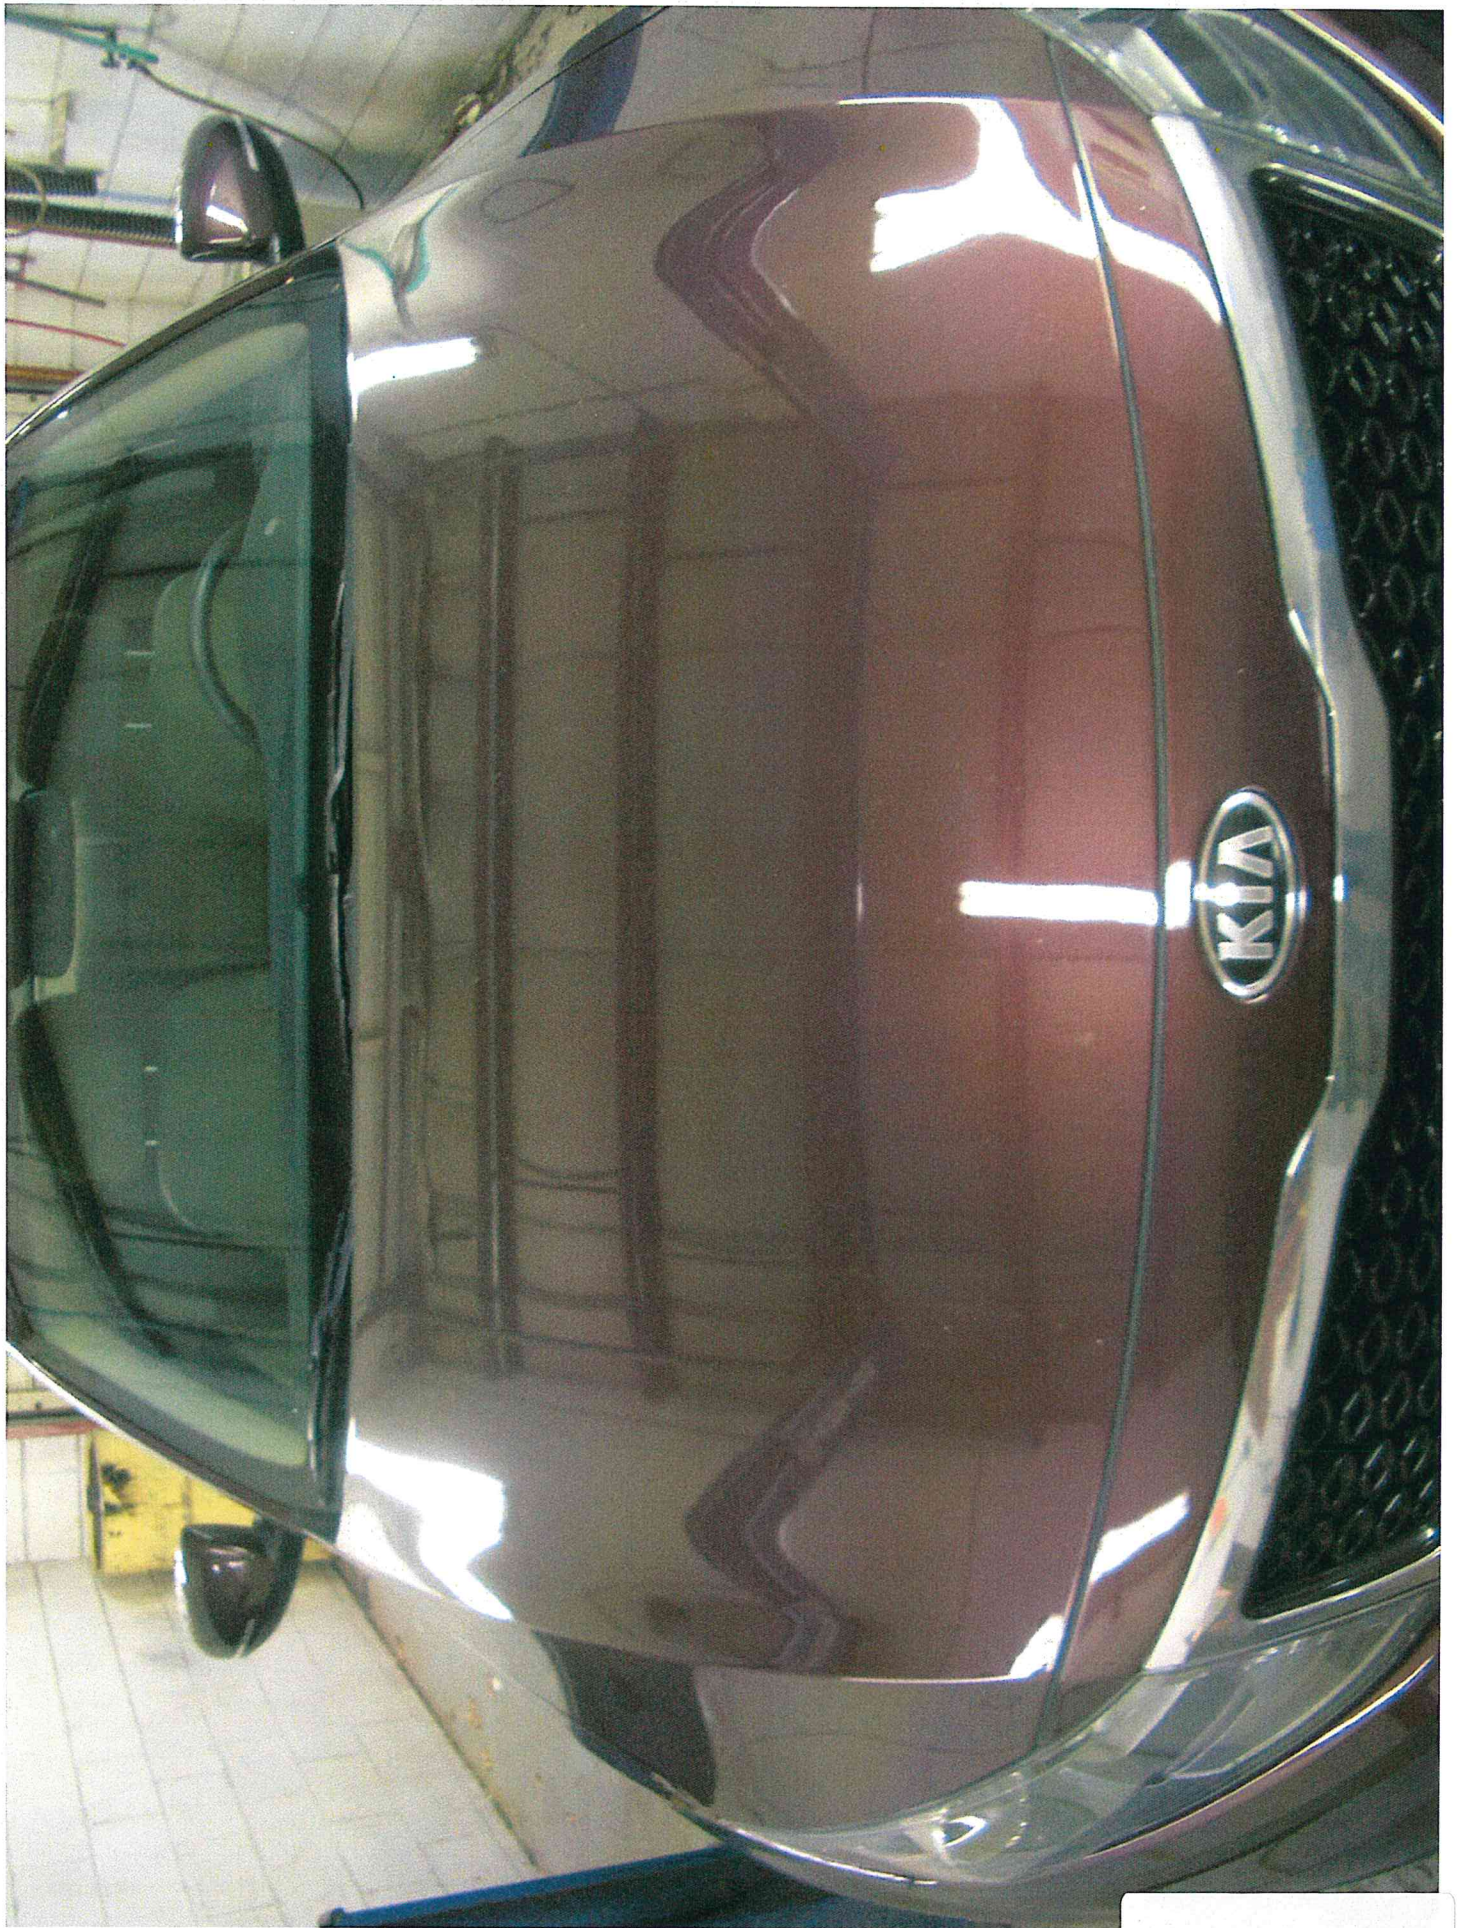
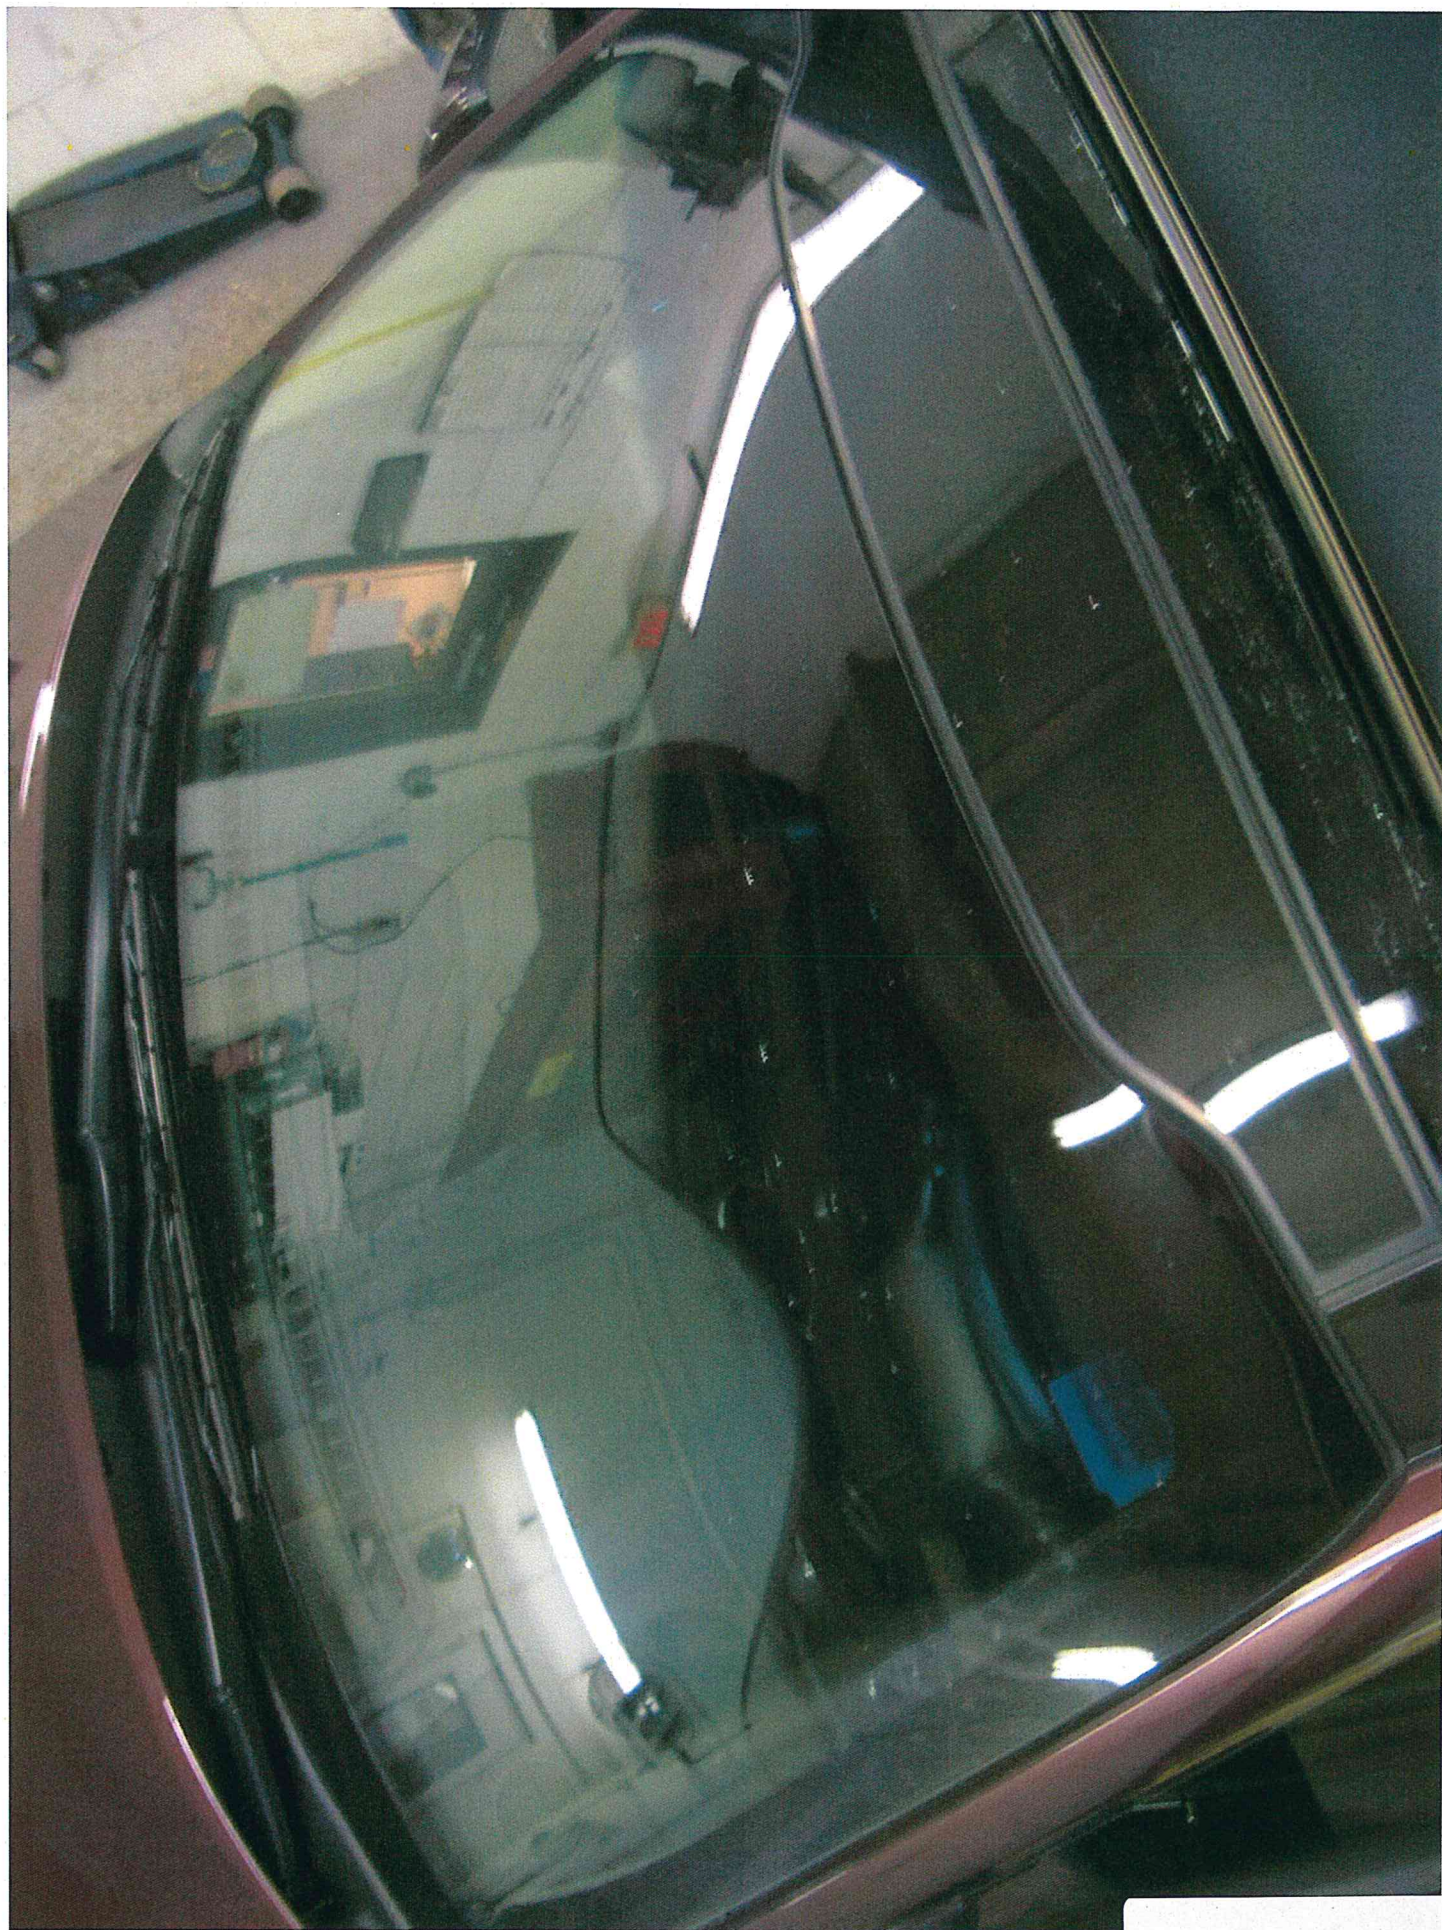
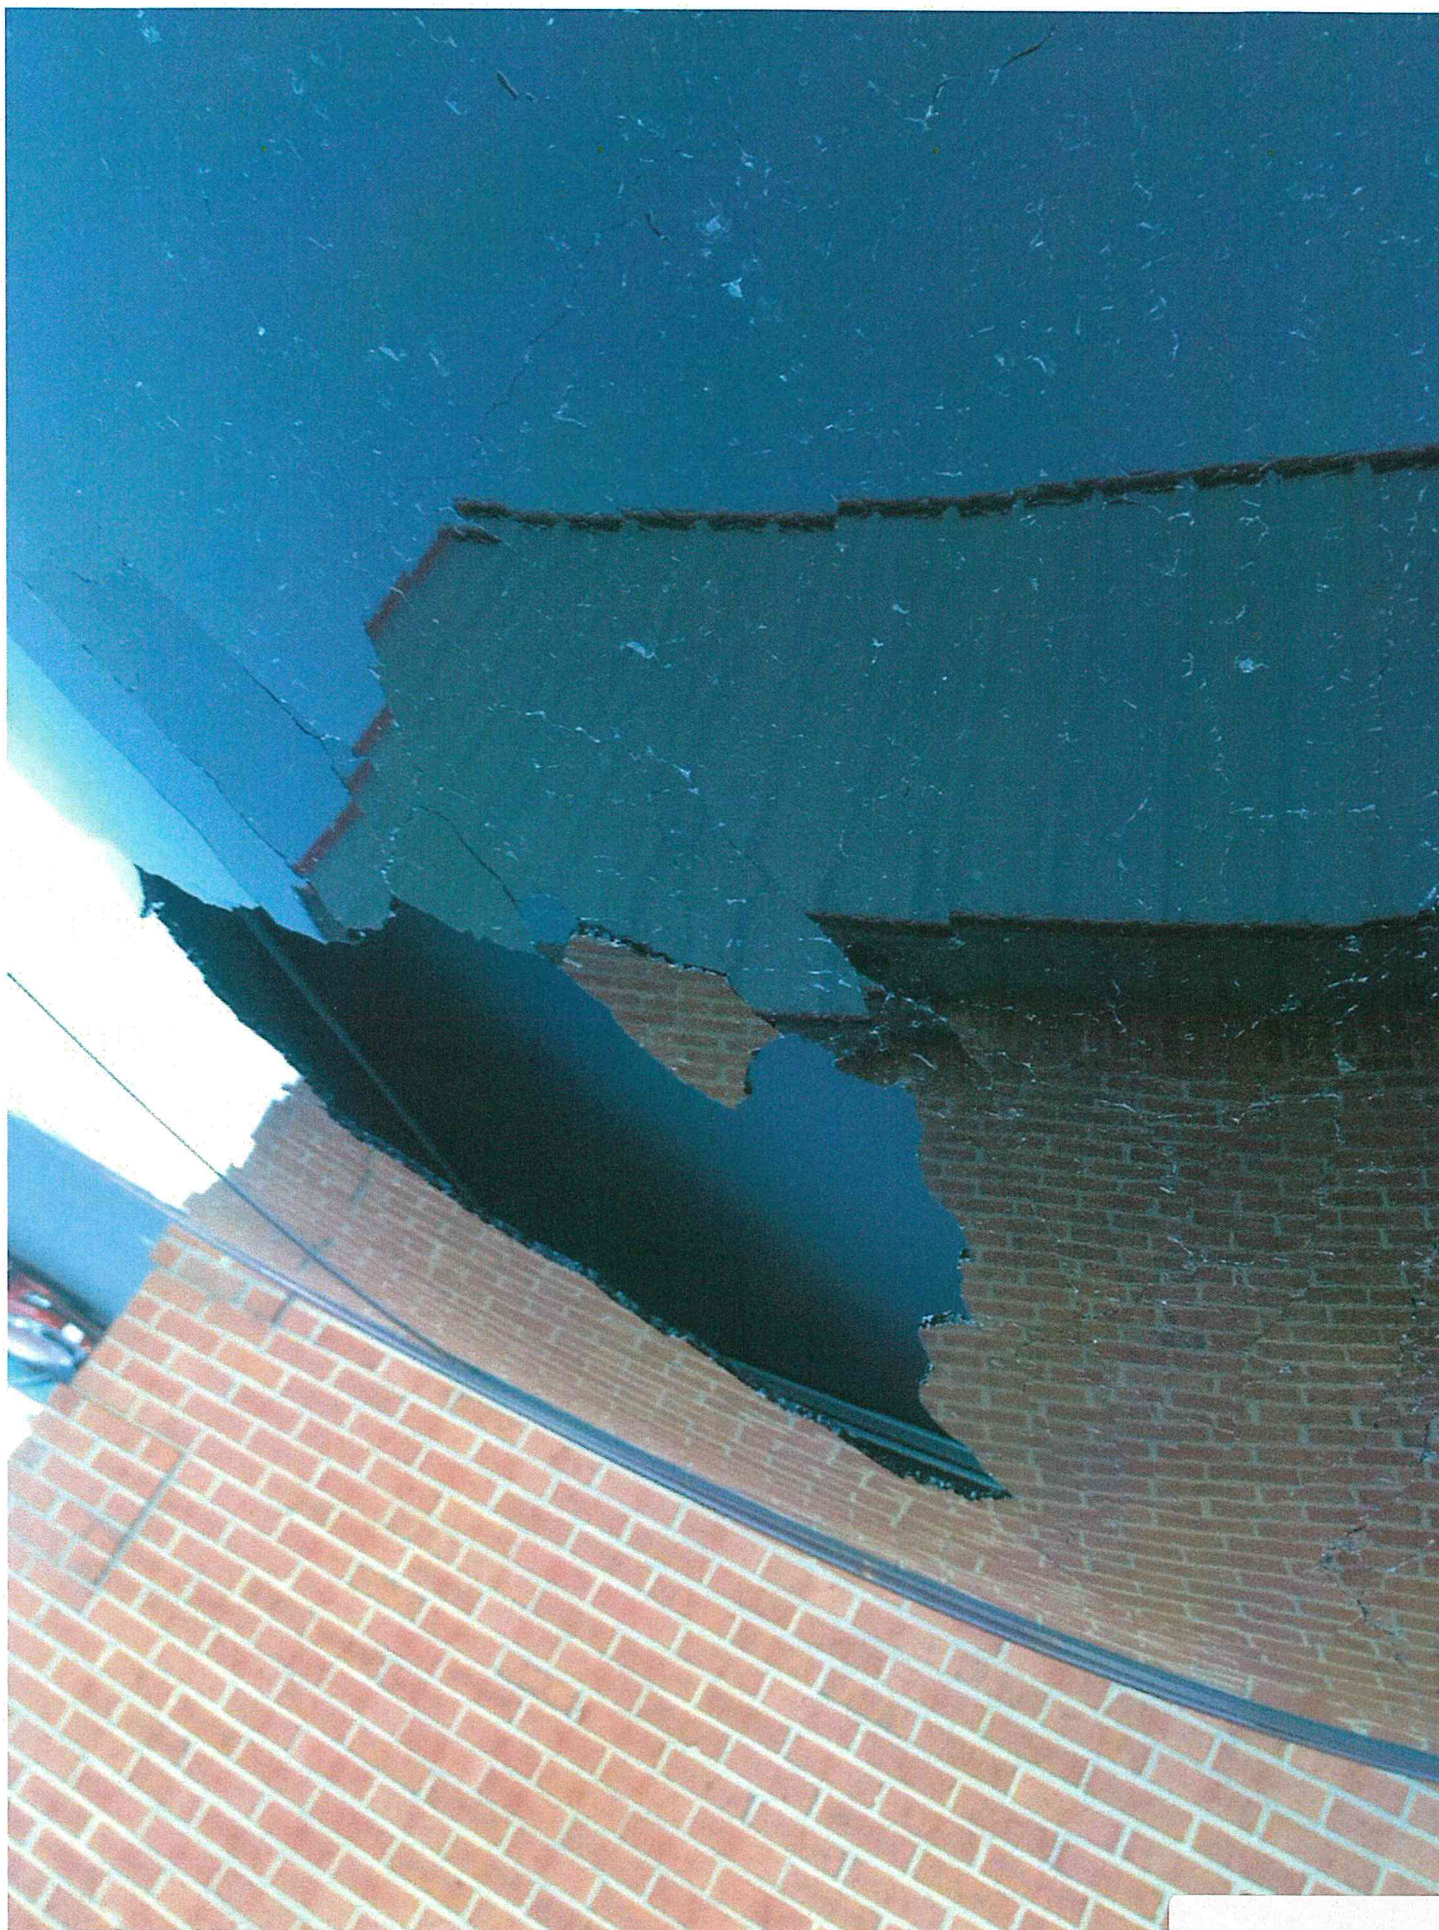
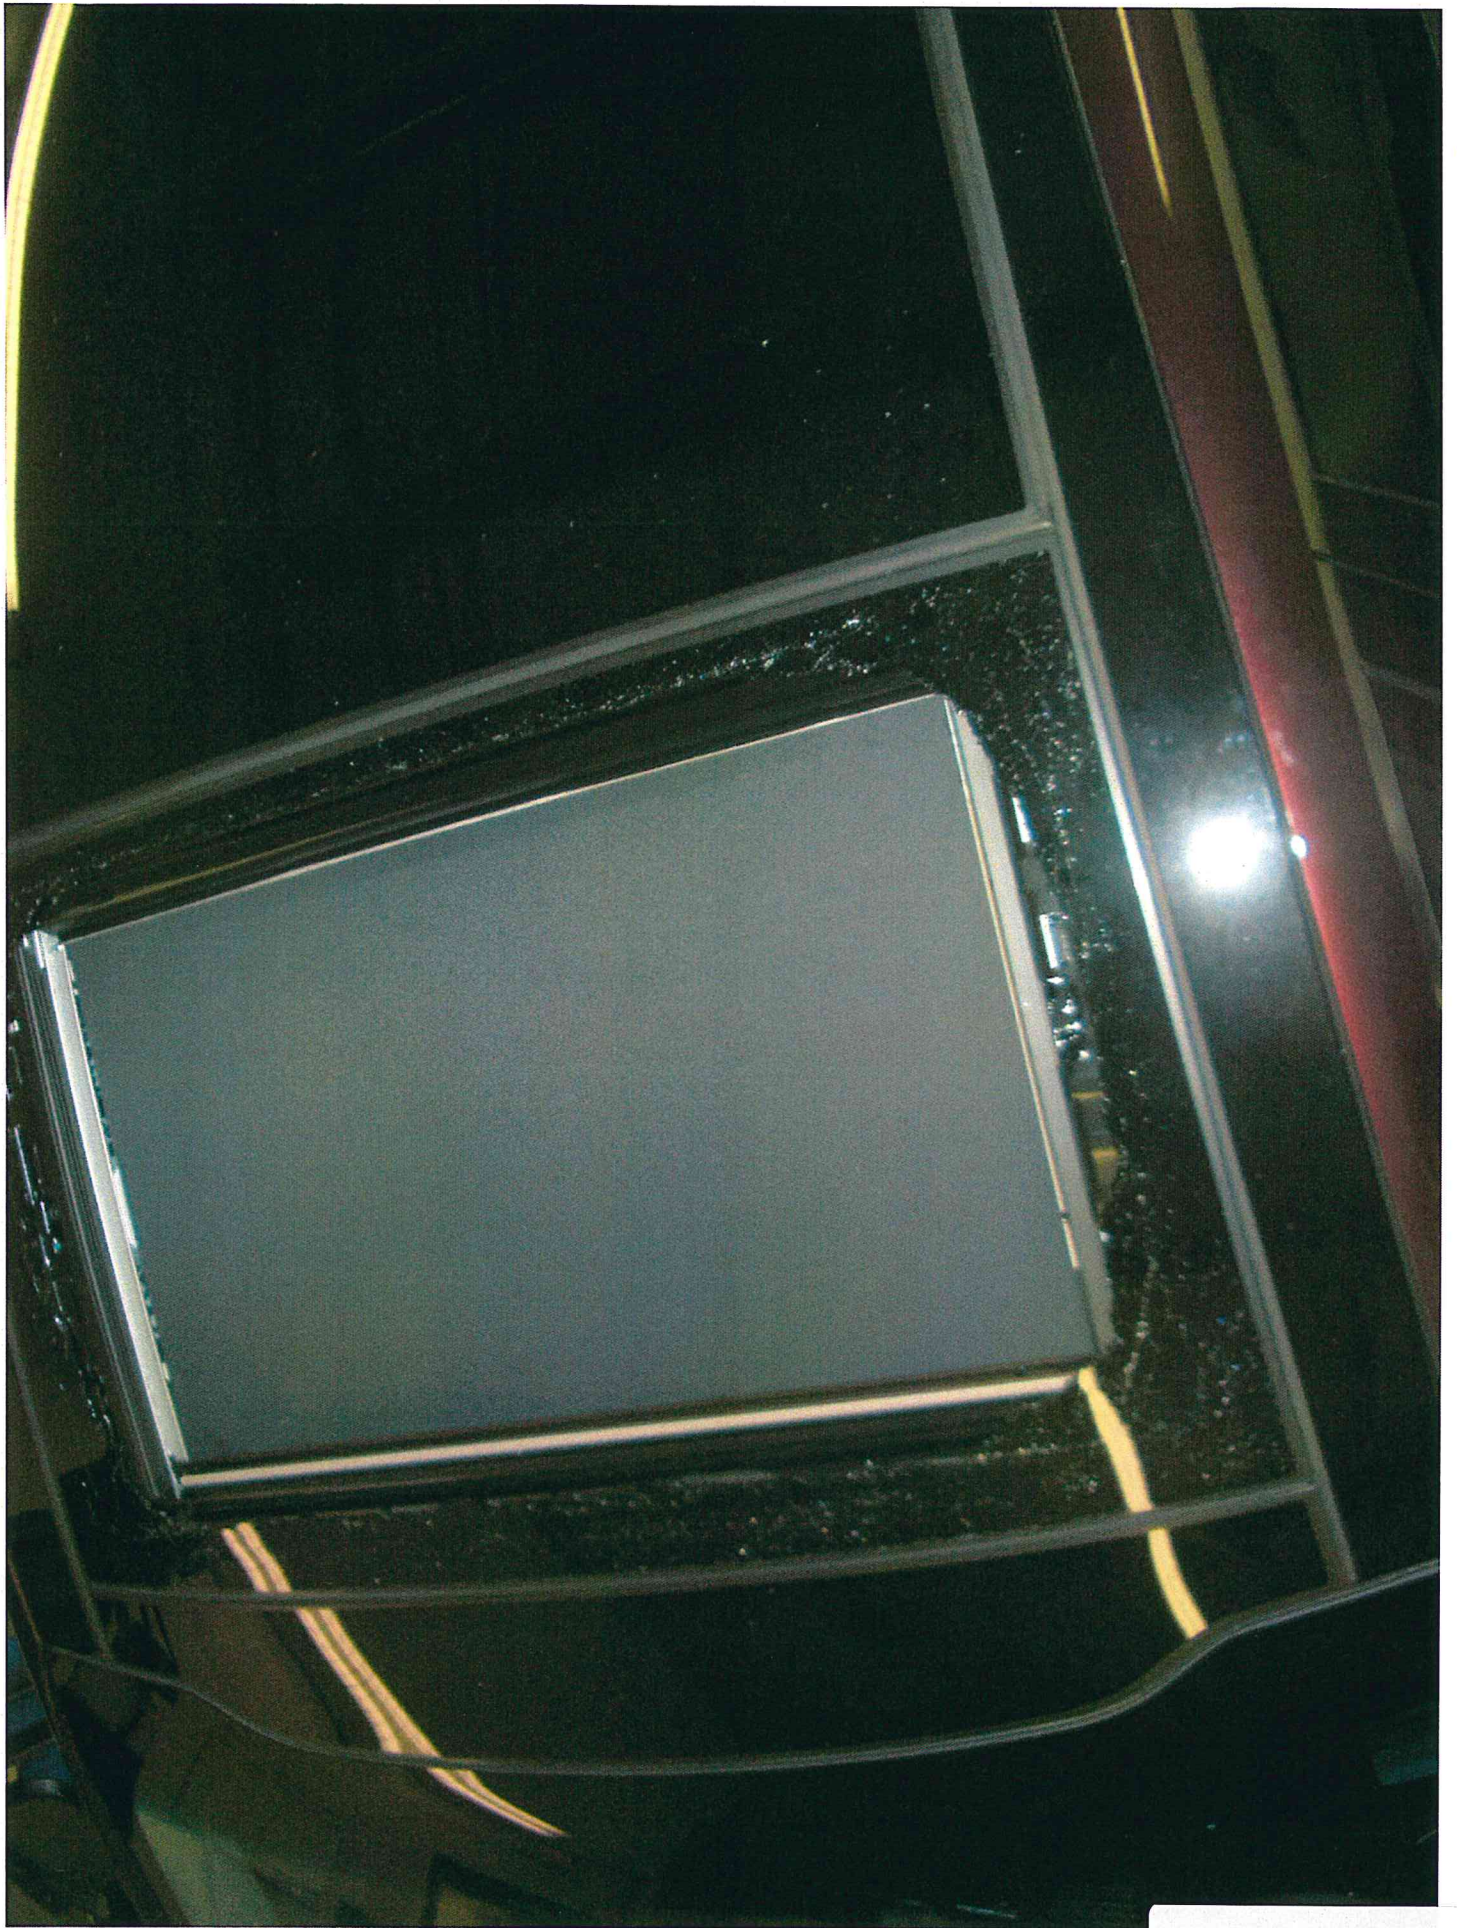
F2499501

FTR inspected the subject vehicle for concern of sunroof shatter. During my inspection I found the sunroof was totally shattered. The sunroof shade was closed and no glass on the shade because the dealer vacuumed off. I found the glass chips traveled back and hit the rear deck lid. From the information I gather, it is possible that the glass shattered due to impact, but it is difficult to determine point of impact.

Replaced the sunroof panel.
