Kia Motors America Field Product Quality Report

Subject/Title: Panoramic Roof Investigation

Model Desc: SORENTO EX 4

Subject/Title: Shattered Sunroof

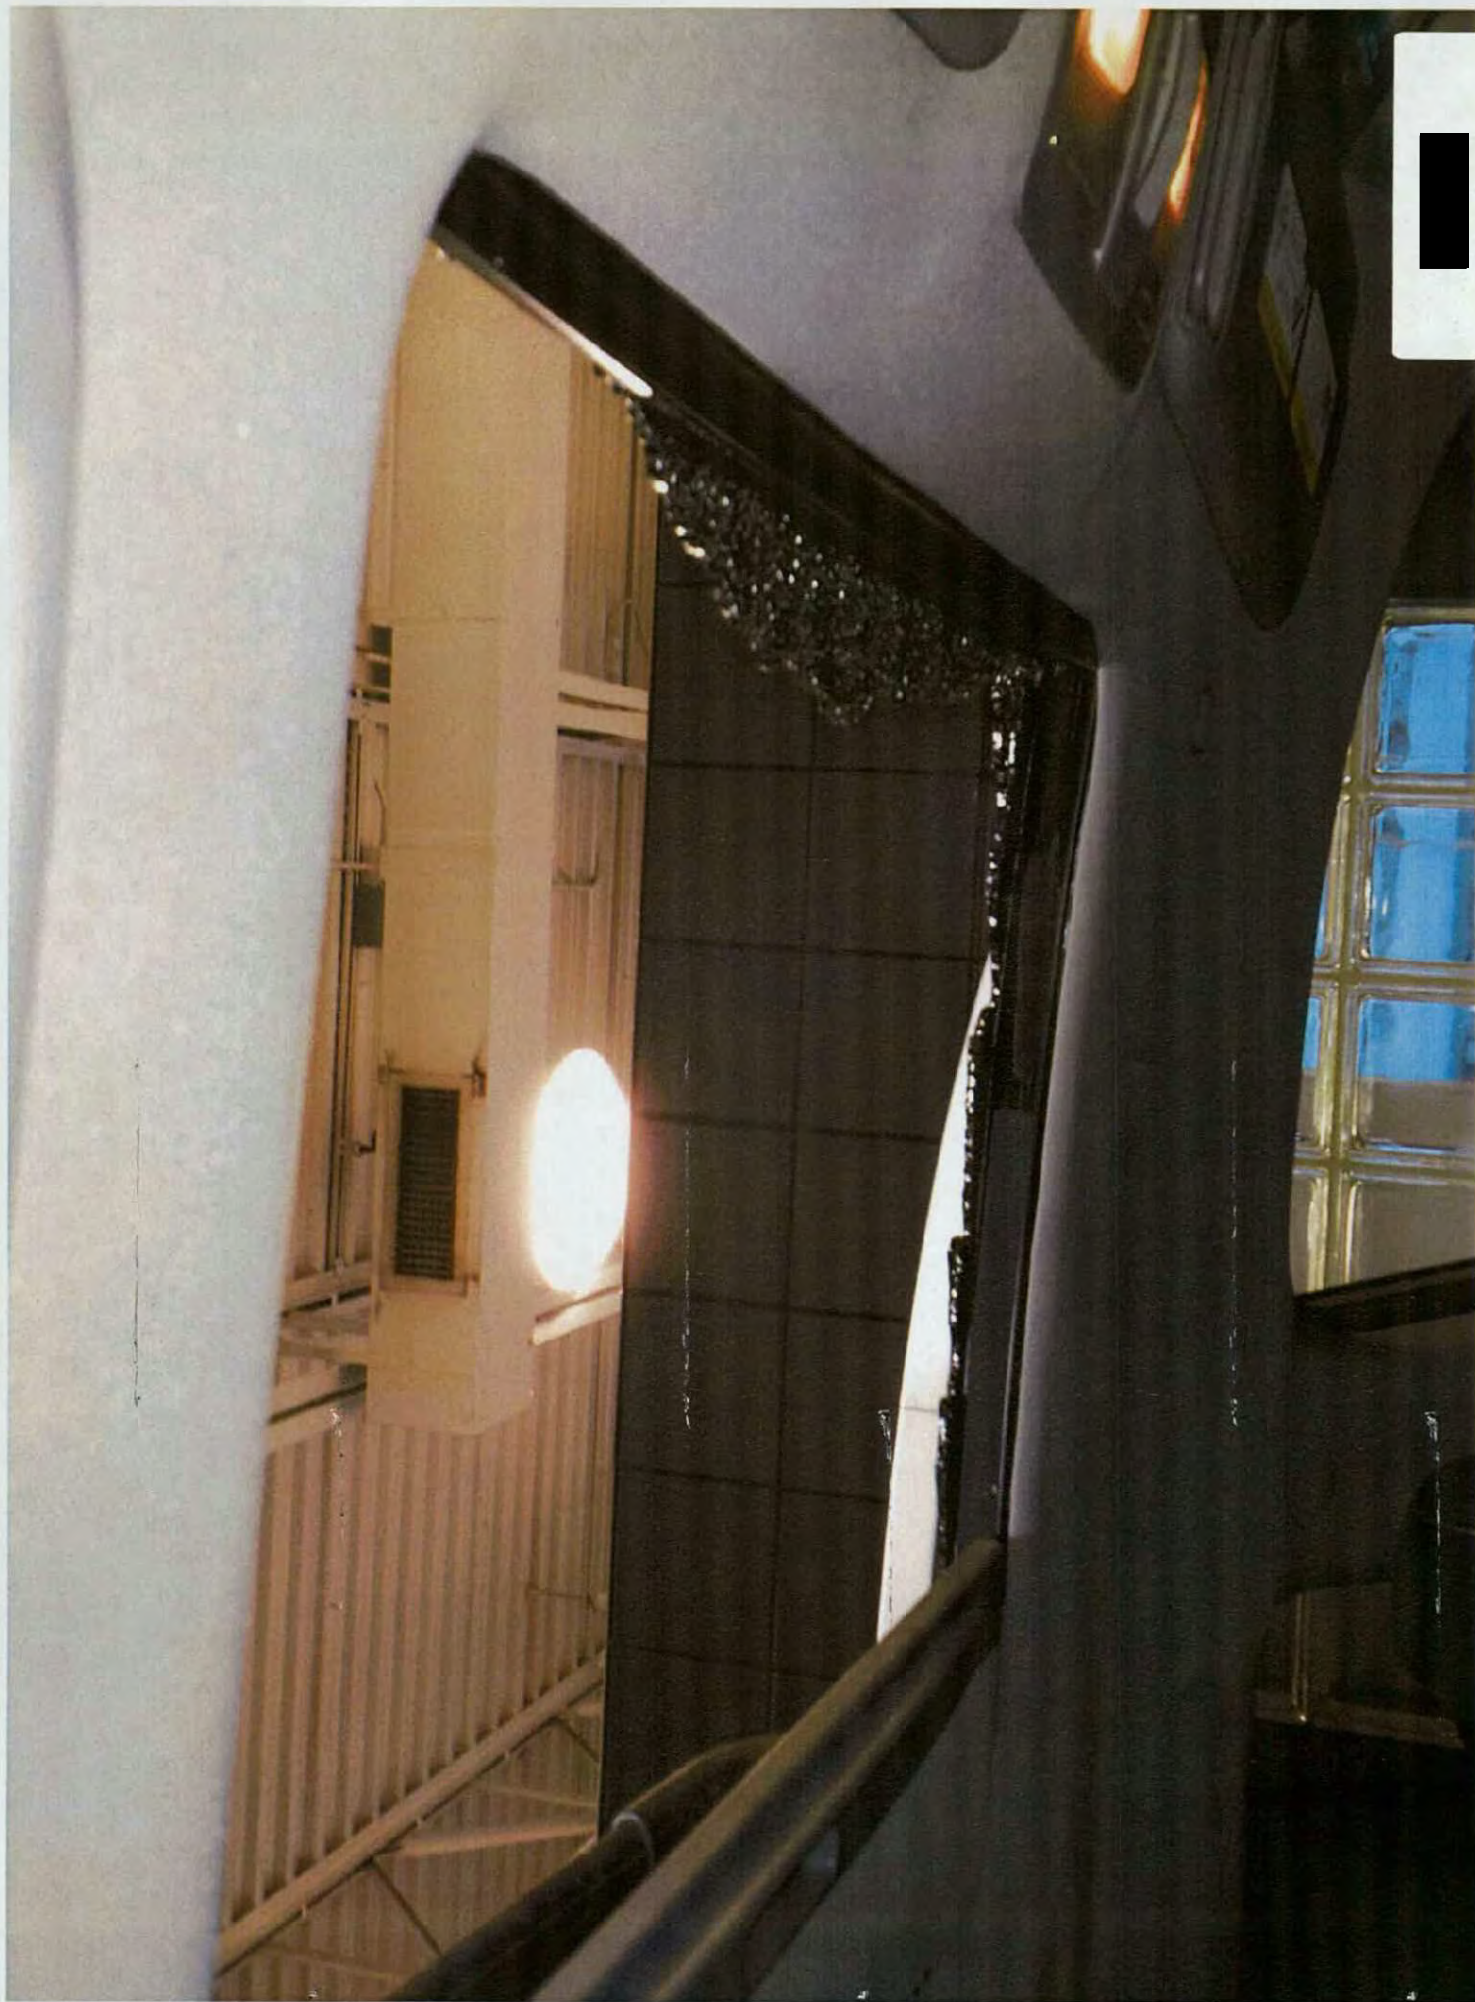
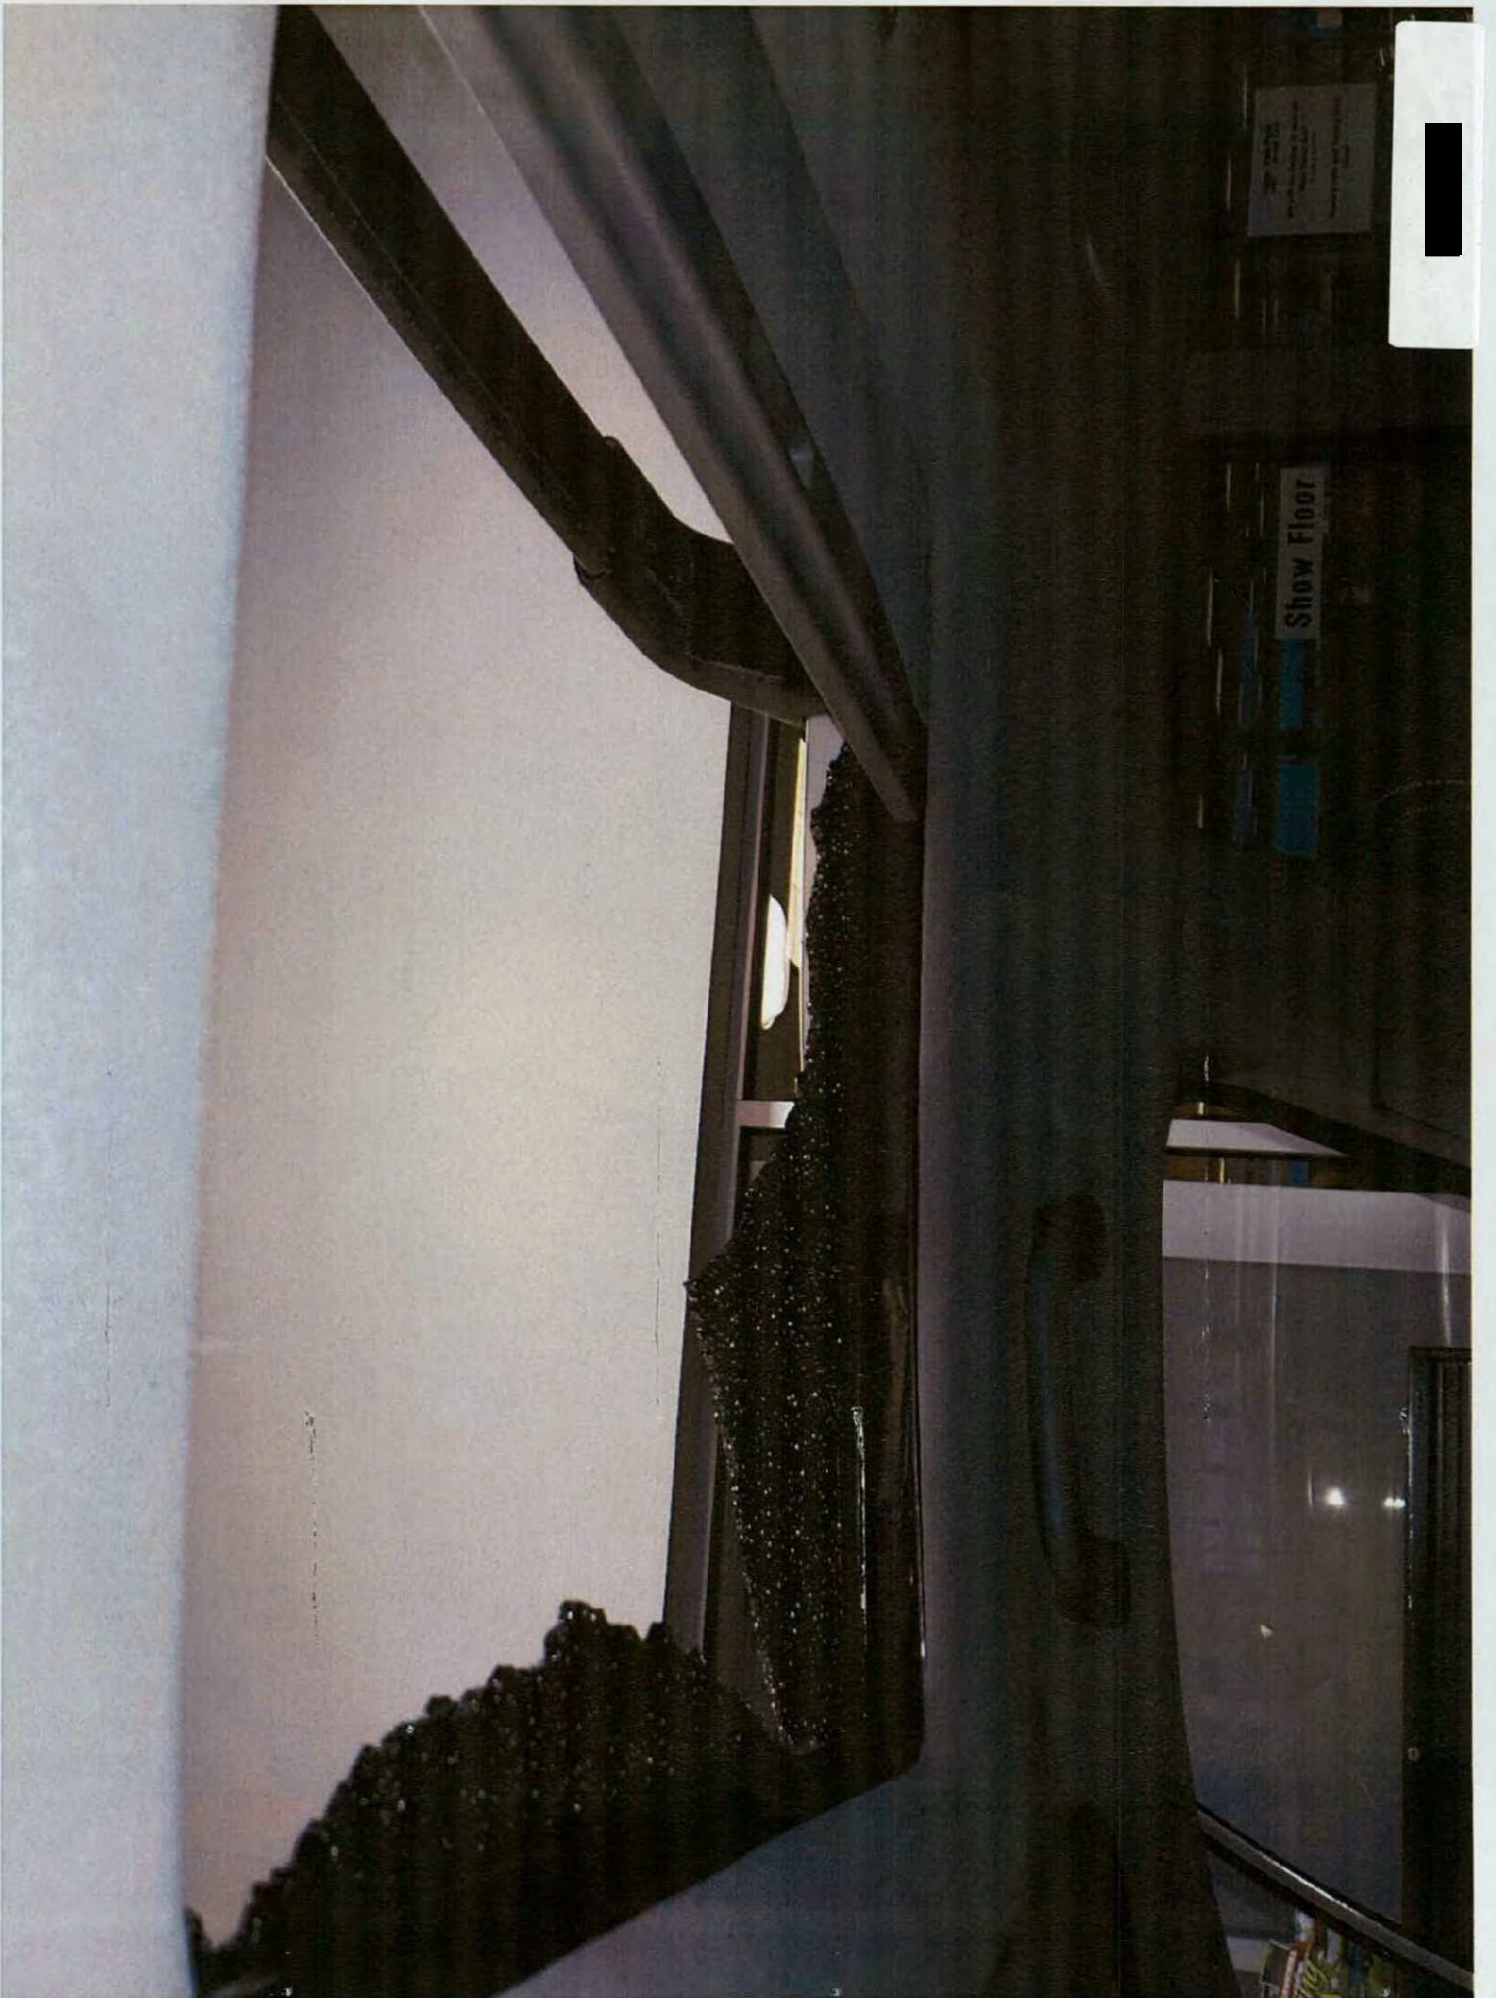
Panoramic roof glass broken.

Dealer created TAC case # [REDACTED] and was advised to contact DPSM for authorization. The dealer took all pictures and did initial inspection. The repair was authorized by DPSM. Vehicle was repaired and released with no direct KMA involvement. No obvious impact damage was noted by dealer.

Due to vehicle being repaired with no KMA inspection and lack of physical evidence root cause could not be accurately

determined.

Dealer installed new sunroof.
