EA14-004

HONDA

QUESTION 6

08M Accord 4dr – Door slam deployment

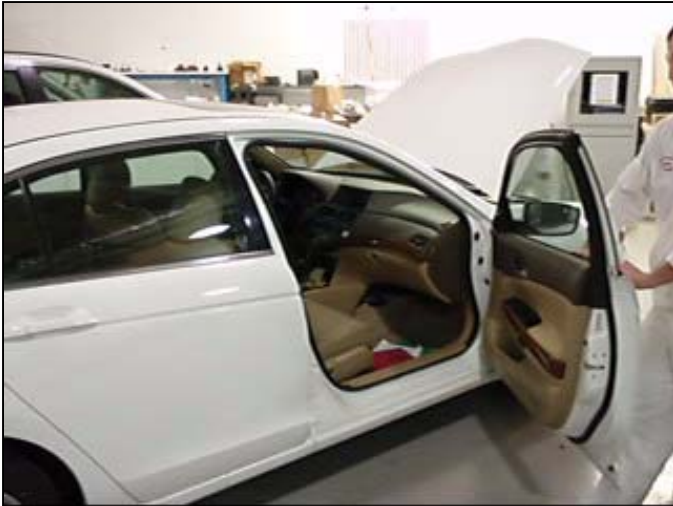
4. Recreation Testing

AQAO/HGT testing

Impact Side	Speed	Test Vehicle Condition	Deployment
-			OFF
-			OFF
L			OFF
L			OFF
L			ON
L			ON
L			OFF
R			OFF
R			ON
R			ON
R			OFF
R			OFF
R			OFF
R			OFF
R			ON
R			ON
R			OFF
R			ON
R			ON
R			OFF

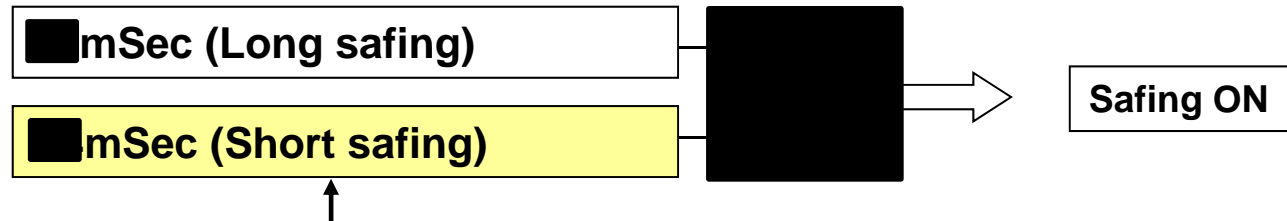
“Safing ON” is activated by short safing █ long safing.

At the hammering testing, “safing ON” was activated by short safing (█ msec).

- “Safing ON” and “side airbag deployment” were recreated by hitting the side sill.
- We assume that these failures could have been recreated while driving even if hitting other areas.
- Short safing was on by hitting the side sill and the floor frame.
- Long safing was not on even if hitting the side sill and the floor frame.
- This vehicle did not collide, but SIS judged as Δ█.

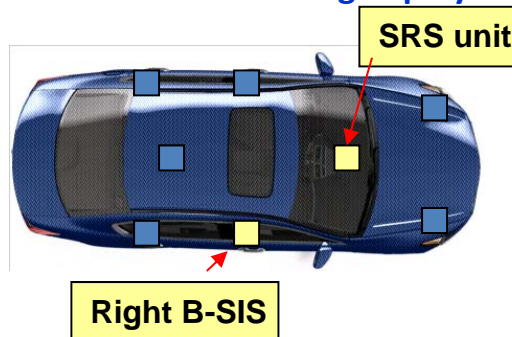
• SRS unit data recorded

- No defects.
- There is a record showing SRS unit and R-side B-SIS judged the vehicle as collided then airbag deployed.

• SRS unit record G data

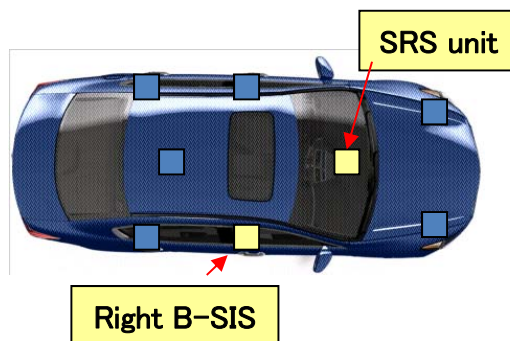
・SRS UNIT 履歴データ

- ・故障は無い。
- ・SRS UNITとR側 B-SISで衝突判定しエアバック展開した履歴有り。

・SRS UNIT レコードGデータ

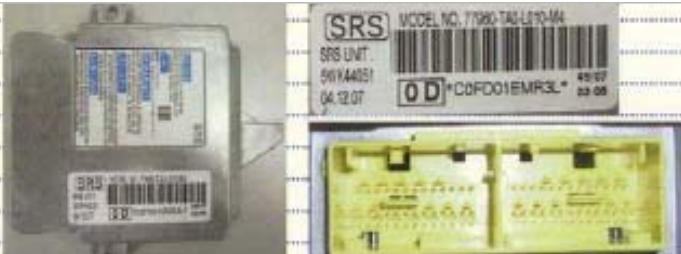
SRS unit visual inspection

1. No scar, or deformation is seen on the outer of SRS unit.

SRS unit performance check

1. No failure is found from the past, or current record.

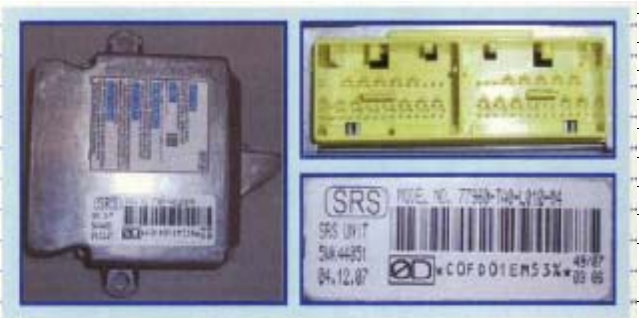
SRS unit visual inspection

1. No scar, or deformation is seen on the outer of SRS unit.
2. No bent, or contaminant adhesion is seen

SRS unit performance check

1. No failure is found from the past, or current record.
2. There is a deployment history for side

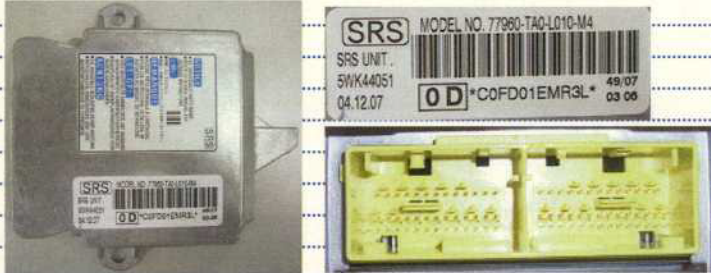
■外観確認結果

- ①SRSユニットの外観に傷や変形等の異常無し。
- ②コネクタの端子曲がり、異物付着等の異常無し。

■動作確認結果

- ①記録内容確認結果、現在及び過去故障の記録は無し。
- ②R側サイドエアバッグ及びカーテンエアバッグの展開履歴あり。

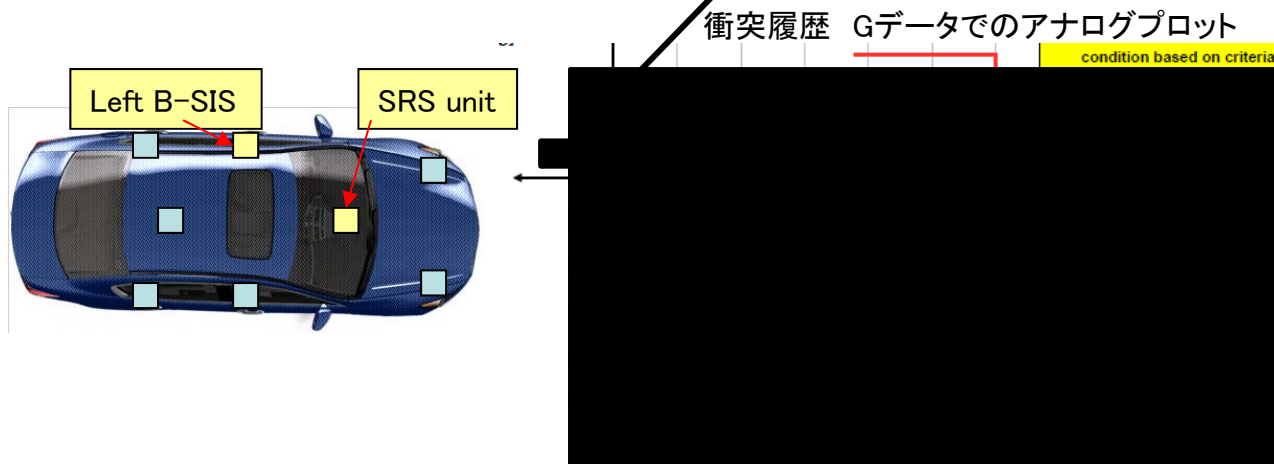
故障は無く、SRS UNITとL側 B-SISにて点火判定している

衝突履歴+履歴Gデータから
SRS UNITが衝突判定した為
サイドエアバック
サイドカーテンエアバックが
展開した事が分かる

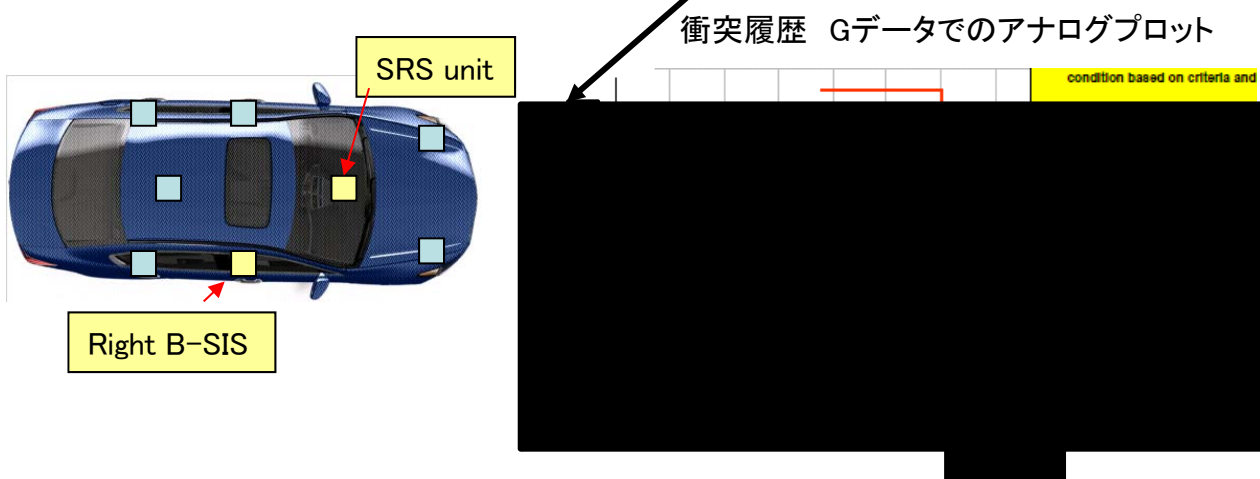
故障は無く、SRS UNITとR側 B-SISにて点火判定している

衝突履歴+履歴Gデータから SRS UNITが衝突判定した為 サイドエアバック サイドカーテンエアバックが 展開した事が分かる

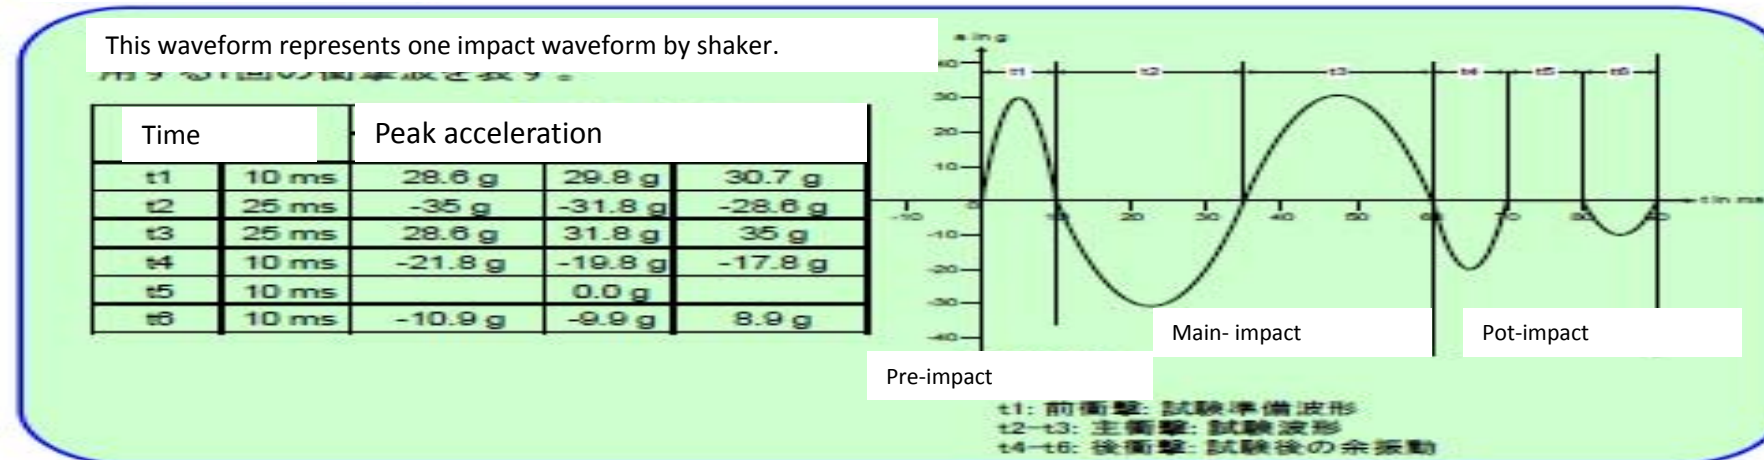
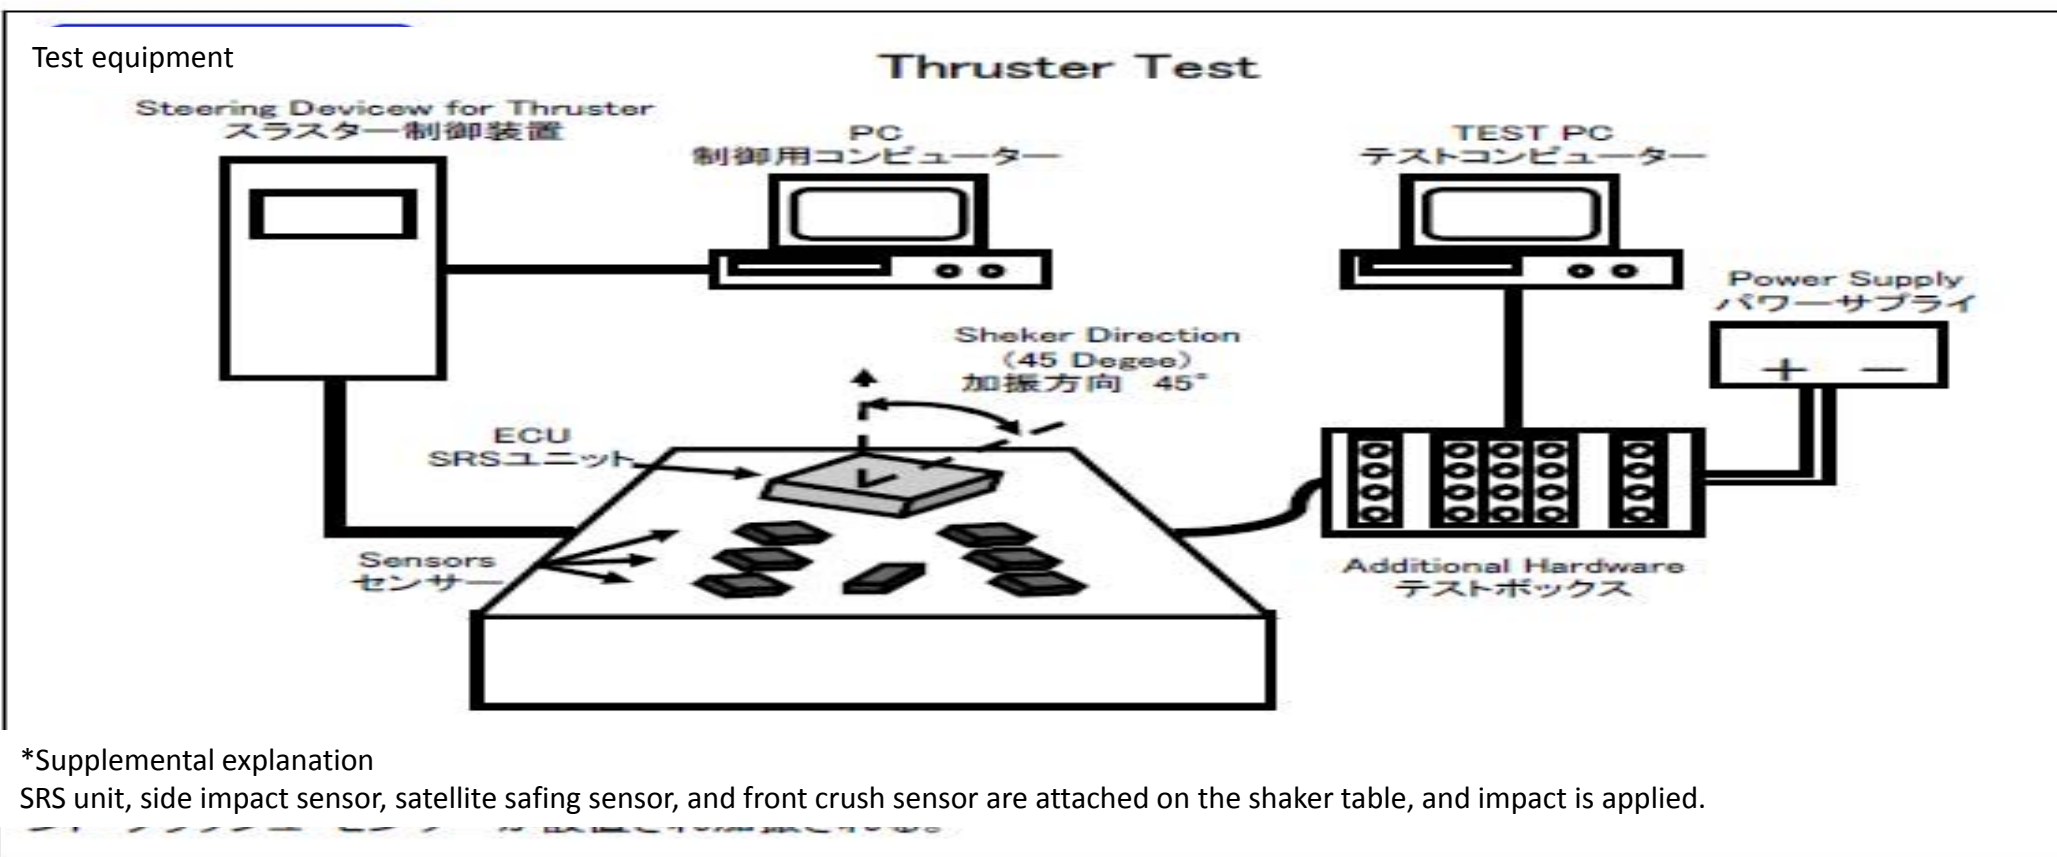
Impact test waveforms

Market returned parts are attached to shaker equipment at 45 degrees against the X, and Y axis. Then the following waveform is applied. Impact is applied once to confirm sensitivity of X, and Y axis.

Shaker test results

Ignition timing/ignition on duration						
Test conditions		seat position sensor - NOT NEAR				Judgment
Items	Ignition timing		Ignition ON duration			
	Spec	Measuring data	Spec	Measuring data		
	単位[ms]	単位[ms]	単位[ms]	単位[ms]		
R side airbag 1 st stage		57.3		2.2	Normal	
L side airbag 1 st stage		57.3		2.2	Normal	
R side airbag 2nd stage		97.4		2.1	Normal	
L side airbag 2nd stage		97.4		2.1	Normal	
R side retractor pretensioner		49.8		2.2	Normal	
L side retractor pretensioner		31.8		2.1	Normal	
R side curtain airbag		49.8		2.2	Normal	
L side curtain airbag		31.8		2.1	Normal	
R side airbag		49.8		2.1	Normal	
L side airbag		31.8		2.1	Normal

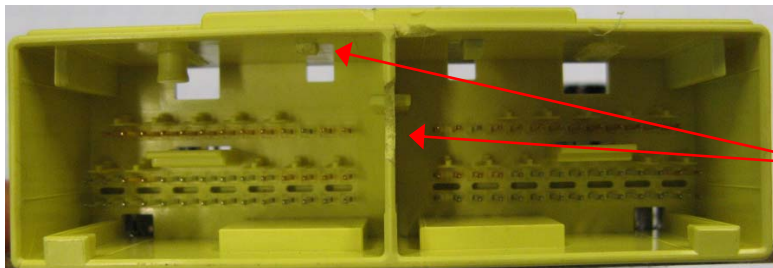
コネクター

コネクタ ハウジングに破損あり。

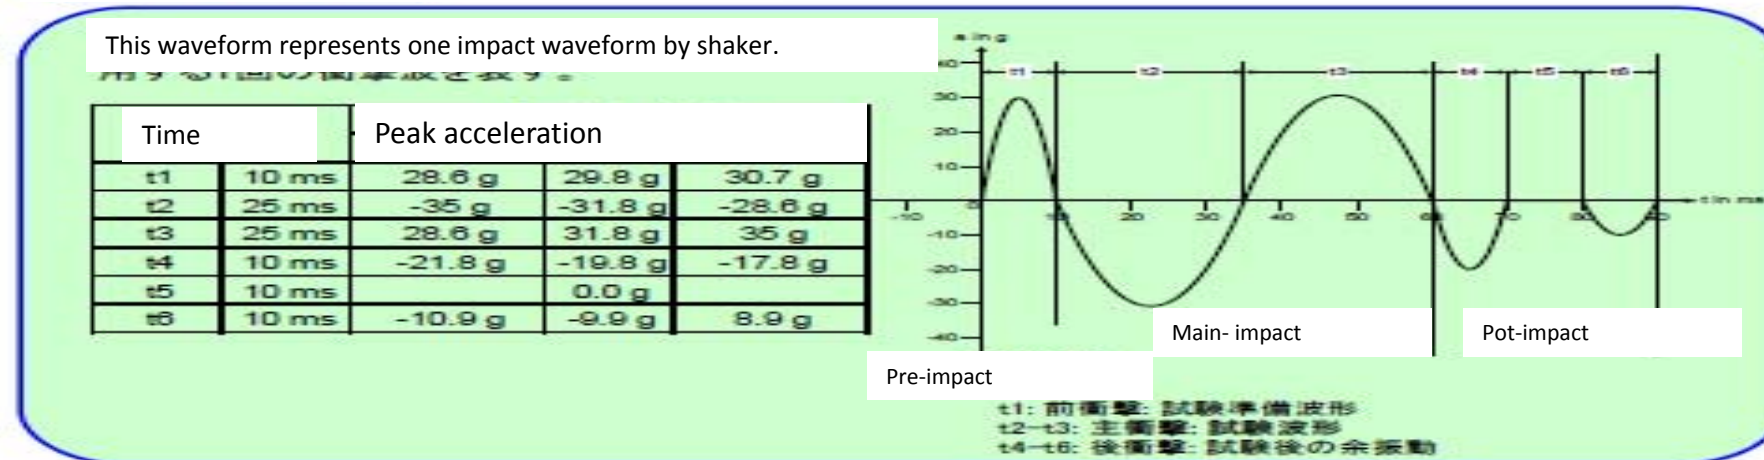
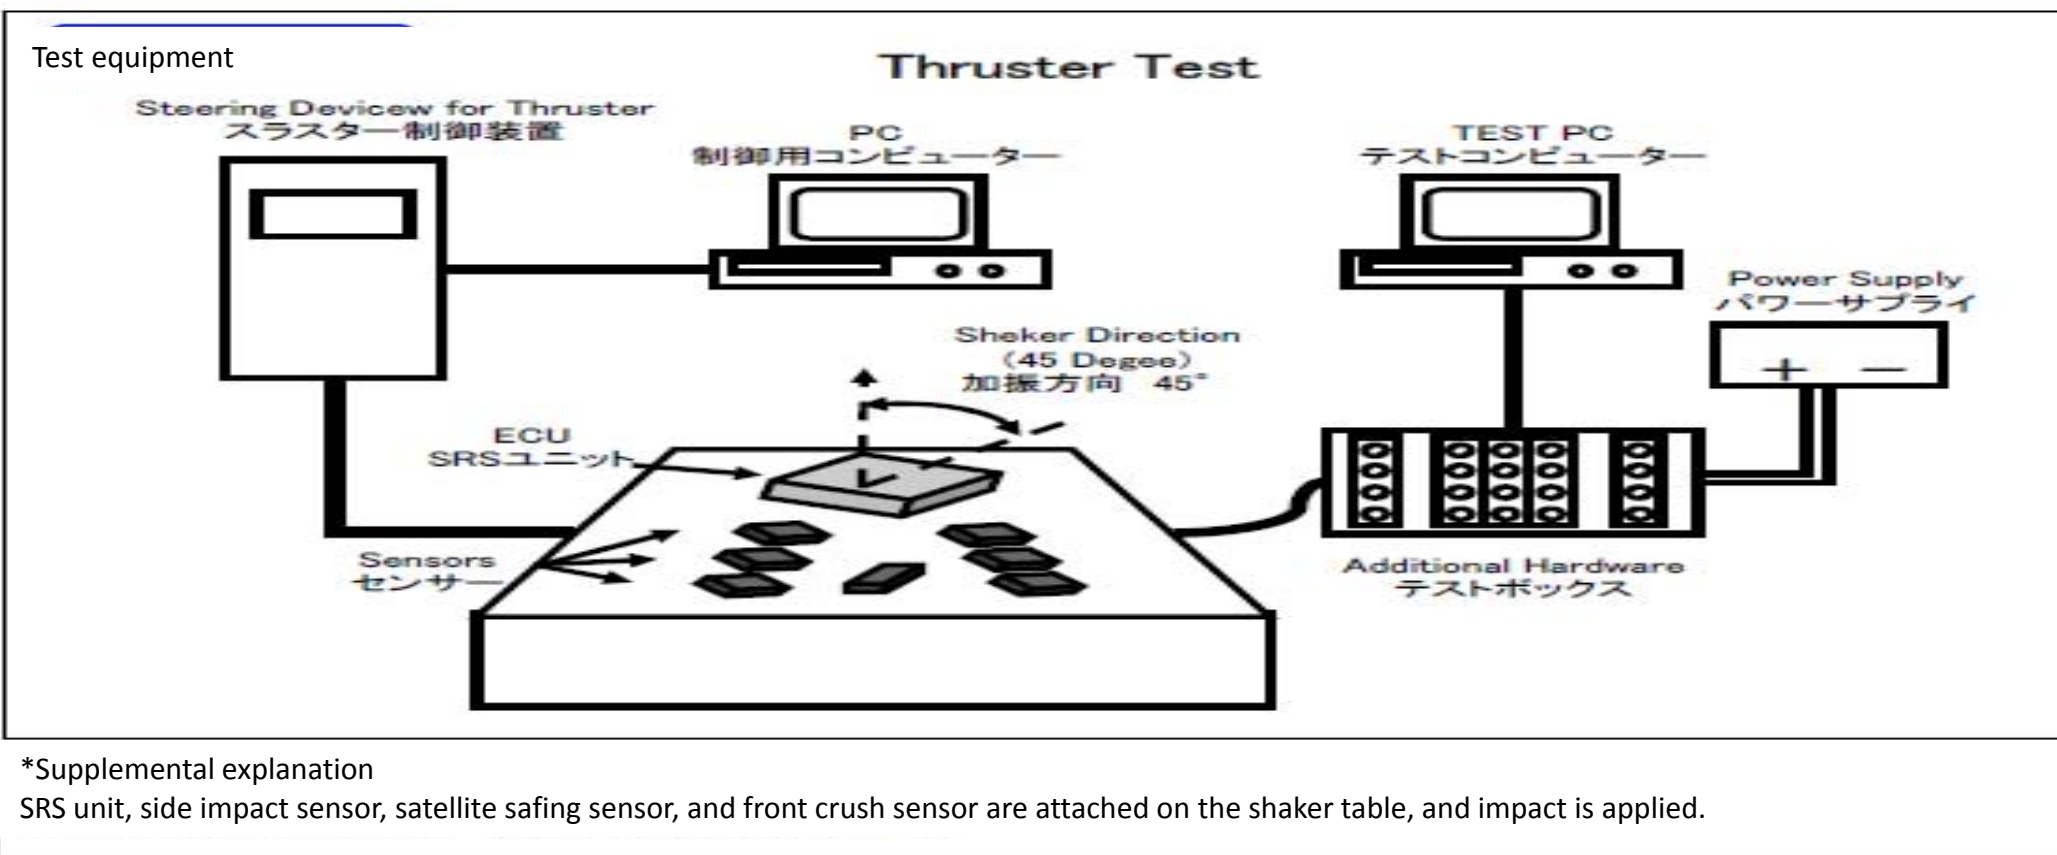
Impact test waveforms

Market returned parts are attached to shaker equipment at 45 degrees against the X, and Y axis. Then the following waveform is applied. Impact is applied once to confirm sensitivity of X, and Y axis.

Shaker test results

Ignition timing/ignition on duration						
Test conditions		seat position sensor - NOT NEAR				Judgment
Items	Ignition timing		Ignition ON duration			
	Spec	Measuring data	Spec	Measuring data		
	単位[ms]	単位[ms]	単位[ms]	単位[ms]		
R side airbag 1st stage		56.7		2.2	Normal	
L side airbag 1st stage		56.7		2.2	Normal	
R side airbag 2nd stage		96.8		2.1	Normal	
L side airbag 2nd stage		96.8		2.1	Normal	
R side retractor pretensioner		49.7		2.2	Normal	
L side retractor pretensioner		31.7		2.1	Normal	
R side curtain airbag		49.7		2.2	Normal	
L side curtain airbag		31.7		2.1	Normal	
R side airbag		49.7		2.1	Normal	
L side airbag		31.7		2.1	Normal
