PE14-001
TOYOTA
3/26/2014
ATTACHMENT 1
RESPONSE 5
Arbitration
1608014

TOYOTA MOTOR SALES, U.S.A., INC. Manufacturer Response Form

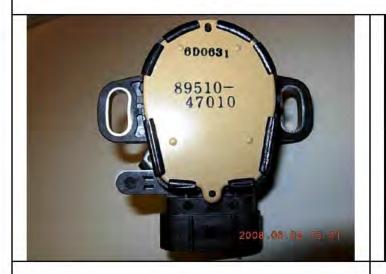
Photo of Brake Stroke Sensor

Stroke Sensor was replaced. Condition has not occurred since replacement.

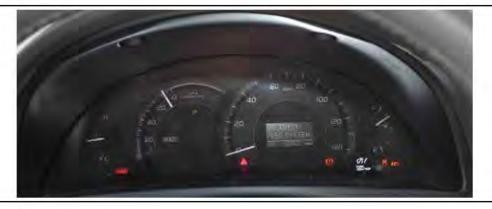
Combination meter during event

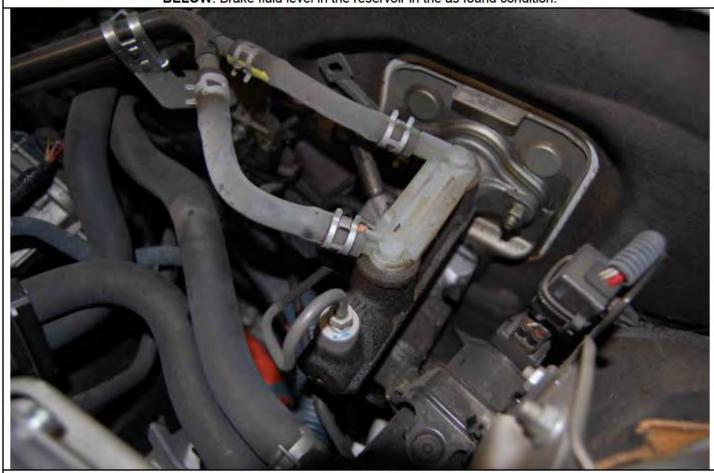
BELOW: Brake fluid level in the reservoir in the as found condition.

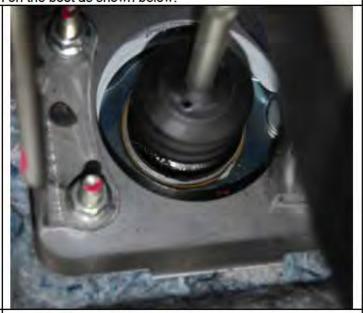
BELOW: Cowl was removed for inspection of the brake master cylinder and stroke simulator.

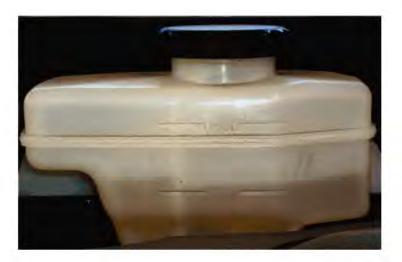
Brake Fluid Level is Low, causing the C1202 code

- Dealership will inspect the flares on the tubes for damage and if damage is found, they will either repair or replace the brake tube
- Dealership will replace the 4-way junction (part needs to be ordered)
- · Replaced part(s) will be collected after repairs are completed

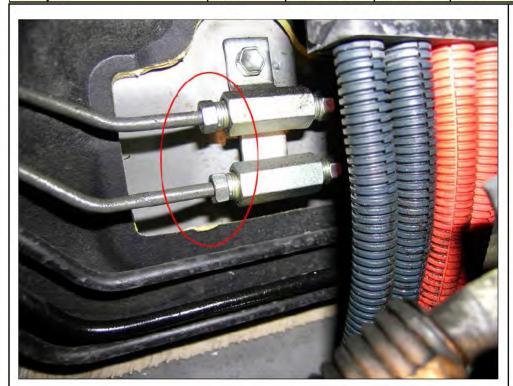
Another view of the 4-way junction showing the wet connections.

Visually, it's not clear which of the two connections are leaking.

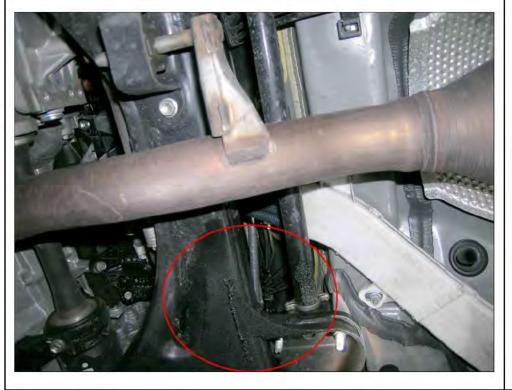
Looking up at the leaking location from below the vehicle.

The red circle in the picture indicates the general area that is wet with brake fluid.

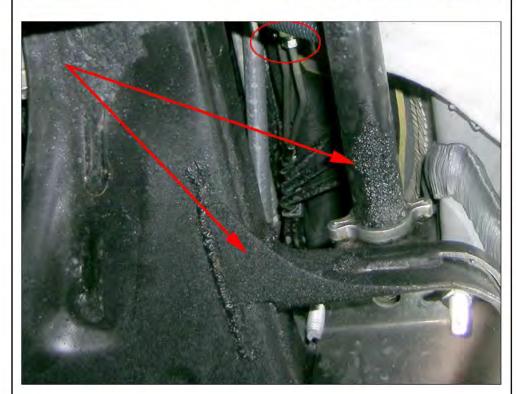
Close-Up picture of the Front Sway bar area showing the paint peeling/wrinkling due to damage from the brake fluid leak.

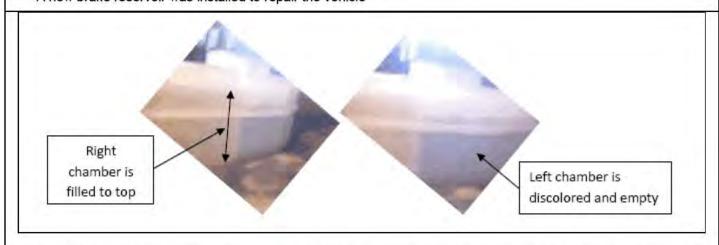
Brake fluid level uneven condition as duplicated by the dealership, before the Go & See activity (pictures were taken by dealership)

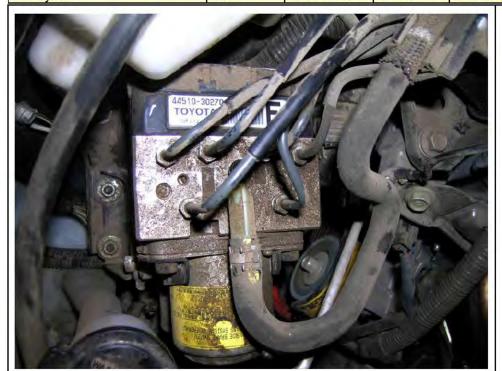
Part # 44510-30270

Overview picture of Actuator (no leaks).

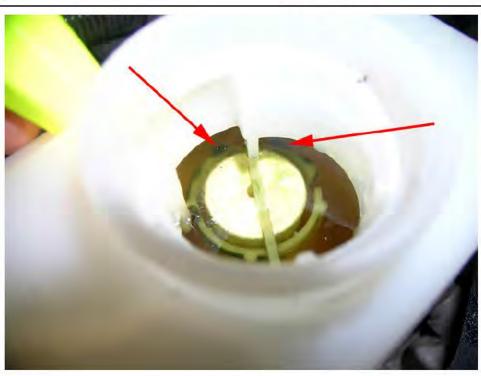
Green substance deposited on the inner surfaces of the brake reservoir

- · Samples of the green substance was collected
- · Brake fluid sample was collected
- The brake reservoir was also Collected (parts/fluid will be sent to TMC for further analysis)
- A new brake reservoir was installed to repair the vehicle

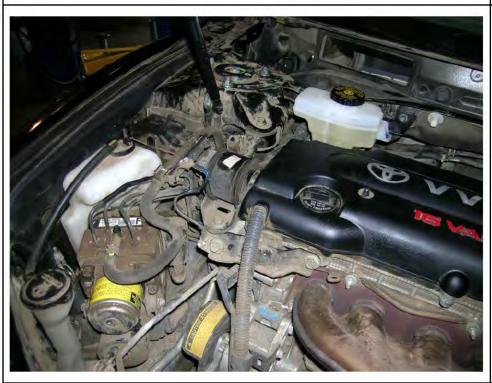
The reservoir was replaced with a new part and was filled with new brake fluid

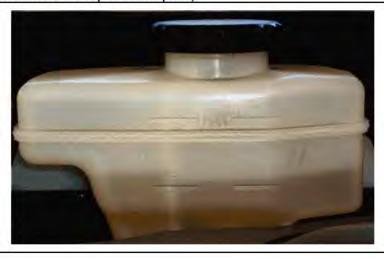
Brake Fluid Level is Low, causing the C1202 code

The level difference between the two chambers is due to internal baffling on the LH side of the reservoir that does not allow the fluid to go lower.

A new brake reservoir was installed and the dealership will repair the fluid leak at the 4-way junction (related parts will be collected once the repair is complete).

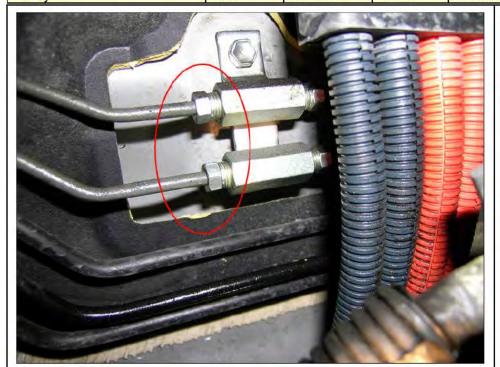
Another view of the 4-way junction showing the wet connections.

Visually, it's not clear which of the two connections are leaking.

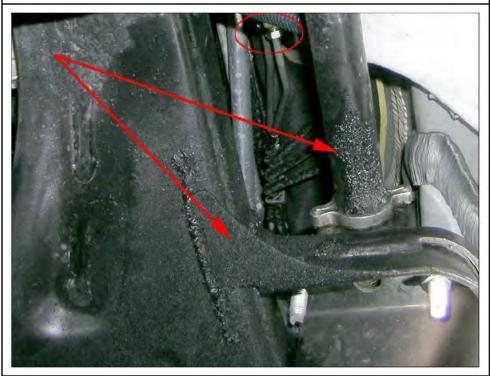
Close-Up picture of the Front Sway bar area showing the paint peeling/wrinkling due to damage from the brake fluid leak.

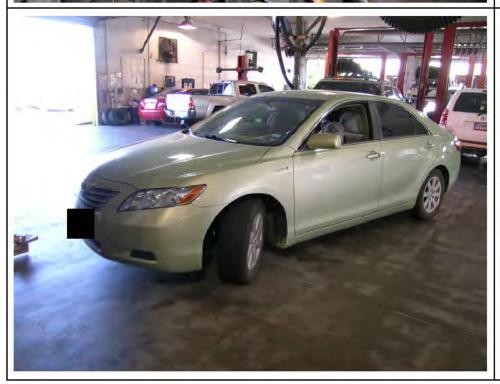
A 2009 Camry HV
(4T1BB46K89U) with
29,324 miles was also checked to
compare the brake fluid, using the
borescope (to check for white
material in the fluid).

NO white substance was found in the brake fluid.

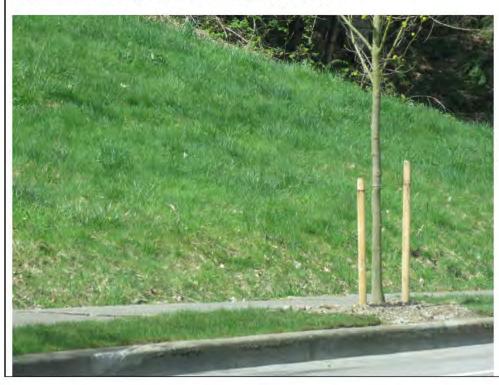
Inspector photos of the incident scene, taken on 4/15/12, were submitted with this report. Witness marks are visible on the curb. The damaged tree had already been replaced.
