PE14-001

TOYOTA

Additional Consumer
Complaint Documents

FIELD TECHNICAL REPORT – INCIDENT INSPECTION

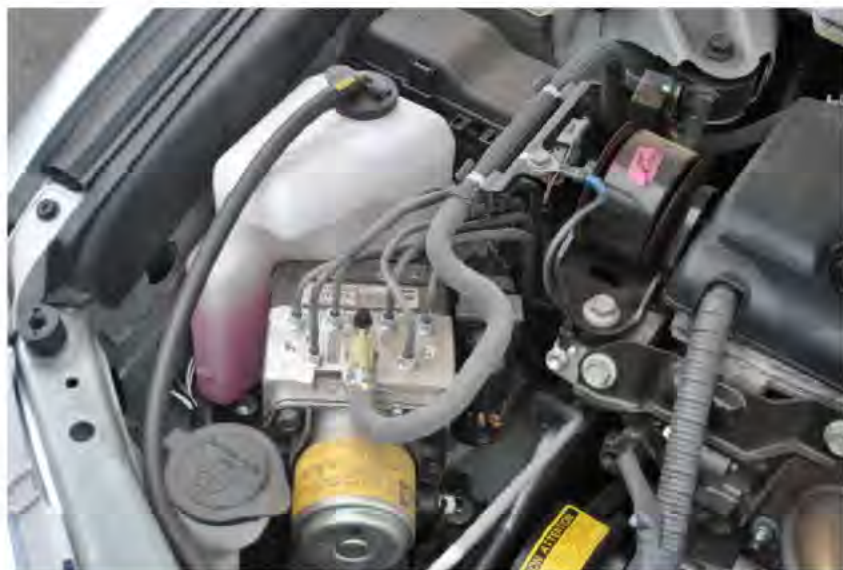
ABS Actuator Visual Inspection.
Any Leaks?

No leaks

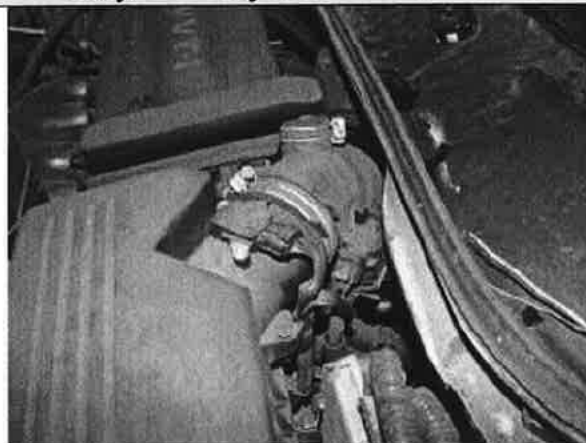
No detail inspection of the Throttle body system conducted. Connector in place.

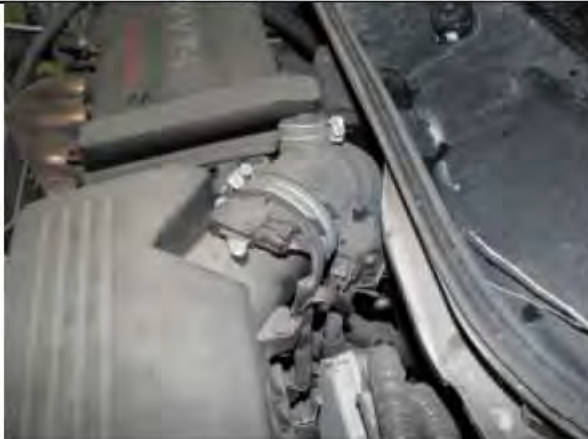
No detail inspection of the Throttle body system conducted. Connector in place.
