PE14-005

MAZDA

Material 1-1 Field Claim  
Investigation Sheet

# Mazda J50 Warranty

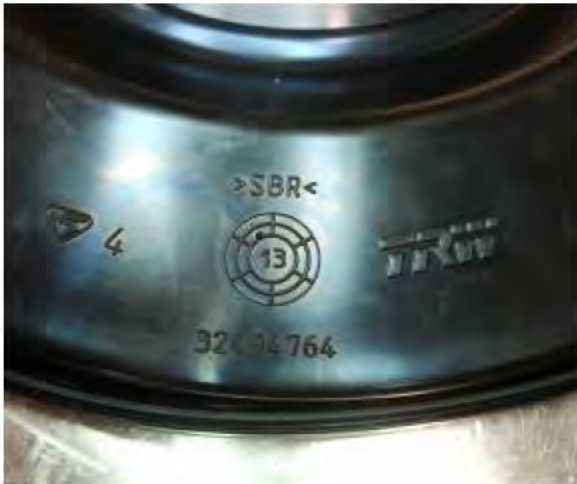
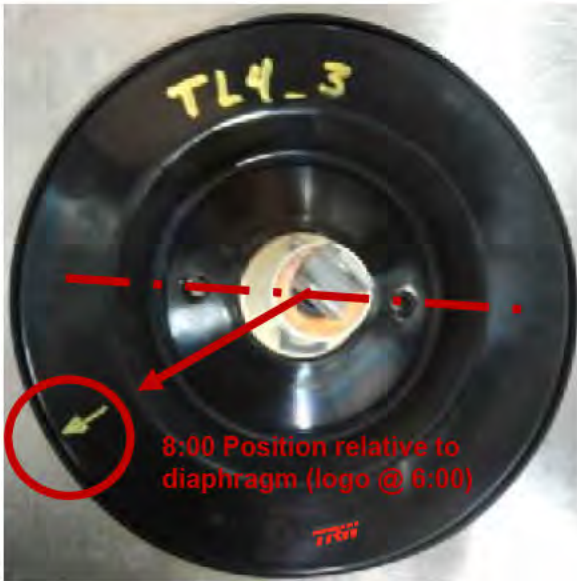
## Performance test results for Tool 3

- Station 2 failure at 86,636 cycles in accelerated high temperature endurance test
  - Tool 3 sample
  - Tear at the plate area (T3)
  - 9:00 position relative to shell (tie bars @ 36°)
  - 8:00 position relative to diaphragm (logo @ 6:00)

- **Tear analysis**
  - The tear is a U shape
  - A cross-sectional dimensional analysis reveals a radius near the tear measuring approximately 0.74mm to 0.87mm
  - No non-homogeneous particle at tear origination point
  - The presence of a radius and absence of a particle at the tear origination point indicates the initial tear is likely from mechanical impingement, possibly during assembly.
  - This type of diaphragm tear is not consistent with tears found in warranty samples (@ location T2) nor tears found in DOE samples (@ location T2 or T3)
- **DOE test samples are experimental and not assembled using the production process**

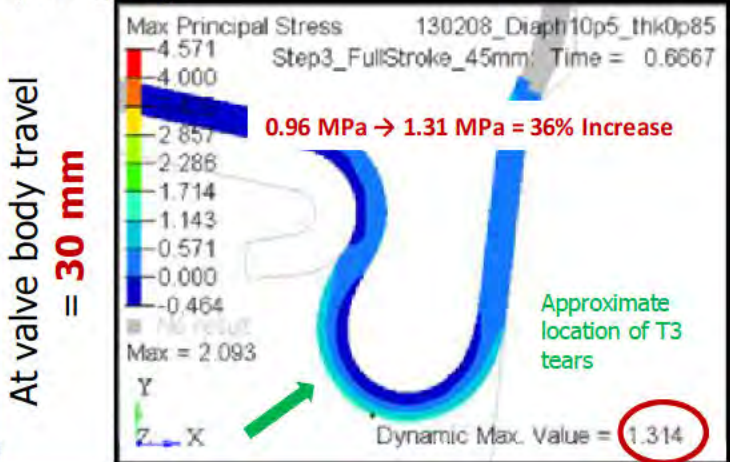
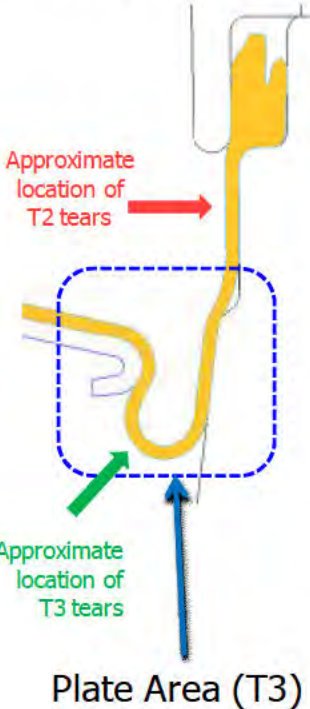
Model at **0.85 mm** Thickness  
 [Tool 2 Diaphragms]

## Max Principal Stress (MPa)

- FEA predicts **Tool 2** diaphragms to have 36% increased stress in the plate area (T3 location) with a 30 mm input stroke v. 9 mm input stroke, and a 60% increased stress in the plate area (T3 location) with a 40 mm input stroke v. 30 mm input stroke

- Thickness in loop (@ T2 location) is 1.0 - 1.5 mm on Tool 1 diaphragms
  - The FEA model predicts maximum principle stress occurs in the loop (T2 location) when the diaphragm thickness in the loop area is 1.25 mm – this prediction correlates well with observed failures in Tool 1 diaphragms

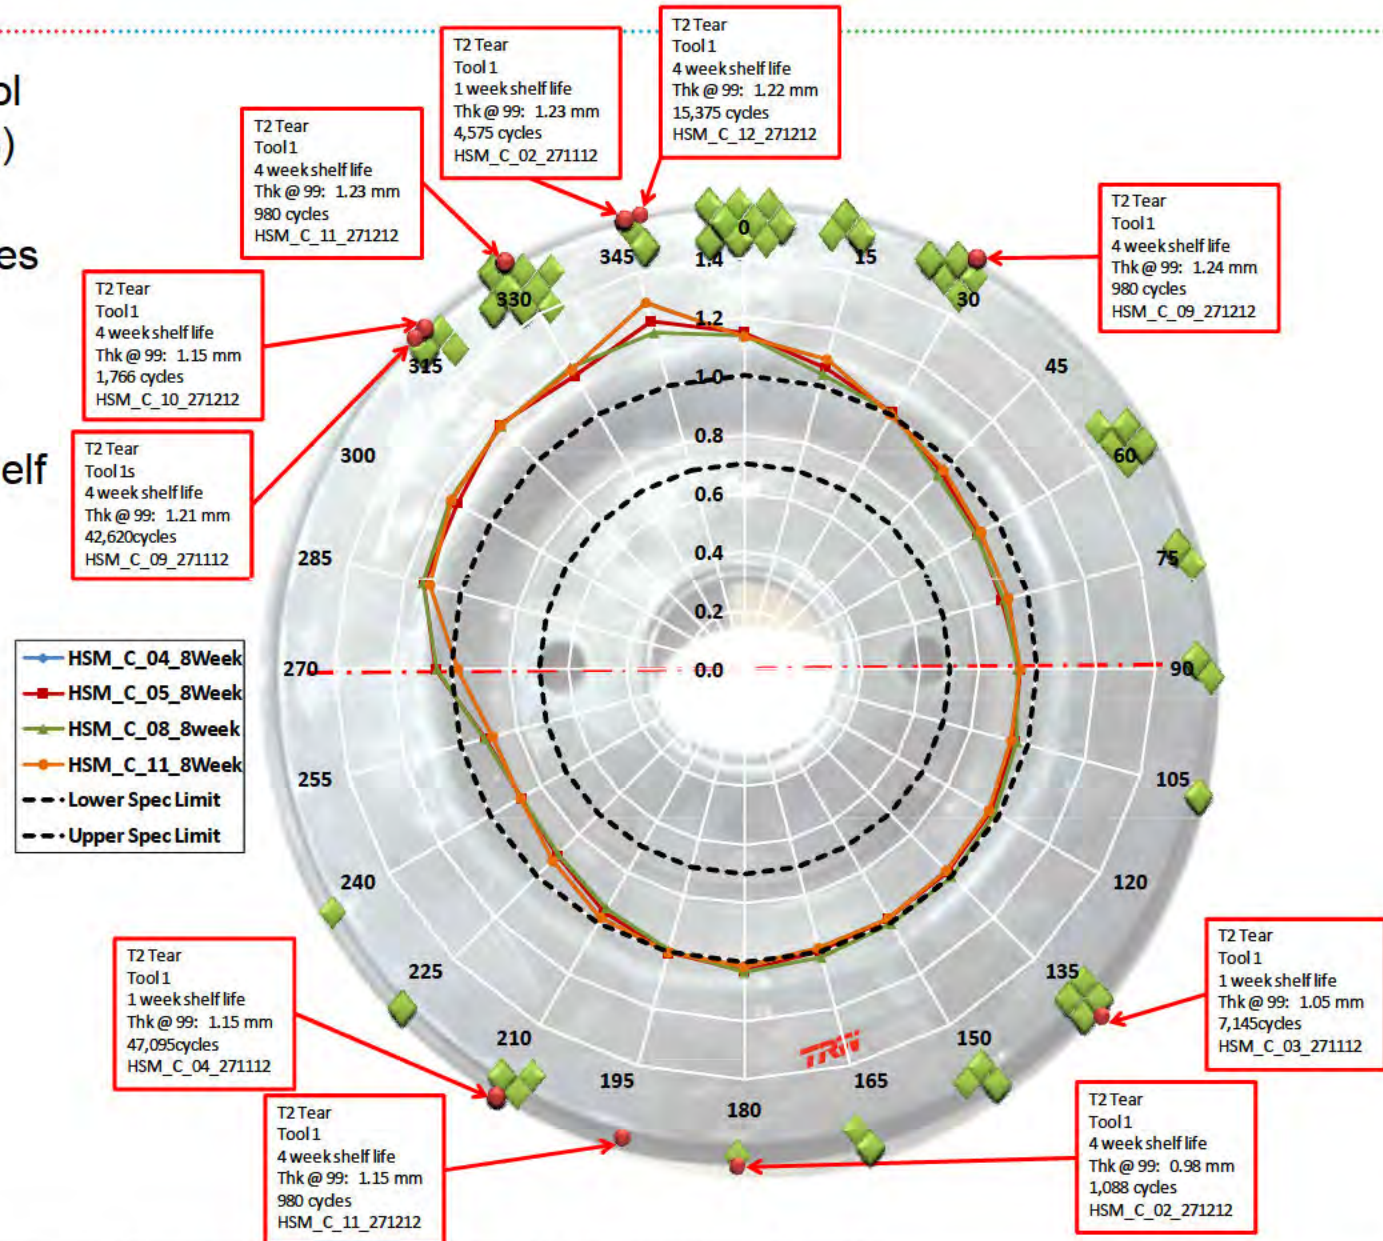
# Tool 1 Tear Locations with Tool 1 thickness at position 99

- T2 DOE failures for Tool 1 diaphragms (red dots)  
Quantity = 10 tears
- Warranty Return Failures (Green Diamonds)  
Quantity = 55 tears
- Radial plot of Tool 1 diaphragms, 8 week shelf life material

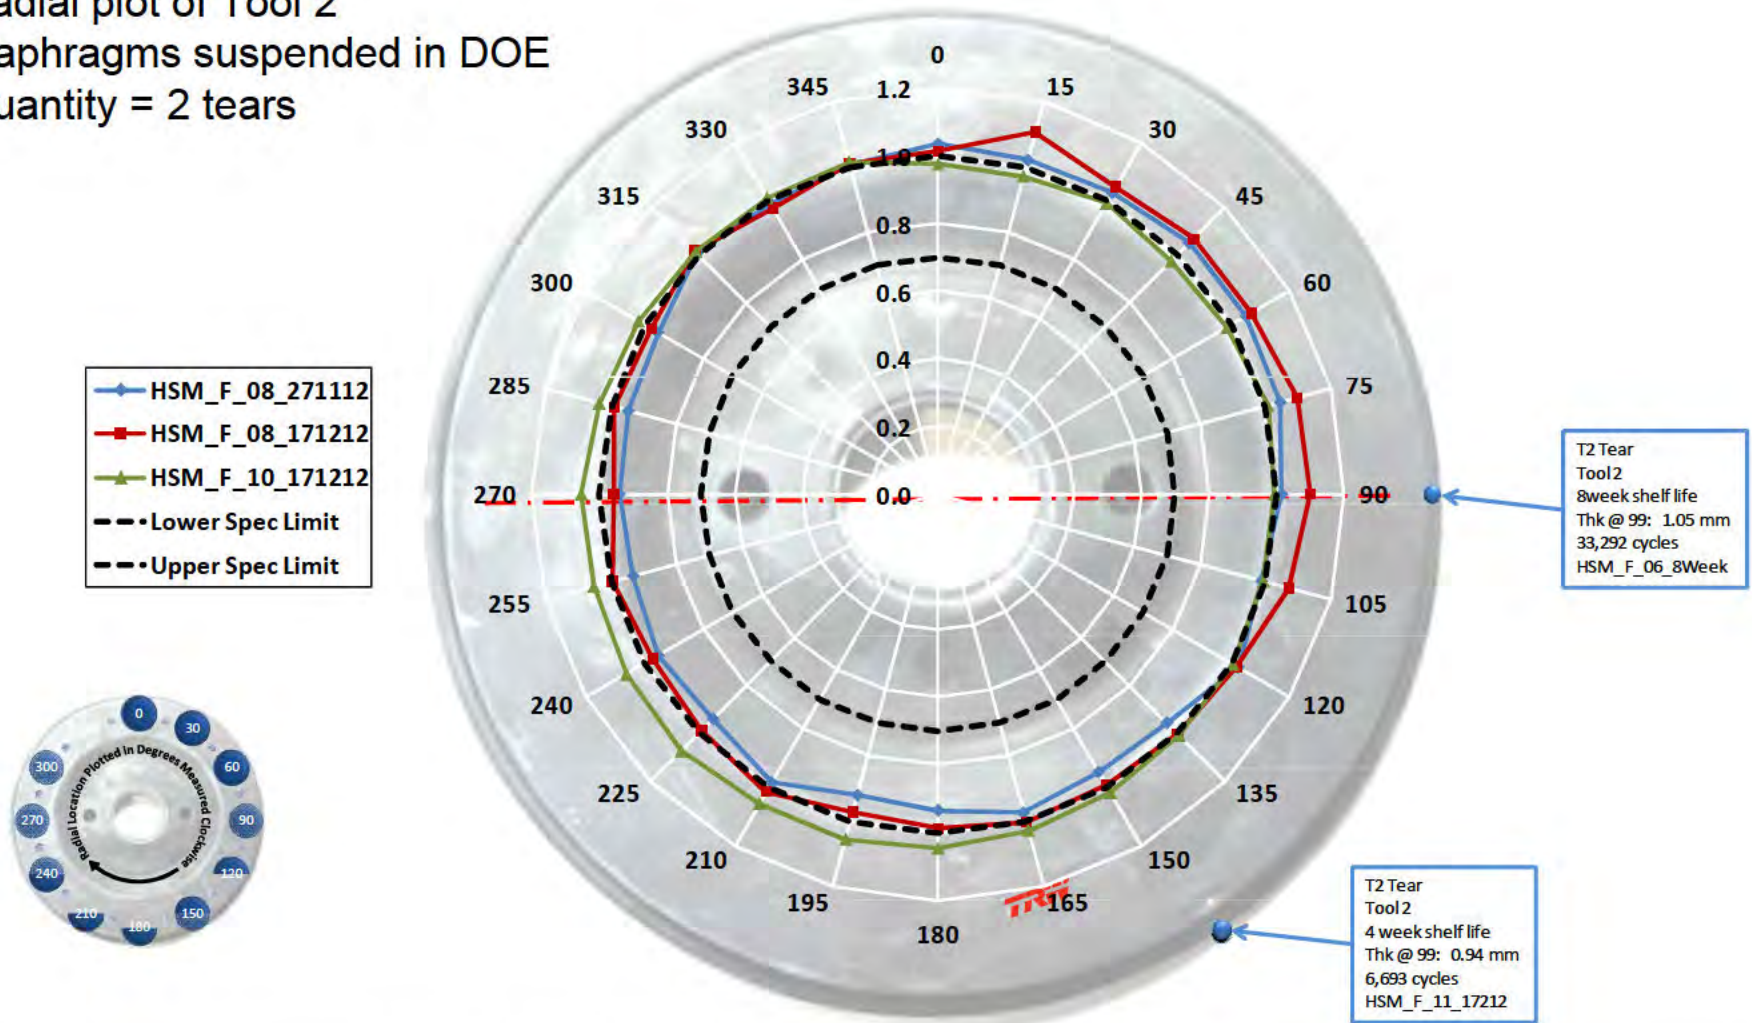
# Tool 2 Tear Locations with Tool 2 thickness at position 99

- T2 DOE failure for Tool 2 diaphragms
- Radial plot of Tool 2 diaphragms suspended in DOE  
Quantity = 2 tears

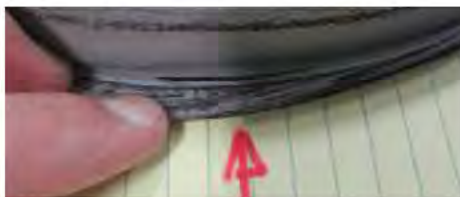
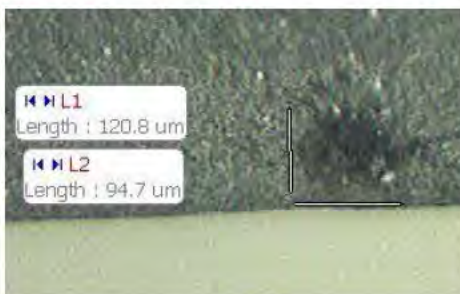
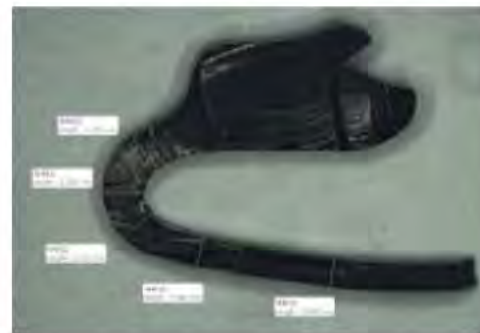
Tear Length	31mm
Particle size	124µmX95µm
Particle Location	5 o'clock
Logo side or backside	Logo Side
Average Hardness IRHD	79.2
Cross Sectional Thickness Range @ 5:15 o'clock	1.13mm-1.31mm

Location (Clock Position)	Thickness (mm)
4:45	1.270
5:15	1.355
9	1.313
12	1.512
3	1.351

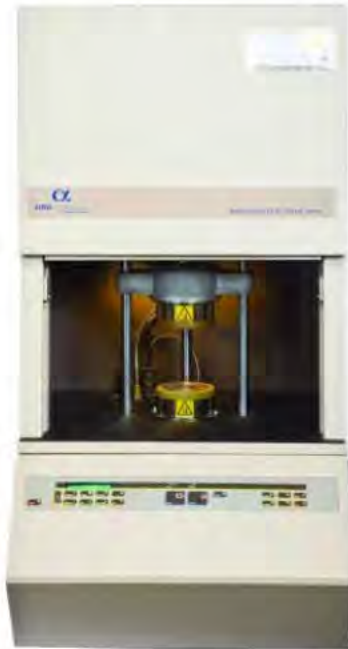
# Rheometer Curve

Each batch produced is tested in a Moving Die Rheometer - MDR

The MDR measures the torque change that is caused by the compound cure.

Each compound has its proper curve.

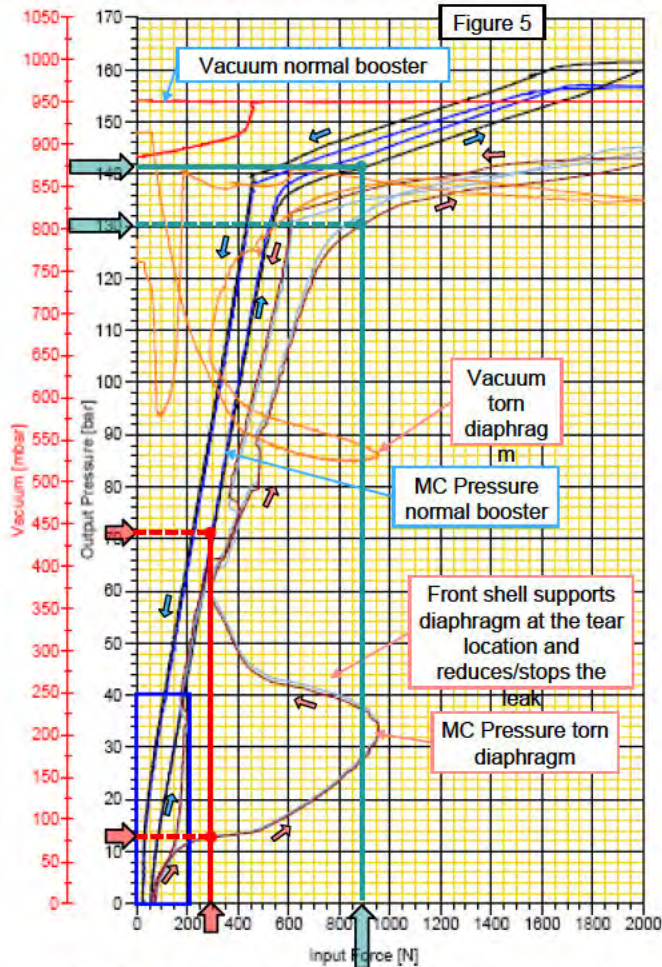
Returned Booster with torn diaphragm with 910 mbar vacuum (not isolated) and apply rate 4.5 mm/sec at input rod

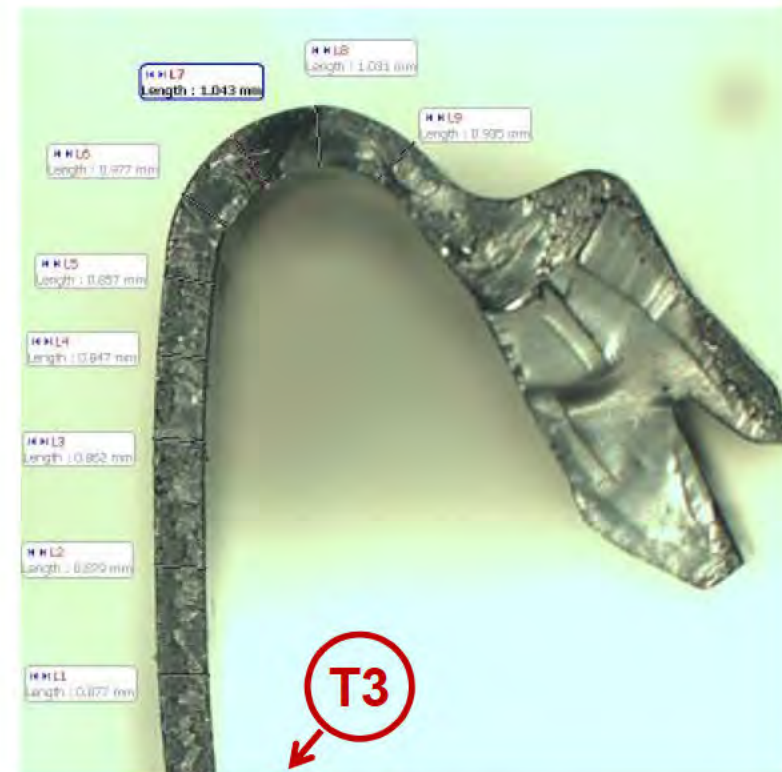
- DOE diaphragm section analysis of old tool (rev C) and new tool (rev F)

Sample HSM\_F\_06\_271112 – New Tool (Rev F)  
Failed at 62,868 cycles (location T3)

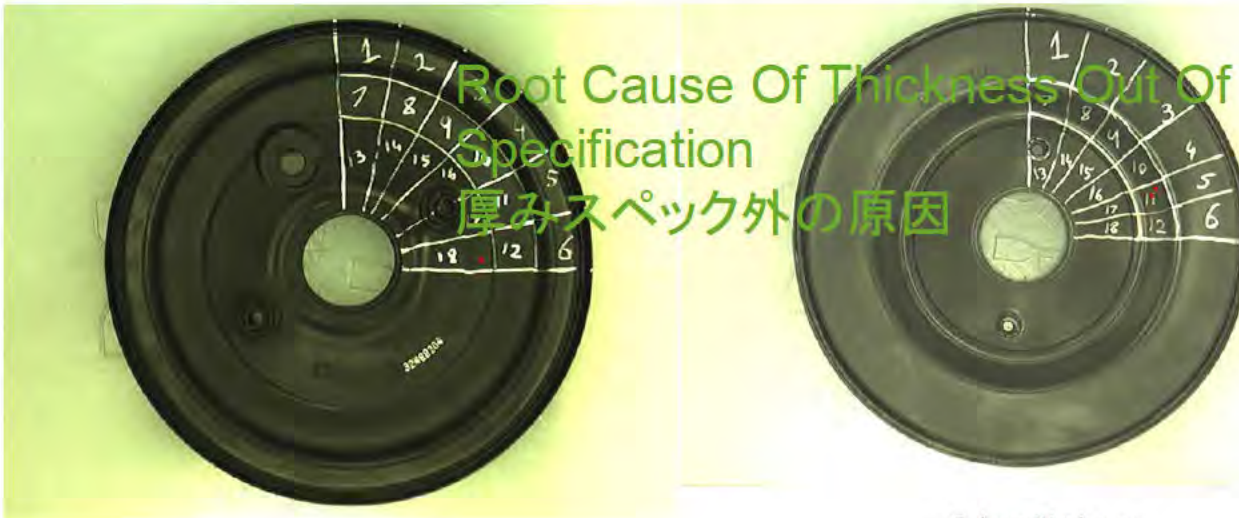
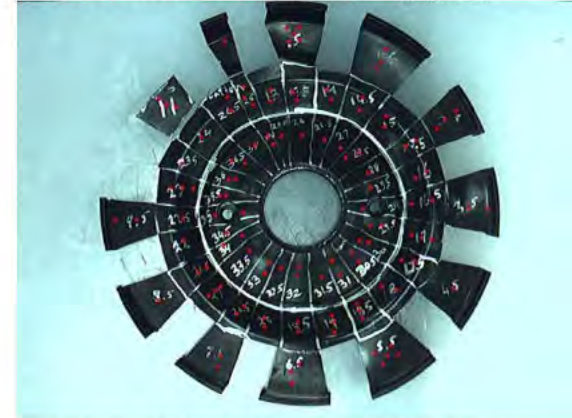
Daetwyler Diaphragm

Rubena Diaphragm

Hutchinson Diaphragm

Above analyses shows the homogenous compound of Datwyler and Rubena with significant decrease in particles.

Particle count and size cannot be controlled any better than current Hutchinson controls with TCU on mixer, this is the reason TRW is changing suppliers.

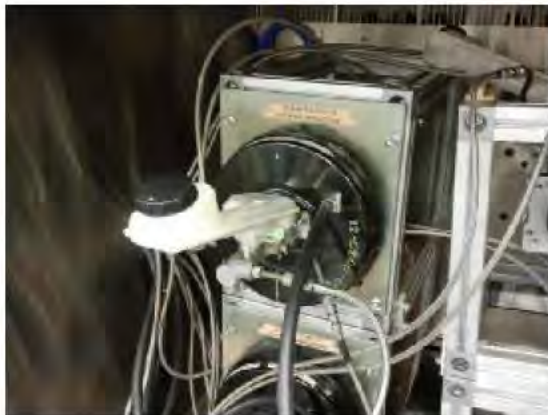
Booster mounted

1. DOE diaphragm assembled into production booster at Livonia prototype
2. Assembled booster mounted vertically to test stand
3. Adjustable volume absorber connected to master cylinder
4. Vacuum source is 0.8 bar
5. The volume absorption characteristic for endurance testing is set so that 90% of the performance curve kneepoint occurs during 2/3 of the total stroke, with 0.8 bar vacuum. This adjustment takes place at test temperature.
6. Test Temperature is 120° C
7. Actuation frequency is 800 - 1200 cycles/hour.
8. Test automated with a programmable controller capable of setting the input force of the test stand, monitoring the output pressure of the duplex, tracking the cycle count of a single test, and suspending the test based on an output pressure fault exceeding a pre-determined limit ( $\geq 10$  bar drop below target output pressure for 5 applies).

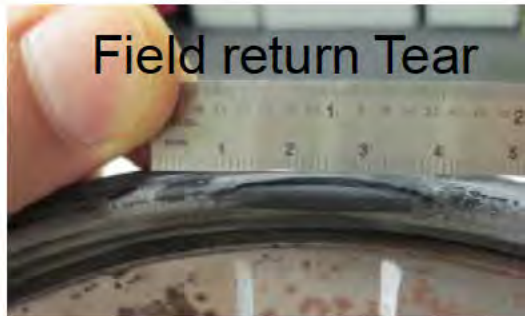
Position of field produced Tears

- A. Accurately reproduces field return conditions
- B. Can quickly produce tears (within 48 hours)

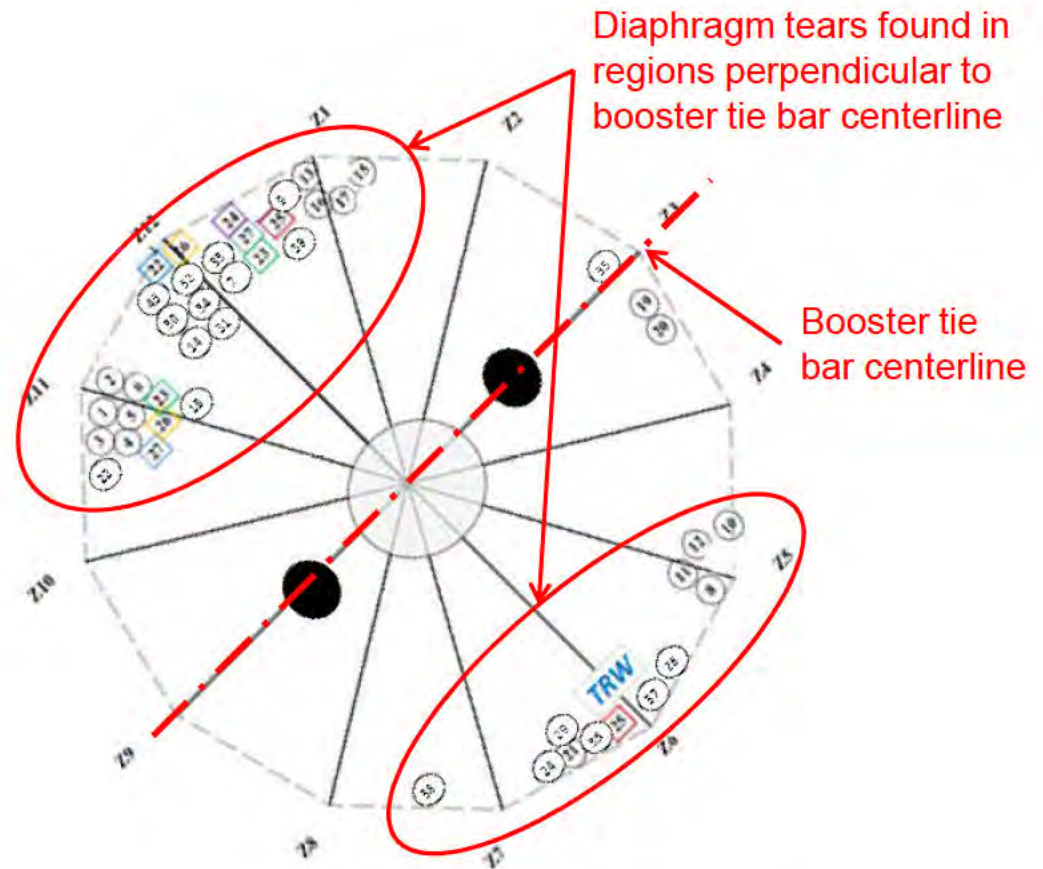
Location of tear relative to diaphragm shown

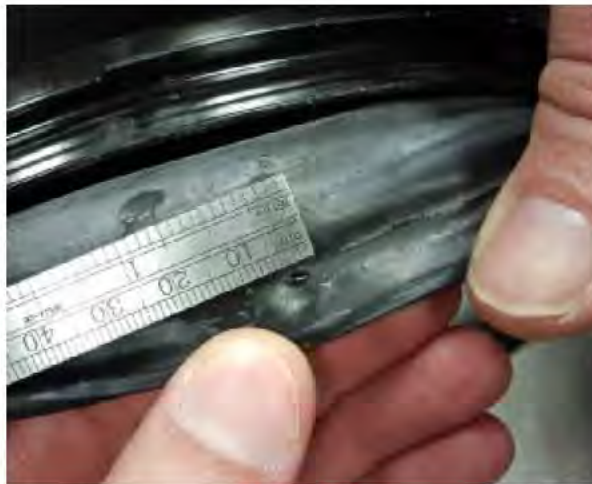
2 mm Tear

Tear Length (mm)	Vacuum Level @ F <sub>IN_0</sub> (mbar)	Vacuum Level @ F <sub>IN_250</sub> (mbar)	Vacuum Level @ F <sub>IN_400</sub> (mbar)	Vacuum Level @ F <sub>IN_KP</sub> (mbar)	Pressure @ F <sub>IN_250</sub> (bar)	Pressure @ F <sub>IN_400</sub> (bar)	F <sub>IN_KP</sub> (N)	Pressure @ F <sub>IN_KP</sub> (bar)	F <sub>IN_THRES</sub> @ 1 bar MC Pressure (N)	F <sub>IN</sub> to Achieve 30 bar M.C. Pressure (N)	F <sub>IN</sub> to Achieve 60 bar M.C. Pressure (N)	F <sub>IN</sub> to Achieve 100 bar M.C. Pressure (N)
0	795	788	785	783	63	102	457	117.7	68.5	134	242	390
3	794	787	784	783	63	102	457	117.8	67.9	132	241	391
5	799	789	786	785	63	102	457	117.7	68.7	134	240	390
7	793	780	777	776	63	102	453	116.3	68.6	135	242	398
10	798	776	773	772	62	102	453	116.5	67.5	134	242	398
15	797	729	720	719	61	100	420	106.2	70.0	138	245	406
20	797	592	581	580	61	84	545	88.0	72.3	147	250	1085
32	794	486	447	234	6	8	1080	46.6	76.2	1152	1580	-

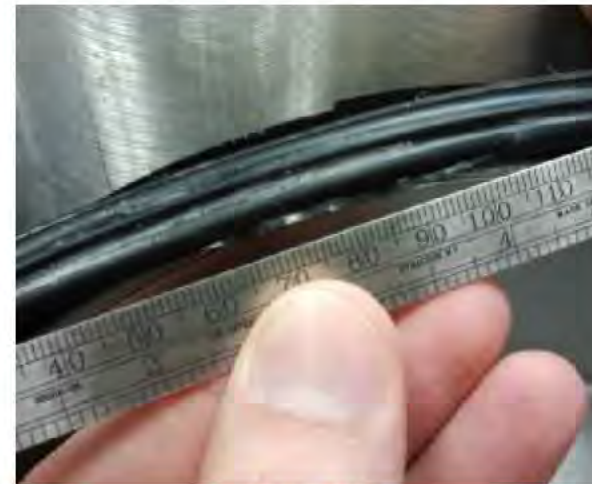
50 mm Tear

41	791	461	421	191	3	6	960	38.6	93.4	1324	-	-
50	794	443	385	0	1	6	238	11.7	238.4	1503	-	-

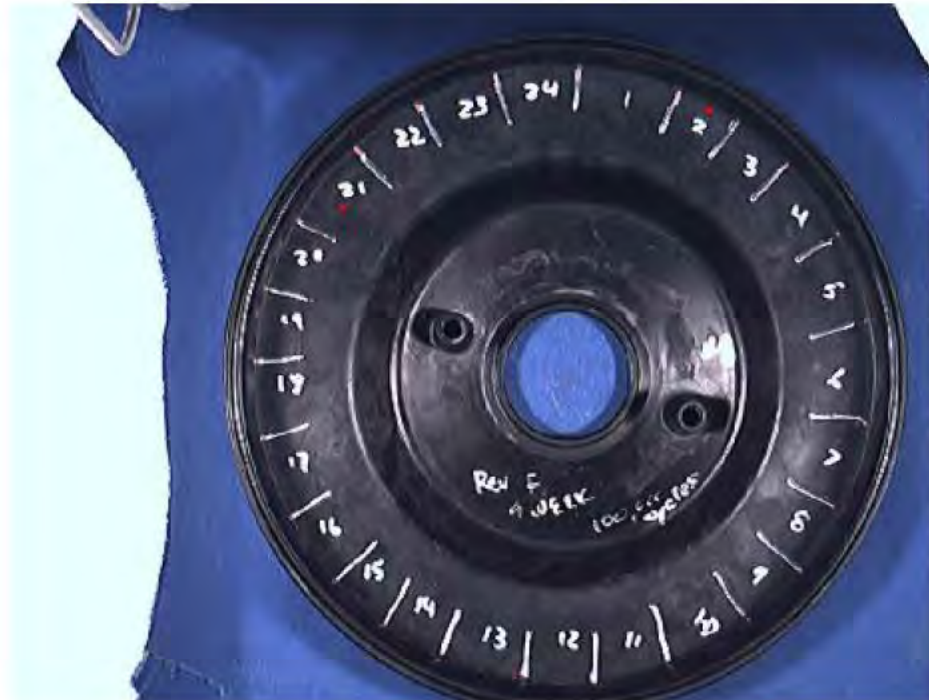
- The sample part is divided into about 24 equal parts around the perimeter:

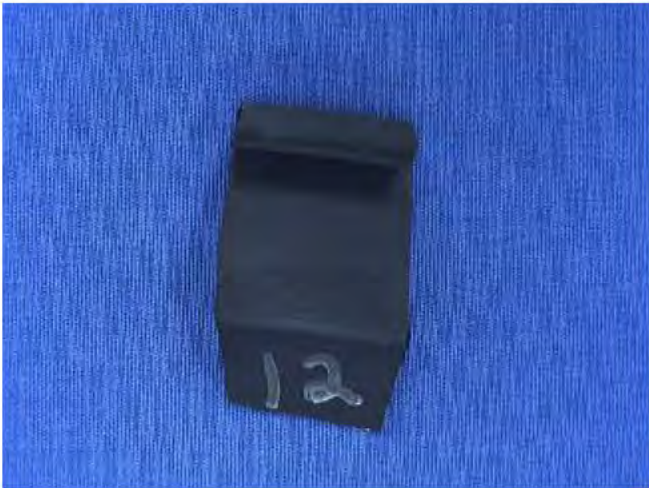
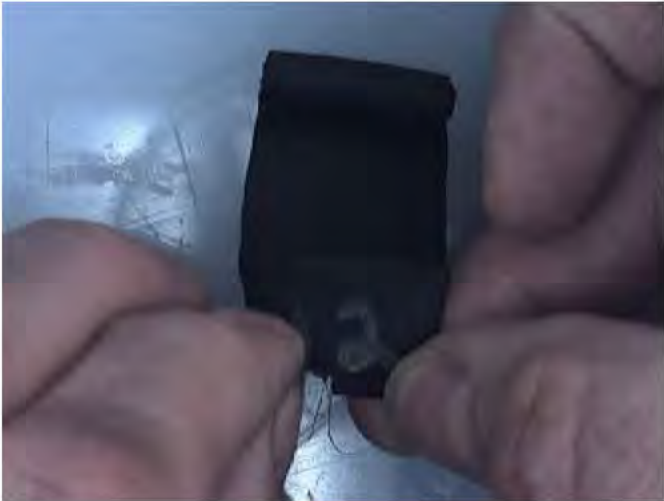
- Each section is then cut from the diaphragm, nicked with a razor and torn

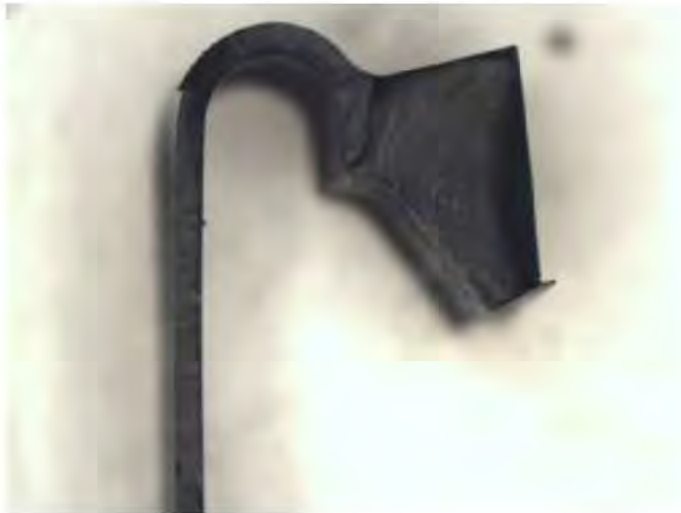
Tear surface of section

- The tear surfaces are then inspected. Particles in the tear surfaces are identified, measured, and recorded.

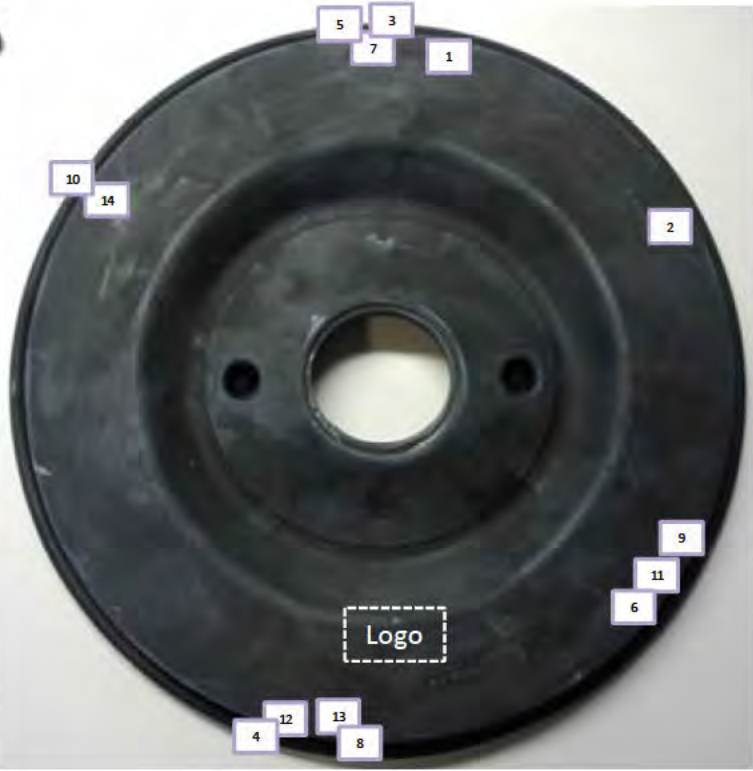
Tear from Field Warranty Return

Label	Diaphragm ID	No. of Tears
1	124391	1
2	124392	1
3	124692	2
4	124699	1
5	124700	1
6	124701	1
7	124702	3
8	124703	1
9	124704	1
10	124705	1
11	124706	1
12	124707	1
13	124708	1
14	124709	1

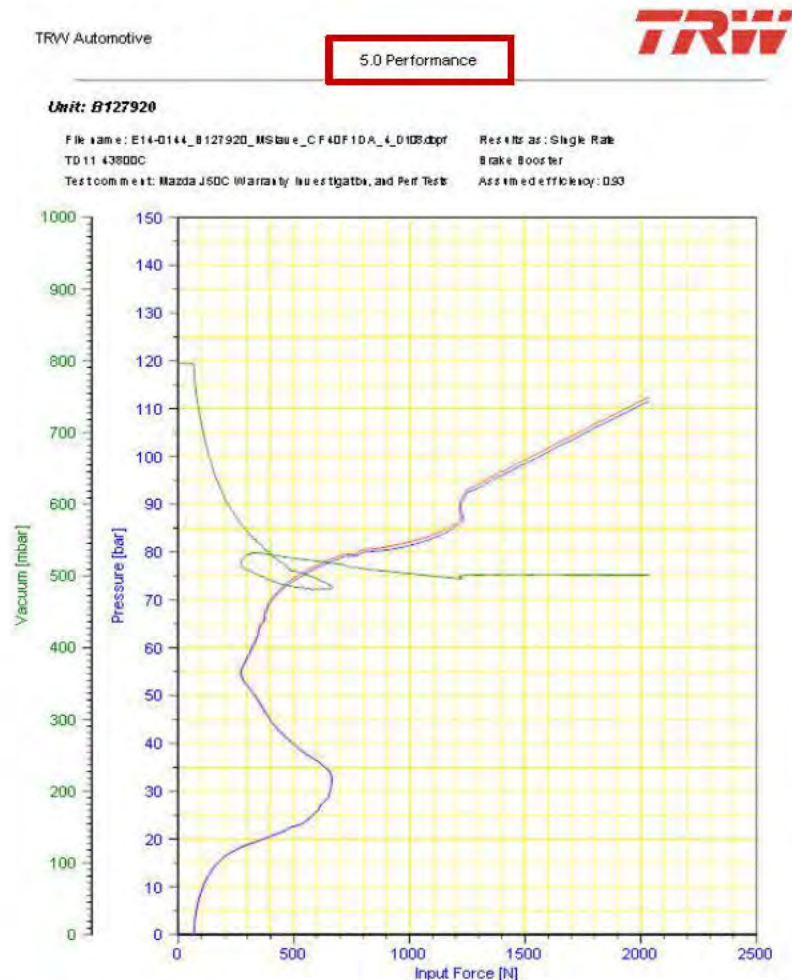
# Appendix: Vacuum Leak and Performance - Rank #5

Vacuum Test measures booster vacuum decay (mbar) over a 15 second time period after vacuum stabilization with a master cylinder mounted onto booster and at 3 booster input stroke positions (test halted if vacuum leak rate exceeds 20 mbar over 15 seconds for any booster input stroke position)

Booster performance test measures master cylinder output pressure (bar) v. booster input force (N) at constant vacuum target of 800 mbar and booster input travel rate of 2 mm/second using standard brake consumers
