**From:** [REDACTED]  
**To:** [REDACTED]  
**Subject:** FW: Service Report - 24 HR SR - Nest Labs - 4/22/2014

Service Report	
Date:	4/22/2014
Technician:	Ben Salazar, Keith Mitchell
Work Order #:	CA5981

**Reason for Visit:**  
 Replace micro SD card for Charger #6. Test unit then call nrg/eVgo back office support for system operation.

Service Report	
Date:	04/28/2014
Technician:	John Mahin
Work Order #:	CA6054

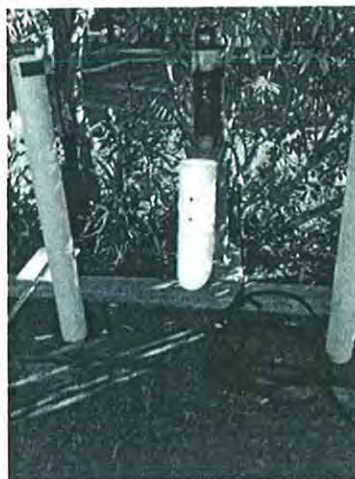
Charger 6 cover removed

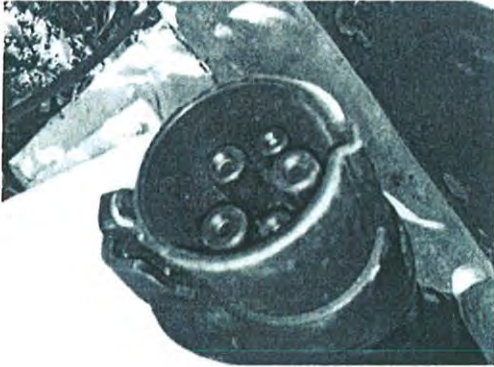
[REDACTED]  
Please see the attached report regarding the burned connector. This charger is in the same location as the other one that was melting Tesla adapters. How do you want to address it?

<b>Conclusion:</b>			
Dream plug communications devices sometime need sd card changes in order to bring them back online. It is noted that the connector on charger #6 has burned portion inside connector barrel. This can be caused while attempting to remove connector while car is charging. Vegetation is still over growing around chargers, as noted in previous reports.			
<b>Final Checklist:</b>			
<b>Final Walk-through completed:</b>	Yes	<b>Monitoring verified:</b>	Yes
<b>All devices secured and online:</b>	Yes	<b>Customer notified of departure:</b>	Yes
<b>Report Completed:</b>	Yes	<b>Follow-up service required:</b>	No

**Charger 6 burned connector**

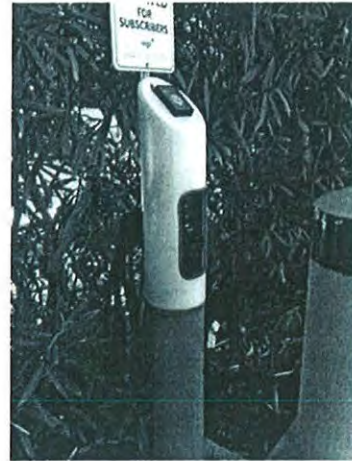
**Charger #6 "as left condition"**

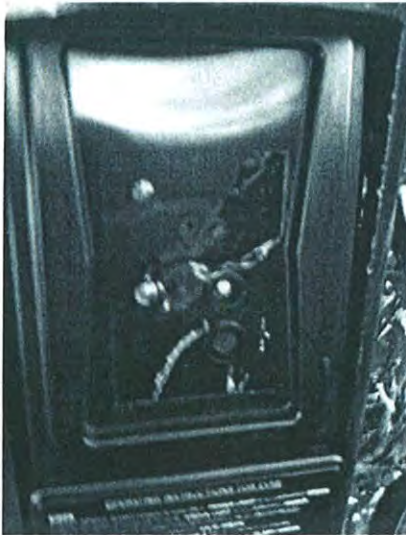
**Charger 7 with factory jumper**

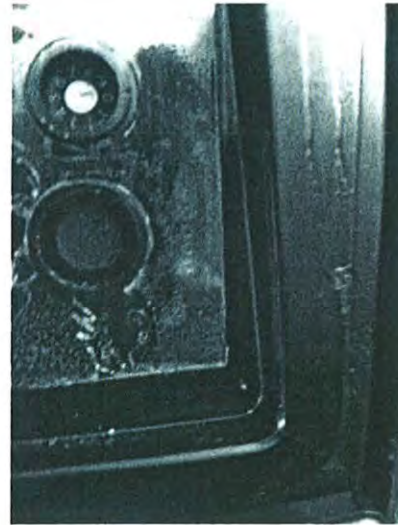
**Jumper removed behind bow-tie plate**

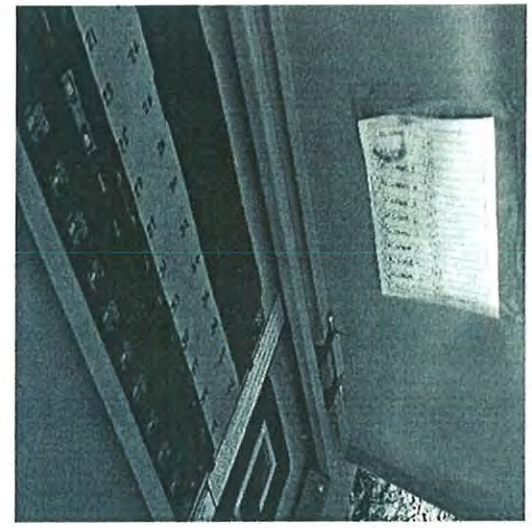
Flipped Breaker

<b>Reason for Visit:</b>			
Request power turned off to charger #6 and to bag off the charger.			
<b>Work Performed / Actions Taken:</b>			
I turned off the breaker and turned the sign around. I also placed a trash bag over the charger and secured it with tape and wrote out of order. Photo attached. I called and text [REDACTED] at request was performed and was departing site.			
<b>Equipment Replaced :</b>	No		
<b>Qty</b>	<b>Description</b>	<b>Model #</b>	<b>Serial #</b>
<b>Pictures Taken:</b>	Yes		
<b>Conclusion:</b>			
The charger unit should be swapped out.

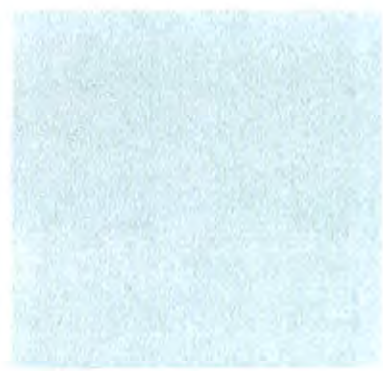
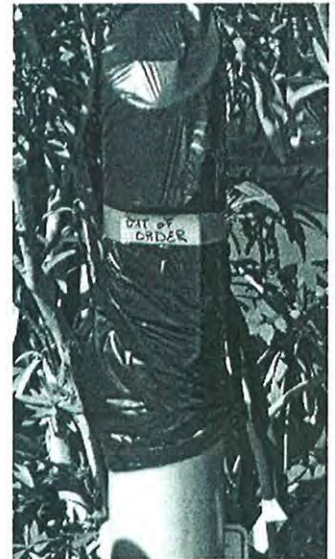
Final tag out.

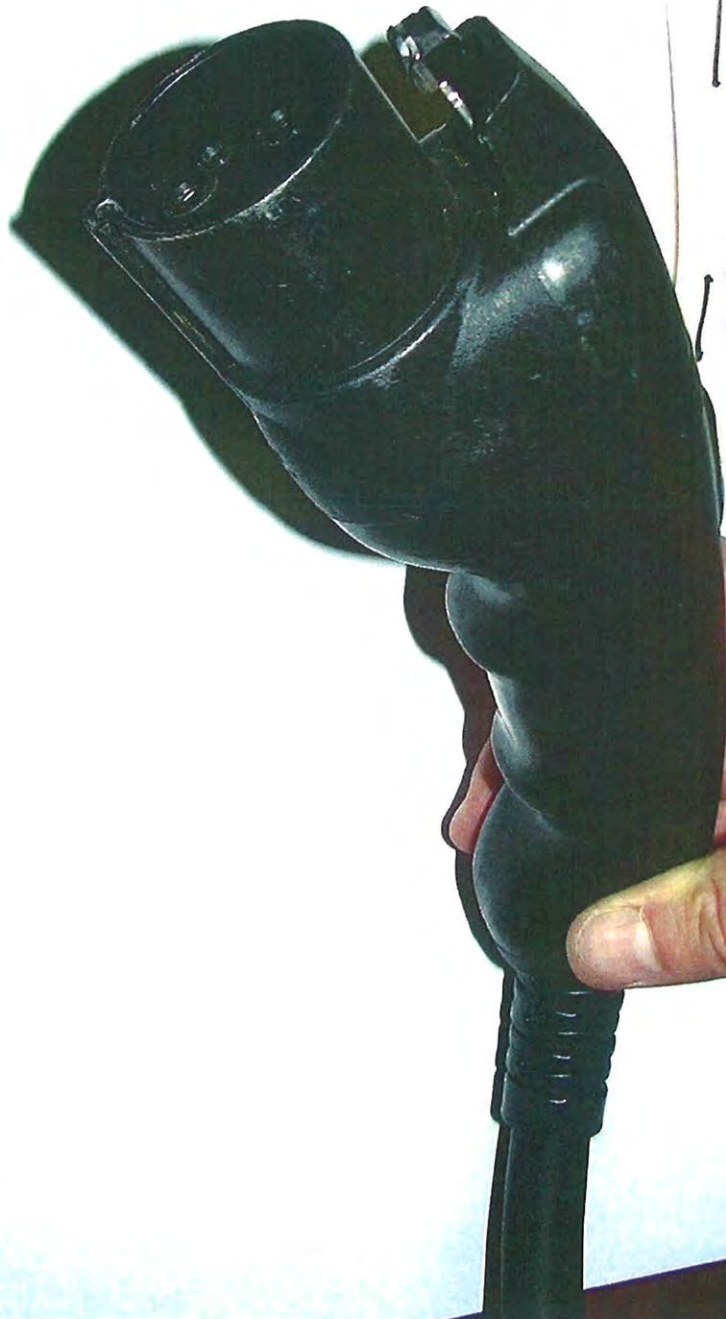
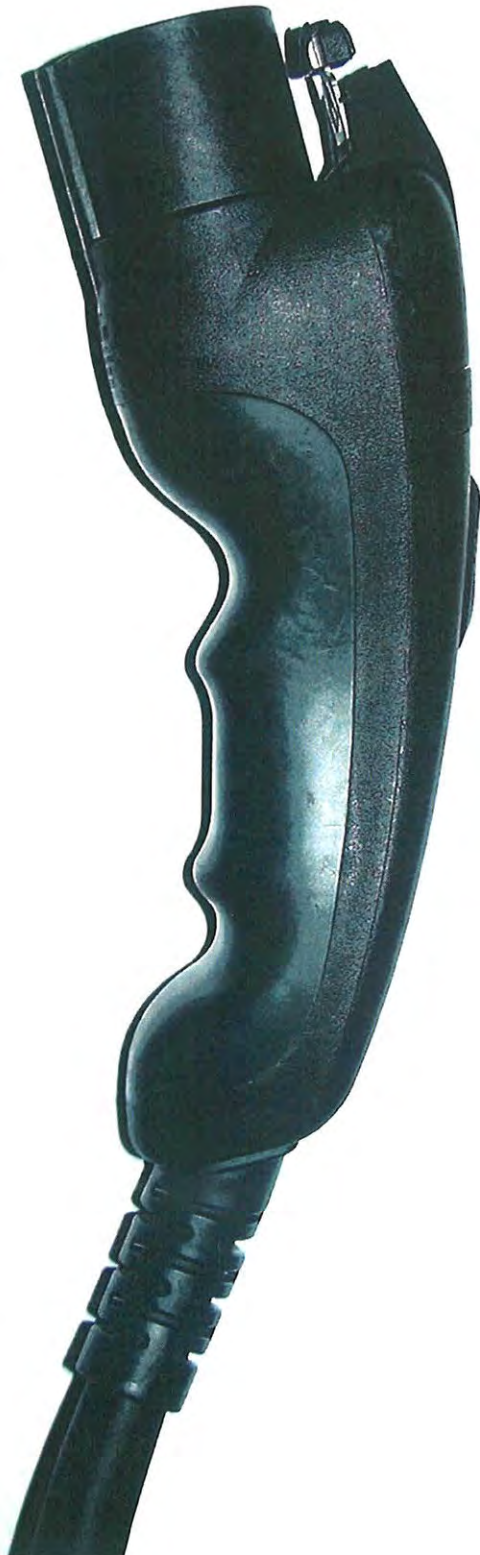
MELTED TESLA  
ADAPTOR #A  
NEST # ~~76~~ 6

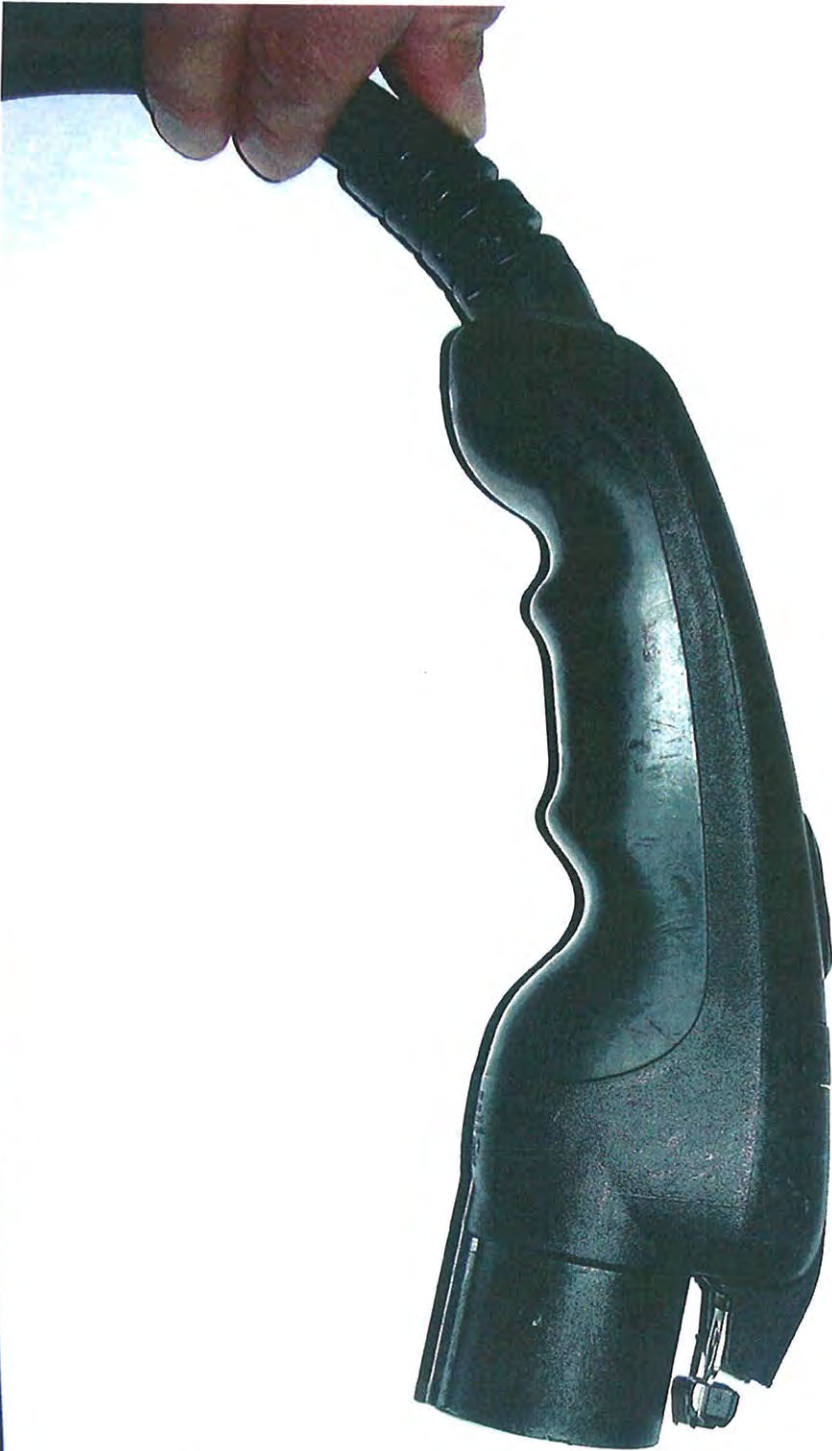
MELTED TESLA  
ADAPTOR #A  
NEST # ~~76~~ 6

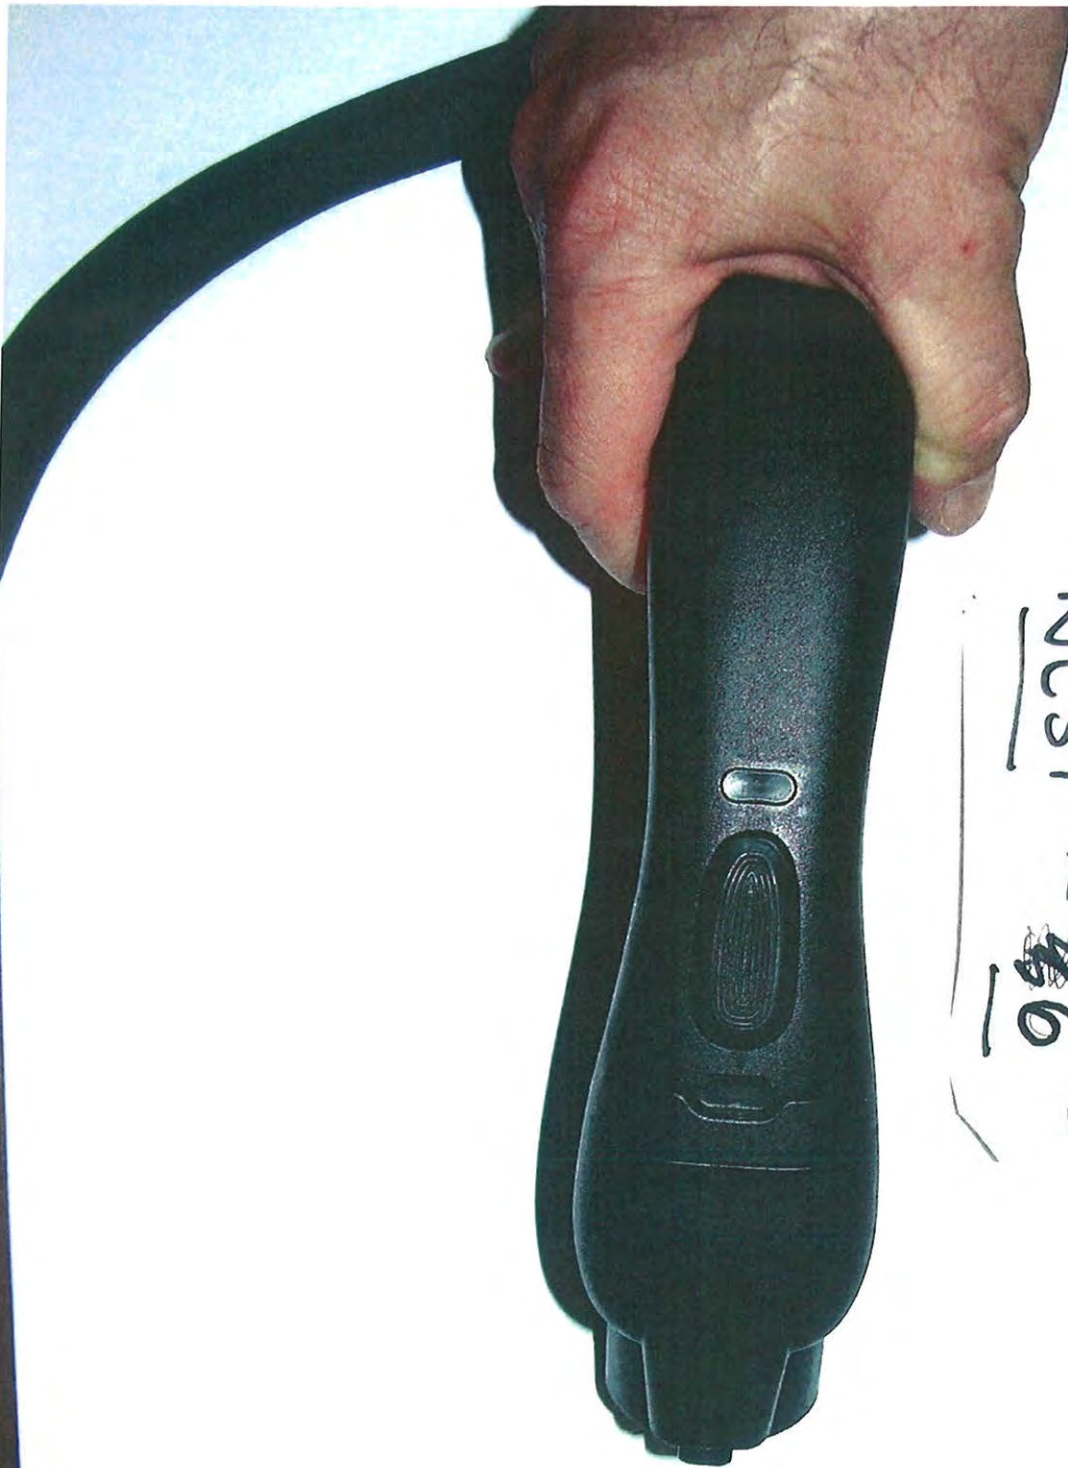
MELTED TESLA  
ADAPTOR #A  
NEST # ~~24~~ 26

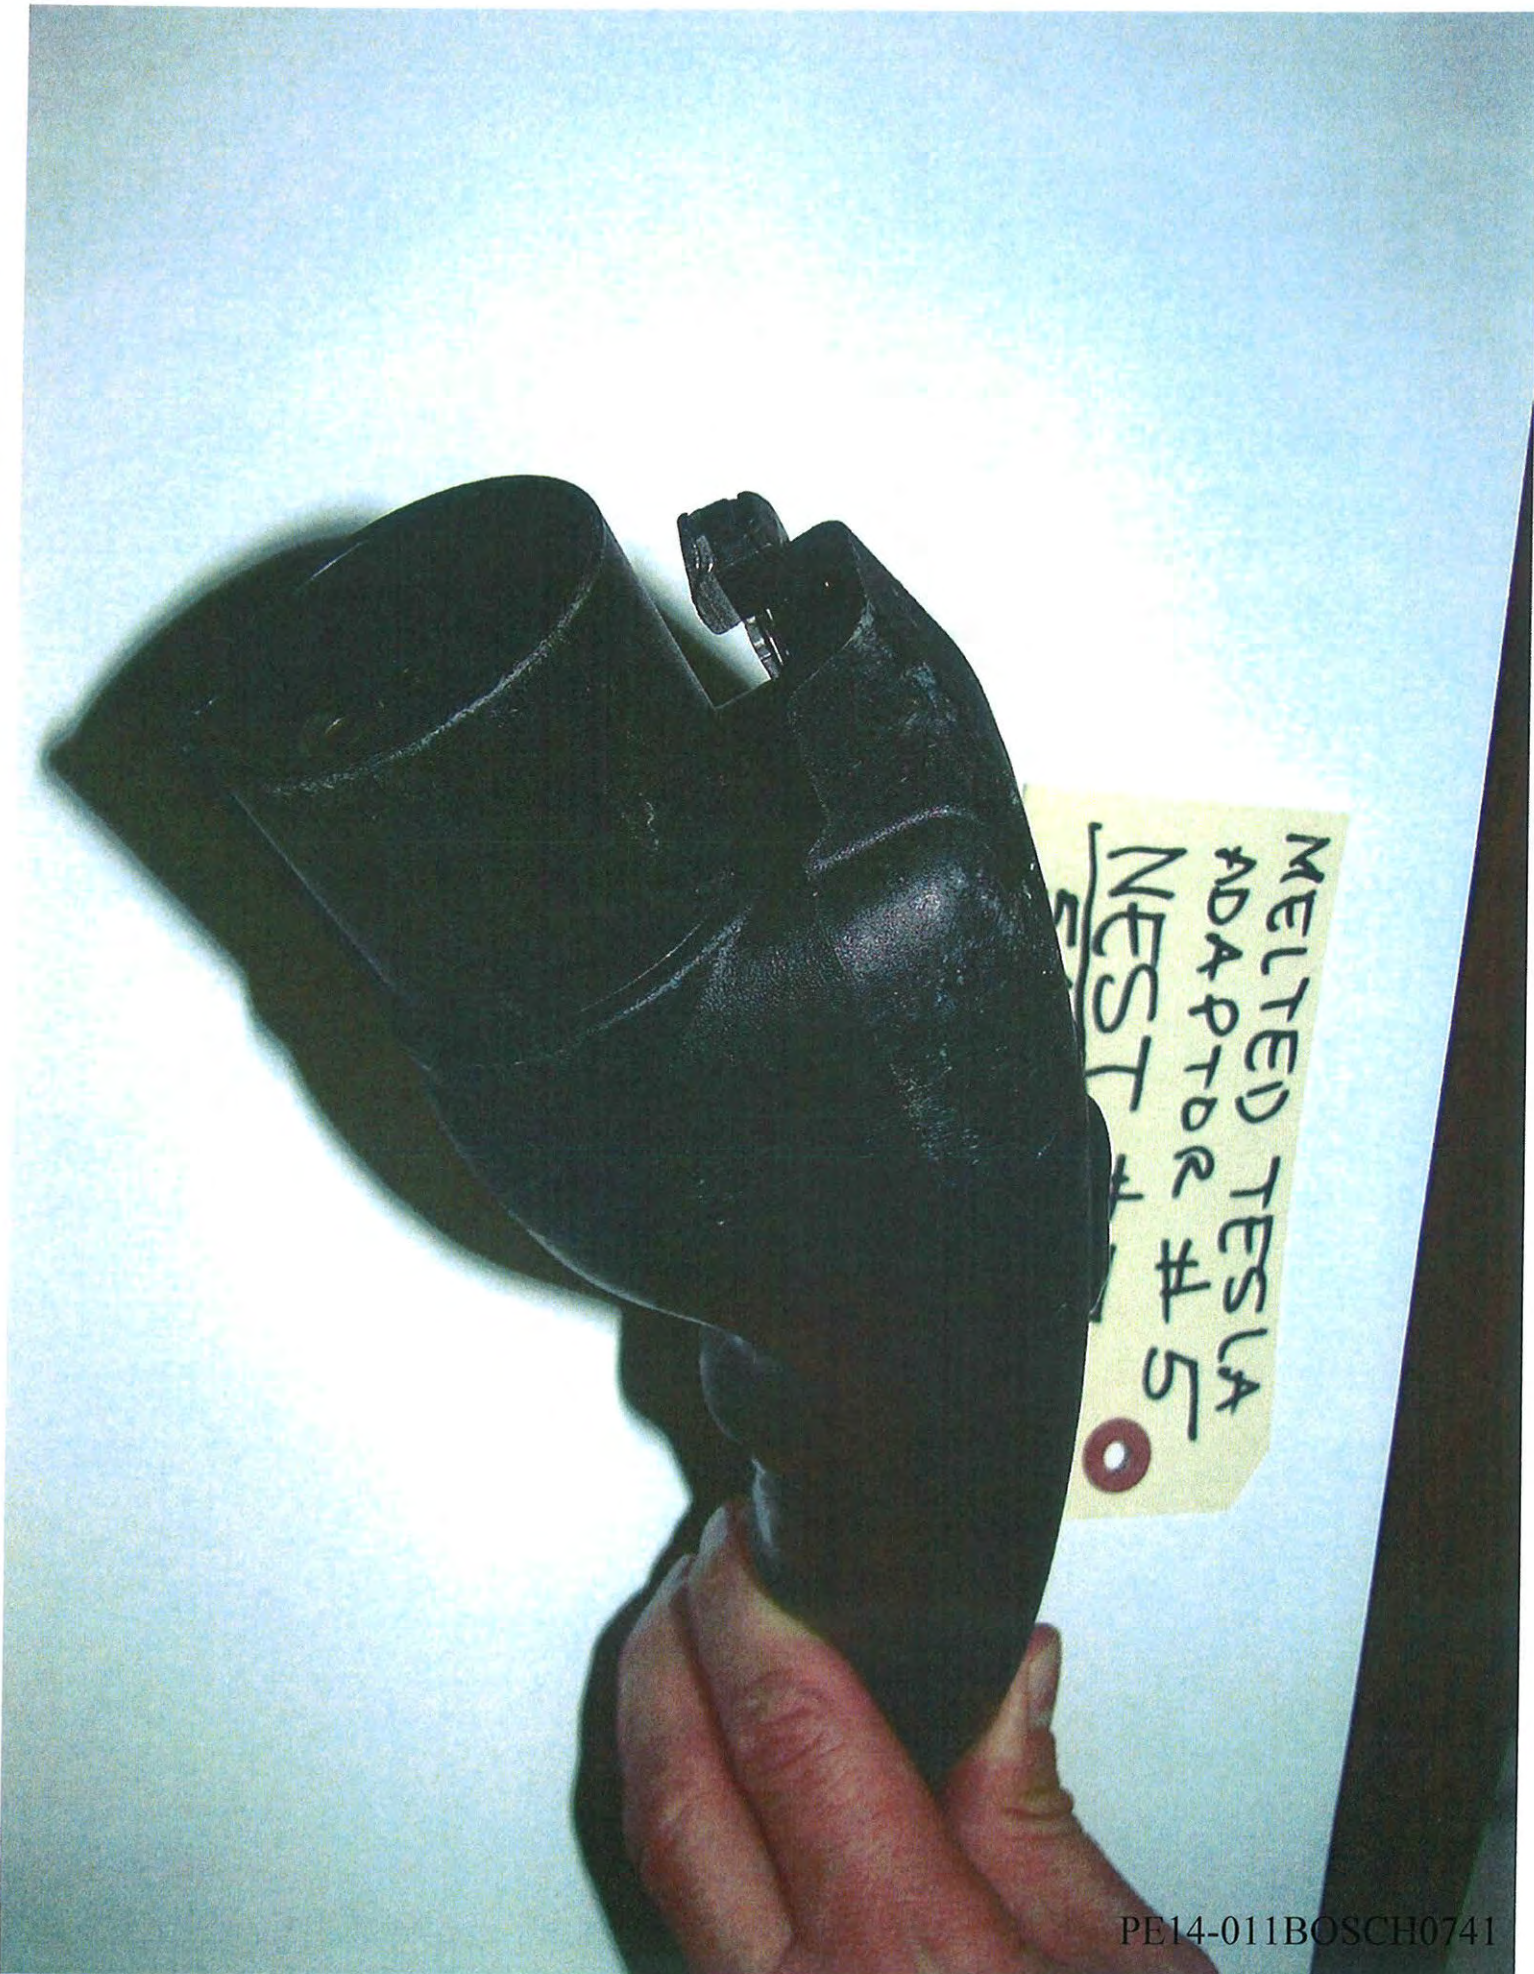
MELTED TEST/A  
ADAPTOR #5  
NEST #5

MELTED TESLA  
ADAPTER #5  
NEST #7  
5/16/14

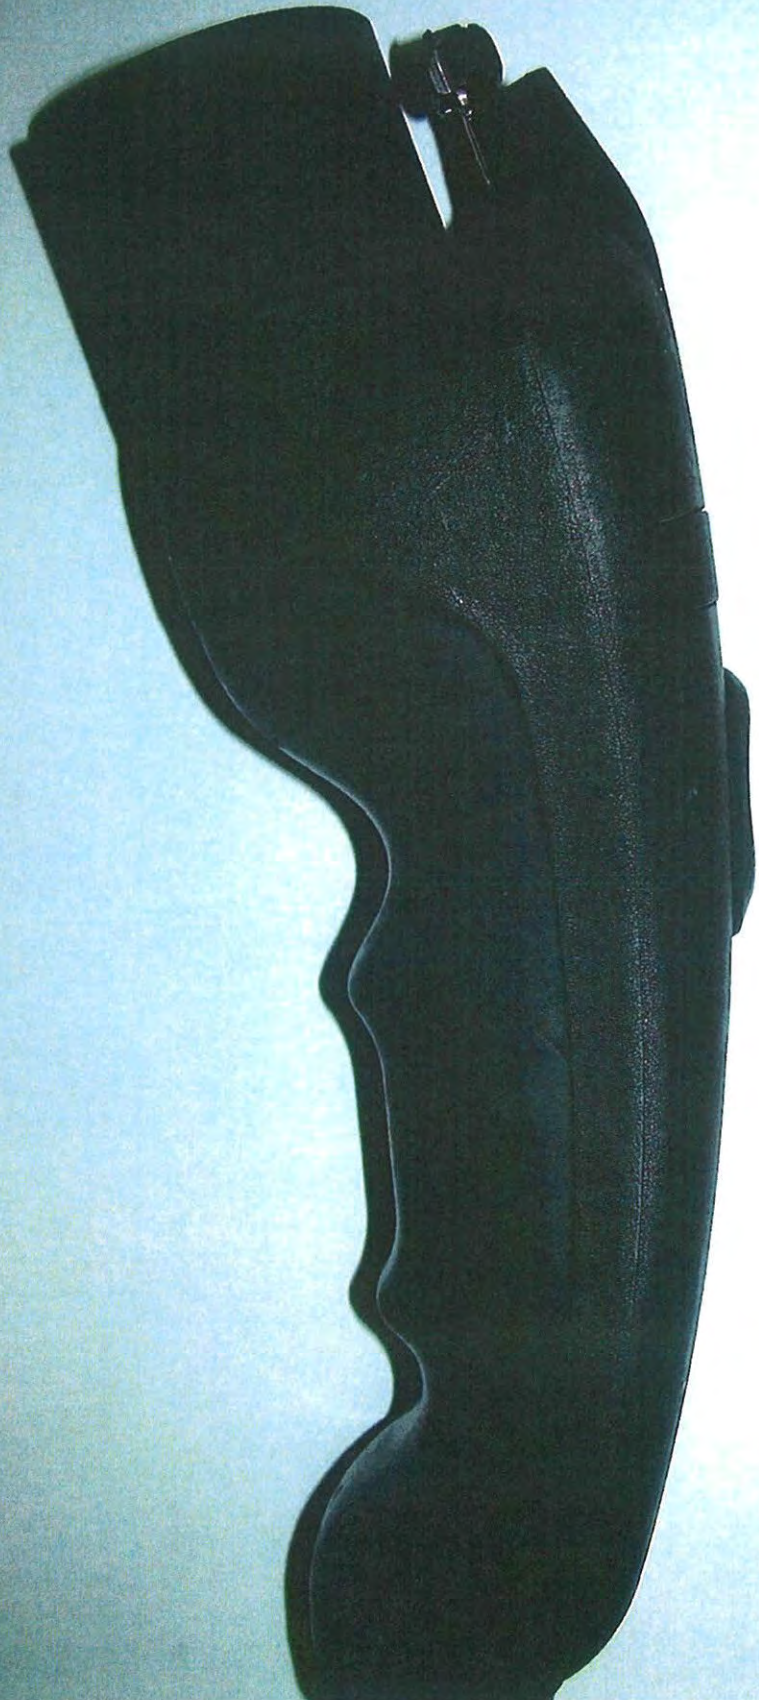
MELTED TESLA  
ADAPTOR #5  
NEST #7  
5/16/14

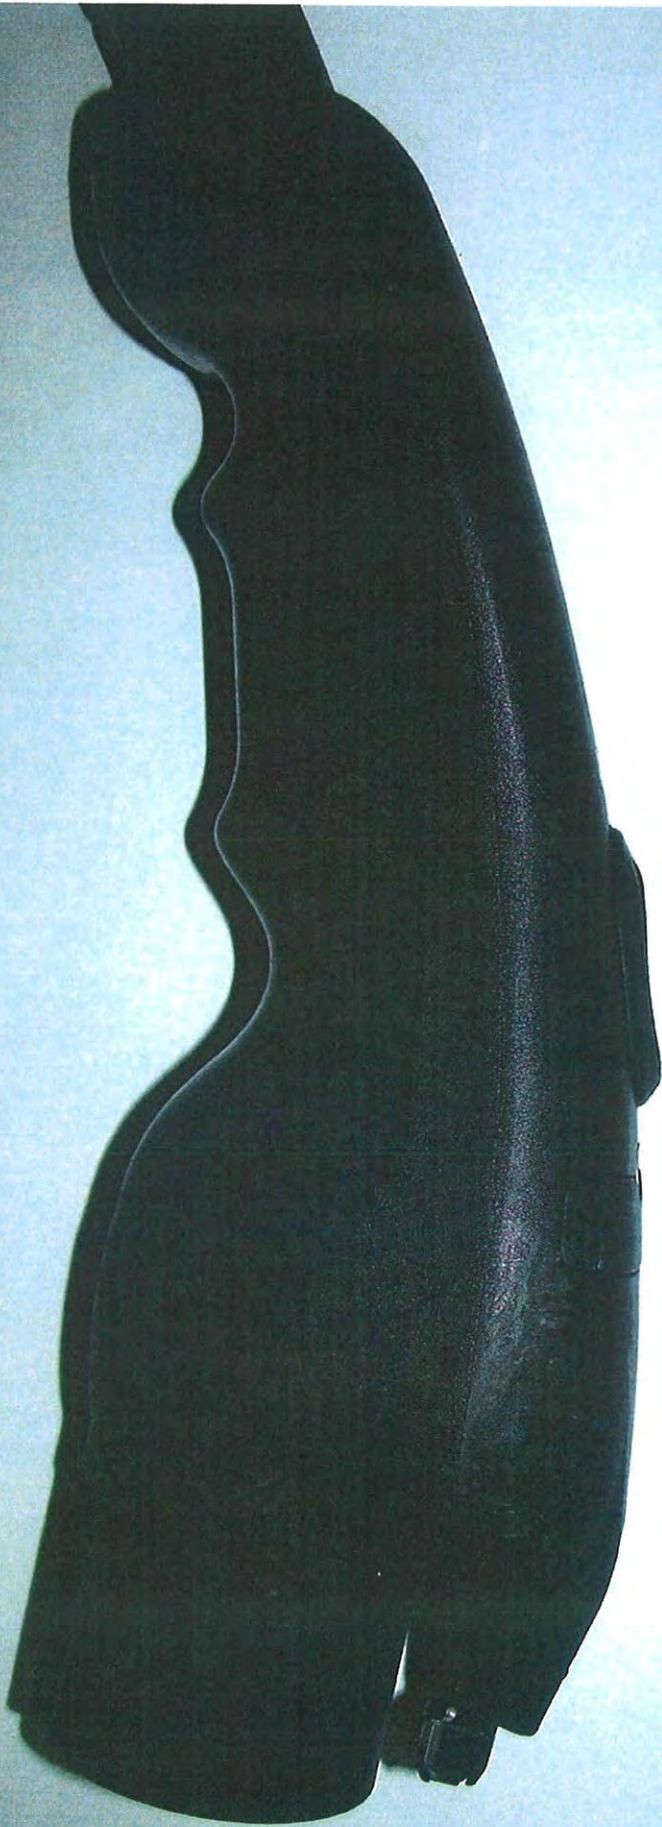
MELTED TESLA  
ADAPTER #5  
NEST #7  
5/16/14
