PE14-017

CHRYSLER

FIELD DATA ALLEGED

CONFIDENTIAL - Prior Approval Required Before Duplicating**Preliminary Vehicle Investigation Report(PVIR)**

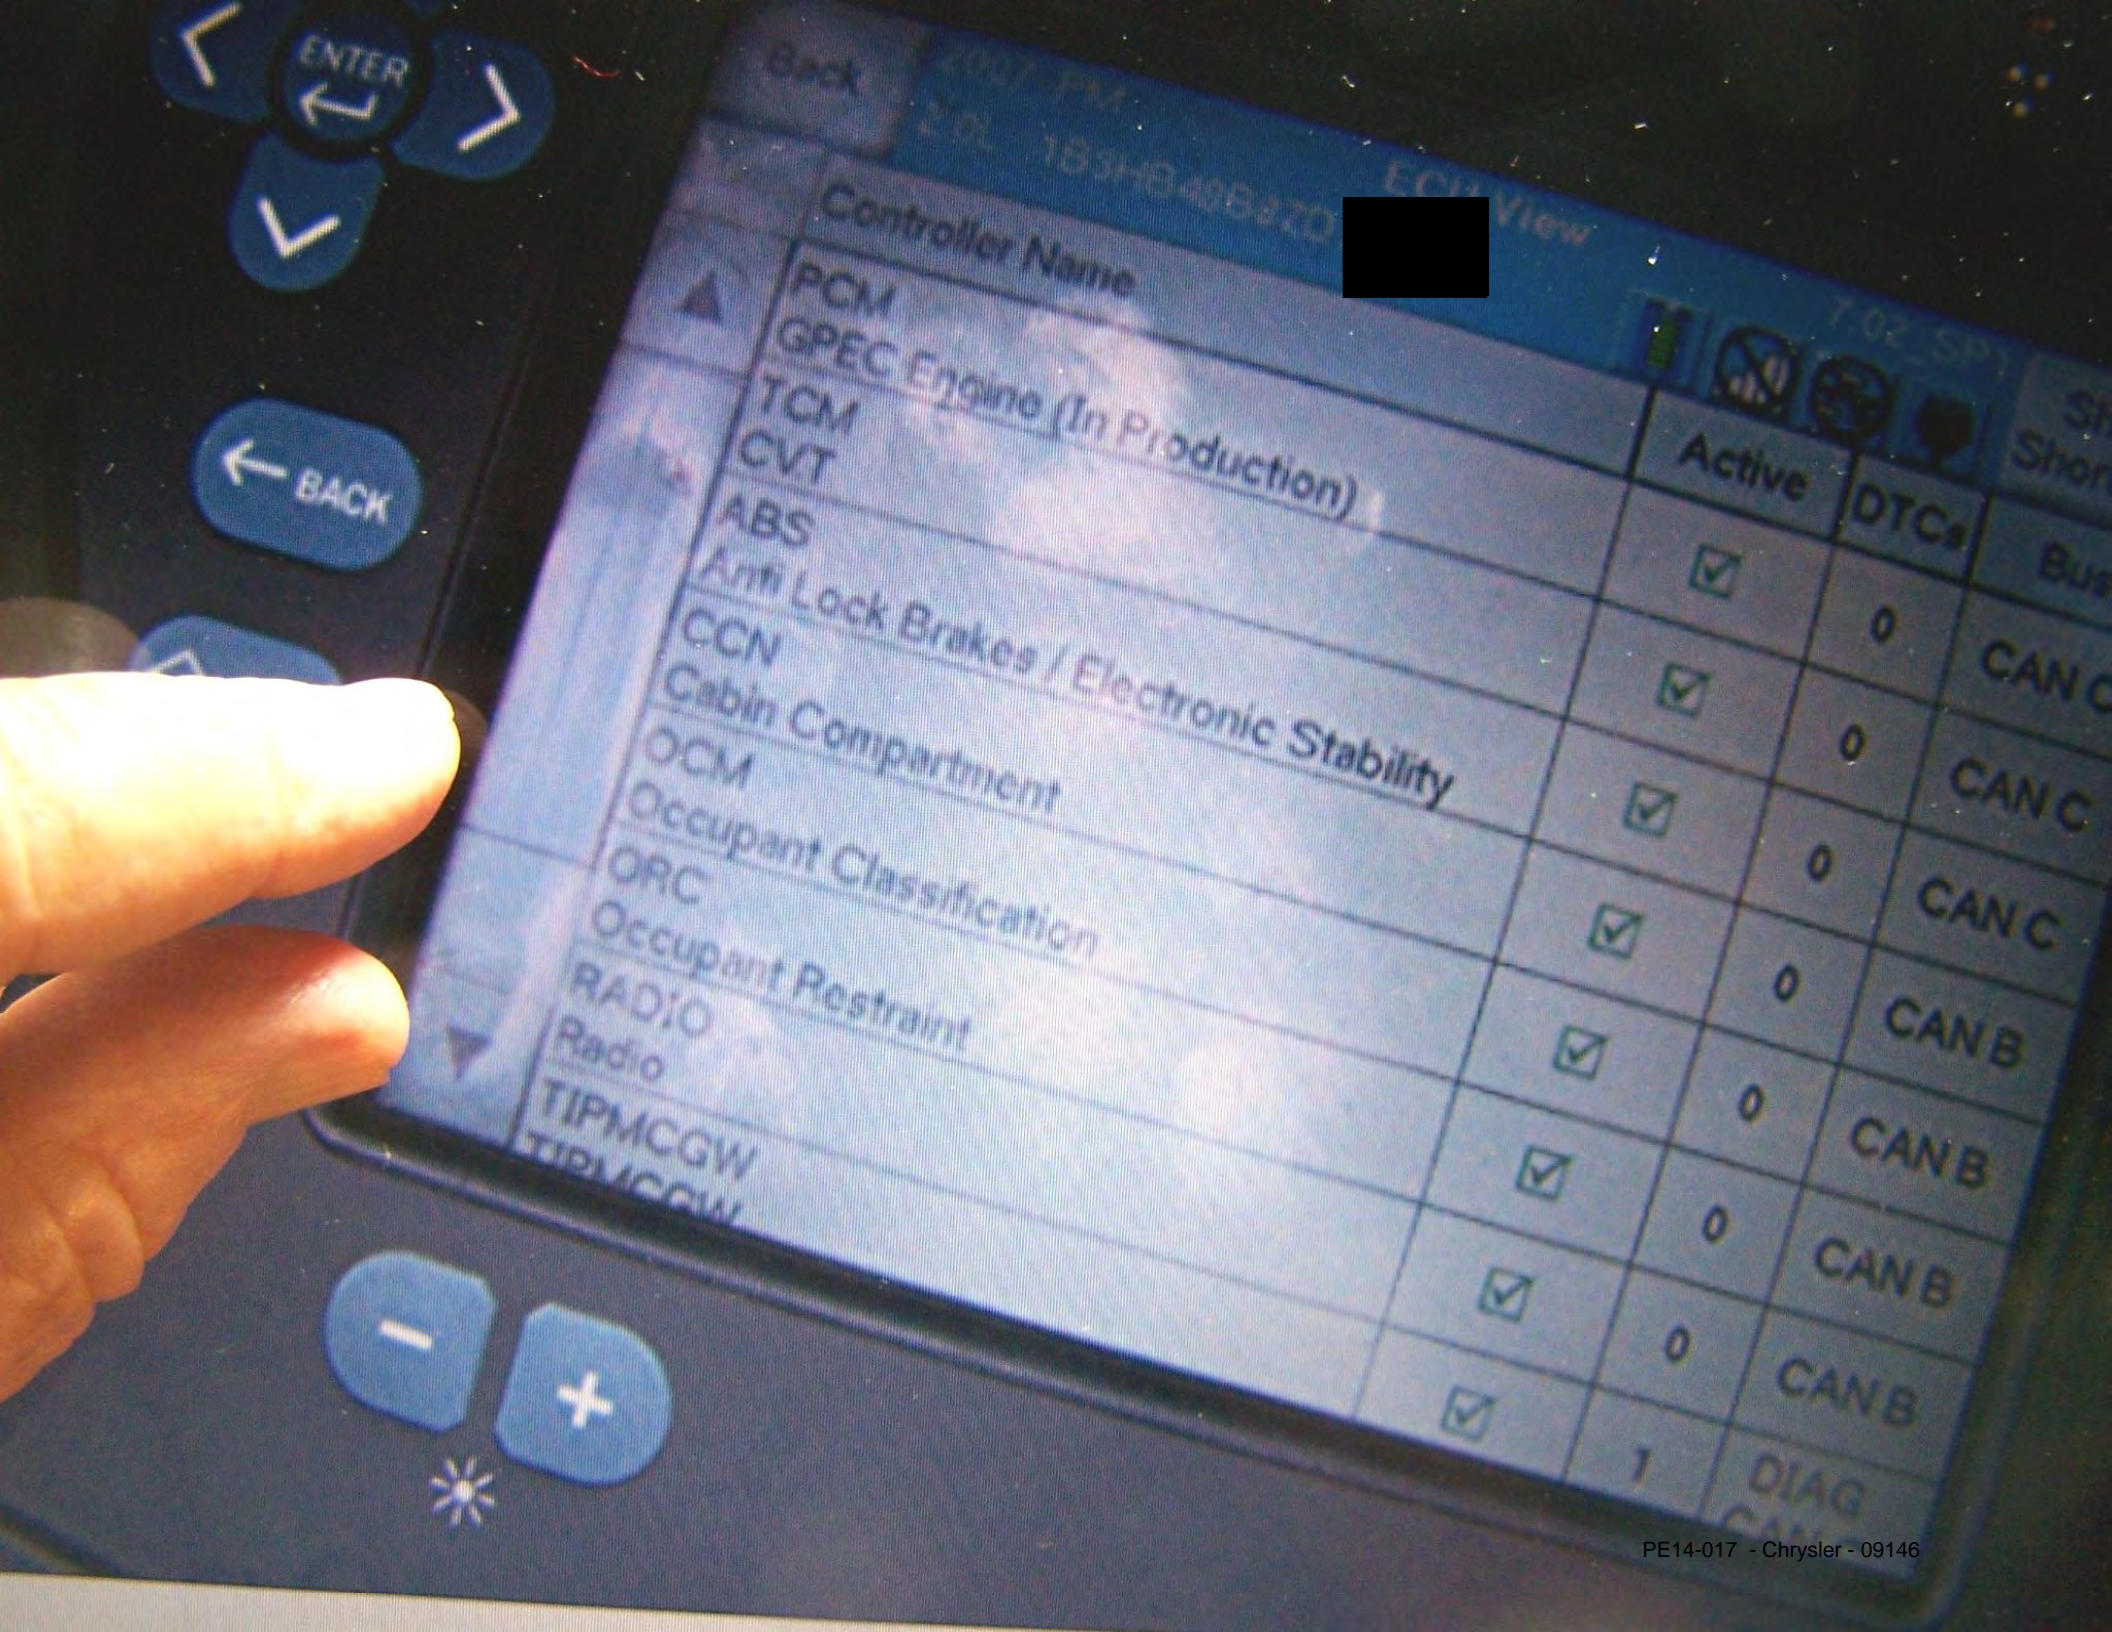
ECU View

Controller Name	Active	DTCs	Bus
PCM	<input checked="" type="checkbox"/>	0	CAN C
GPEC Engine (In Production)	<input checked="" type="checkbox"/>	0	CAN C
TCM	<input checked="" type="checkbox"/>	0	CAN C
CVT	<input checked="" type="checkbox"/>	0	CAN B
ABS	<input checked="" type="checkbox"/>	0	CAN B
Anti Lock Brakes / Electronic Stability	<input checked="" type="checkbox"/>	0	CAN B
CCN	<input checked="" type="checkbox"/>	0	CAN B
Cabin Compartment	<input checked="" type="checkbox"/>	0	CAN B
OCM	<input checked="" type="checkbox"/>	0	CAN B
Occupant Classification	<input checked="" type="checkbox"/>	0	CAN B
ORC	<input checked="" type="checkbox"/>	0	CAN B
Occupant Restraint	<input checked="" type="checkbox"/>	1	DIAG
RADIO	<input checked="" type="checkbox"/>		
Radio	<input checked="" type="checkbox"/>		
TIPMCGW	<input checked="" type="checkbox"/>		
TIPMCGW	<input checked="" type="checkbox"/>

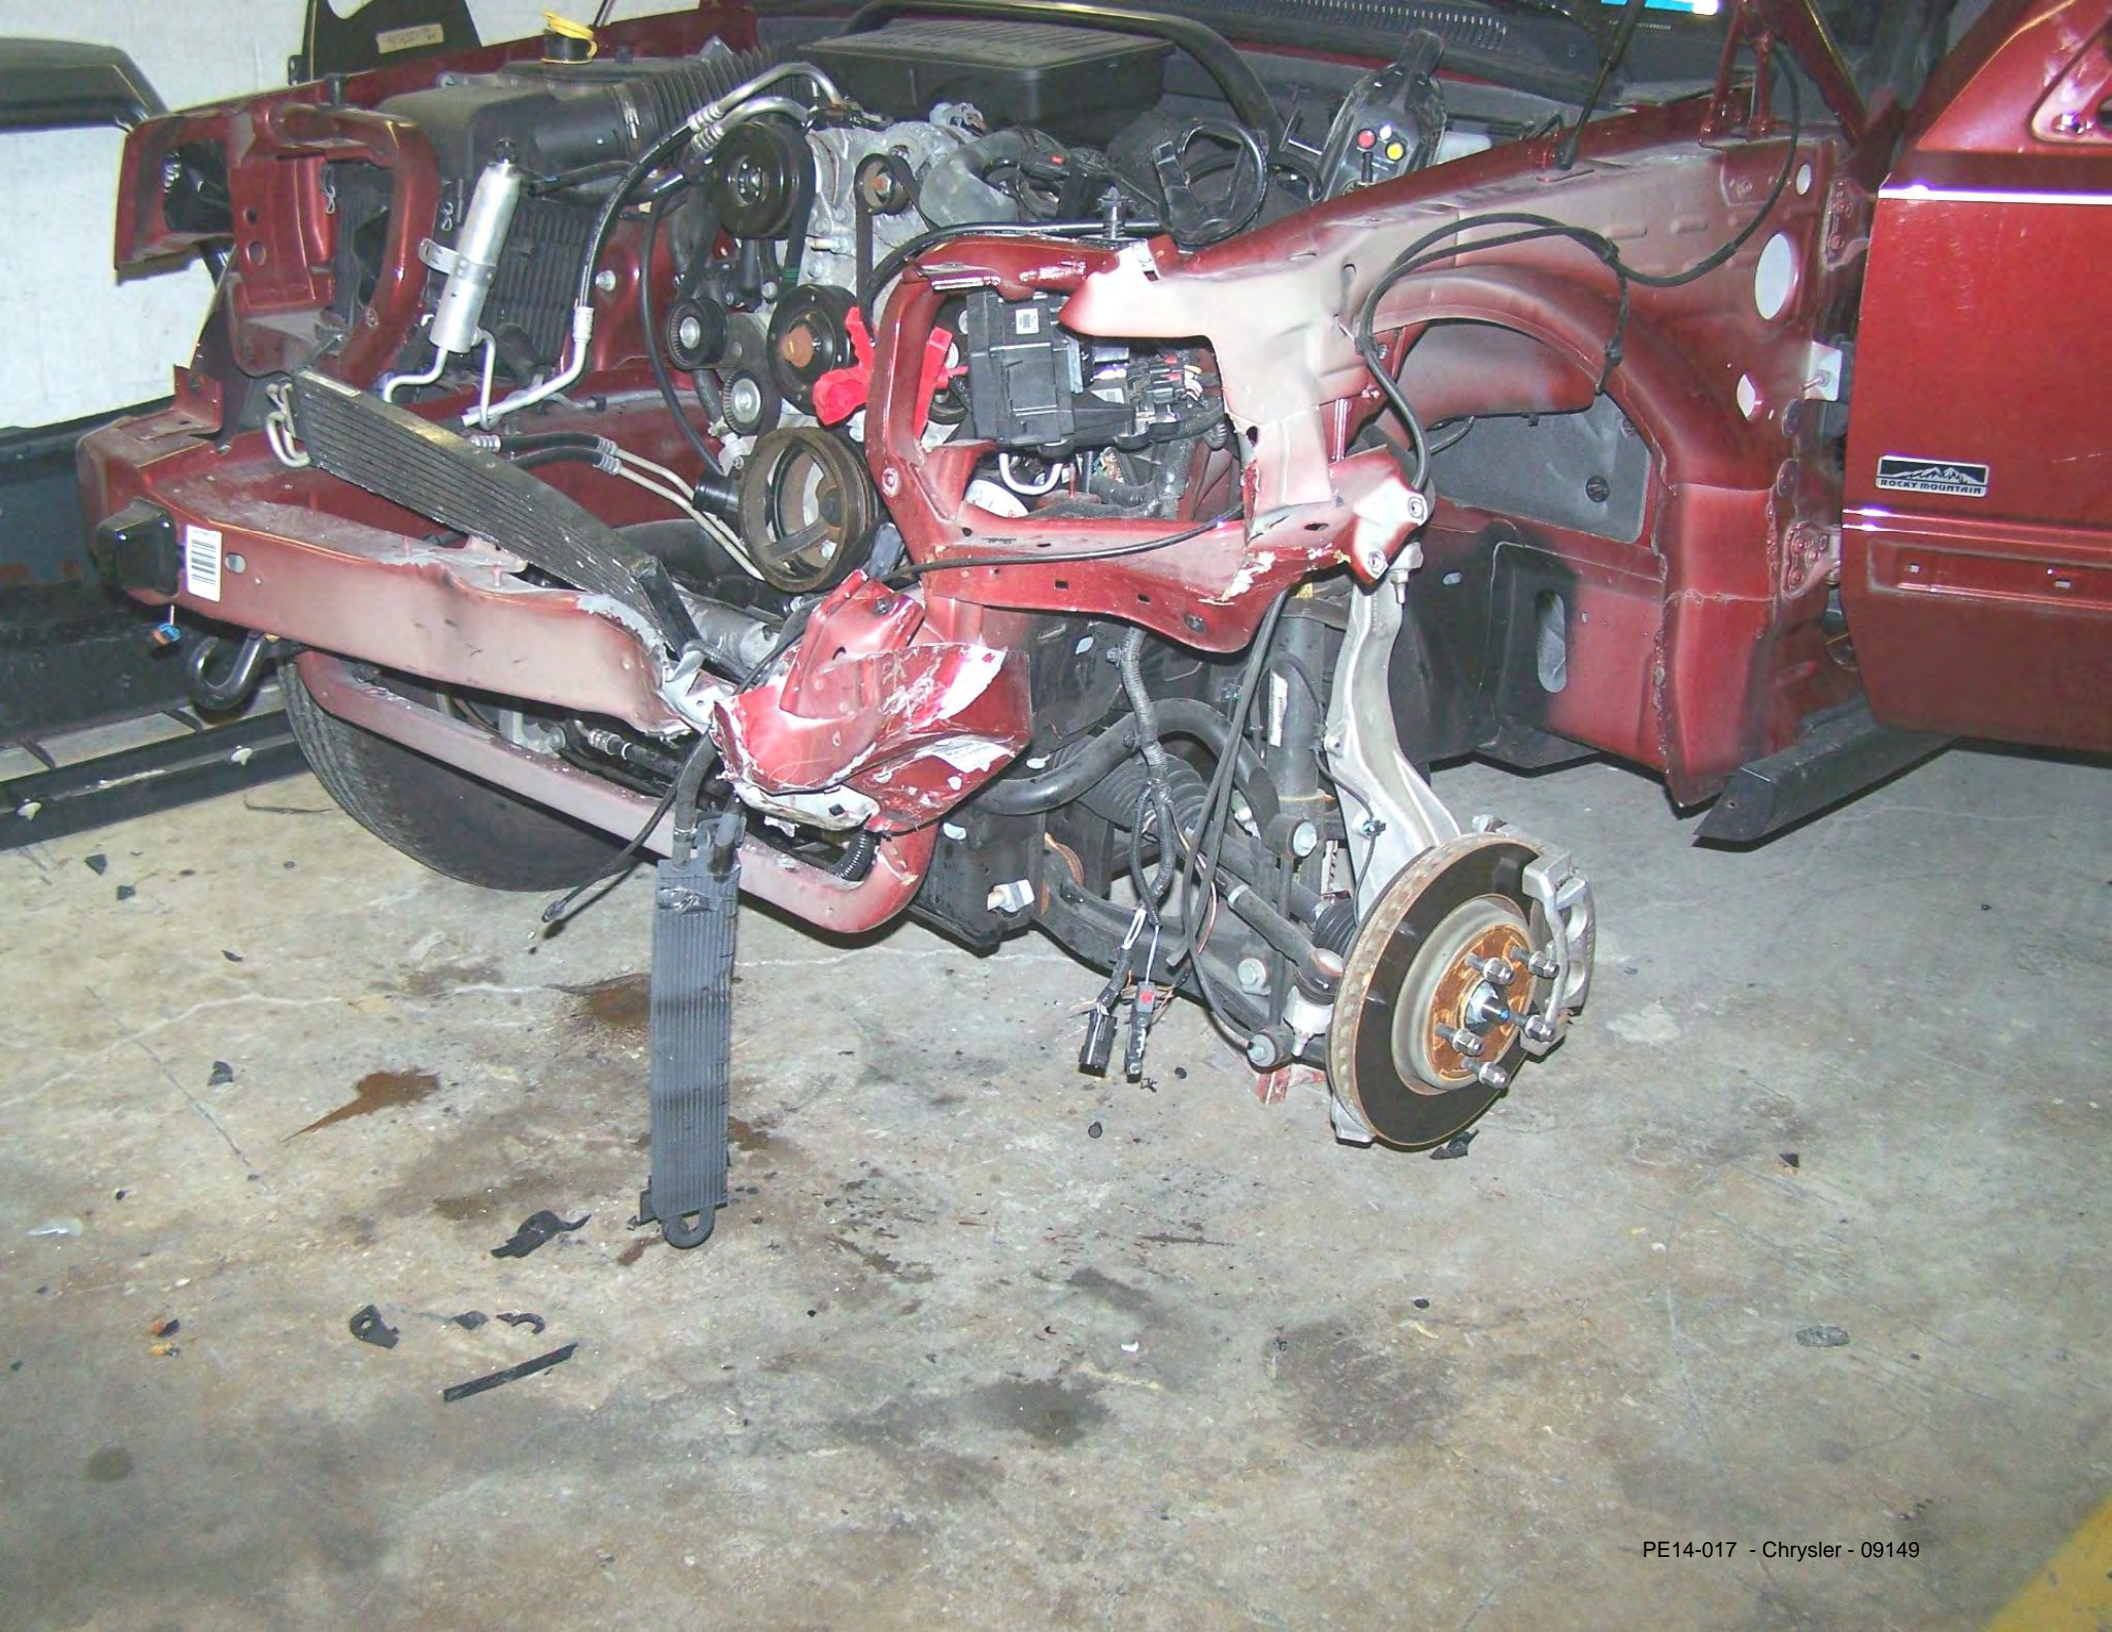
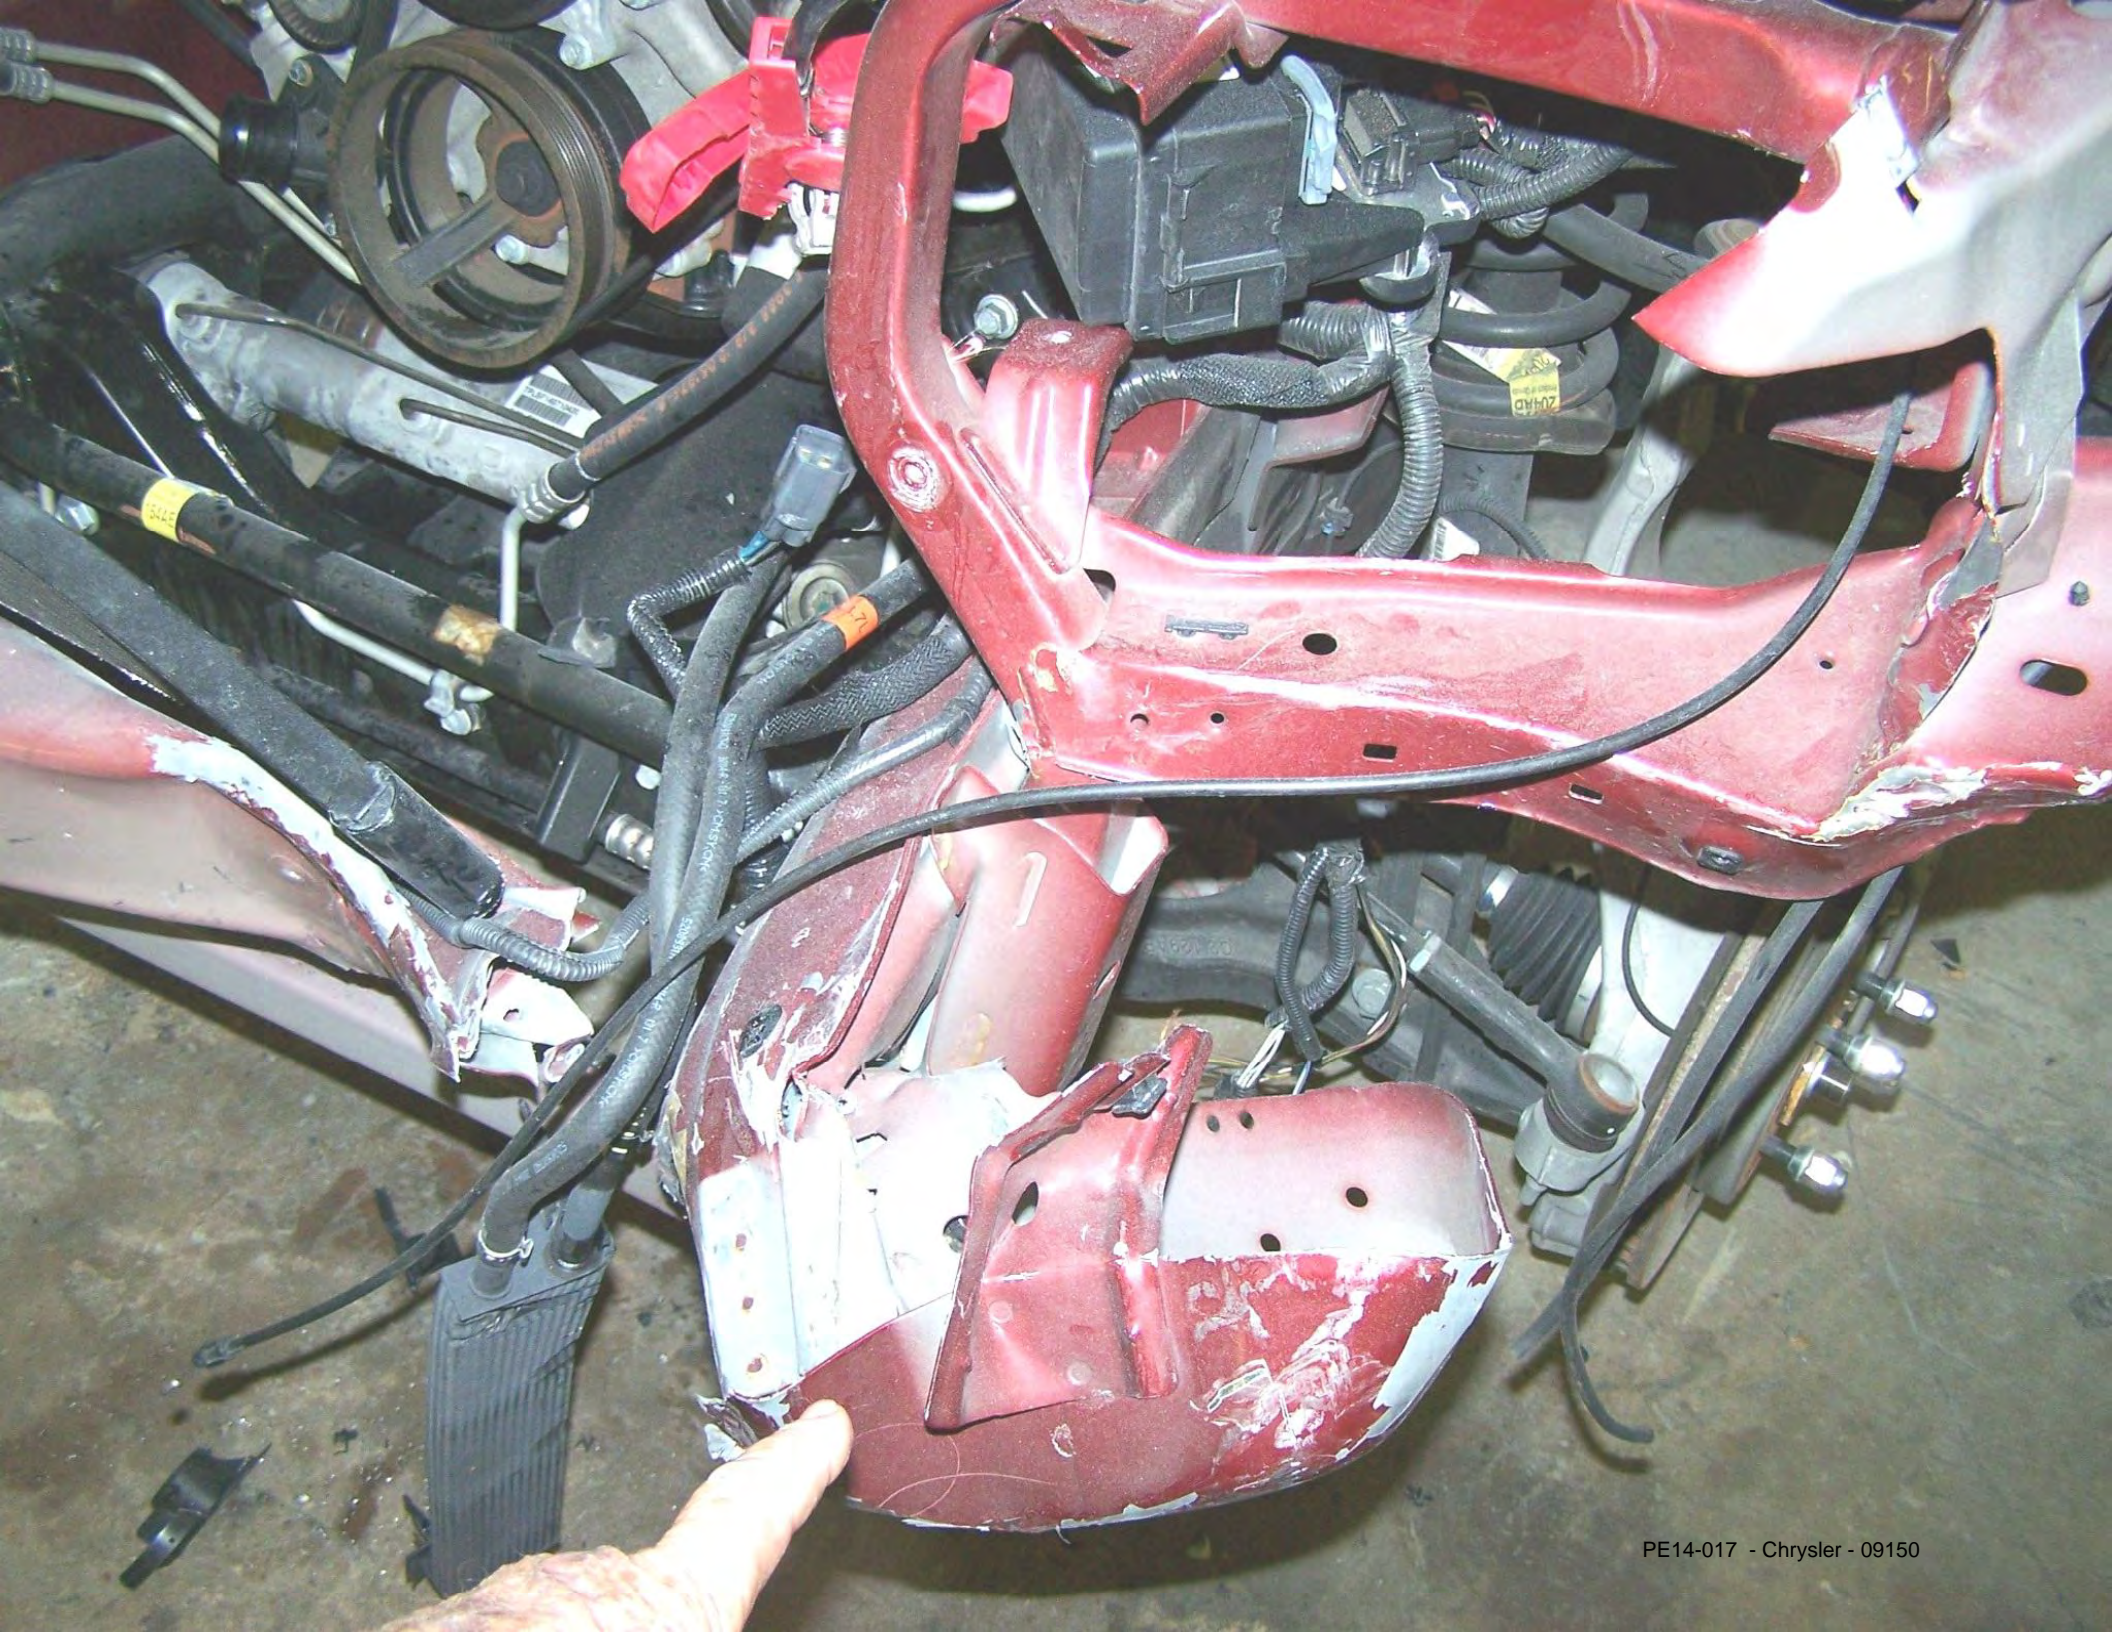
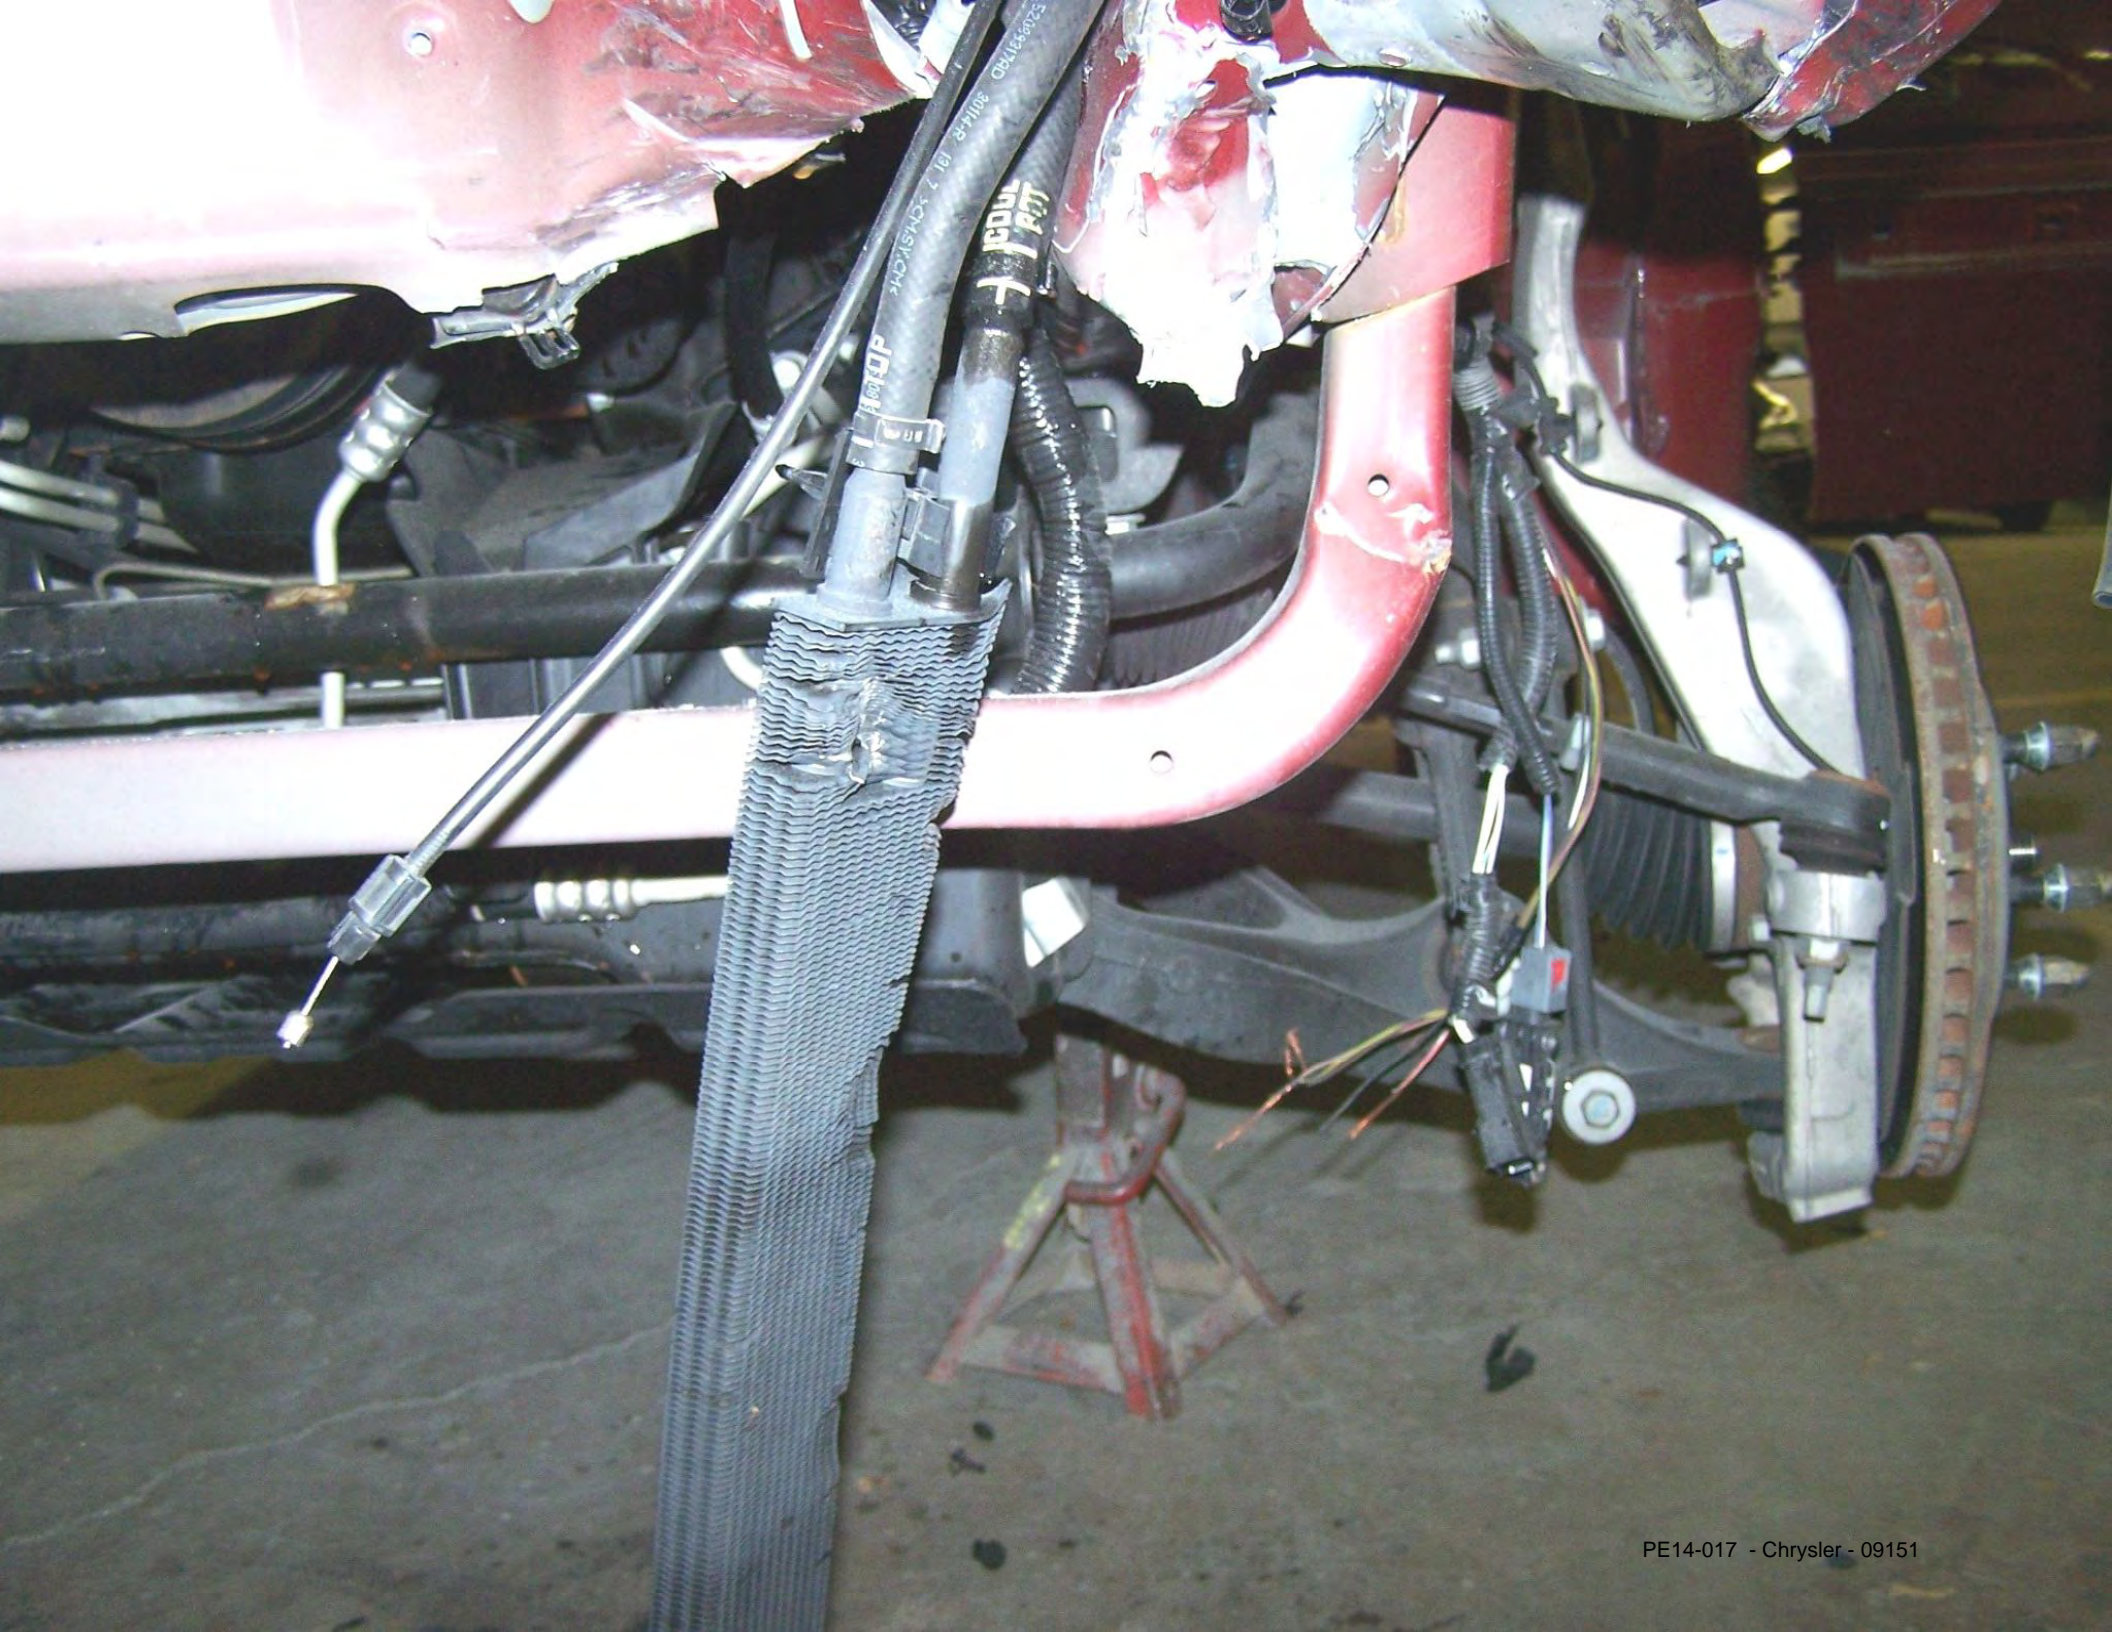
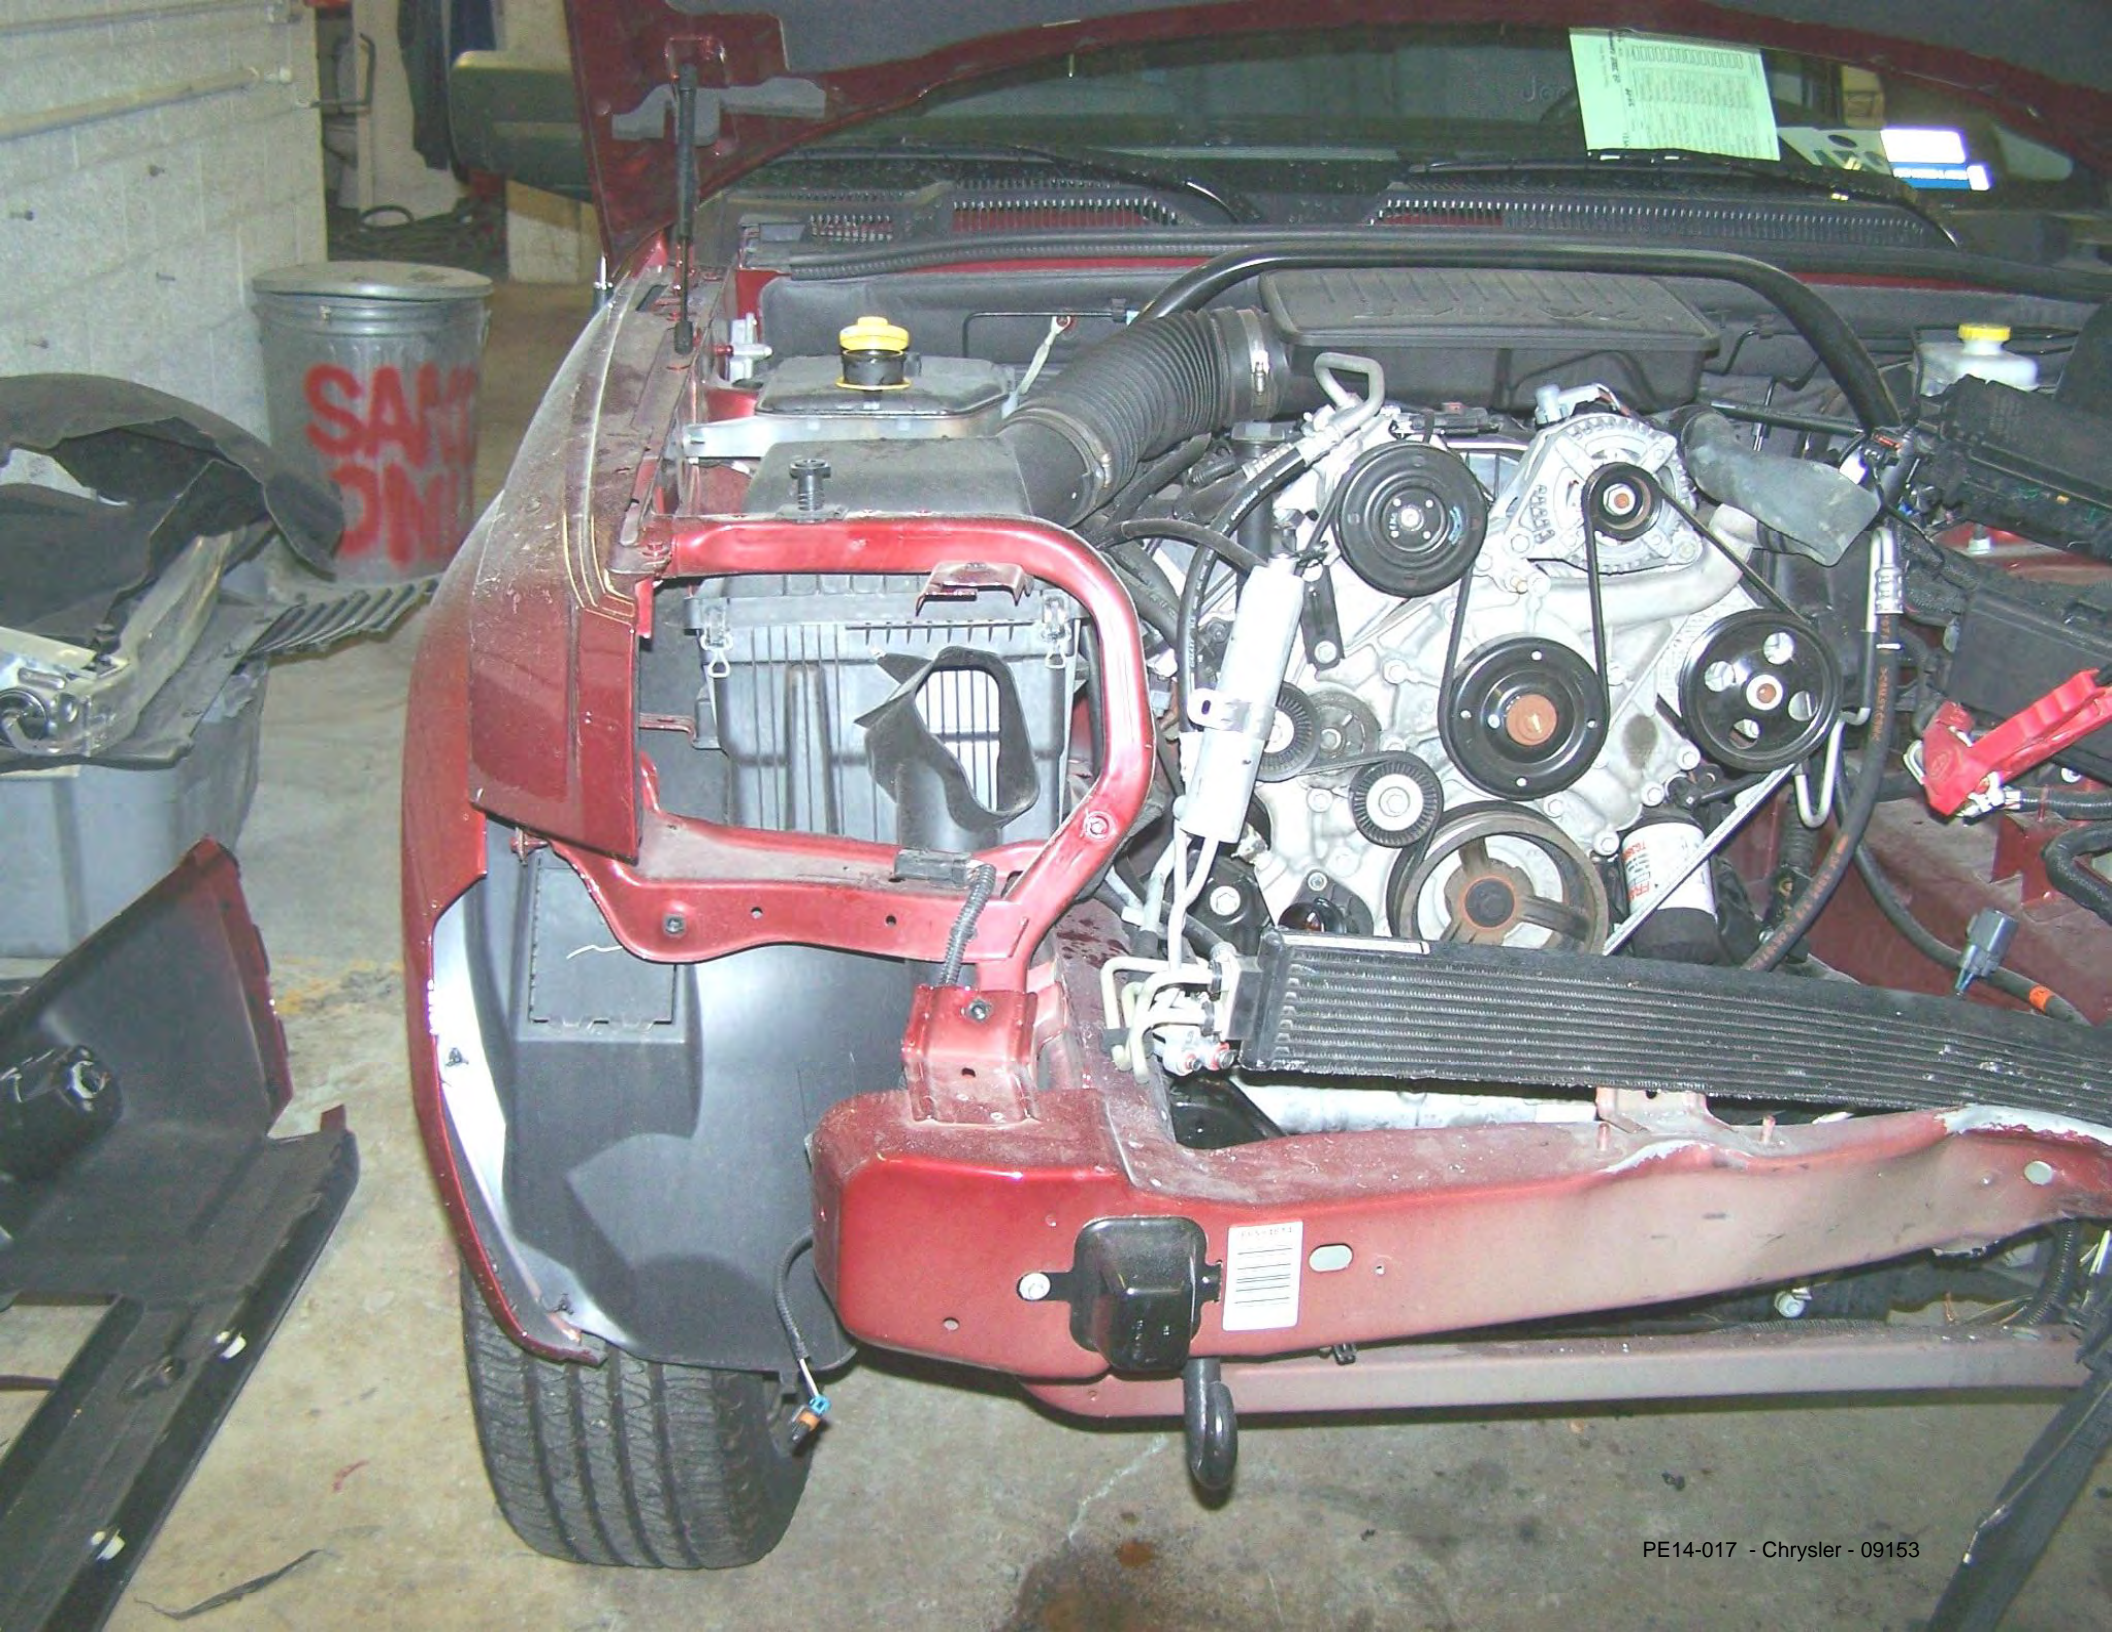
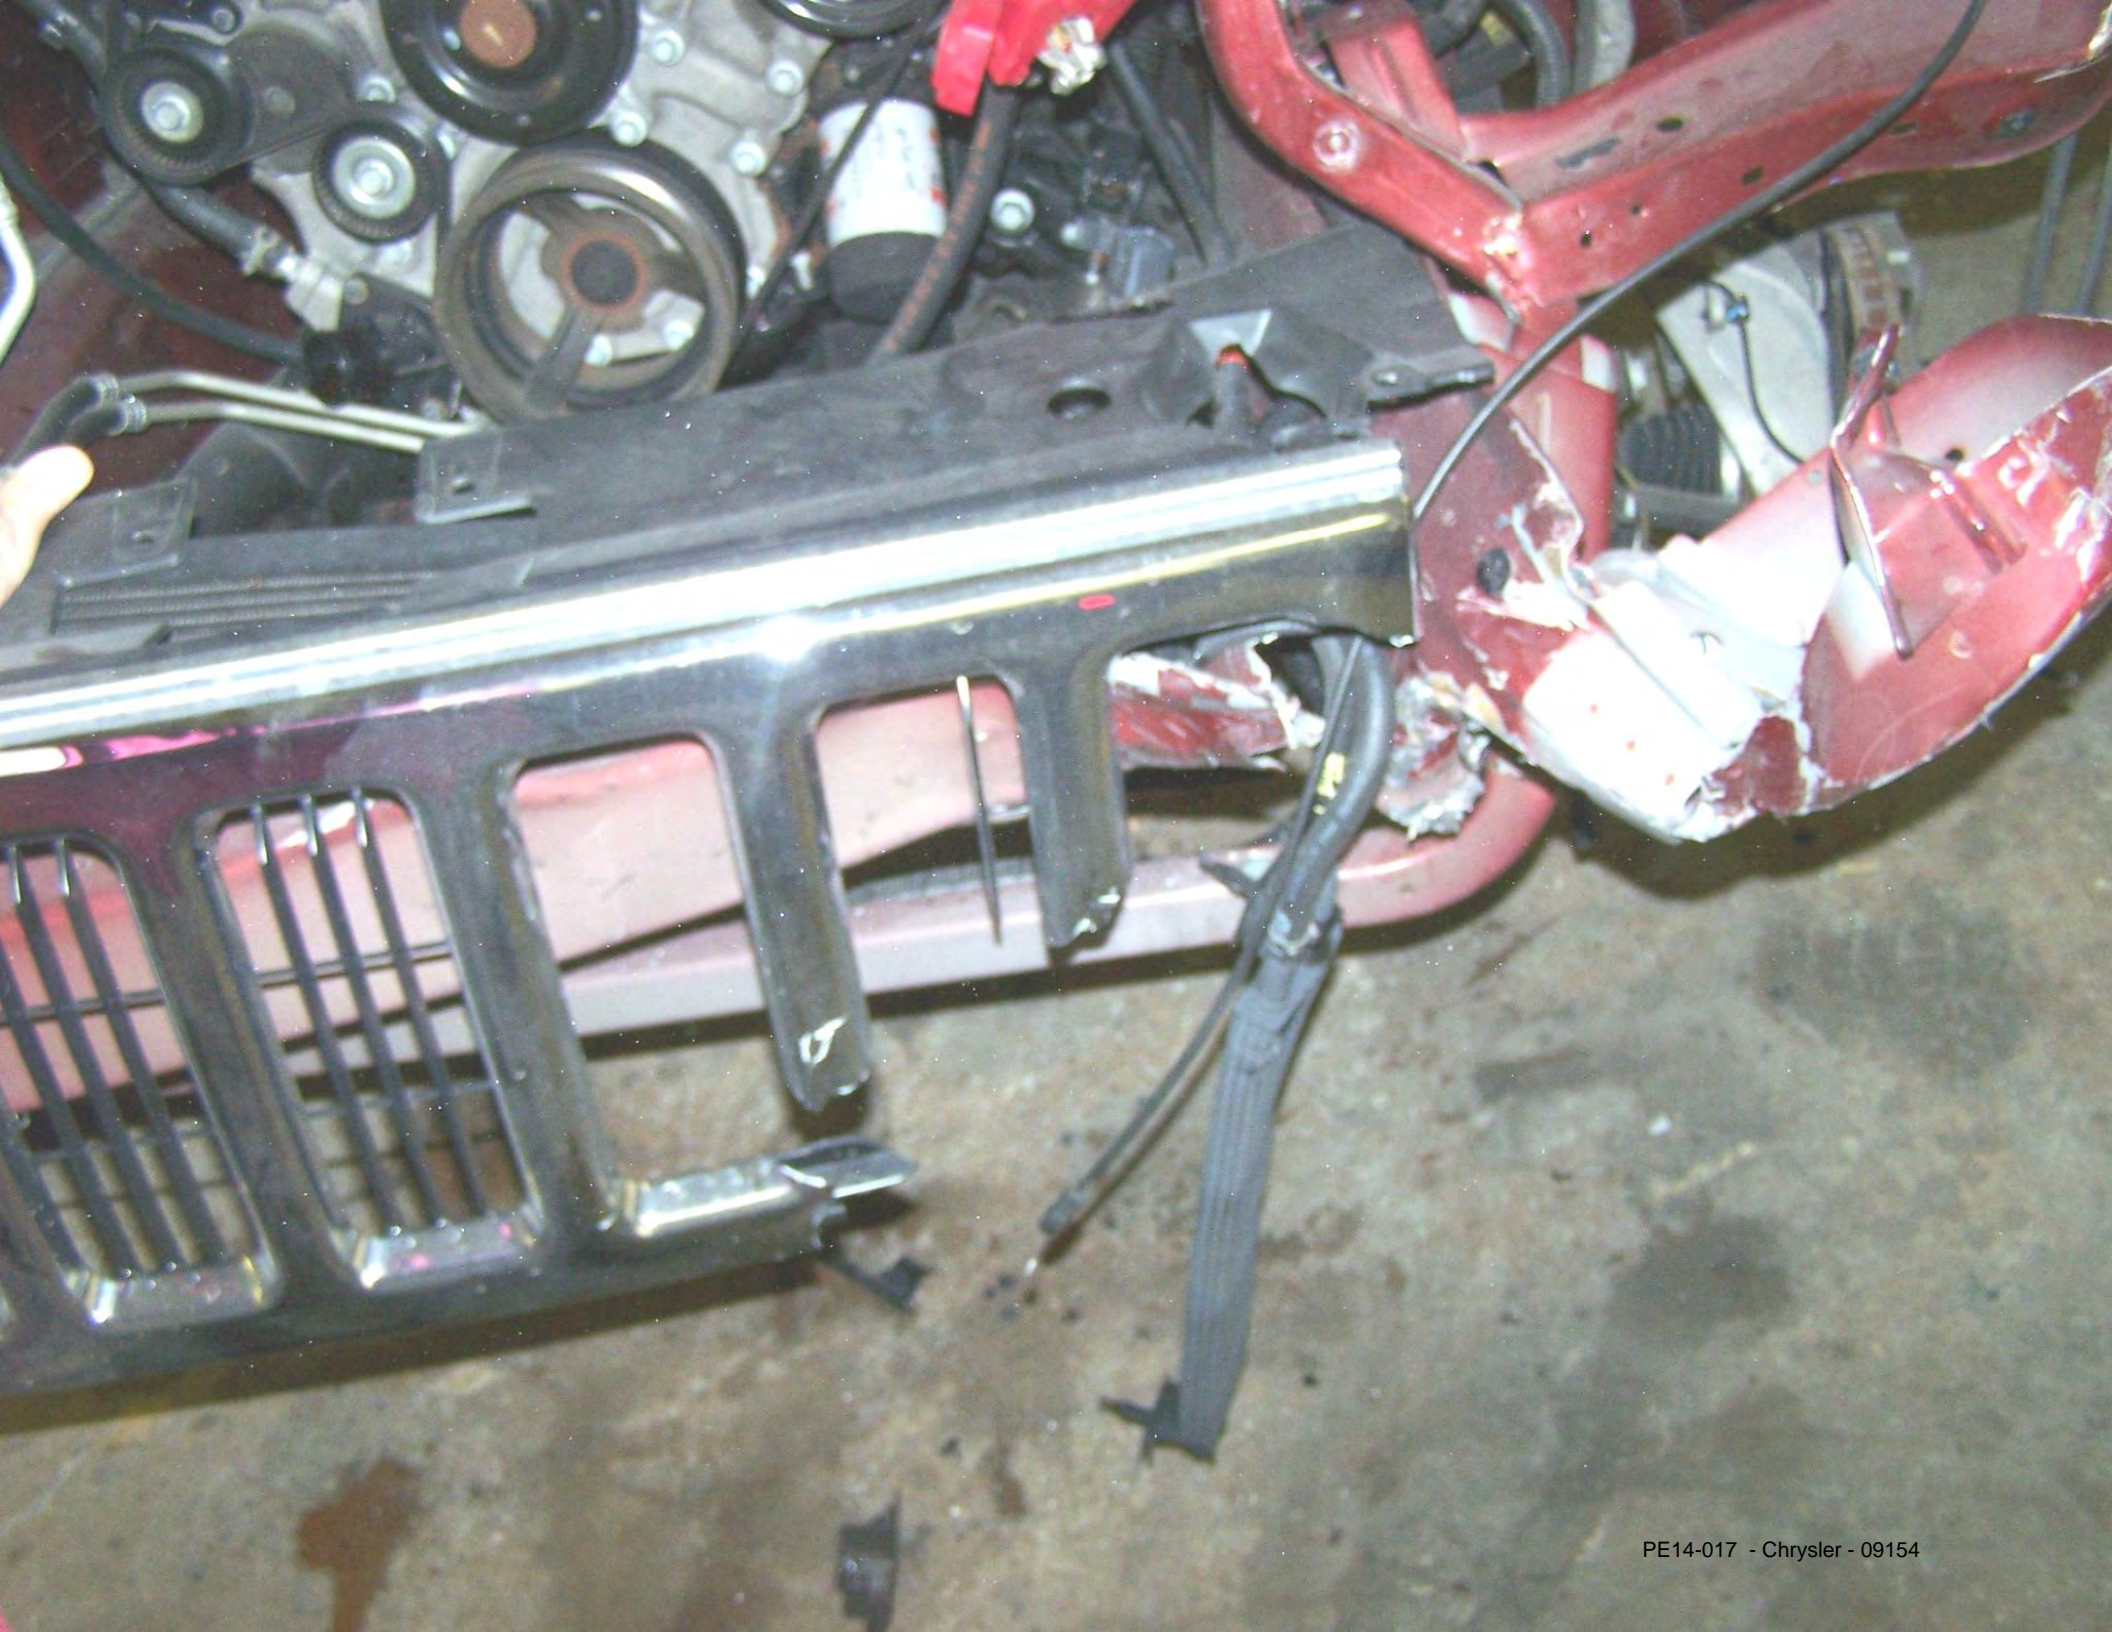
WORK WAS IN PROGRESS AT TIME OF INSPECTION. NO BROKEN GLASS. NO INTERIOR DAMAGE. The main impact was to the left front corner. The front corner of the bumper bar is bent inward 2" and is twisted. Photo# 9--41. The bumper cover was torn off. The left front head light area is damaged and metal is pushed to the right side. The top radiator cross bar is twisted and torn loose from the welds. Photo# 8--35. The grill is broken in half. The radiator was damaged and is laying loose on the front bumper bar. The left front wheel and tire are damaged. The left front steering control-[tie rod] is bent and does rub on the inner brake shield when the wheel is turned to the right. The left front strut is bent and rubs on the coil spring. photo # 29--32. The frame is out of alignment on the left front. photo # 41. Driver said, he injured his neck and head.

Work was in progress at time of inspection. Main impact was to the left front corner. The left front wheel [RIM] is bent. The left front tire is flat. The left front bumper bar is twisted and head light area damaged. A quick pull on the seat belt webbing locked up the belt retractor. No DTCS WERE DETECTED.

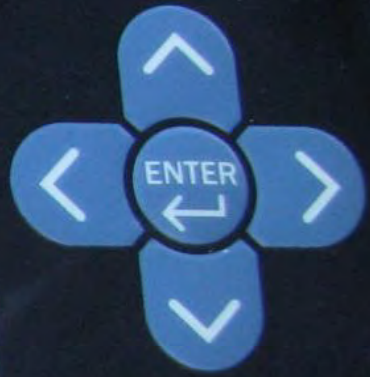
Back 2006 WK ECU View 9.03 Show Shortcuts
3.7L 1J4GR48KX6C [REDACTED]

Controller Name	Active	DTCs	Bus
▲	FCMCGW Central Gateway	<input checked="" type="checkbox"/>	2	DIAG CAN C
	OCM Occupant Classification	<input checked="" type="checkbox"/>	0	CAN B
	ORC Occupant Restraint	<input checked="" type="checkbox"/>	0	CAN B
	PDM Passenger Door Module	<input checked="" type="checkbox"/>	0	CAN B
	RADIO Radio	<input checked="" type="checkbox"/>	0	CAN B
	SCM Steering Column	<input checked="" type="checkbox"/>	1	CAN B
	WCM Wireless Control	<input checked="" type="checkbox"/>	0	CAN B

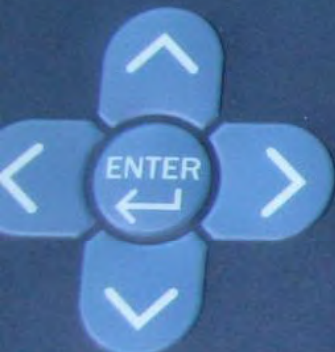
Back		2006 WK		Data Display - ORC		9.03		Show Shortcuts	
		3.7L 1J4GR48KX6C							
		Name		Value		Unit			
▲		Driver Digressive Load Limiter		0.0		Ohms		Show Graph	
		Passenger Digressive Load Limiter		0.0		Ohms		Add to Graph	
		First Row Left Pretensioner		2.4		Ohms		Remove From Graph	
		First Row Right Pretensioner		2.4		Ohms		Isolate Row	
		Second Row Left Pretensioner		0.0		Ohms		More Options	
		Second Row Right Pretensioner		0.0		Ohms			
▼		Second Row Center Pretensioner		0.0		Ohms			
No DTC Detected

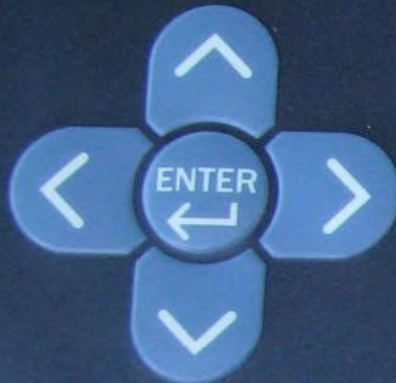
2006 WK 3.7L 1J4GR48KX6C [REDACTED] All DTCs 9.03

ECU	Code	Status	Description
ABS	C2204	Stored	Dynamics Sensor Internal
ABS	C2205	Stored	Steering Angle Sensor Internal
FCMCG	B1640	Active	Front Right Turn Lamp Control Circuit High
FCMCG	B1630	Active	Right Low Beam Control Circuit High
SCM	C1241	Stored	Steering Angle Sensor Velocity Performance
