PE14-017

CHRYSLER

FIELD DATA ALLEGED

CONFIDENTIAL - Prior Approval Required Before Duplicating**Preliminary Vehicle Investigation Report(PVIR)**

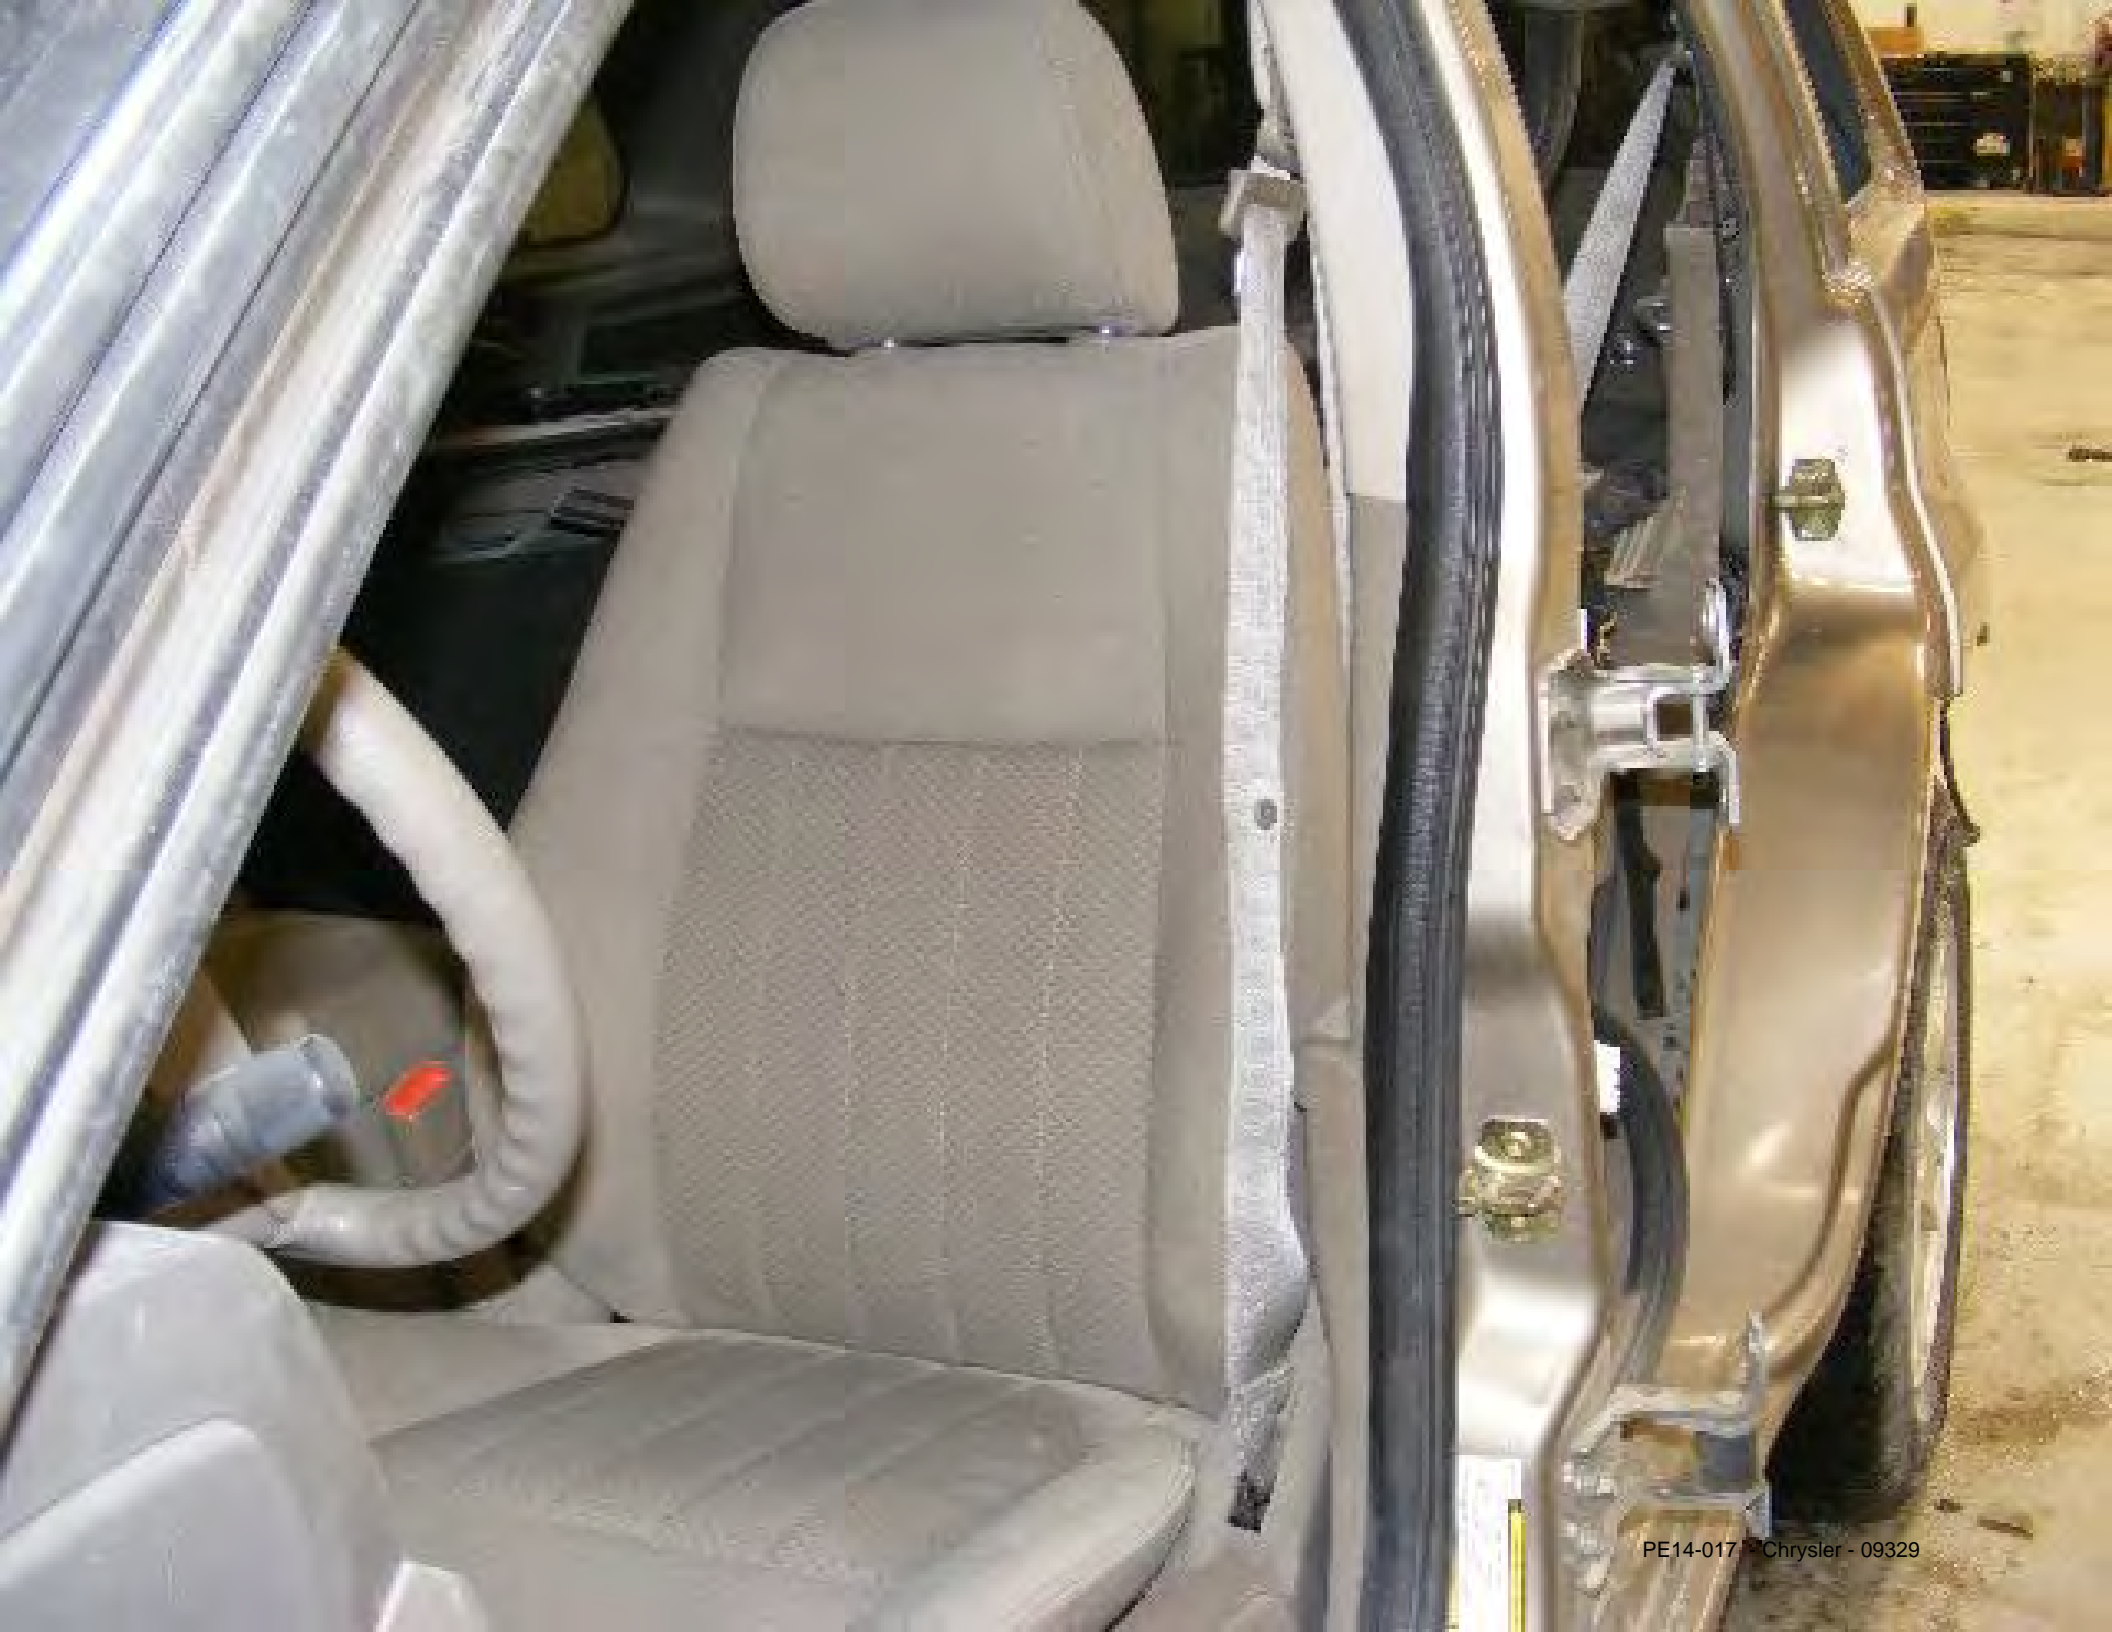
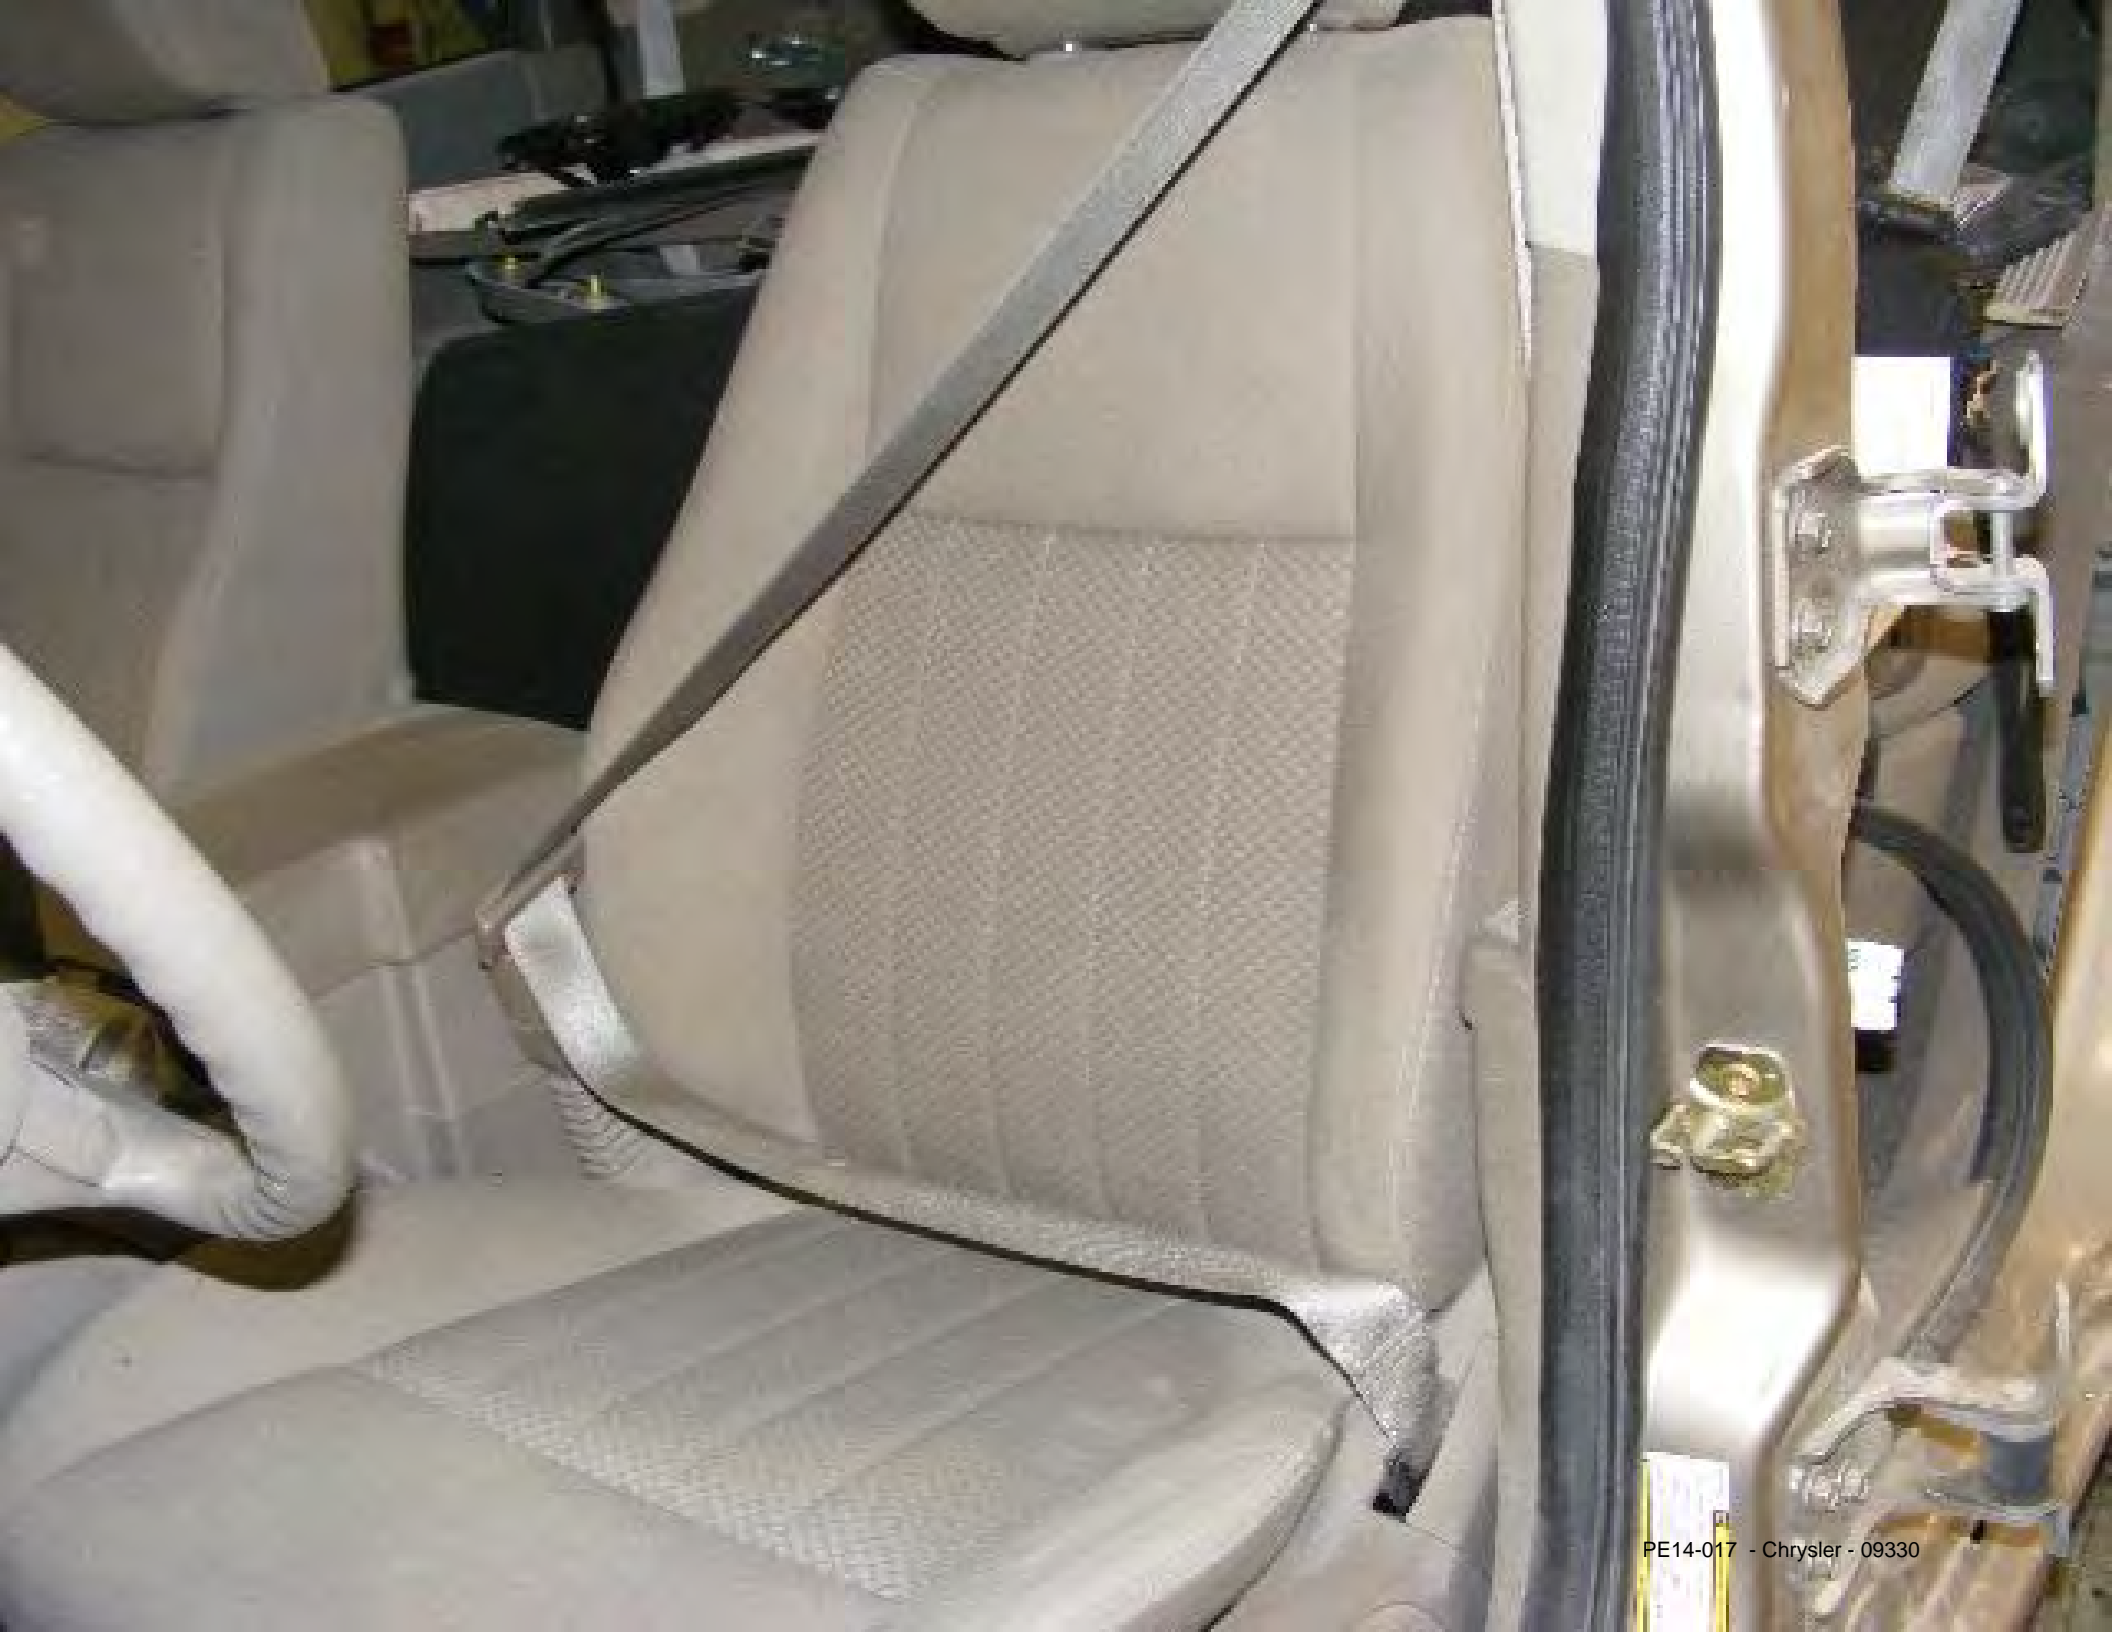
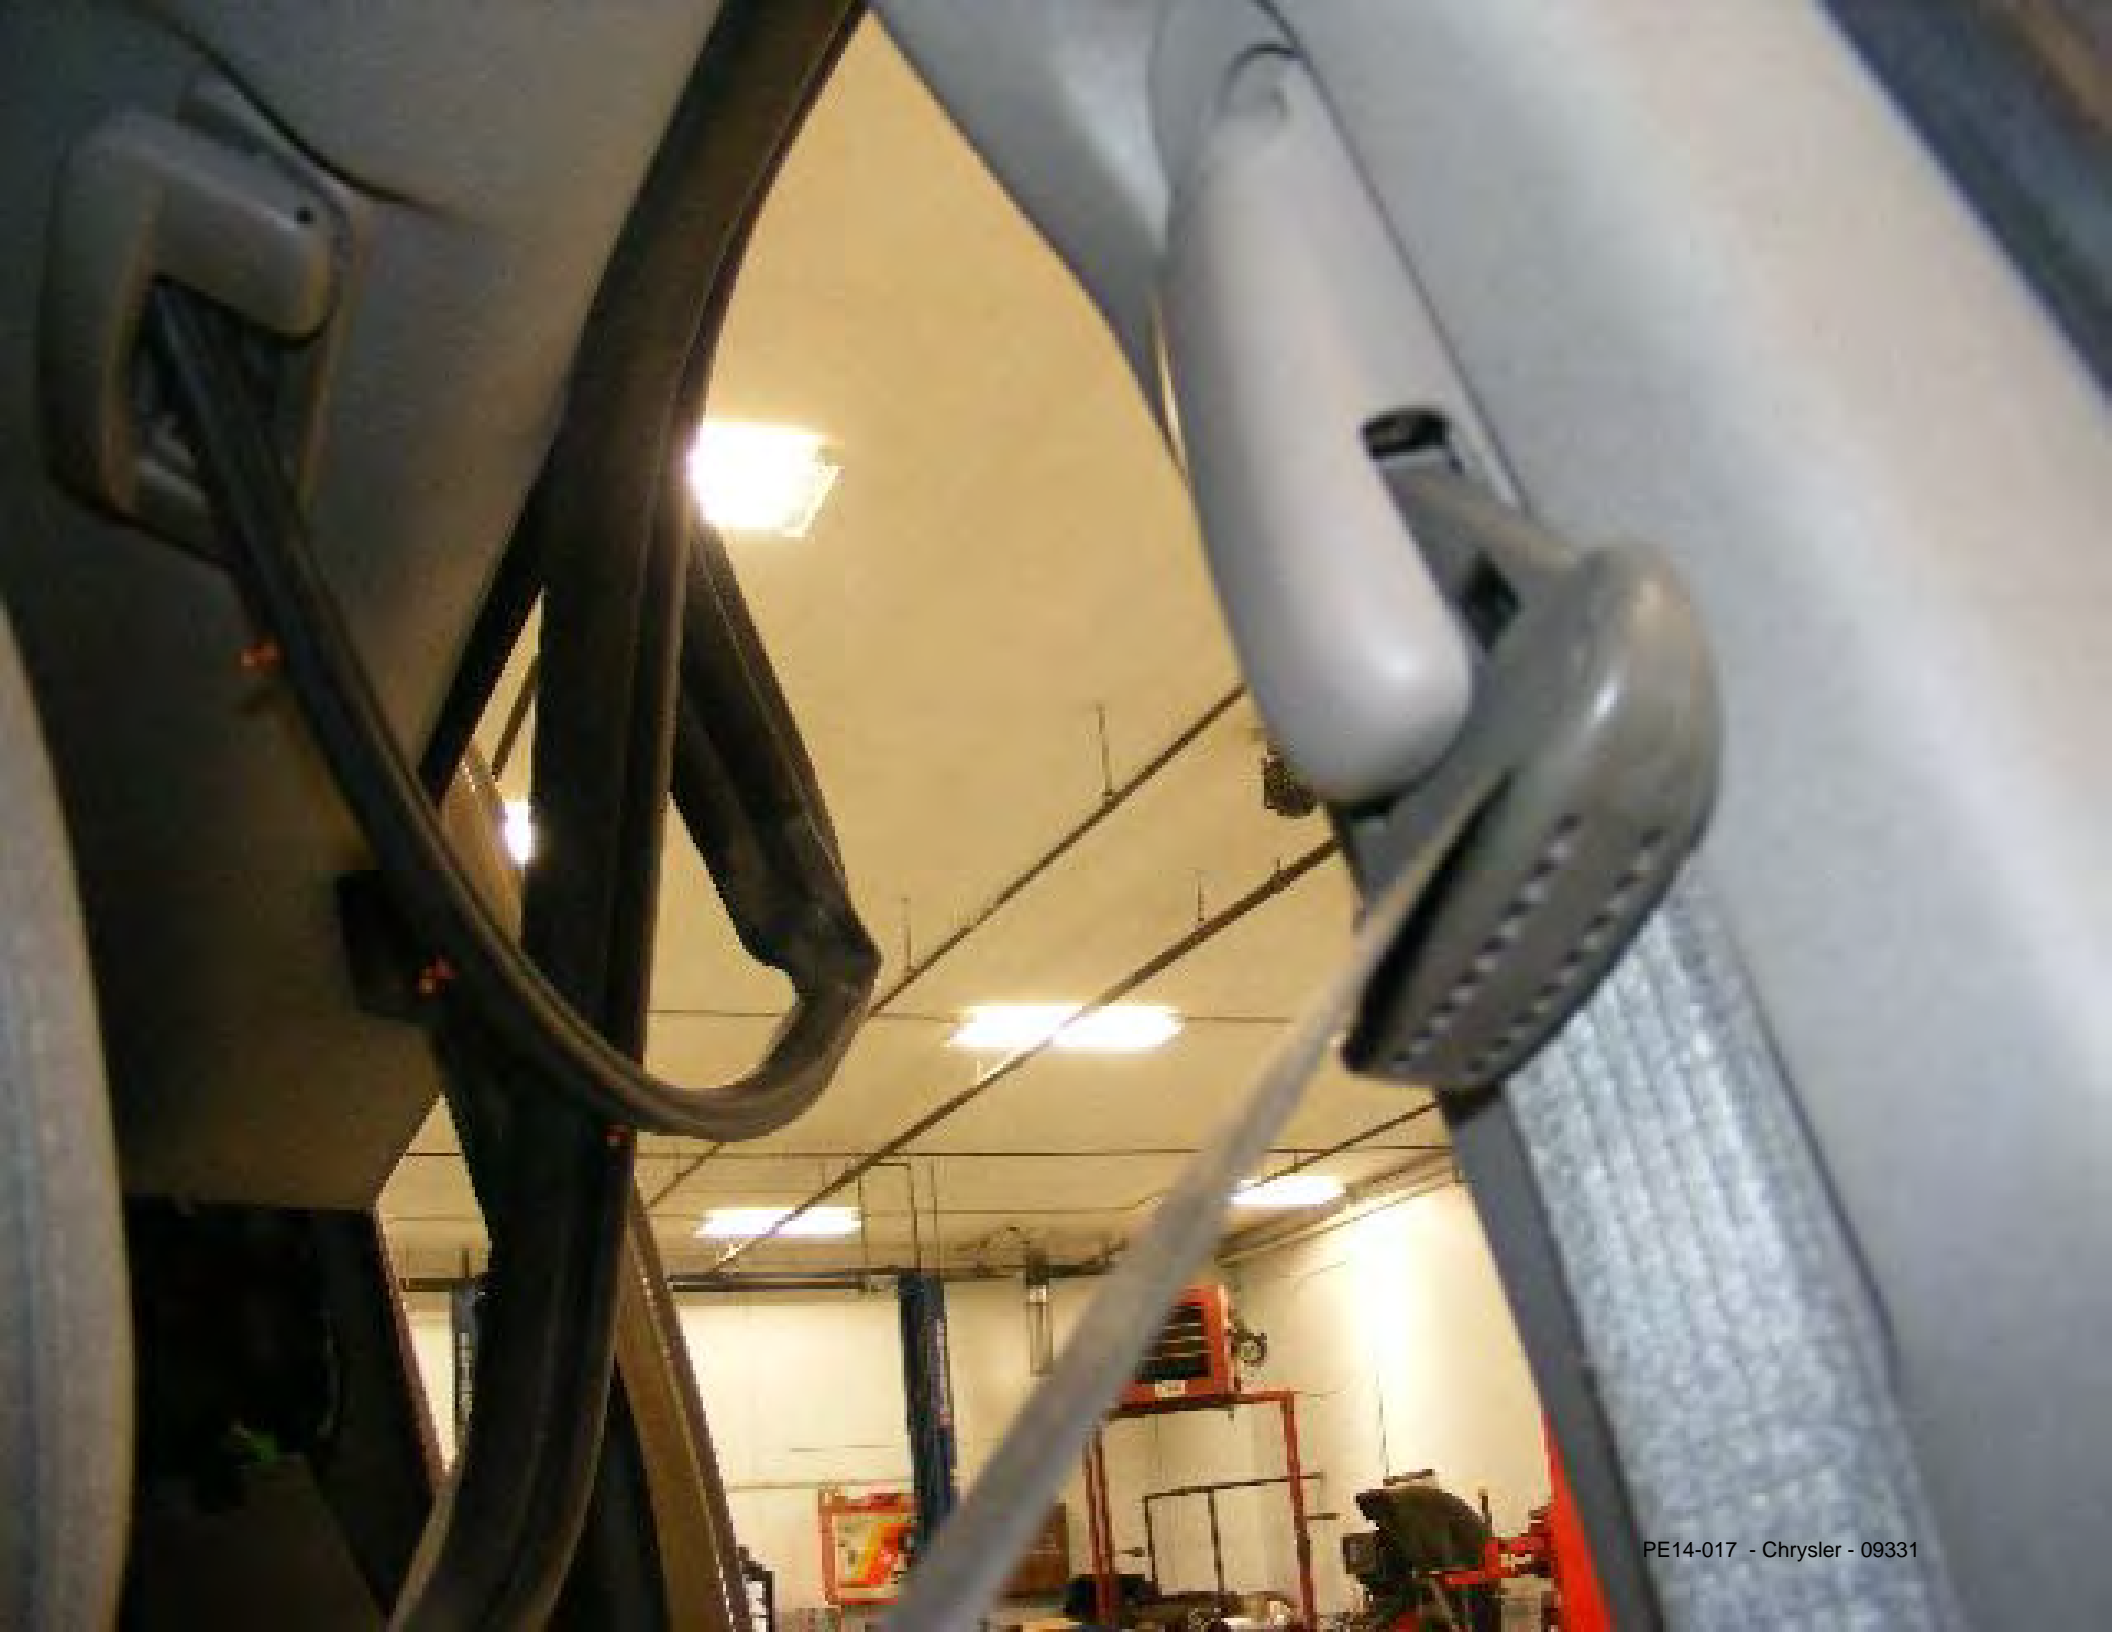
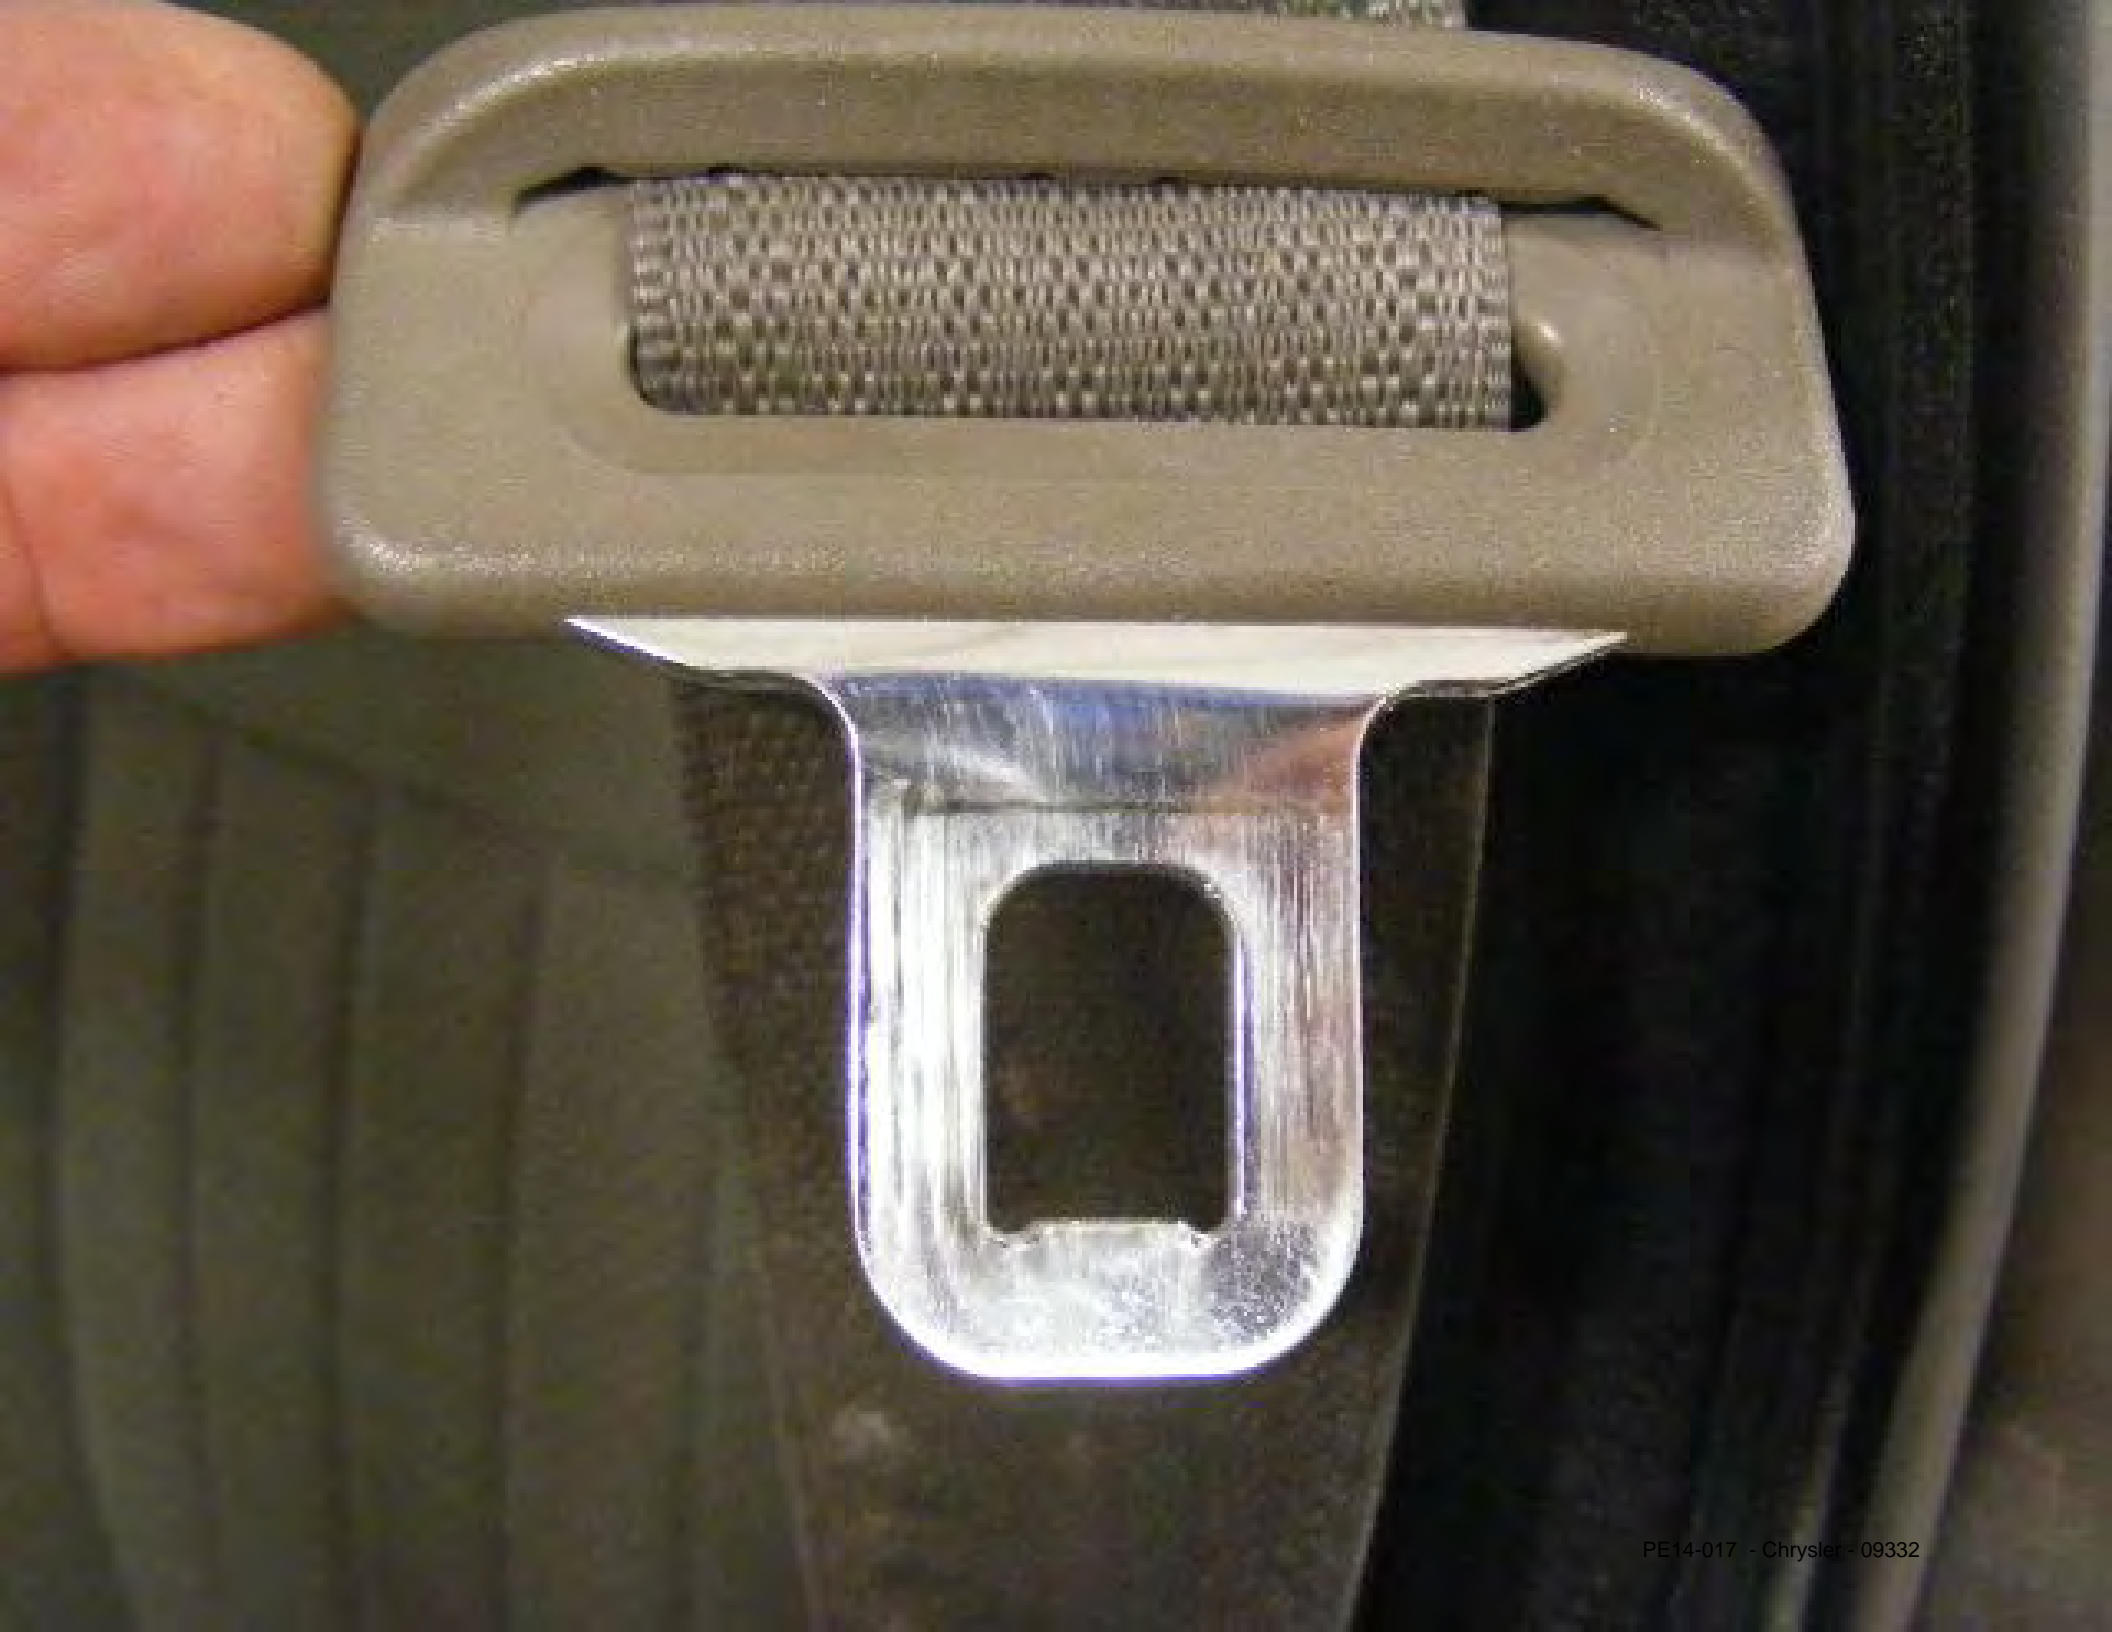
P R N D

051717 mile

1J4GR48K65C

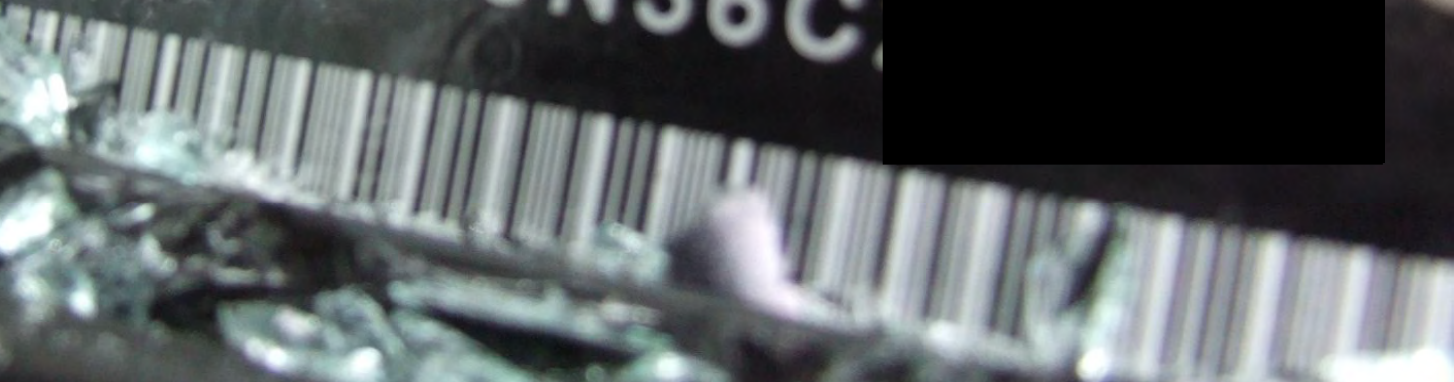
CHRYSLER JEEP
1J8HG48N36C

MADE BY DAIMLERCHRYSLER CORPORATION
DATE OF MFR: 2-06
GAWR FRONT: 1339 KG 2950 LB
GAWR REAR: 1656 KG 3650 LB
17X7.5
17X7.5

GAWR: 2903 KG 6400 LB
WITH P245/65R17 Tires
RIMS AT 242 MPa (35 PSI) COLD
WITH P245/65R17 Tires
RIMS AT 242 MPa (35 PSI) COLD

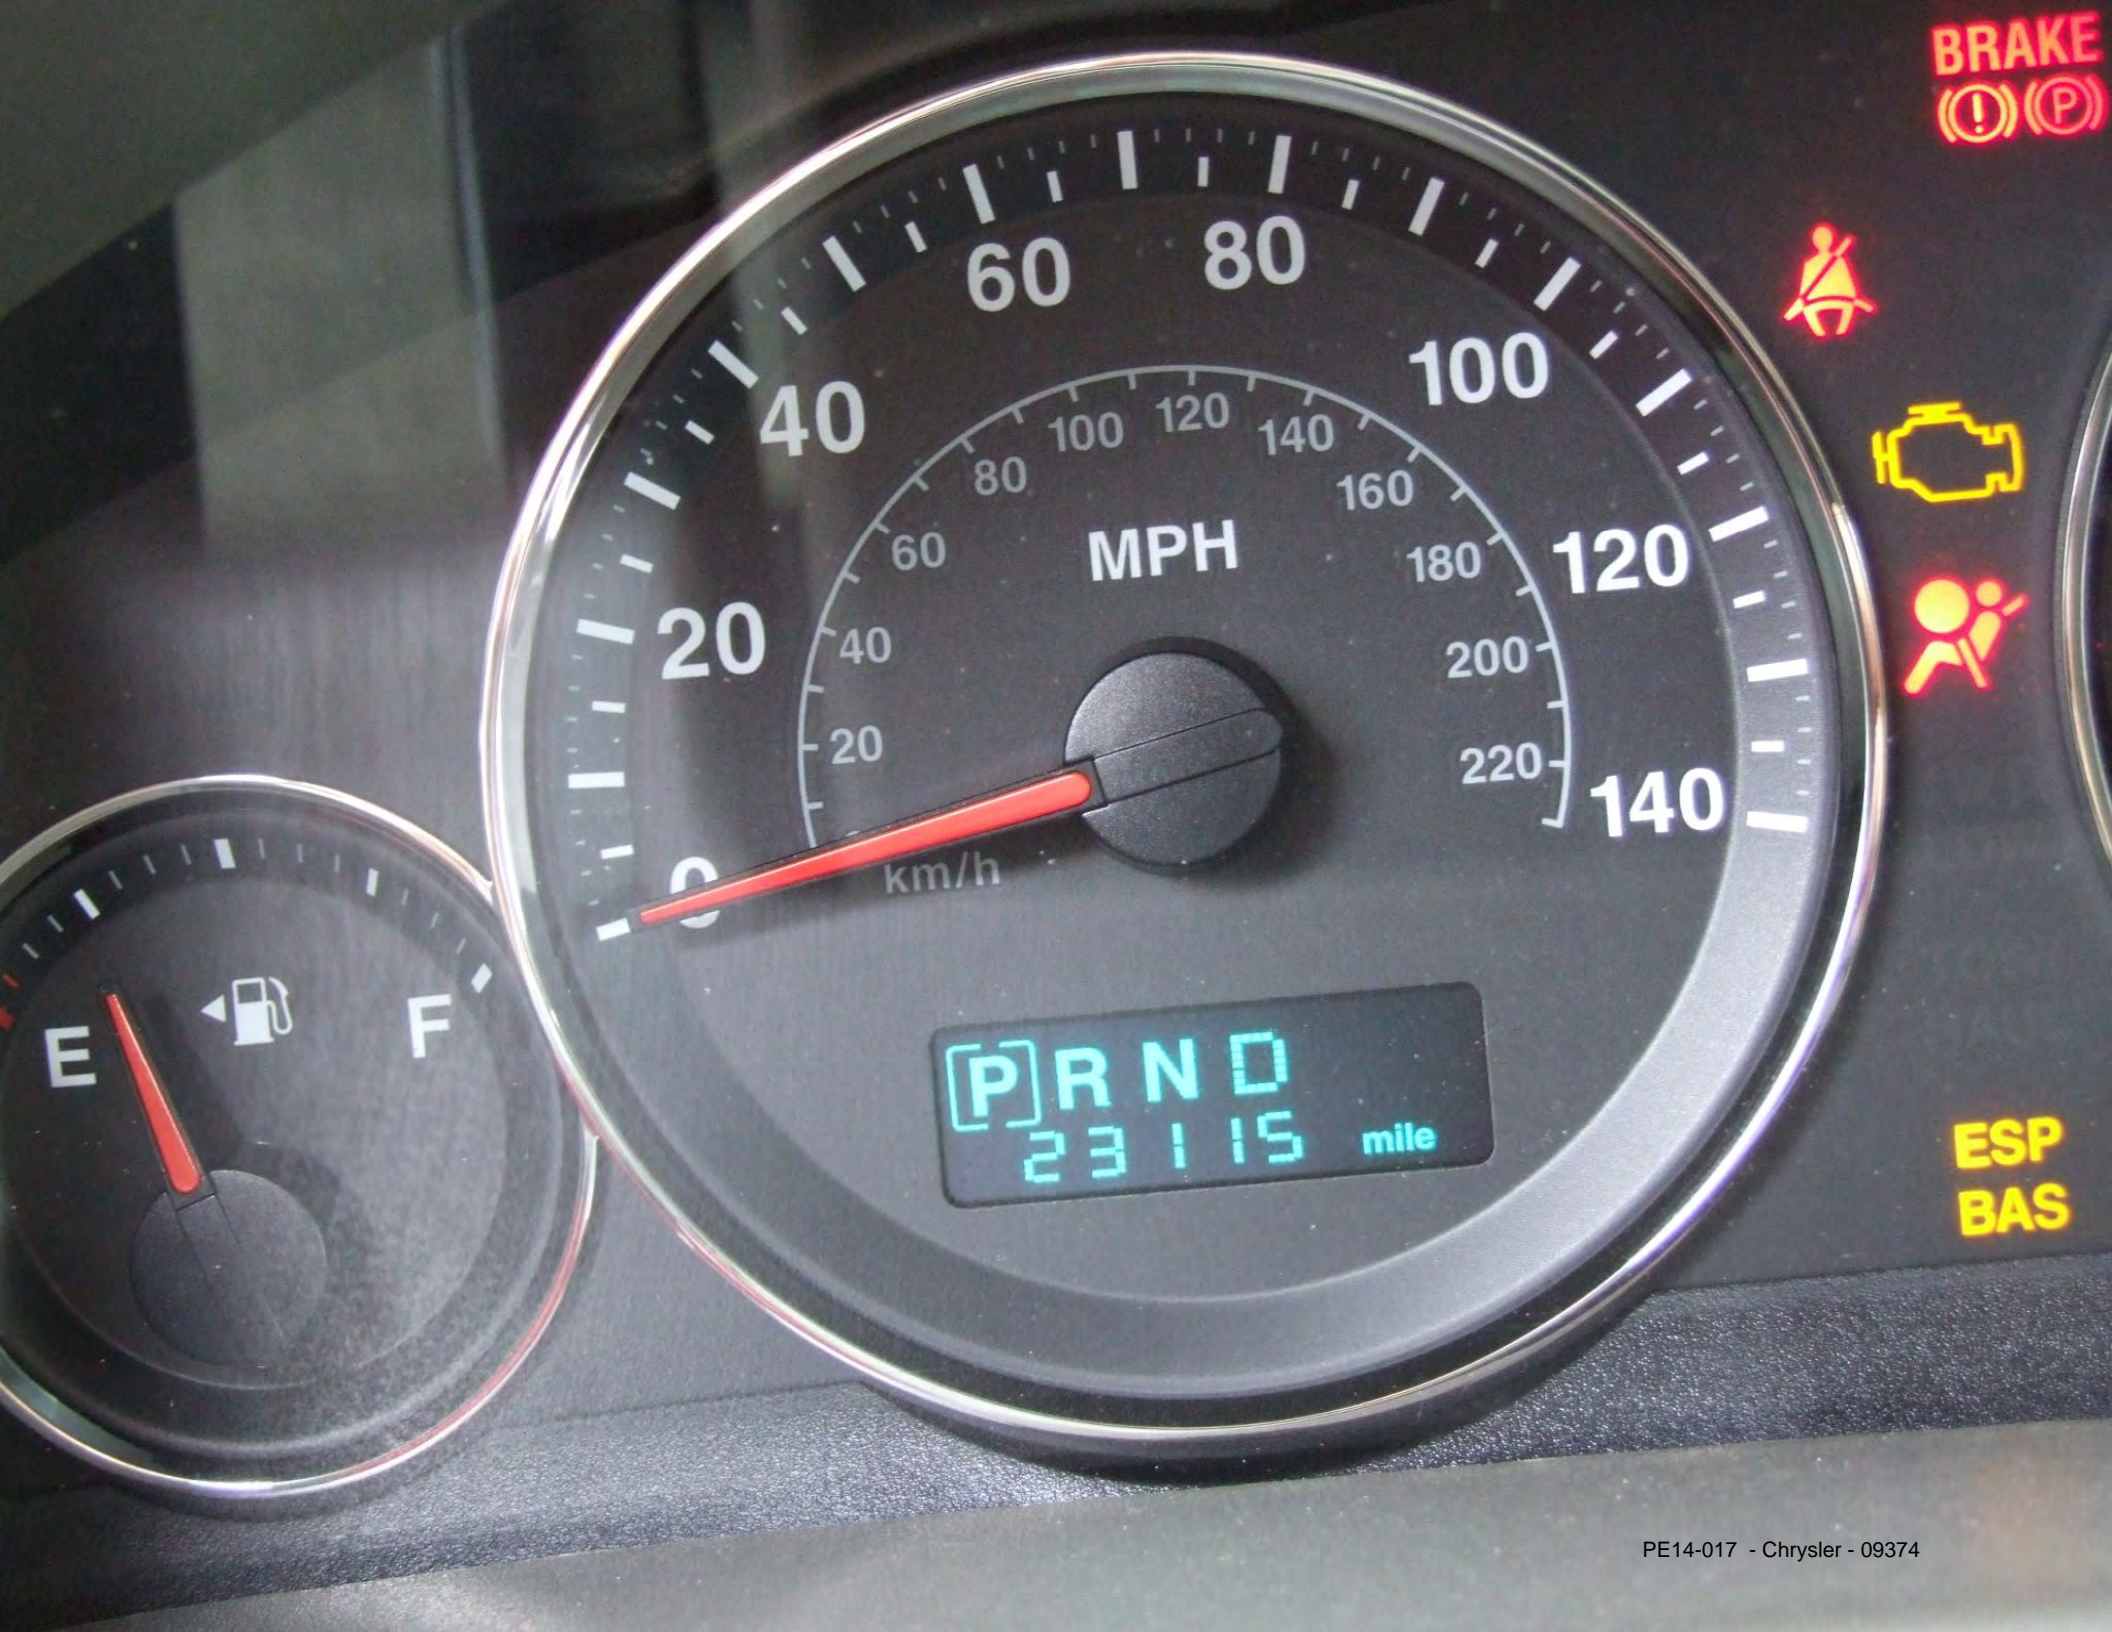
Code	Status	Description
C140A	Stored	Transfer Case Motor Performance
U0415	Stored	Implausible Data Received from ABS

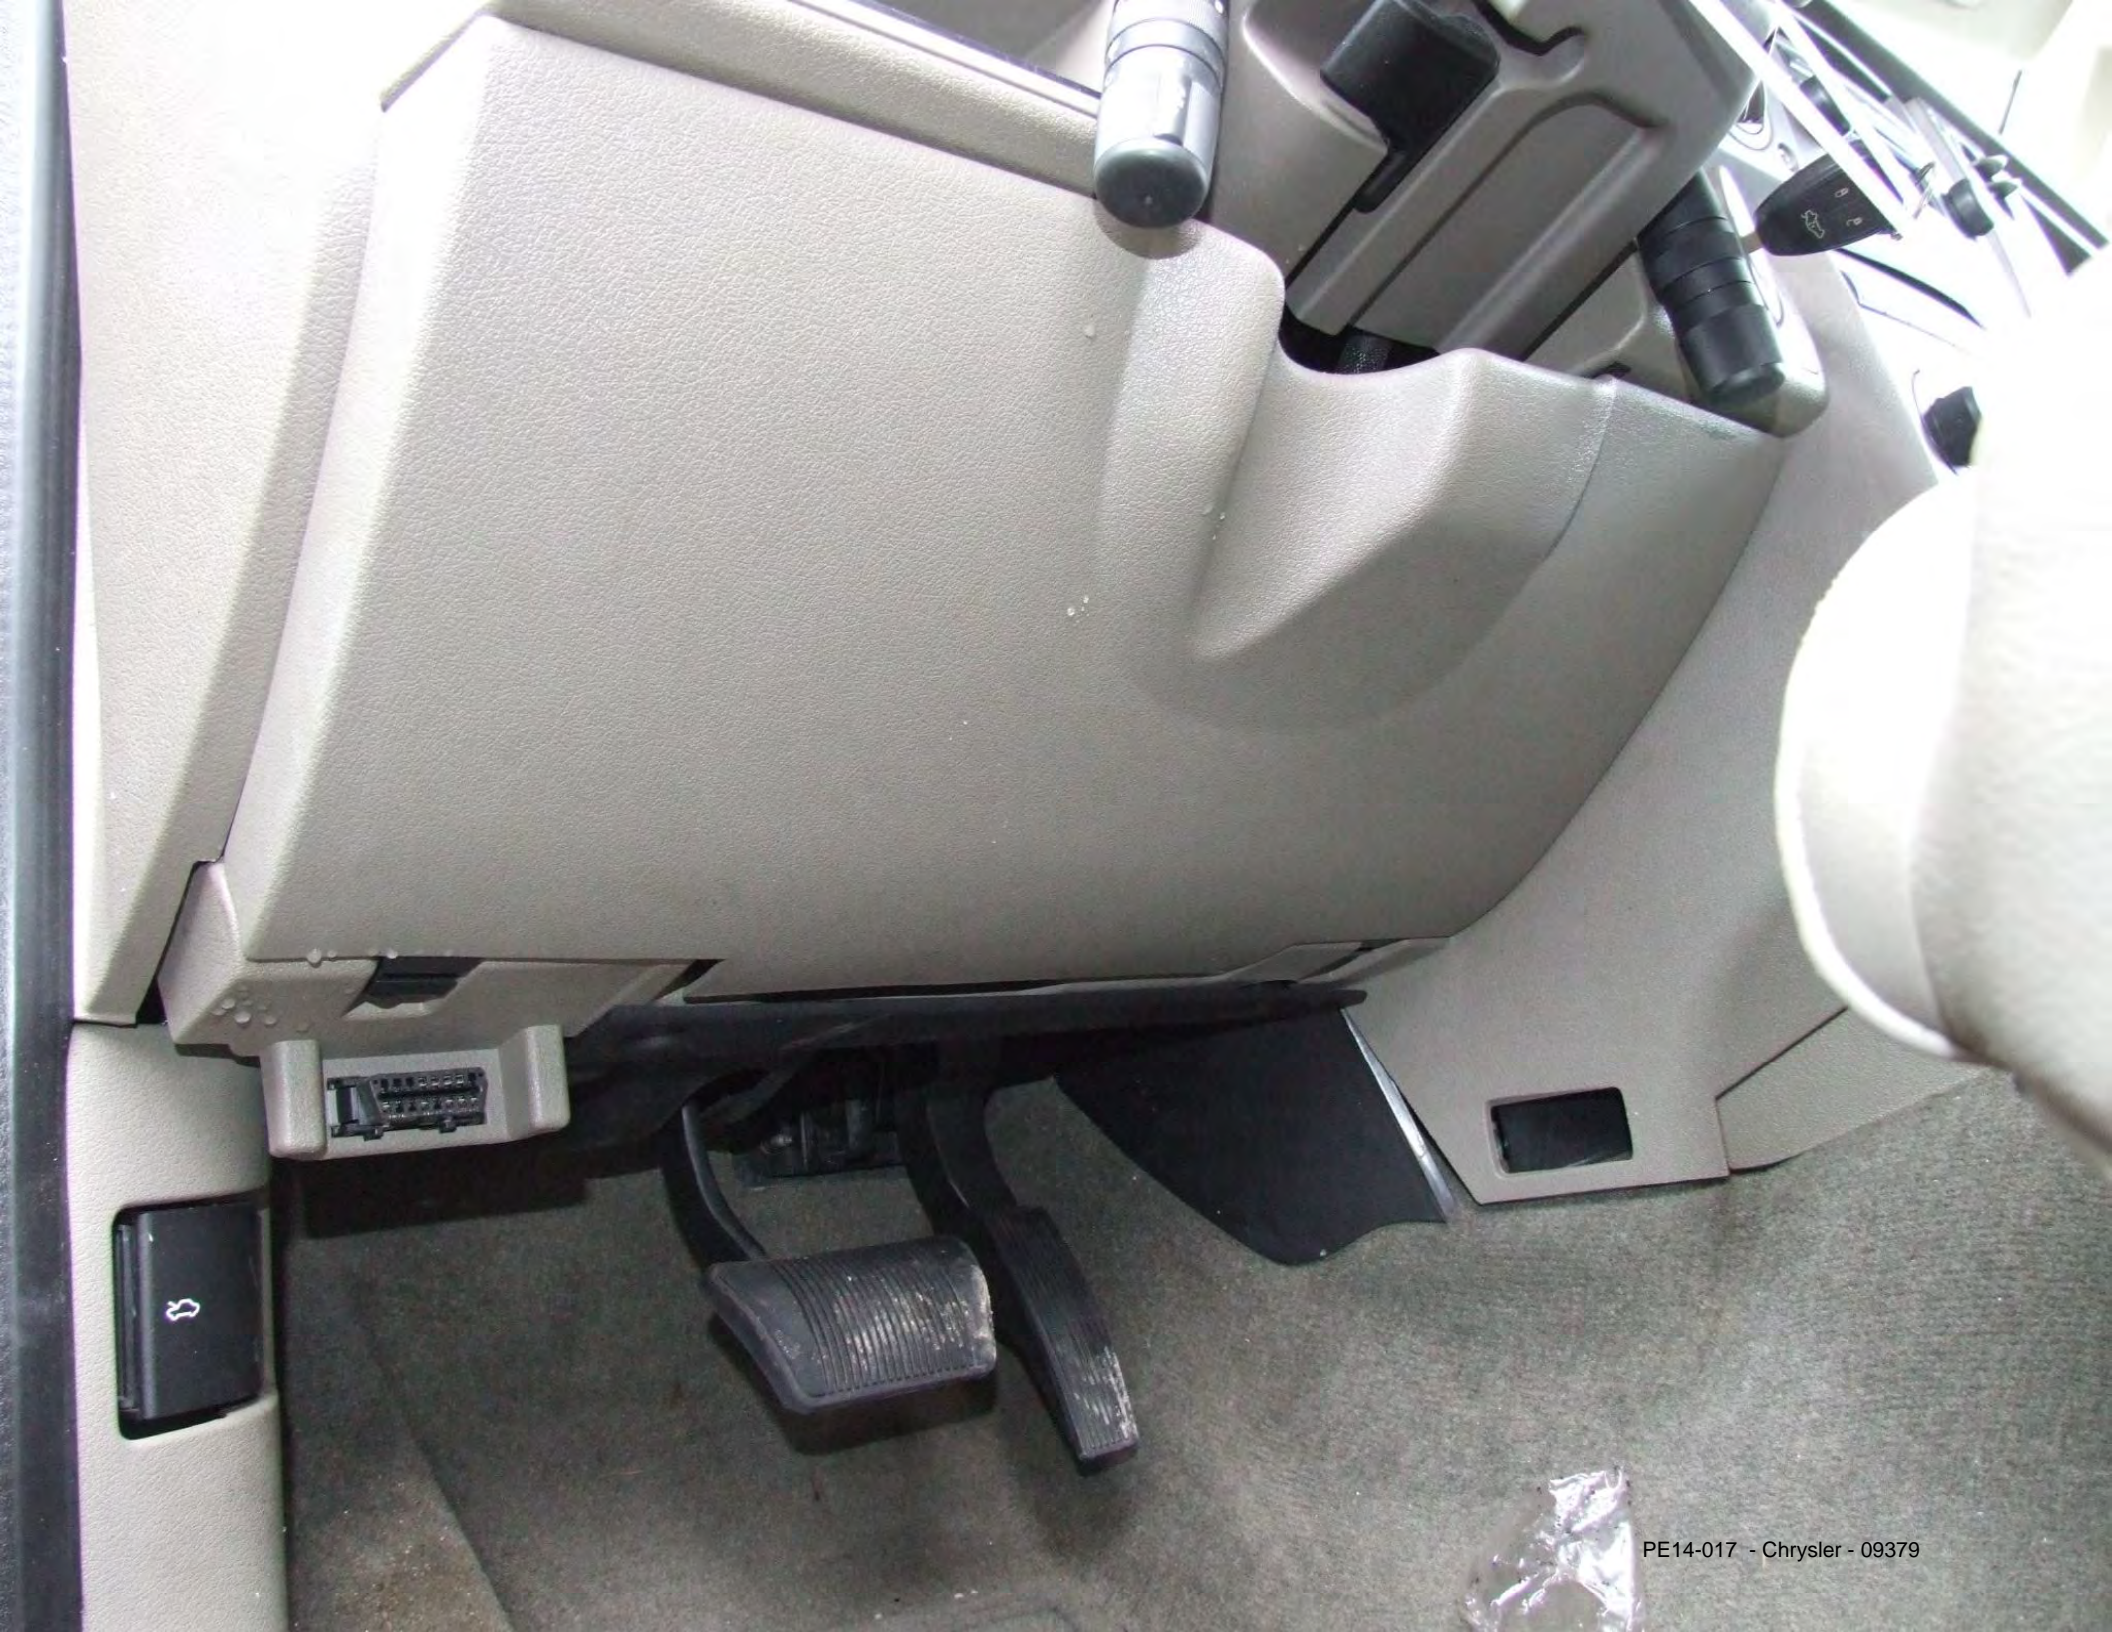
ECU	Code	Status	Description
▲	ORC	B1B2C	Stored	1st Row Passenger Seat Belt Pretensioner Circuit
	ORC	B1B2A	Active	1st Row Driver Seat Belt Pretensioner Circuit Open
	ORC	B1B28	Stored	1st Row Driver Seat Belt Pretensioner Circuit Low
	ORC	B1B2E	Active	1st Row Passenger Seat Belt Pretensioner Circuit
	ORC	B223D	Active	OCM DTC Present
	RADIO	U0020	Stored	CAN B Bus Off Performance
	SUNR	B210D	Active	Battery Voltage Low
▼	SUNR	B1847	Active	Sunroof Vent Switch Circuit High
