PE14-023

HYUNDAI

ATTACHMENT B

Airbag Sys. Electrical
Performance Test

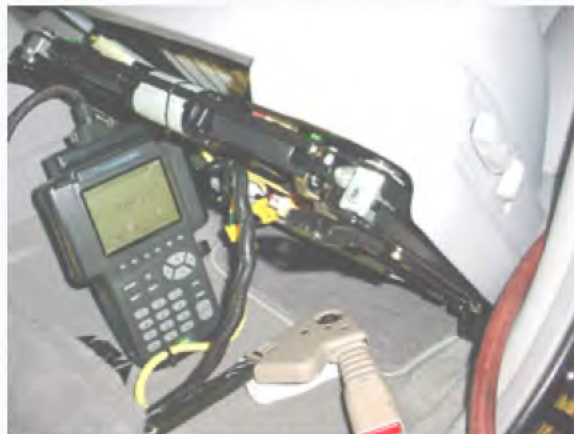
Incident LH seat belt buckles were test installed to a known "good" vehicle for evaluation

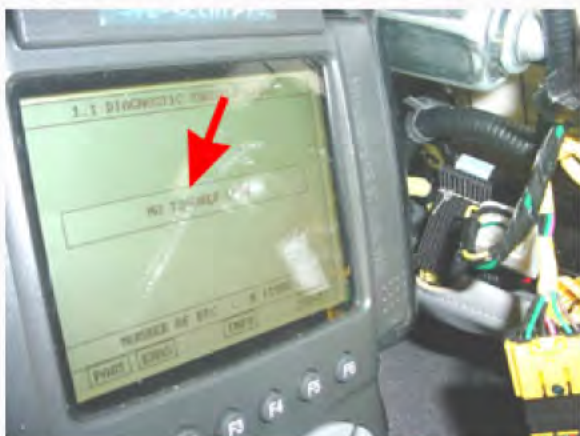
The seat belt buckle failure condition could not be duplicated when test installed in the vehicle

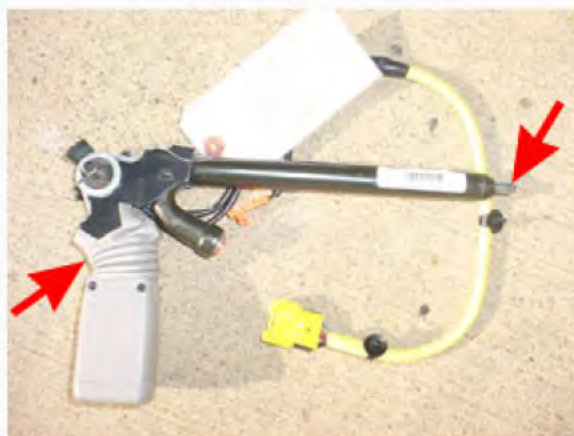
Seat belt buckle has already been deployed by the dealer before shipment to HMA

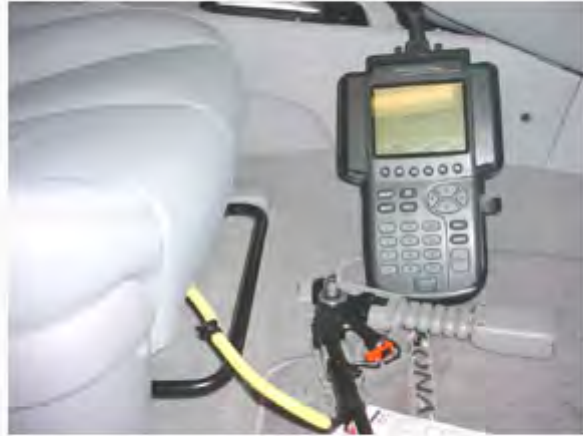
RH seat belt buckle assembly installed to known good vehicle for evaluation

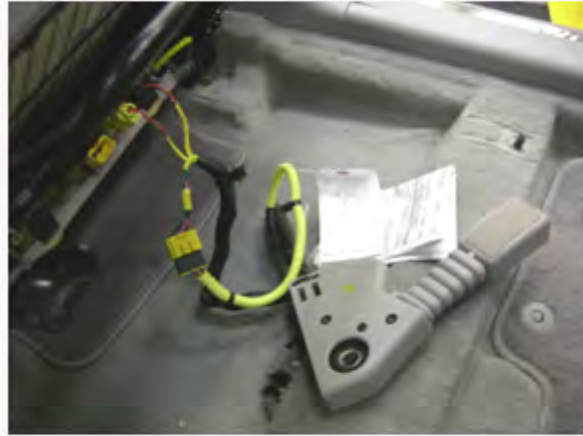
Incident seat belt buckles were test installed into a known good vehicle for evaluation

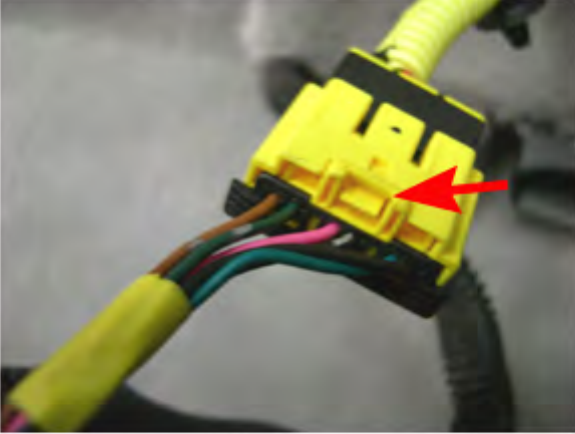
Seat belt buckle connector tab

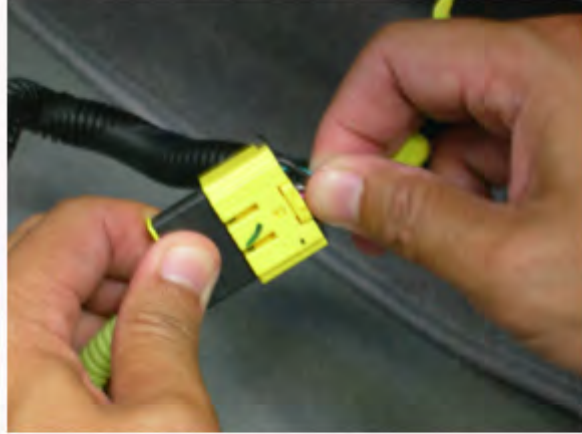
There was noticeable play when the seat belt connector was pulled in the closed position

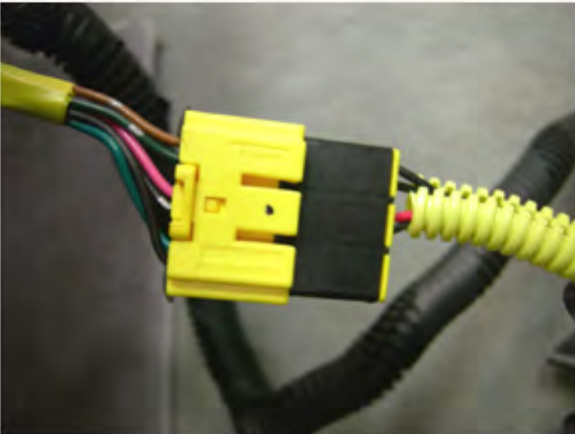
Seat belt buckle connector does not have a secondary latch

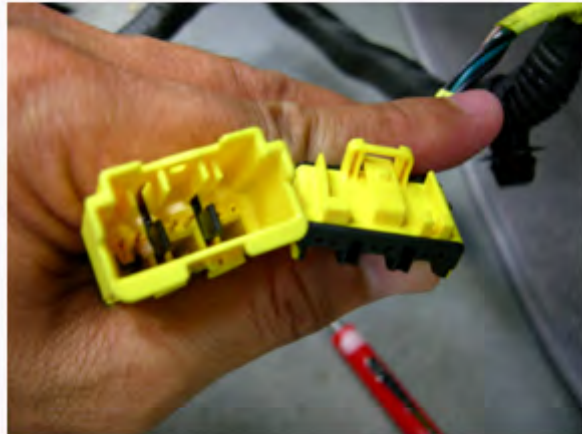
Seat belt buckle connector

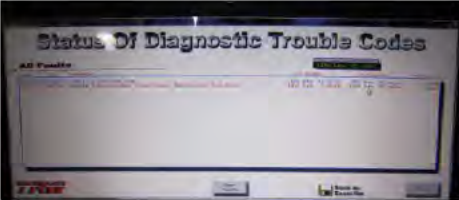
Attachment . #4 vehicle investigation_013505 (Dealer : Automall Circle)

Details	Results														
Vehicle details	VIN ████████ / 268,561mile / Production date :2005.07.13 / Driver seat auto, Passenger seat manual														
DTC code	B1706 Pass. Resistance too high(history)														
Investigation result	<ul style="list-style-type: none"> • Duplicate fault B1706 . Measured buckle PT resistance normal → connector(under seat) resistance high - Finding connector resistance high causes fault code B1706 														
DTC	Driver under seat	Passenger under seat	ETC

<p>B1706 Pass. Resistance too high</p>

<table><tr><td>PPT Belt Resistance</td><td>1.6-2.2 ohms</td></tr></table>

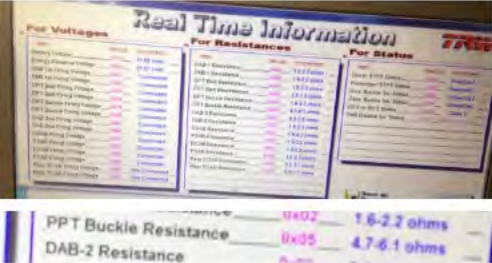
Details	Results
Vehicle details	VIN [REDACTED] / 98,248mile / Production date : 070126 / Driver·Passenger seat manual
DTC code	B1706 Pass. Resistance too high
Investigation result	<ul style="list-style-type: none"> • Repair background : 08.10.20 Pass. Pt repair(change part) / OCS sw updated • Loose Pass. Seat wiring / connector mounting clip • Touching at connector for measuring, resistance faults disappears

DTC	Driver under seat	Passenger under seat	ETC
<p>B1706 Pass. Resistance too high</p>
