NHTSA PE14-023
Supplemental Information

NFa Buckle PT Firing
test result

Buckle PT side wire terminal compression part analysis (CT analysis)

Buckle PT side connector SEM analysis

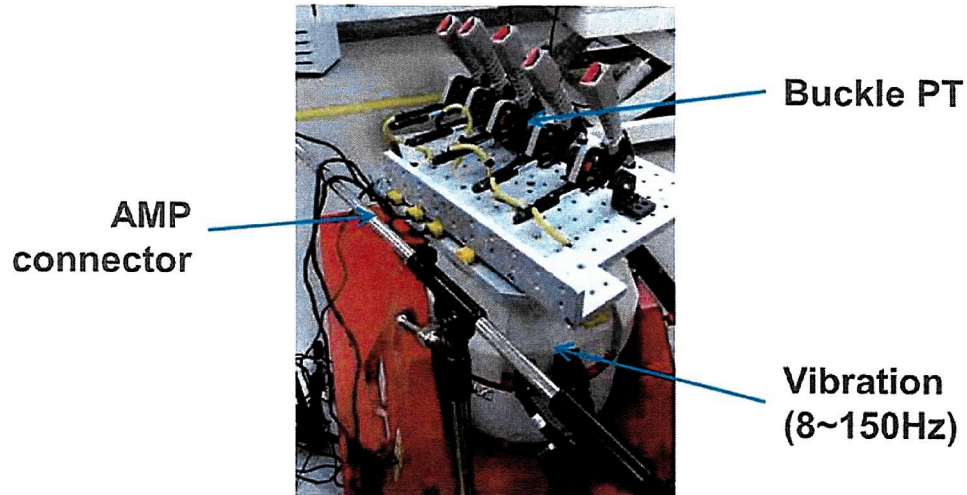
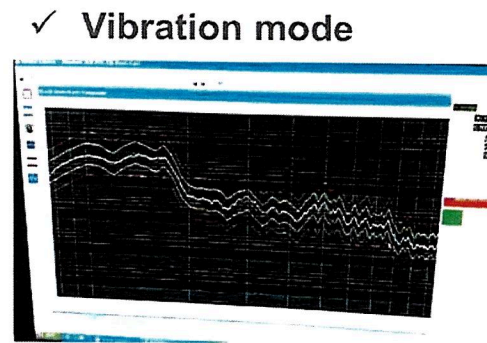
➤ Test Series 1

Initial Resistance	Vibration (Z axis)	Elapsed Time	Resistance after Elapsed Time	Fire (Y/N)
Sample 6	2.47	8 ~ 150Hz (Random)	4 hours	2.46	N/A
Sample 7	2.48	8 ~ 150Hz (Random)	4 hours	2.47	N/A
Sample 8	2.44	8 ~ 150Hz (Random)	4 hours	2.43	N/A
Sample 9	2.43	8 ~ 150Hz (Random)	4 hours	2.43	N/A
Sample 10	2.38	8 ~ 150Hz (Random)	4 hours	2.37	N/A

- The result of test series 1 shows no change of resistance during 4hours at vehicle vibration condition (8~150Hz)
- The result of test series 2 shows Buckle PT fires additional resistance range during 20ohm ~ 32ohm.
(MGG terminal resistance value : 2.15 ± 0.35 ohm)

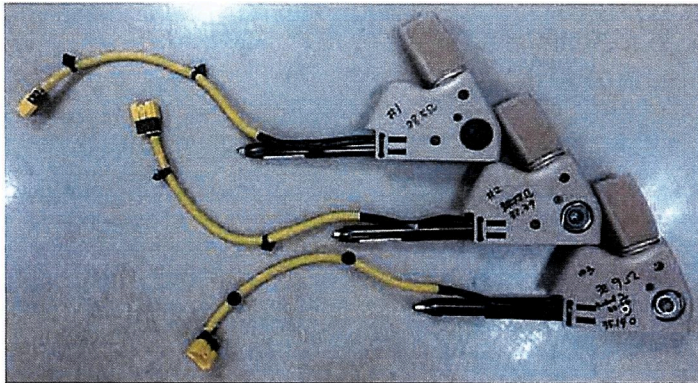
➤ After test (sample 1 ~ 3)

Input	Initial Resistance	Additional resistance	Electric wire resistance (From ACU to BKL P/T)	Resistance after Setup	Fire (Y/N)	Test date
Sample 1	12V 5A	-	25	-	28.50	Y	9/16
Sample 2	12V 5A	-	30	-	33.39	Y	
Sample 3	12V 5A	-	35	-	38.90	N	
	12V 5A	-	32	-	35.14	Y	
Sample 4	12V 5A	-	35	-	38.59	N	
	12V 5A	-	32	-	35.23	Y	
Sample 5	12V 5A	-	35	-	38.16	N	09월 18일
	12V 5A	-	34	-	37.62	N	
	12V 5A	-	33	-	36.18	N	
	12V 5A	-	32	-	35.08	Y	
Sample 6 (After Vibration)	12V 5A	-	34	-	36.99	N	
	12V 5A	-	33	-	36.15	N	
	12V 5A	-	32	-	35.11	Y	
Sample 7 (After Vibration)	12V 5A	-	34	-	37.15	N	
	12V 5A	-	32	-	35.10	Y	
	12V 5A	-	20	-	23.03	Y	
Sample 8 (After Vibration)	12V 5A	-	34	-	37.17	N	
	12V 5A	-	32	-	35.19	Y	
	12V 5A	-	20	-	23.10	Y

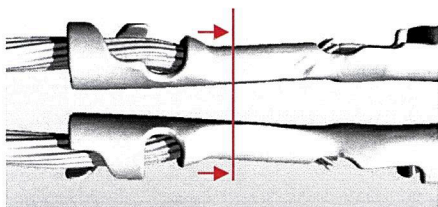
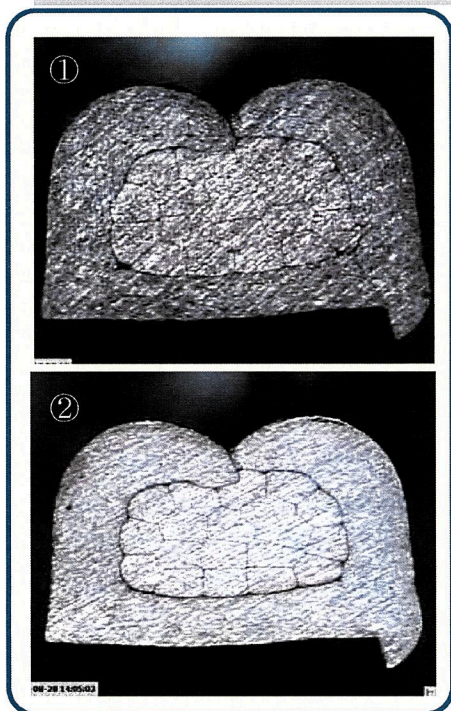
▣ CT analysis result:

- No gap in terminal compression part

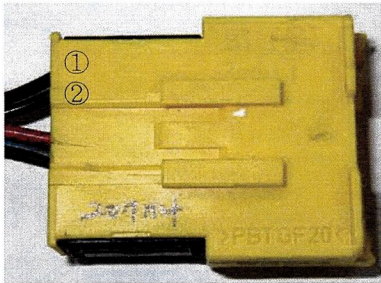
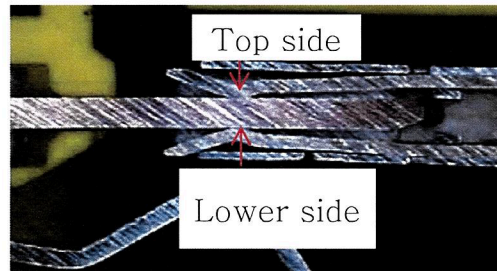
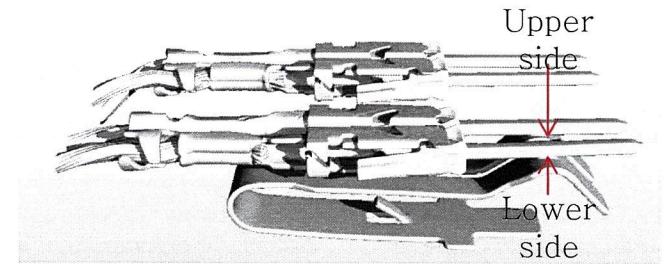
SEM analysis result

- Male terminal upper/lower side gold plating had surface scratch but had no lower gold plating exposure

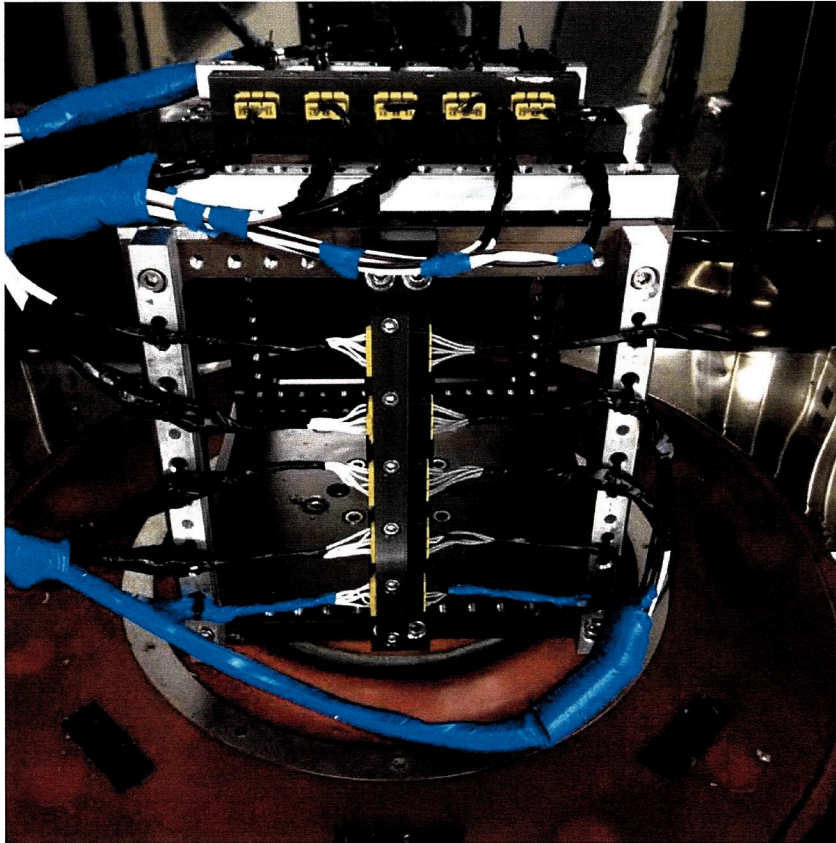
※ Single axis (+/-) vibration fixture. Axis under test oriented as required.

■ Test condition

Sinusoidal Vibration

- Applied current: 30mA
- Vibration acceleration: 4.4G
- Vibration Frequency : 20~200Hz
- Vibration direction +/- x, y, and z axes
- Time 40 hours each axis

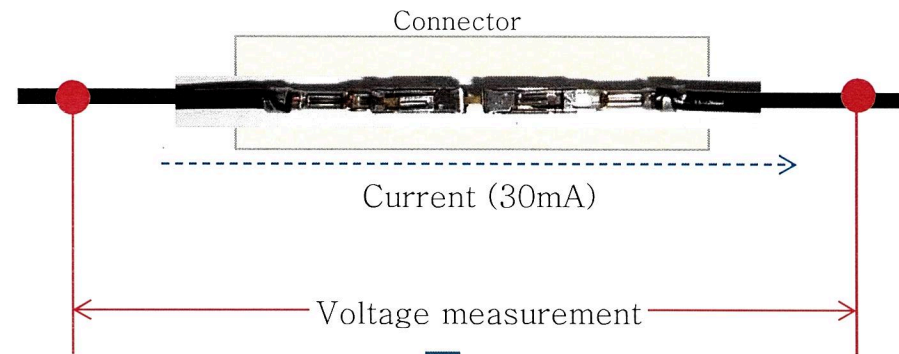
■ Measurement method

$$\text{Resistance} = \text{Voltage} / \text{Current (30mA)}$$

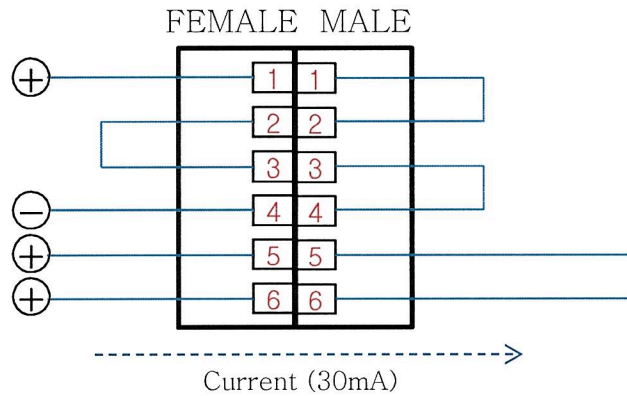
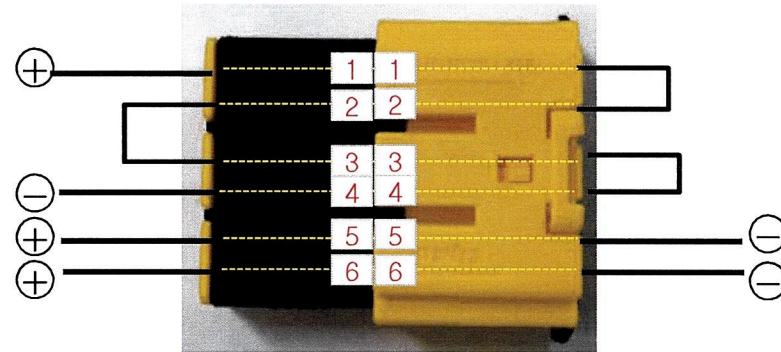
■ Circuitry connection schematic

FEMALE MALE

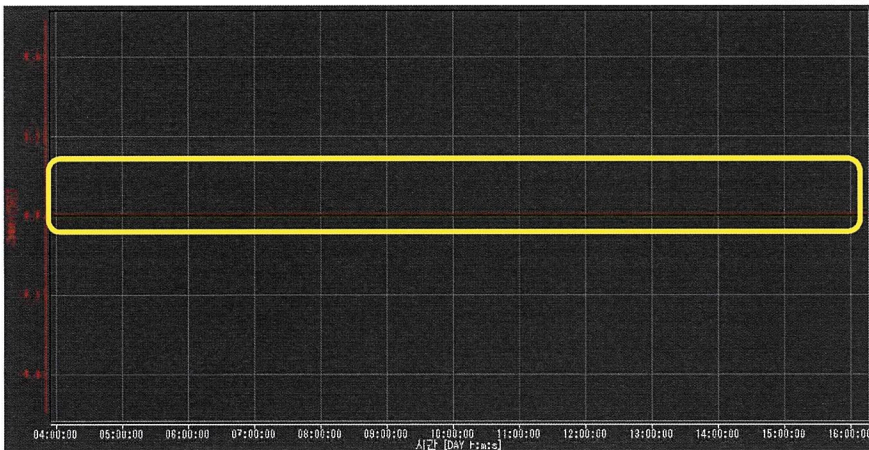
■ Evaluation result

- Maximum value of 0.067Ω observed
- No warning lamp ON condition

Sample		Resistance(Ω)					
		X axis		Y axis		Z axis	
		MIN	MAX	MIN	MAX	MIN	MAX
#1	PIN 1~4	0.043	0.067	0.040	0.063	0.050	0.057
	PIN 5	0.007	0.017	0.003	0.017	0.007	0.013
	PIN 6	0.007	0.017	0.007	0.017	0.010	0.017
#2	PIN 1~4	0.040	0.063	0.040	0.063	0.050	0.057
	PIN 5	0.007	0.017	0.003	0.017	0.007	0.013
	PIN 6	0.007	0.017	0.007	0.017	0.010	0.013
#3	PIN 1~4	0.043	0.067	0.043	0.067	0.050	0.057
	PIN 5	0.007	0.017	0.007	0.017	0.010	0.013
	PIN 6	0.007	0.017	0.007	0.017	0.010	0.013
#4	PIN 1~4	0.040	0.063	0.040	0.063	0.050	0.057
	PIN 5	0.007	0.017	0.007	0.017	0.010	0.013
	PIN 6	0.007	0.017	0.007	0.017	0.010	0.017
#5	PIN 1~4	0.040	0.063	0.040	0.063	0.050	0.057
	PIN 5	0.007	0.017	0.007	0.017	0.010	0.017
	PIN 6	0.007	0.017	0.007	0.017	0.010	0.017

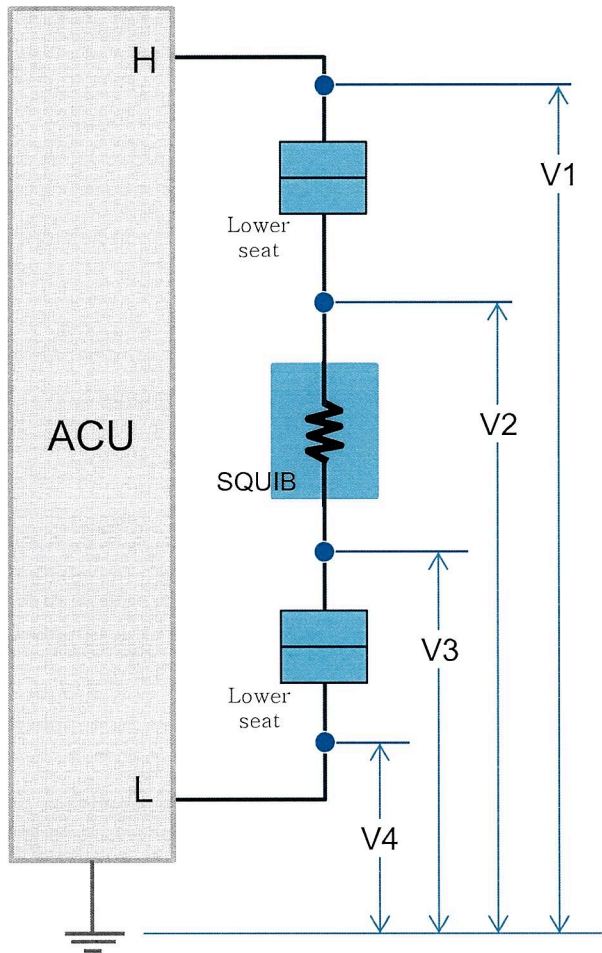
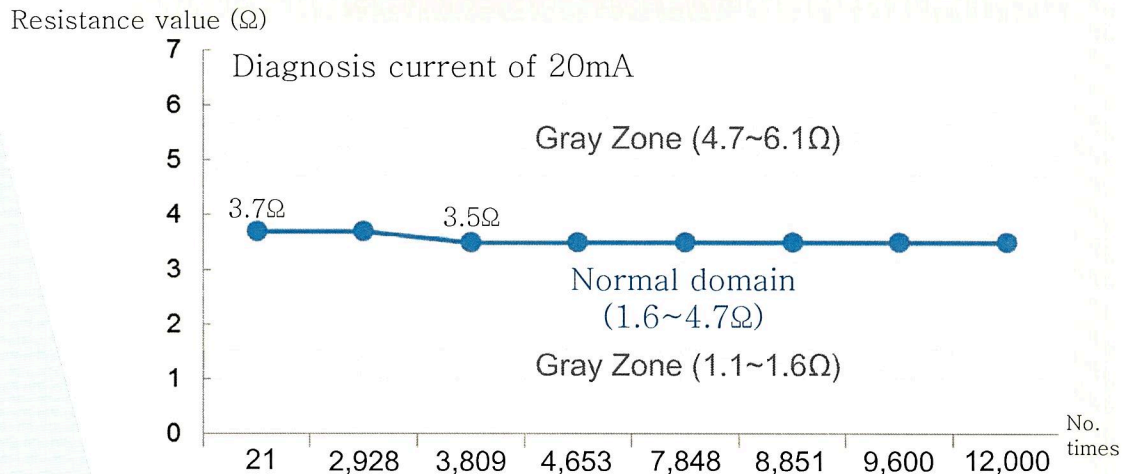
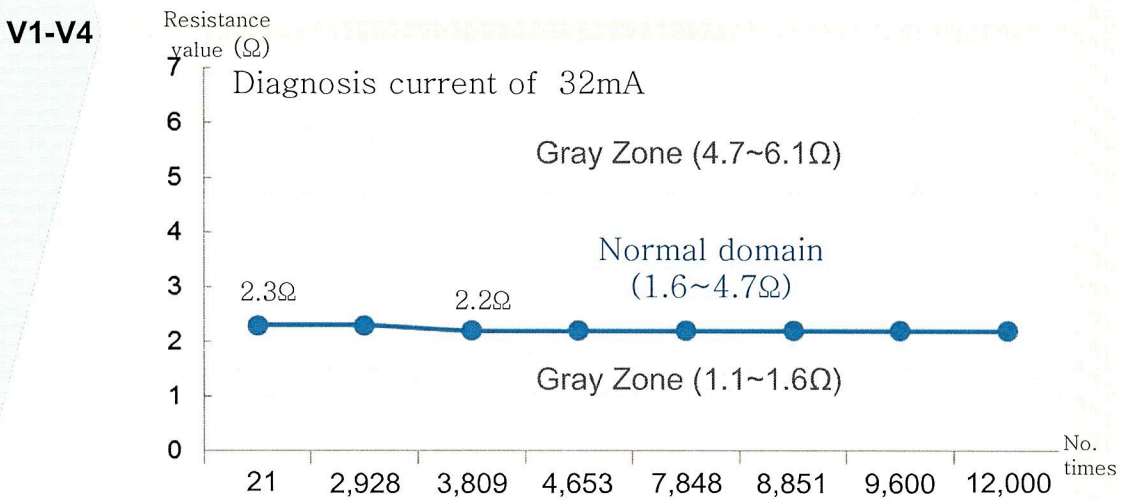
Buckle Pretensioner circuit seat sliding evaluation

- Sliding evaluation result
 - Measured resistance value within specification
 - ACU diagnosis currents of 20 and 32mA used

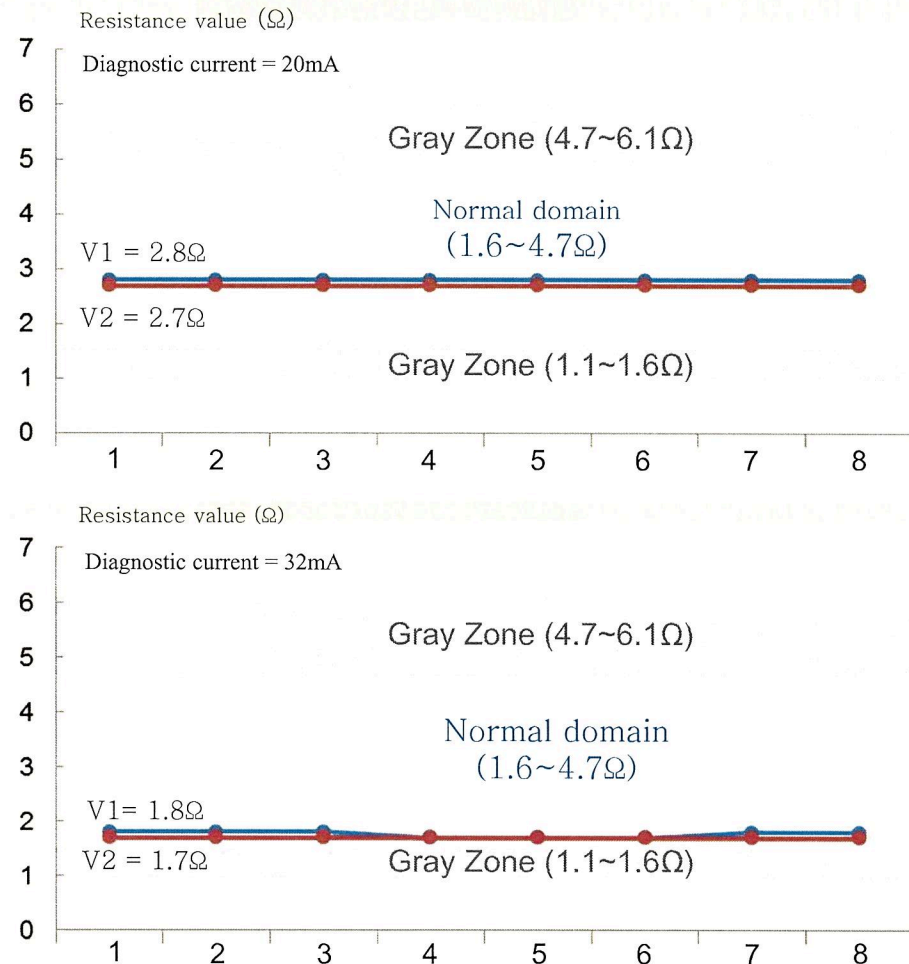
Buckle Pretensioner 6-axis vibration evaluation

- 6-axle vibration evaluation results:
 - Resistance remained within specification

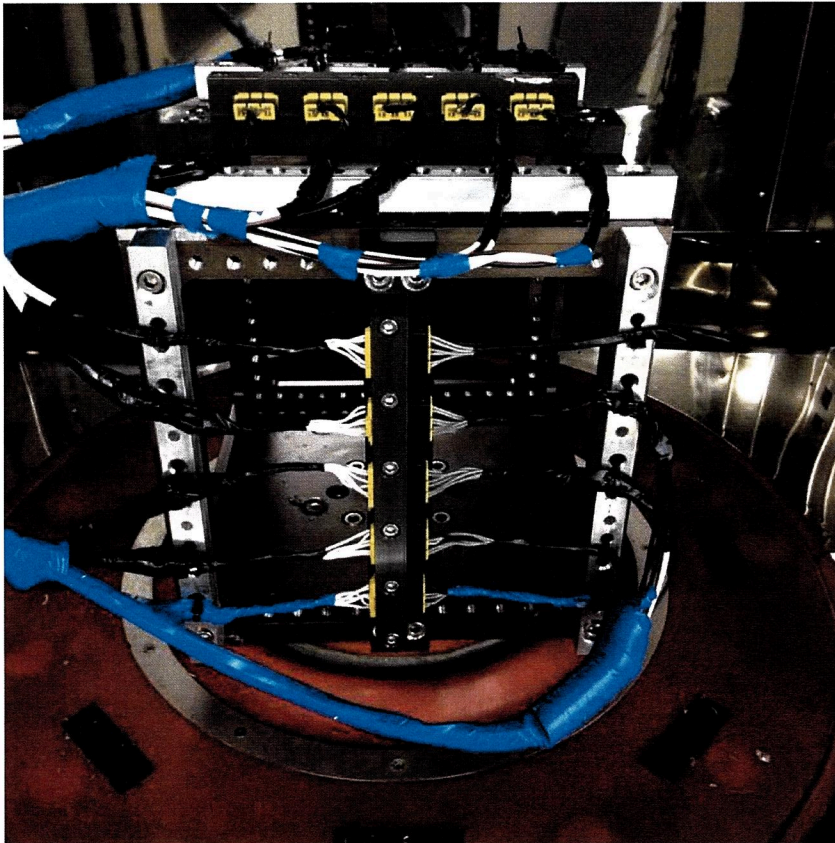
※ Single axis (+/-) vibration. Device under test oriented according to testing plan.

■ Test condition

Sinusoidal Vibration

- Applied current: 30mA
- Vibration acceleration: 4.4G
- Vibration Frequency : 20~200Hz
- Vibration direction +/- x, y, and z axes
- Time 40 hours each axis

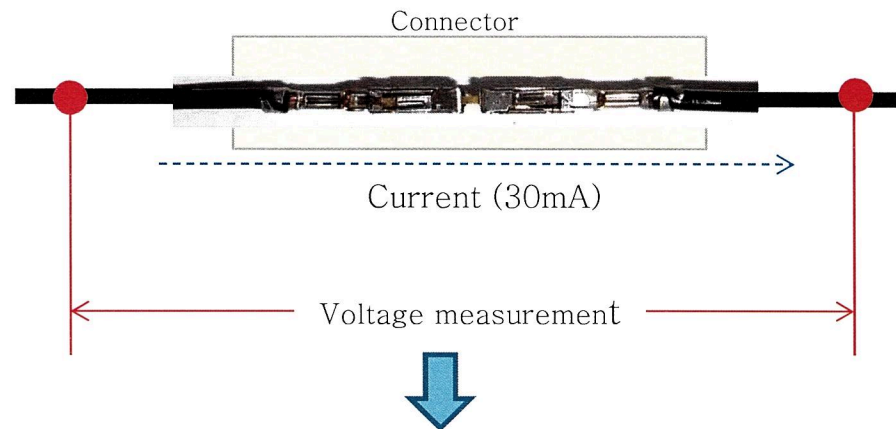
■ Measurement method

$$\text{Resistance} = \text{Voltage measurement} / \text{Current (30mA)}$$

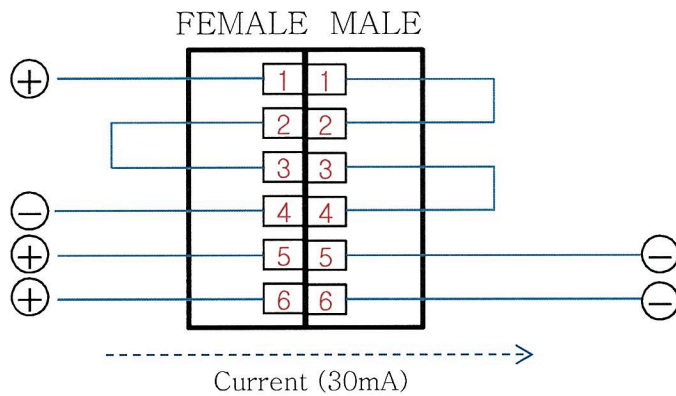
■ Sample #1/2/3/4

- Connector lock mechanism removed

Sample		Resistance(Ω)					
		X axis		Y axis		Z axis	
		MIN	MAX	MIN	MAX	MIN	MAX
#1	PIN 1~4	0.050	0.057	0.043	0.067	0.040	0.063
	PIN 5	0.010	0.013	0.003	0.017	0.007	0.017
	PIN 6	0.010	0.017	0.003	0.017	0.007	0.017
#2	PIN 1~4	0.053	0.057	0.043	0.067	0.043	0.067
	PIN 5	0.010	0.013	0.007	0.017	0.007	0.017
	PIN 6	0.007	0.013	0.003	0.017	0.007	0.017
#3	PIN 1~4	0.060	0.063	0.043	0.070	0.013	8.380
	PIN 5	0.013	0.020	0.007	0.020	0.010	0.020
	PIN 6	0.020	0.023	0.010	0.023	0.010	0.033
#4	PIN 1~4	0.053	0.060	0.043	0.067	0.037	0.073
	PIN 5	0.020	0.027	0.007	0.017	0.007	0.020
	PIN 6	0.013	0.020	0.003	0.017	0.007	0.023

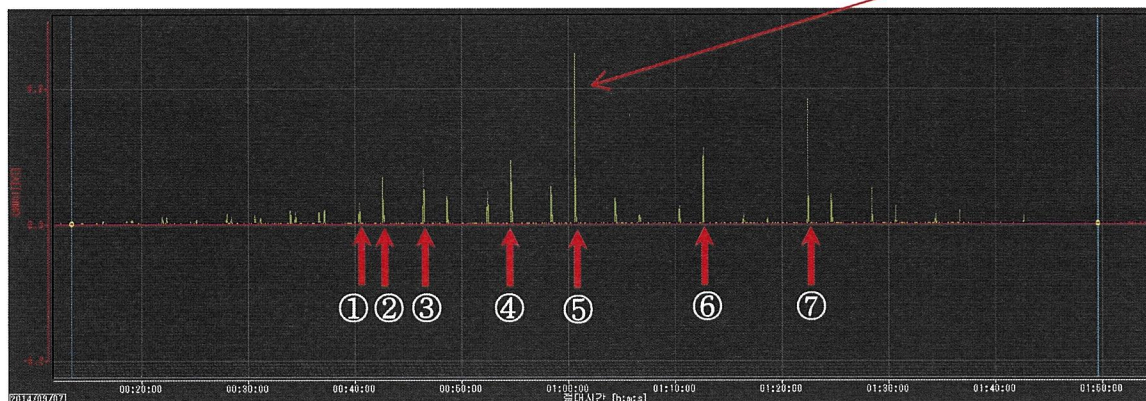
■ Evaluation result

- Upon Z axis vibration, resistance fluctuation occurs for 1 hour and 30 minutes at a 3-minute interval

No	Voltage (mV, MAX)	Resistance (Ω, MAX)
1	0.032	1.1
2	0.069	2.3
3	0.081	2.7
4	0.090	3.0
5	0.251	8.4
6	0.112	3.7
7	0.186	6.2

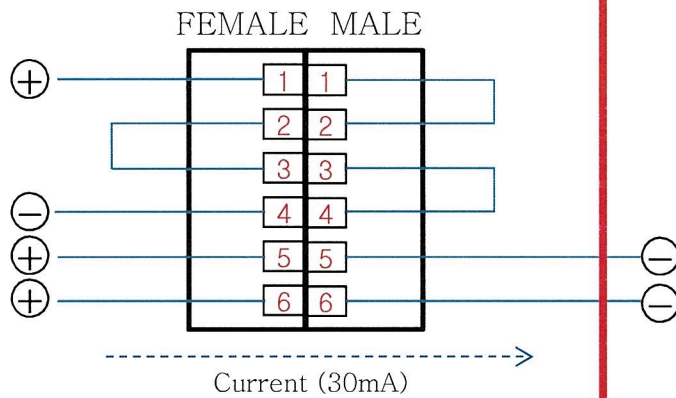
Connector vibration evaluation result (Cable Tie application)

- Sample #1/2/3/4
- Cable tie is applied to connector body

Sample		Resistance(Ω)					
		X axis		Yaxis		Zaxis	
		MIN	MAX	MIN	MAX	MIN	MAX
#1	PIN 1~4	0.053	0.057	0.053	0.060	0.053	0.060
	PIN 5	0.007	0.017	0.007	0.017	0.010	0.013
	PIN 6	0.007	0.017	0.007	0.017	0.010	0.017
#2	PIN 1~4	0.053	0.060	0.053	0.060	0.057	0.060
	PIN 5	0.010	0.017	0.010	0.017	0.010	0.017
	PIN 6	0.007	0.017	0.010	0.017	0.010	0.013
#3	PIN 1~4	0.053	0.060	0.053	0.060	0.053	0.060
	PIN 5	0.007	0.017	0.007	0.017	0.010	0.013
	PIN 6	0.010	0.017	0.010	0.017	0.010	0.017
#4	PIN 1~4	0.050	0.057	0.050	0.057	0.053	0.057
	PIN 5	0.007	0.013	0.007	0.013	0.010	0.013
	PIN 6	0.007	0.017	0.007	0.017	0.010	0.013
