Supplemental Report, DP14-003, EDR Examples

A General Discussion of the Event Data Recorder in the Toyota Corolla: The Event Data Recorder (EDR) is part of the Supplemental Restraint System that records data for some types of collision events for future safety research or crash analysis. The EDR will record data when the vehicle experiences a rapid change in speed that exceeds a specified threshold, above changes in speeds that are considered normal driving use. For example, stopping hard with the brakes would not cause a recording, but hitting a curb may. The system limitations include the fact that different types of data are recorded at different intervals and may not be sufficient to record the entire crash. This limitation means that the data reported for a specific time interval was recorded near that time interval but due to the varying rates of data collection the value noted is not necessarily the *exact* data at the *exact* time marker.¹

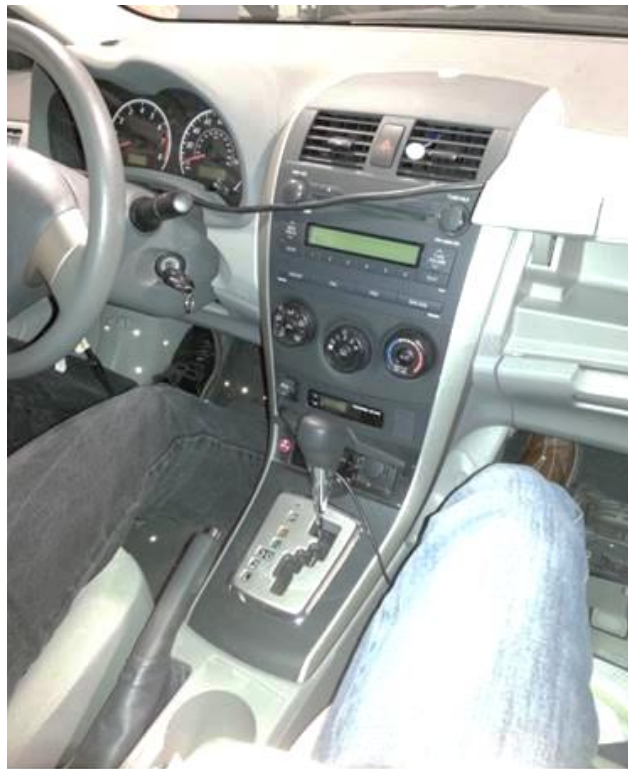
The complainant in VOQ 10507434 noted that he [thought] he was able to observe her foot on the brake pedal from his position in the passenger seat. As indicated by the EDR download the acceleration event started when the driver’s foot has released the accelerator pedal with less than 1.75 seconds before impact, which is a short time for a passenger to be able to realize what is occurring, and then look over to observe the driver’s foot position. Testing was done at NHTSA’s Vehicle and Research Testing Facility (VRTC) as to visibility of the driver’s foot from the front passenger seat of the subject vehicle. Figure 1 is a photo taken from the front passenger seat looking towards the driver’s footwell. From the position of the passenger (who is sitting upright, not leaning toward the driver, with the seat in the rearmost position) it is difficult to ascertain which pedal the driver’s foot is on.

Figure 1: View from passenger seat of driver's footwell.

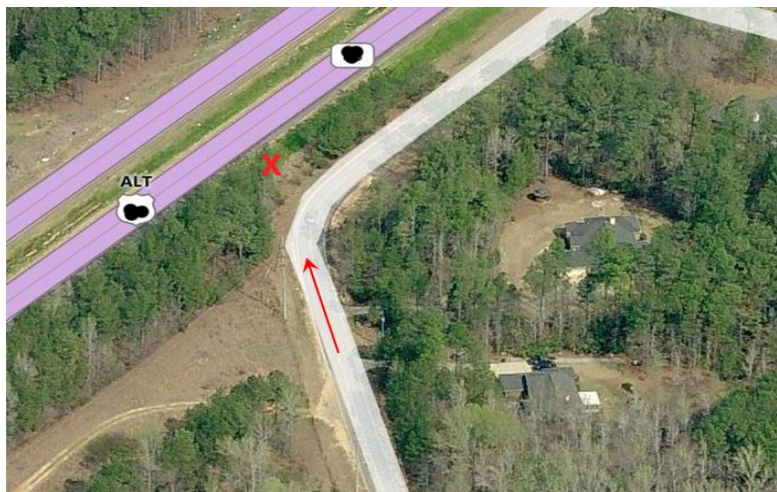
Analysis: Two very different versions of the crash are presented to two different sources. In order to understand the event better ODI obtained an accident report from the responding law enforcement agency. Based on the report, the surface conditions are wet (research on historical weather data indicates there had been a light rain most of the day and into the evening), there is no roadway lighting or street lamps, and there is a sharp curve to the right at the location of the crash. The posted speed limit is 35 mph. At -5.0 seconds prior to the crash the vehicle is 10 mph over the posted limit and the accelerator pedal pressure remains relatively steady until around -2.0 seconds prior to impact. At -1.0 seconds prior to impact the brake is ON. It appears from the accident report diagram and aerial photo mapping of the crash site that the brakes were not applied until the vehicle left the roadway, failing to negotiate the curve in the dark, traveling some distance over undeveloped wet ground until striking a tree in a forested area. See Figure 2.

Figure 2. Red arrow indicates direction of travel, red X indicates approximate crash site.

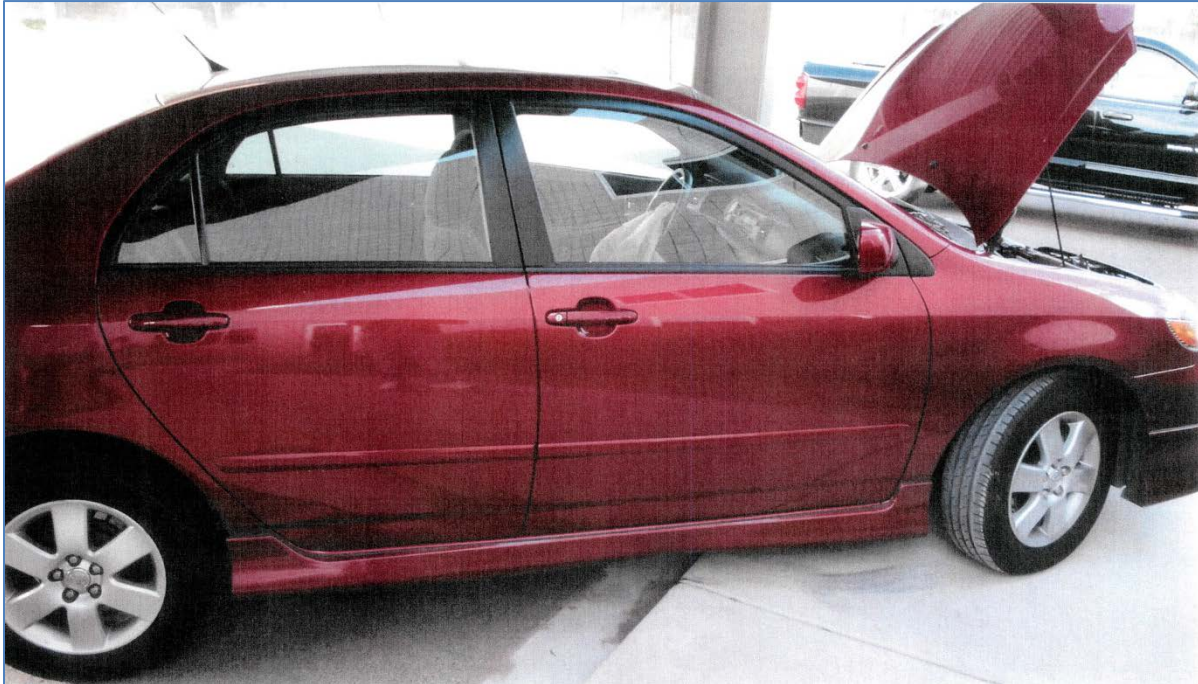
Analysis: Reviewing photographs of the crash shows that the “skid marks,” which theoretically proved the application of braking, are coming from the front wheels. The Toyota Corolla is a front wheel drive vehicle, which means it is impossible for the front tires to be rotating and surging the vehicle forward and, at the same time, be dragging because the brakes are applied. The “skid marks” are actually “burnout” marks caused by the front wheels spinning because the accelerator is being applied fully as the vehicle is crashing into the pole. This is a common misperception; if the skid marks were from the brakes causing the tires to drag then the marks would be from the rear tires, not the front.

Figure 3. “Burnout” mark visible directly behind front right tire.
