PE15-030

FLAT CHRYSLER

ENCLOSURE 4

CAIR Backup

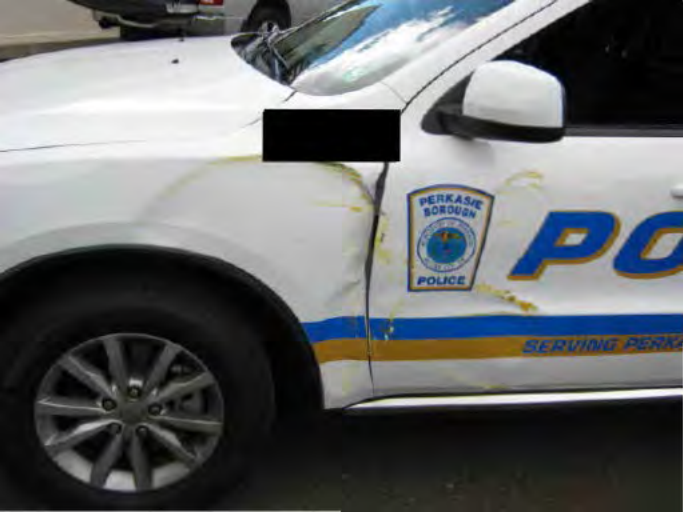
Attached are the vehicle photos.
Picture #5 shows minor scuff marks to the vehicle from backing into another vehicle, prior to the incident we are concerned about. Vehicle is presently right next to my police station at the address below. Correct cell number for me is also below.
Thanks

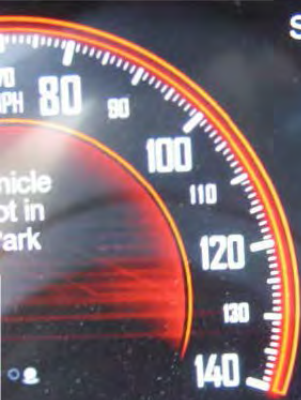
Vehicle
not in
park

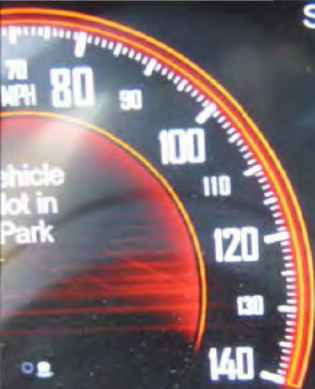
Vehicle
not in
Park
