EA16-002

FLAT CHRYSLER

ENCLOSURE 04

CAIR Backup

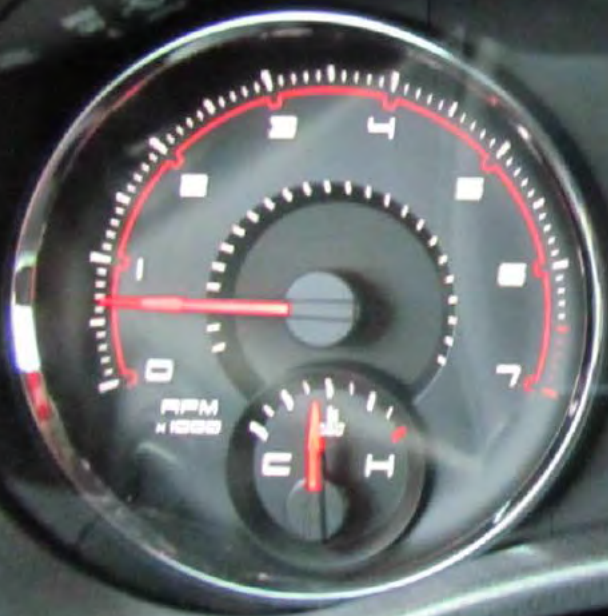
000000 07  
Vehicle Speed  
0 mph  
change to lock  
P  
R  
N  
D  
L

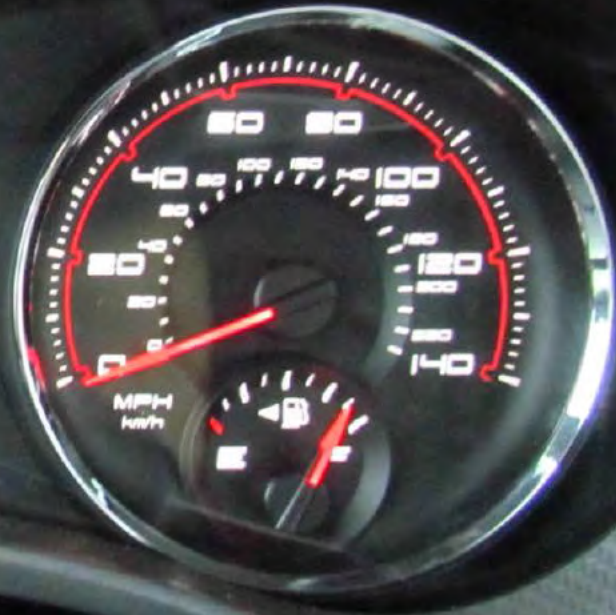
P  
R  
N  
D/L

I was not able to shift the gear selector lever out of N into either R or D without pressing the service brake pedal and pressing the selector release button at the same time.

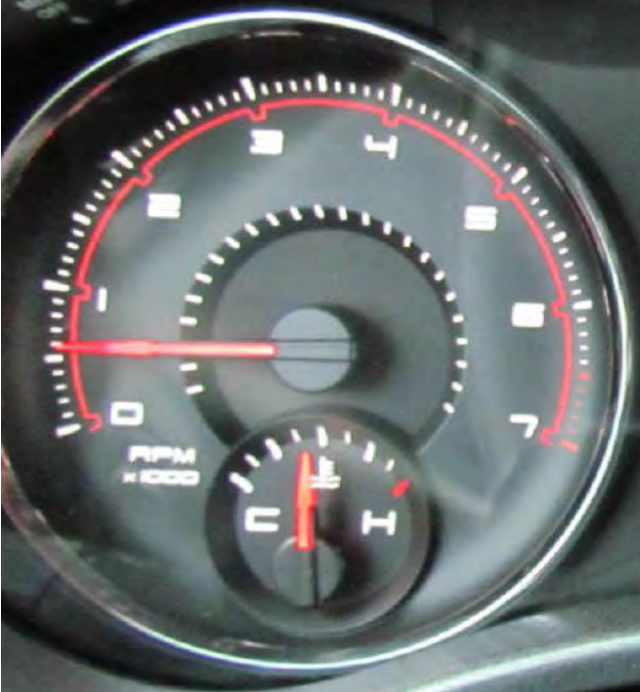
000000 00  
Vehicle Speed  
0 mph  
1 change to lock  
P  
D

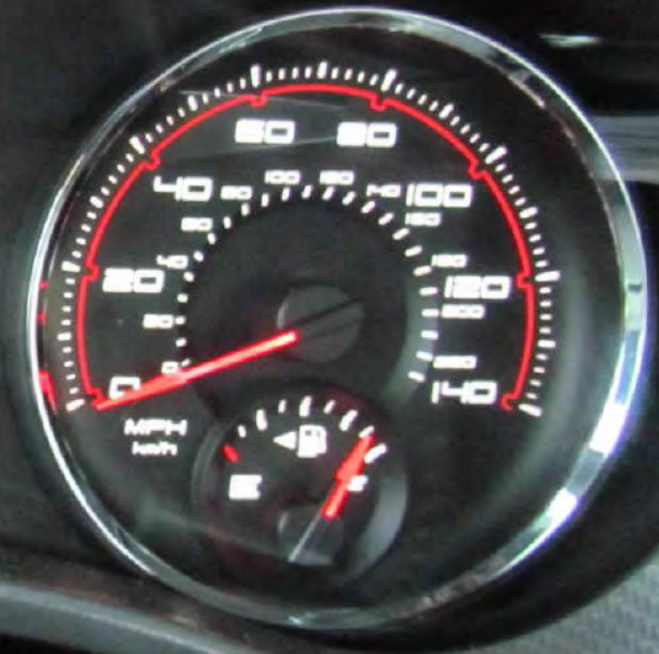
The gear selector will go from D/L to N without pressing the selector button.

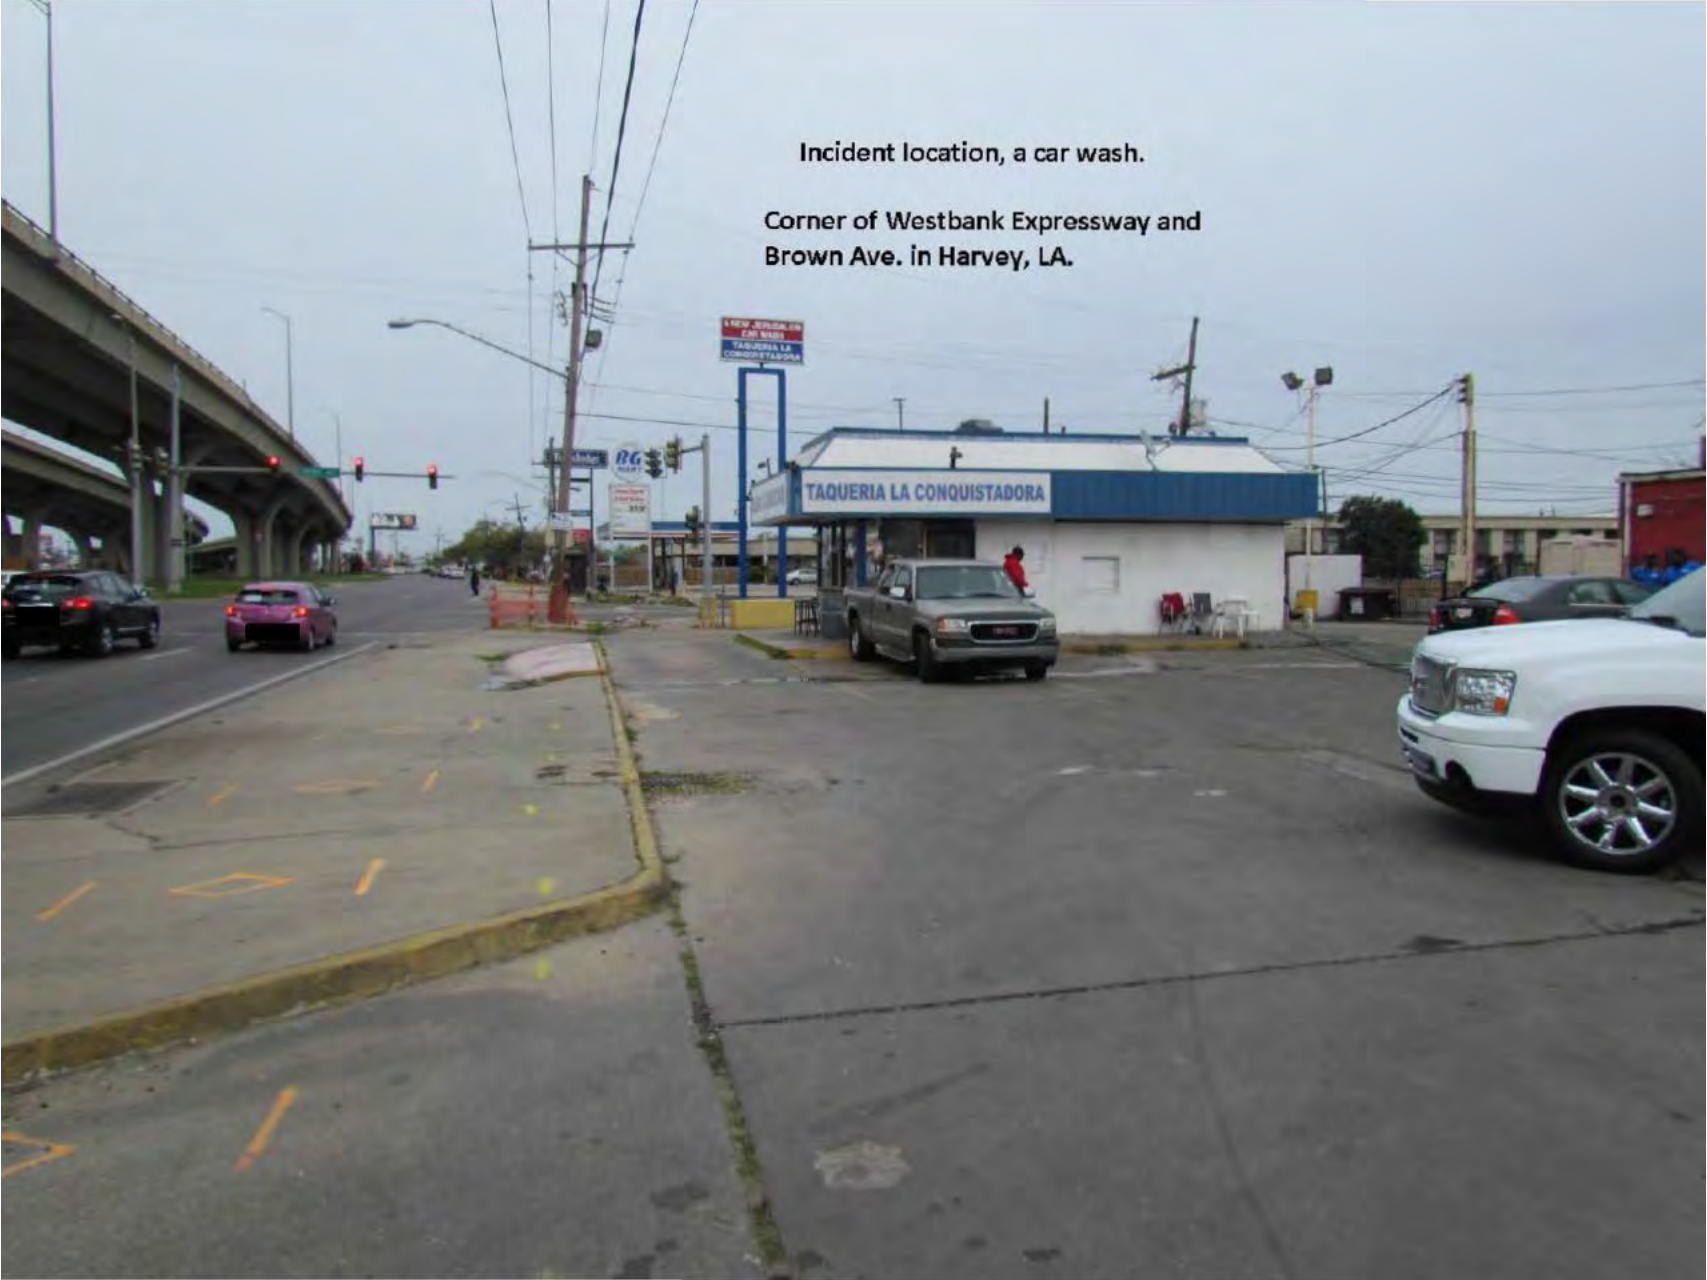
owner and driver, offered to drive his vehicle to the accident site. I asked him to Park the vehicle in the same position as he did the afternoon of the incident. This is where he stated it was Parked just prior to going "into Reverse and backing into the fence".

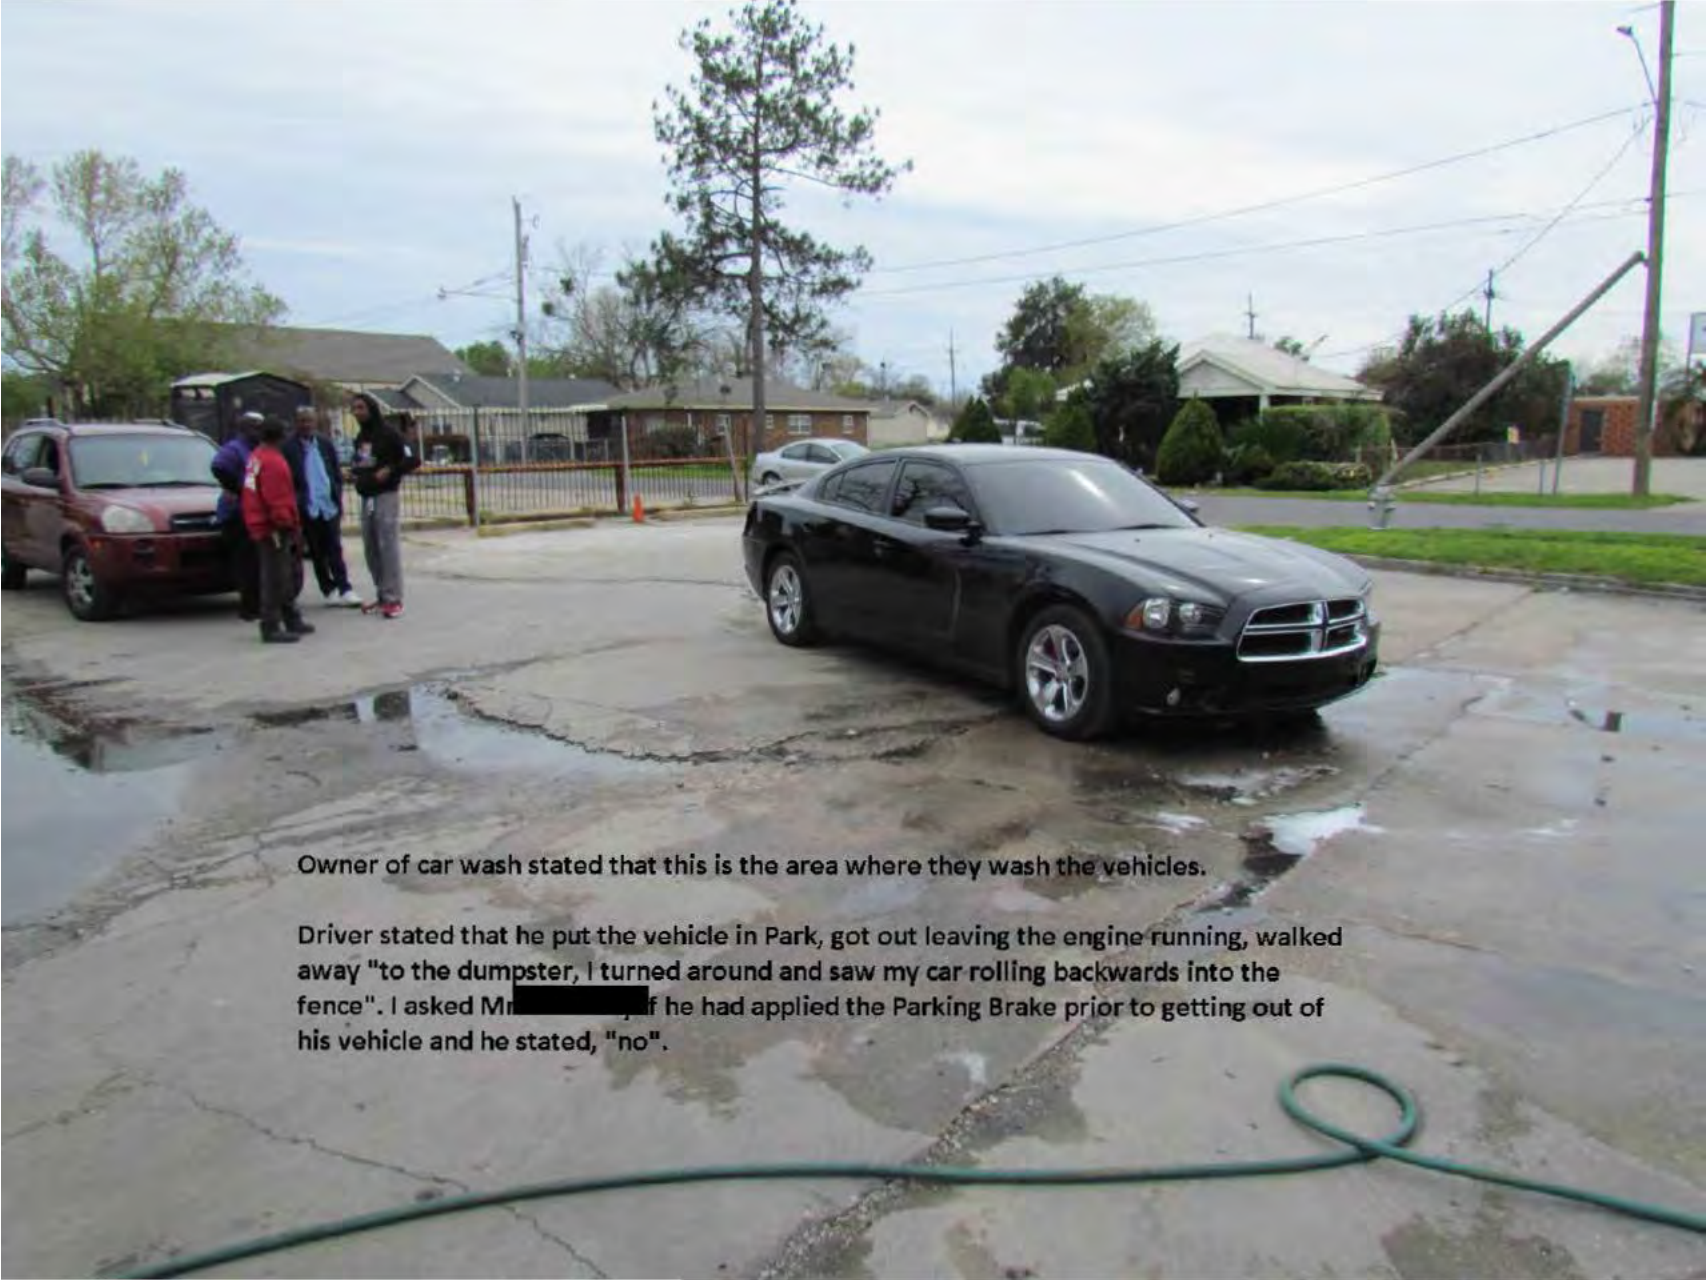
Owner of car wash stated that this is the area where they wash the vehicles.

Driver stated that he put the vehicle in Park, got out leaving the engine running, walked away "to the dumpster, I turned around and saw my car rolling backwards into the fence". I asked Mr. [REDACTED] if he had applied the Parking Brake prior to getting out of his vehicle and he stated, "no".

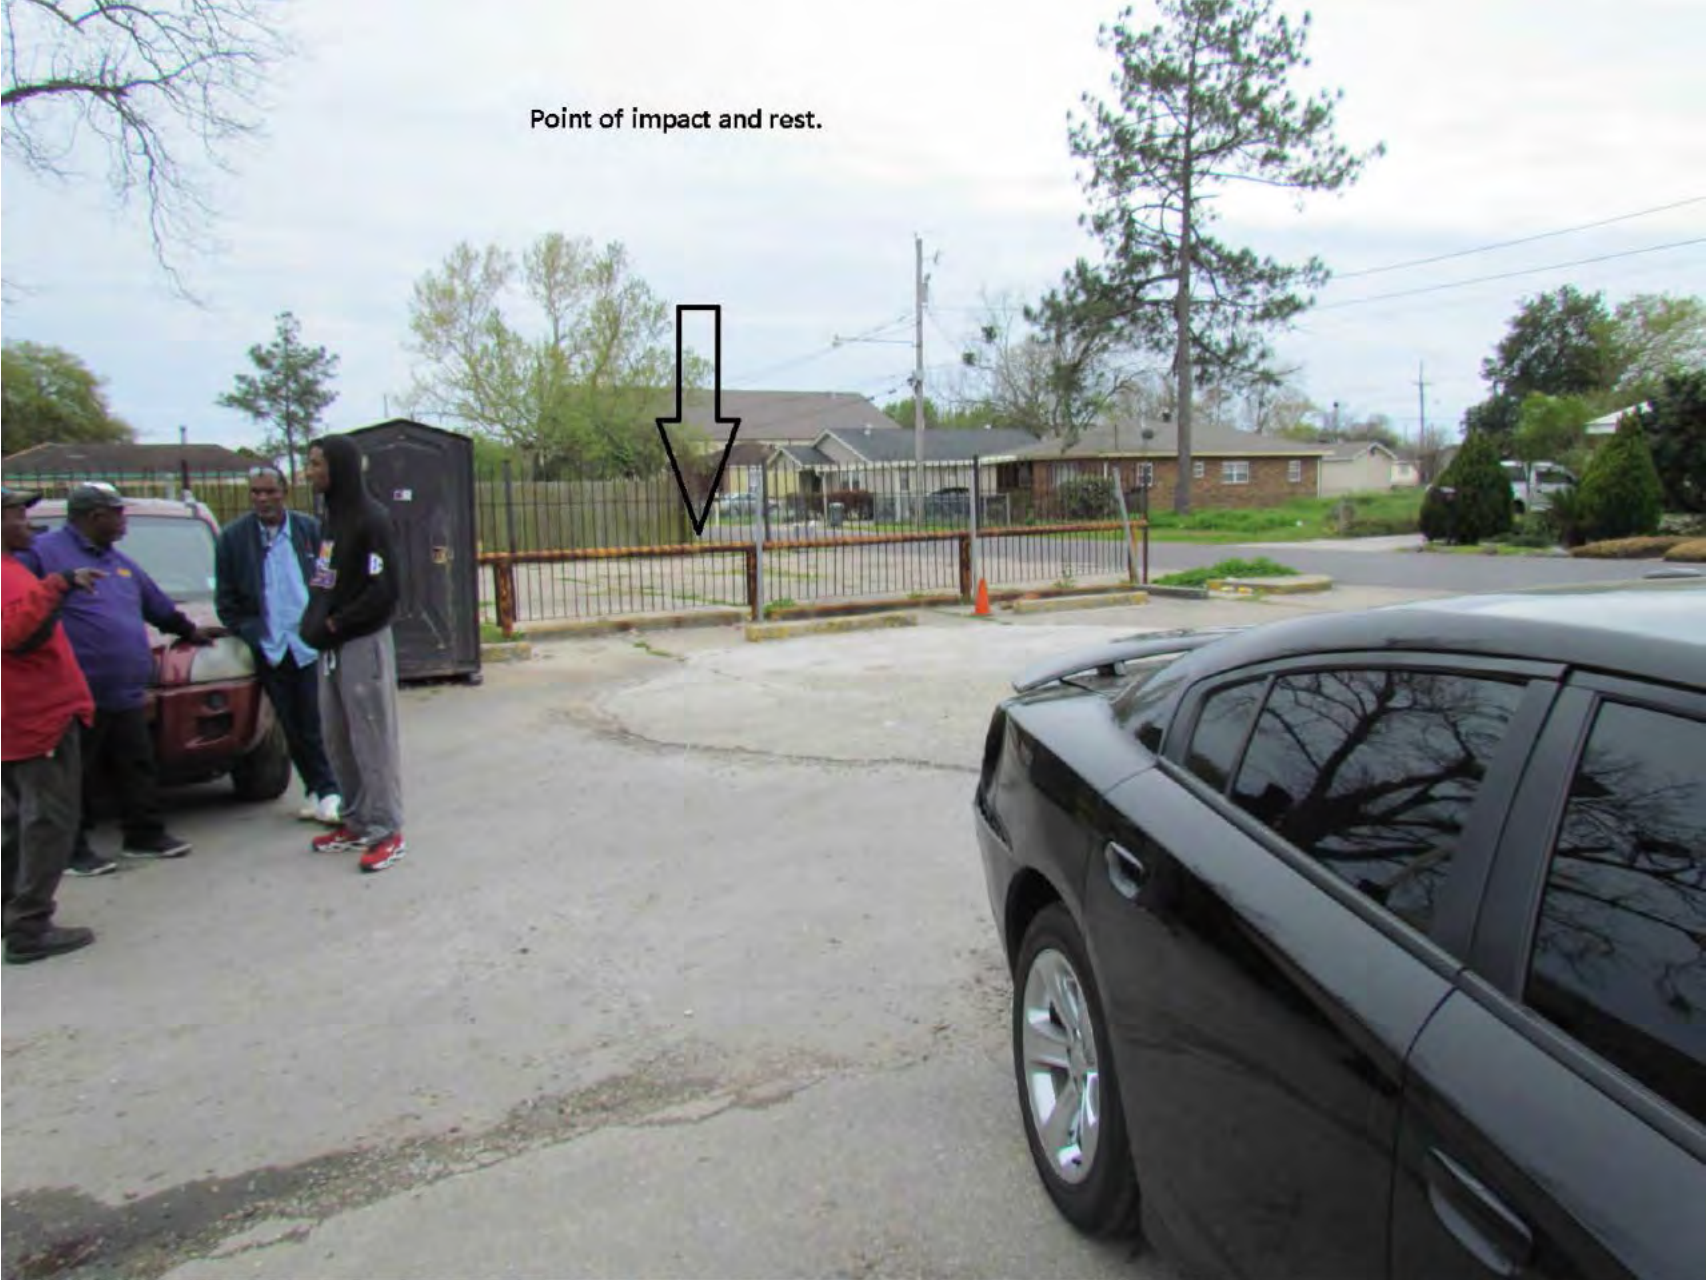
Point of impact and rest.

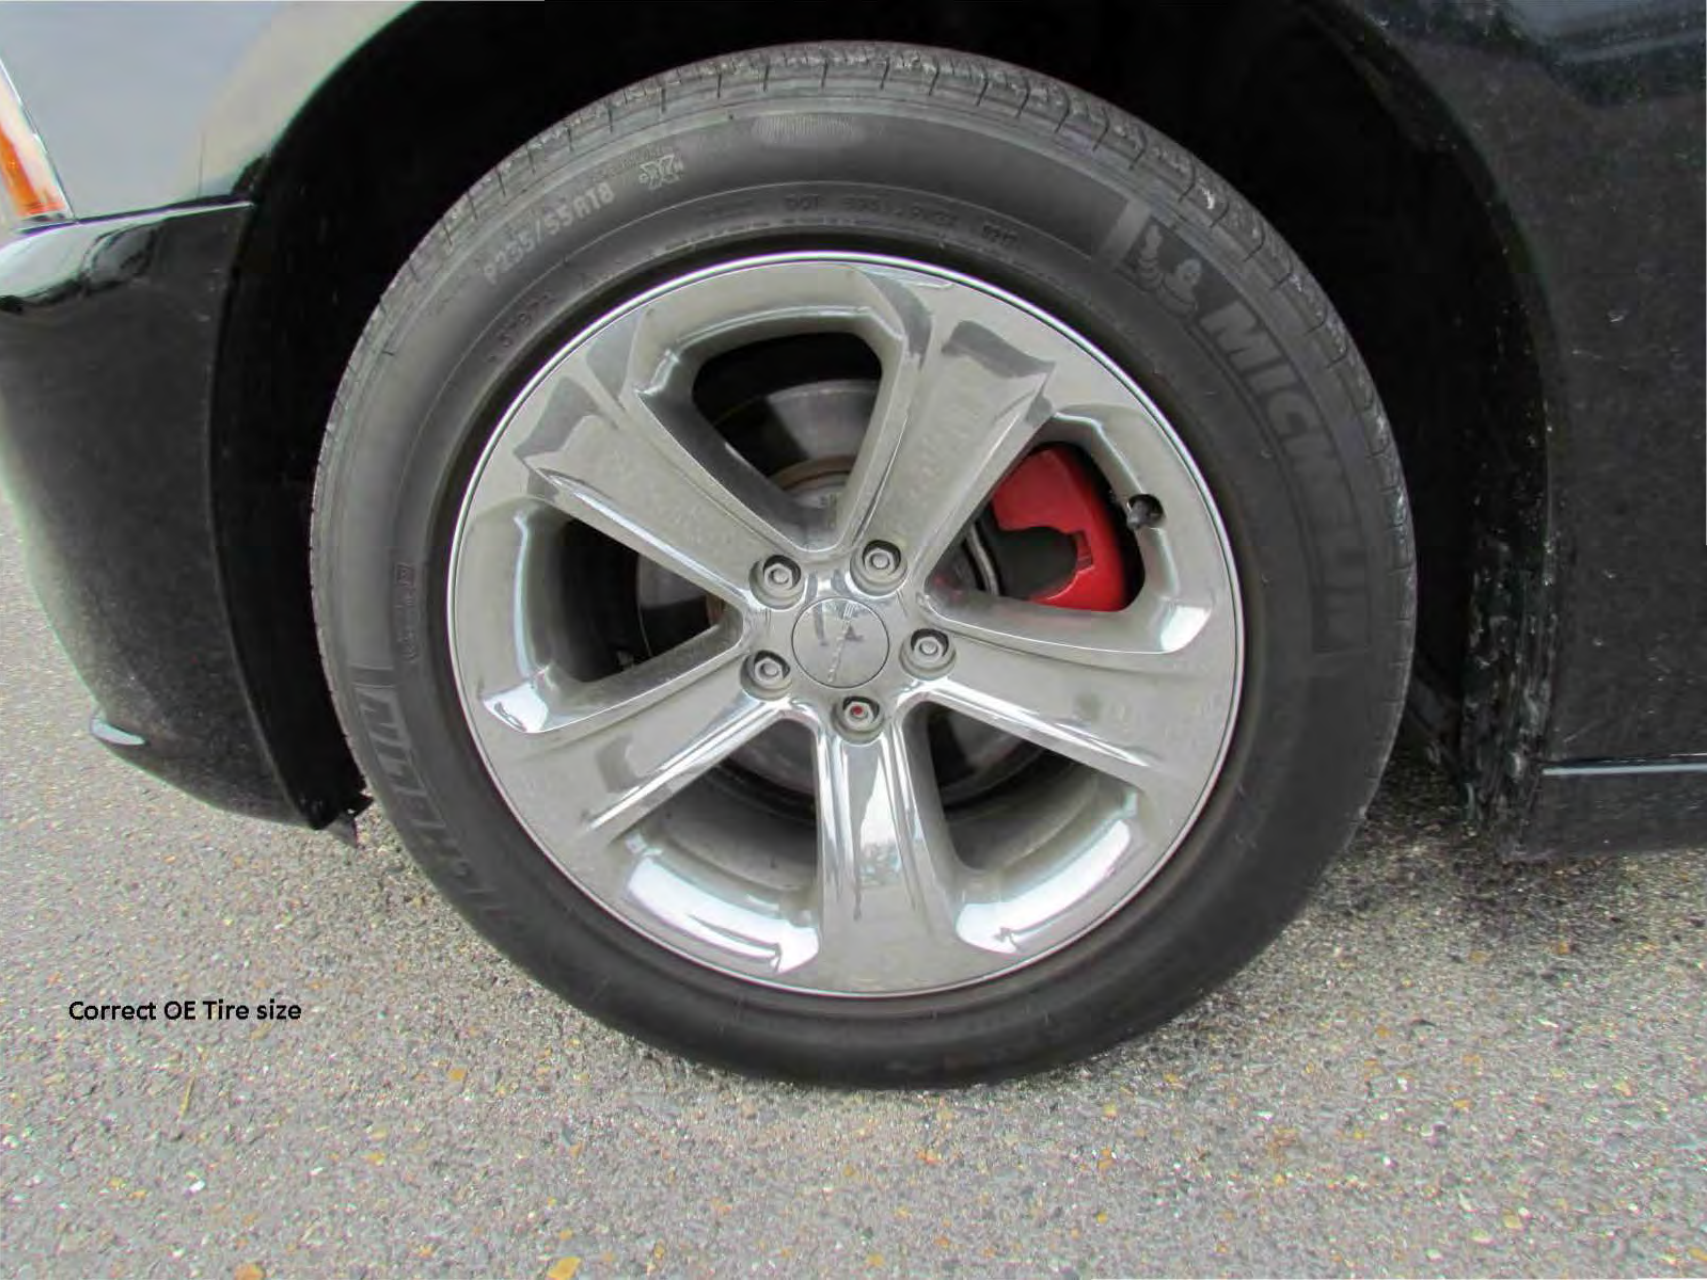
Correct OE Tire size

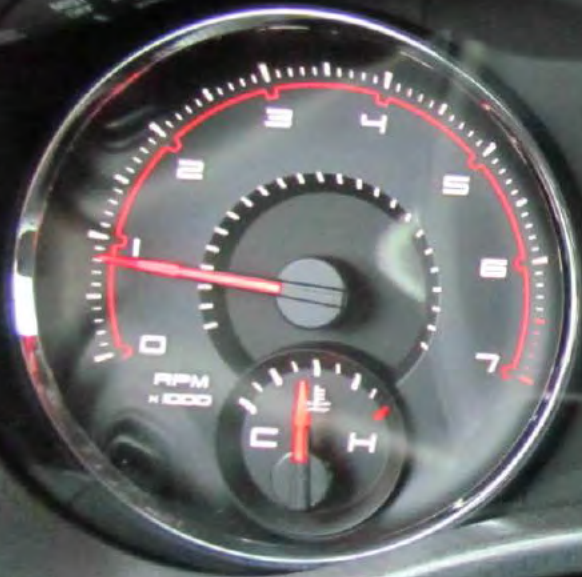
STATUS 66°

Press Brake and  
Push Button to Shift  
into Gear

P  
R  
N  
D  
L

This central display shows a red status bar at the top with 'STATUS 66°'. Below it is a blue instruction: 'Press Brake and Push Button to Shift into Gear' accompanied by a blue shift button icon. To the right, a vertical gear indicator shows 'P' selected.

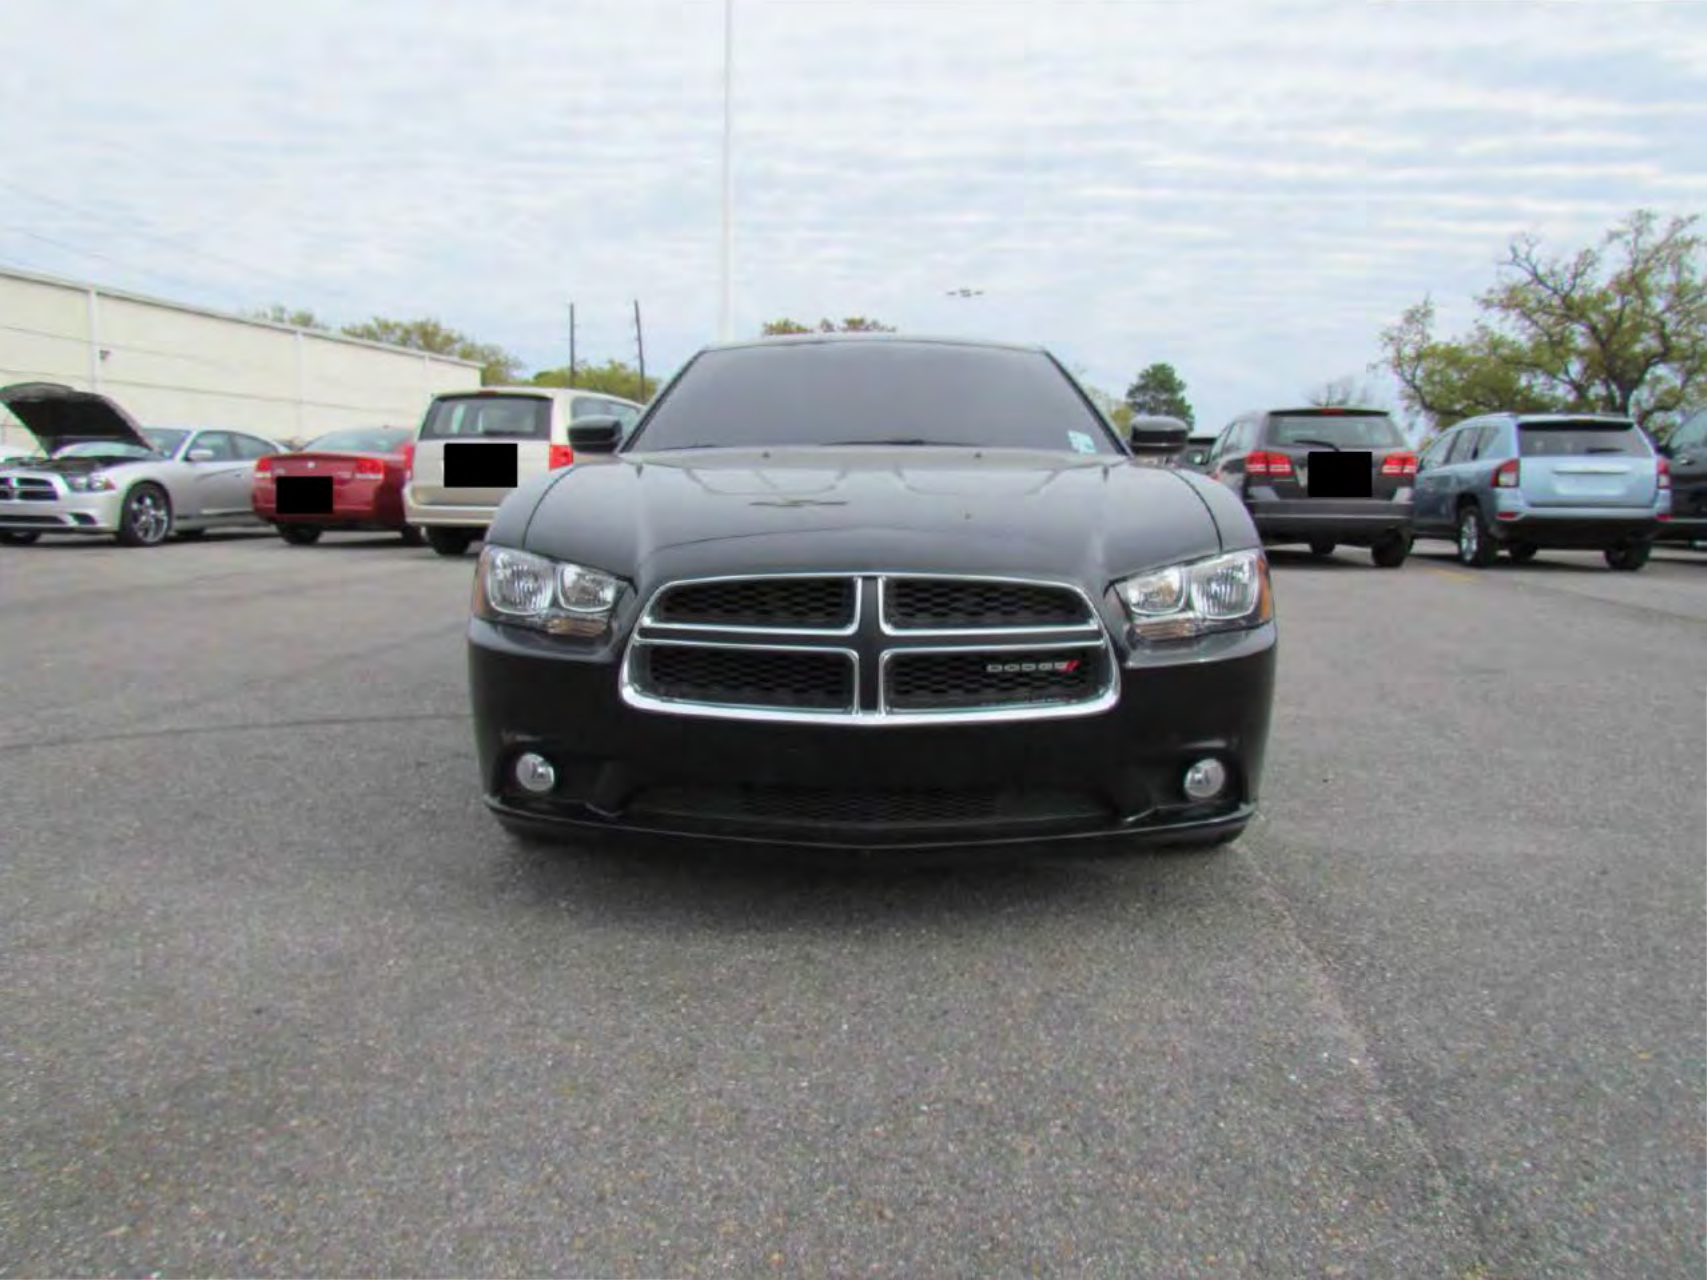
When attempting to shift out of Park without pressing the service brake pedal, this is the warning message displayed in the dash.

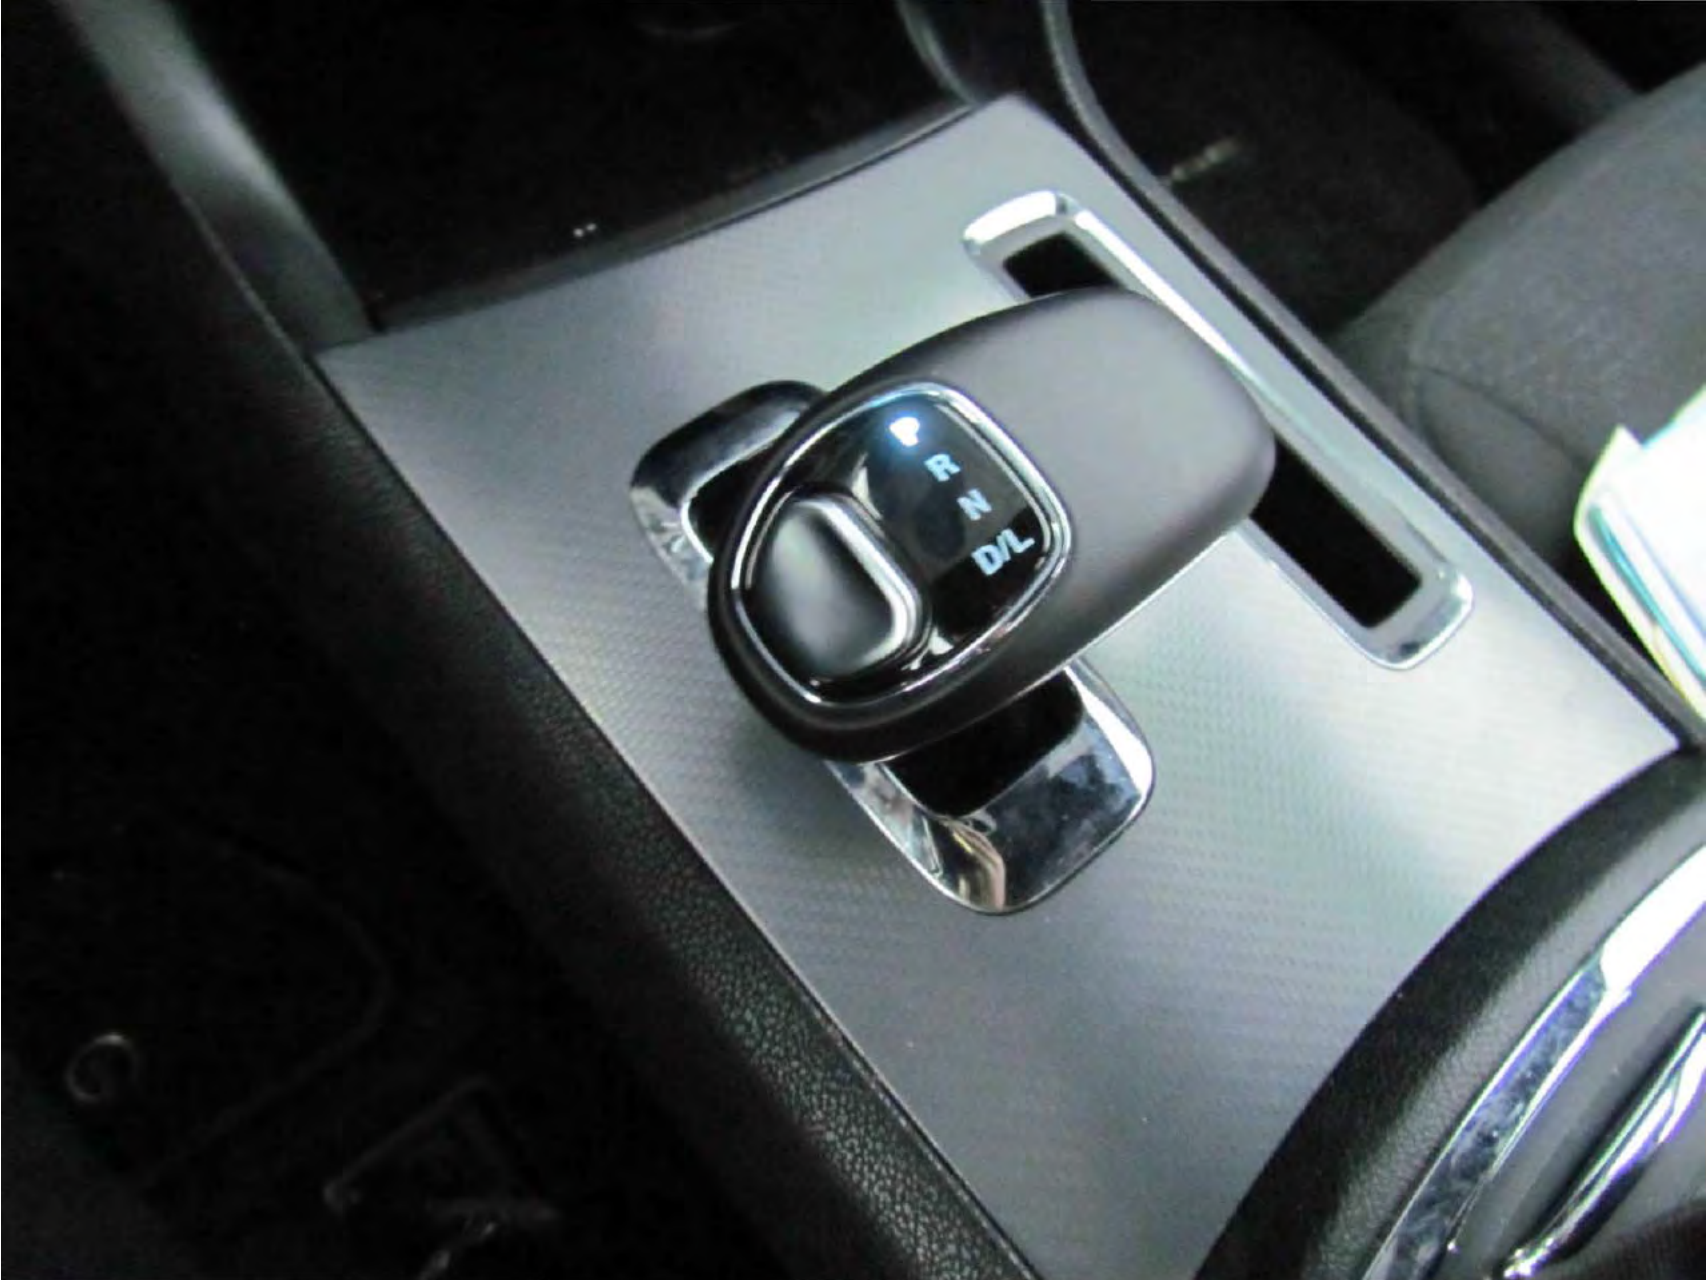
I was NOT able to shift the gear selector lever out of P without Pressing the service brake pedal and Pressing the selector lever button at the same time.

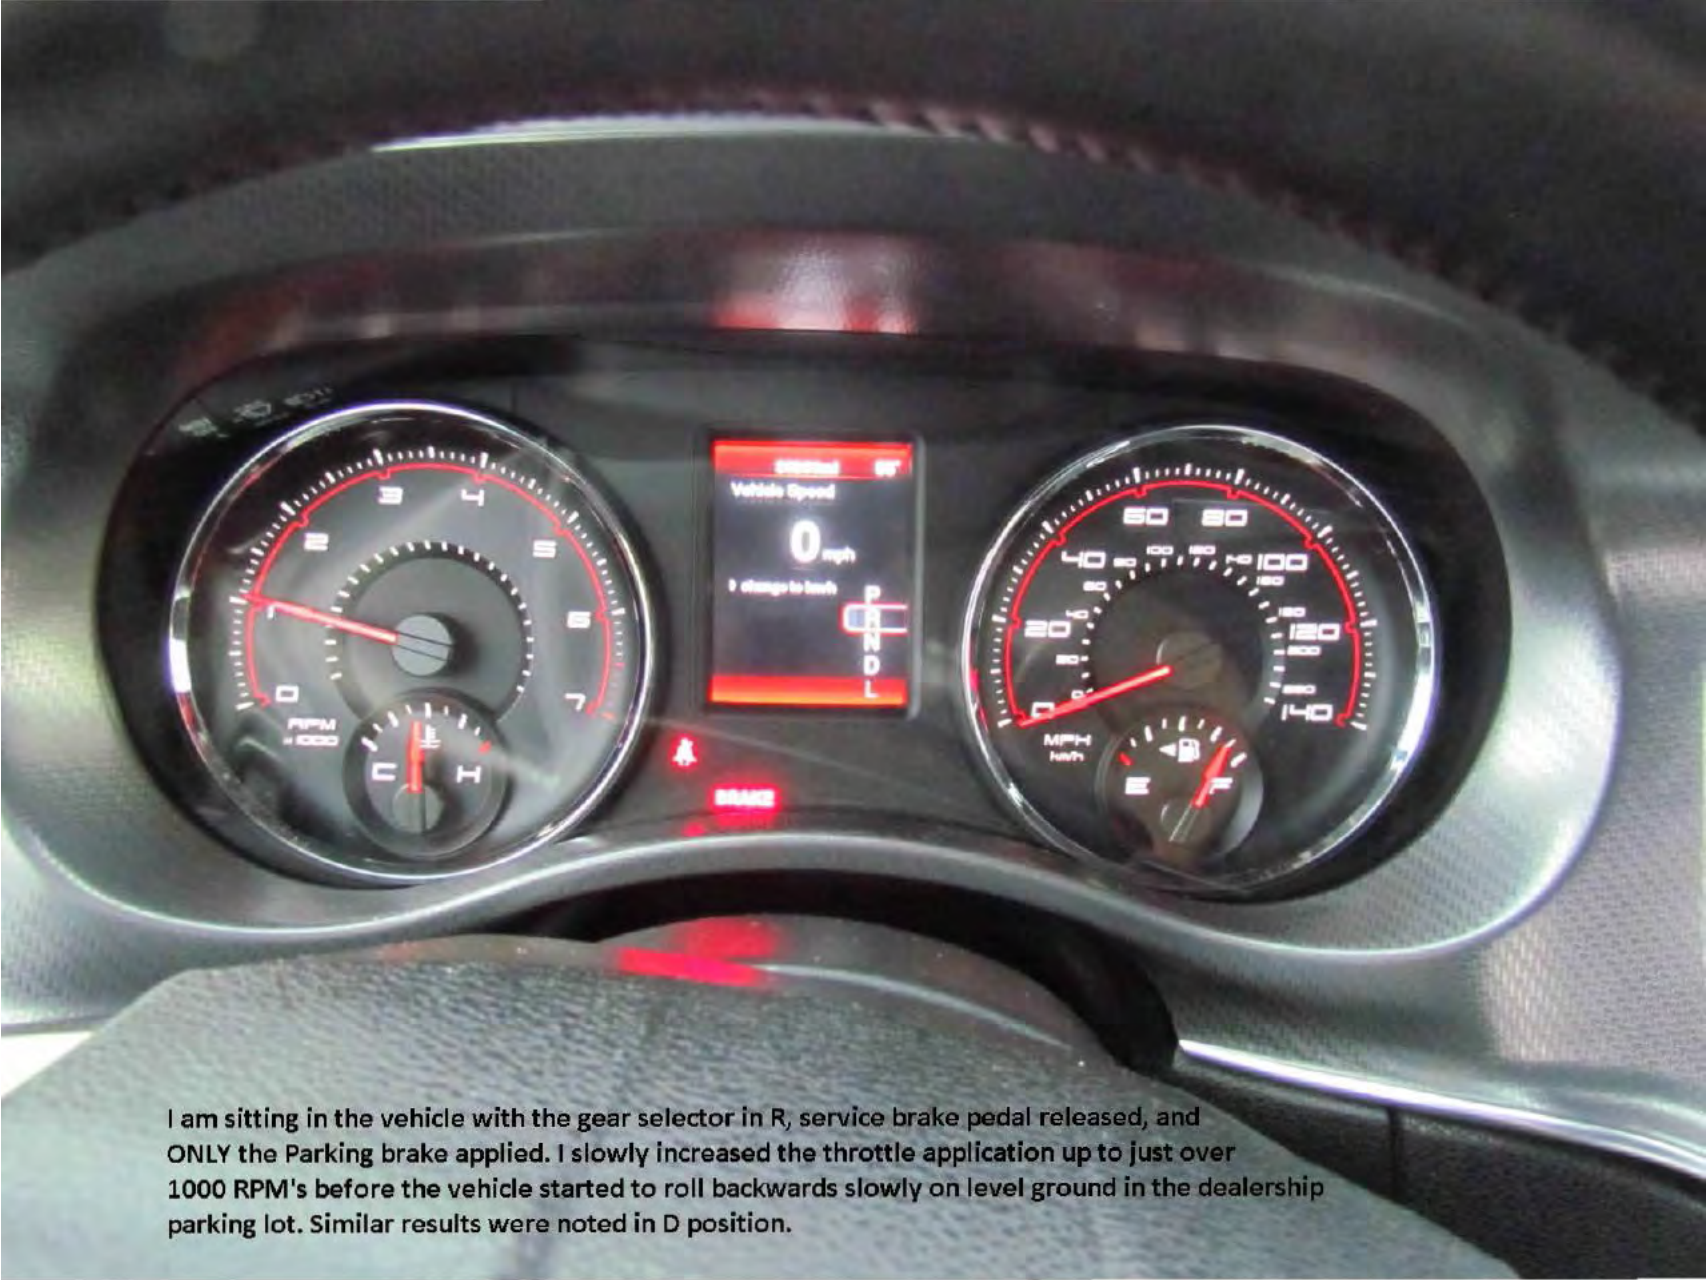
I am sitting in the vehicle with the gear selector in R, service brake pedal released, and ONLY the Parking brake applied. I slowly increased the throttle application up to just over 1000 RPM's before the vehicle started to roll backwards slowly on level ground in the dealership parking lot. Similar results were noted in D position.

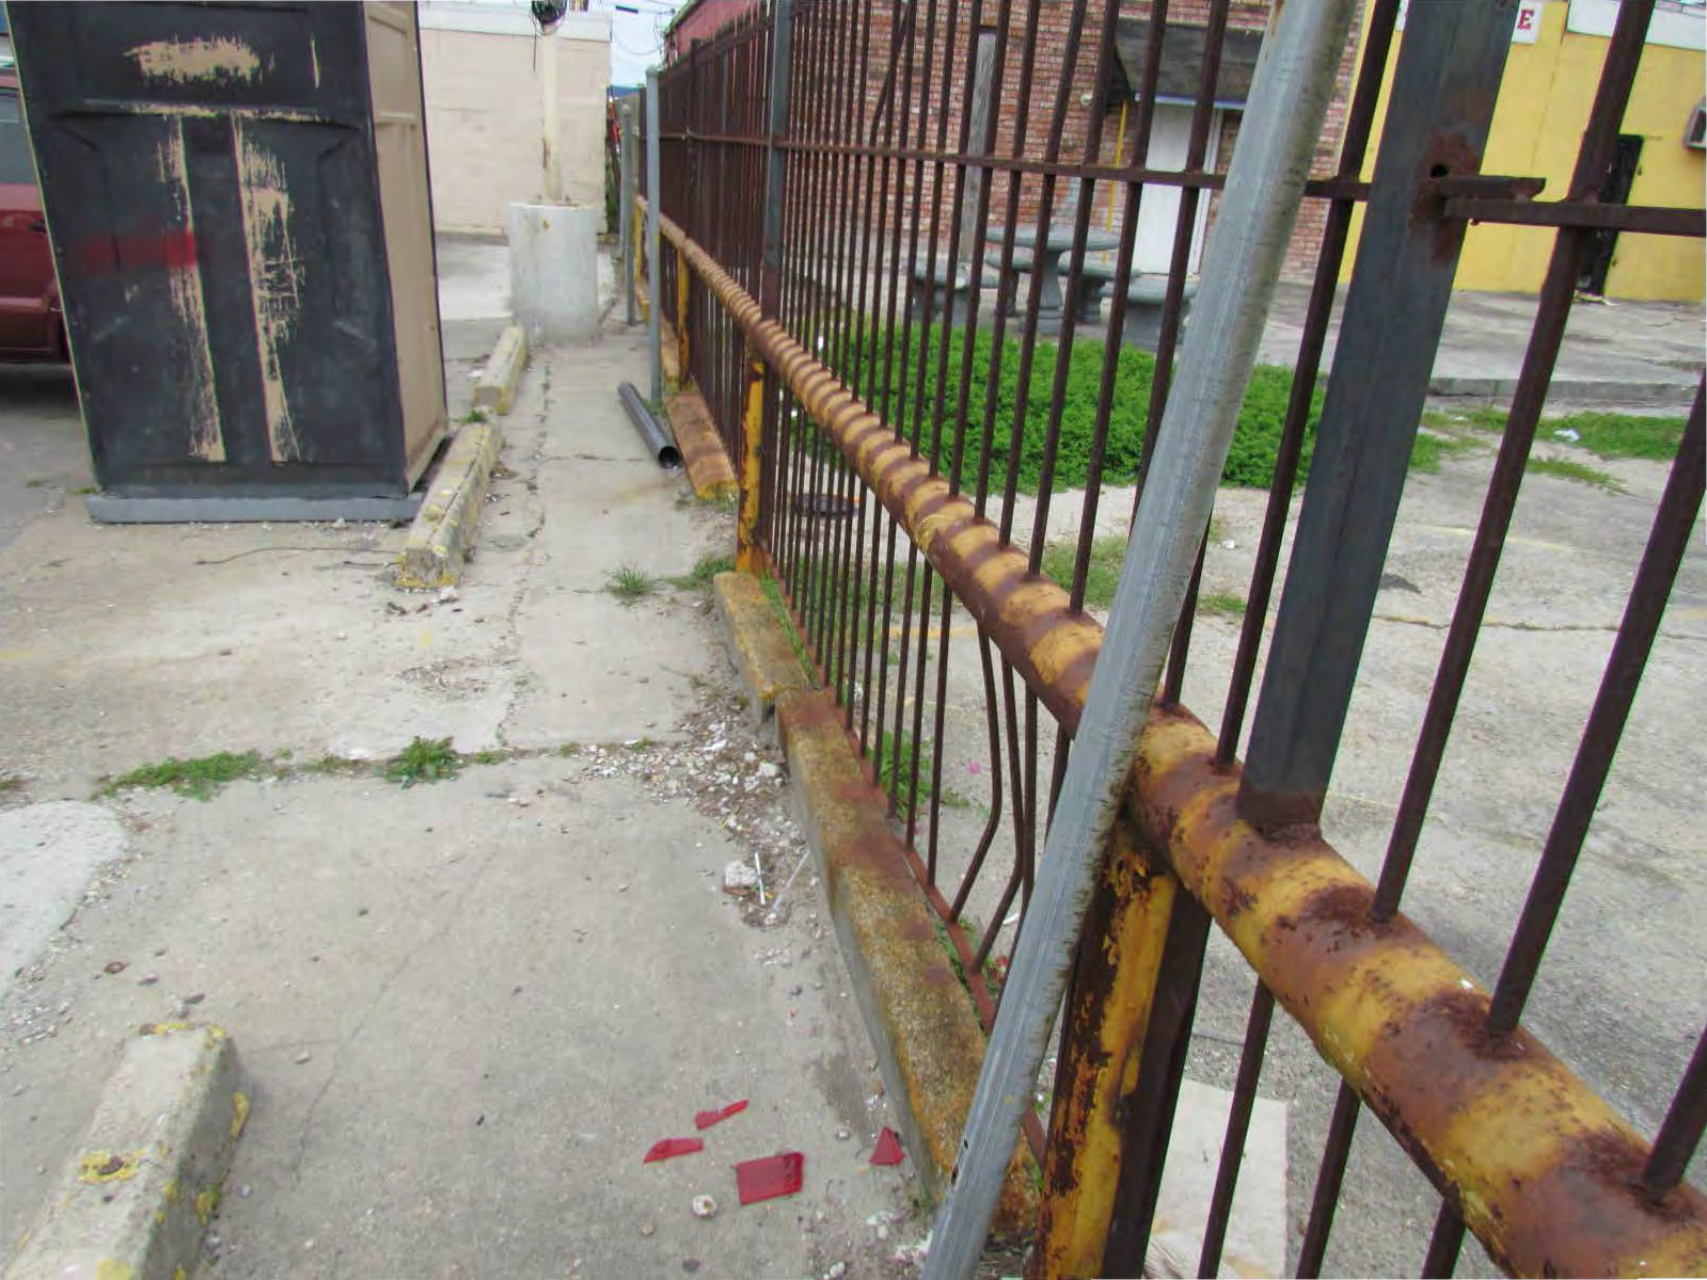
Mr. [REDACTED] and I are sitting in his vehicle, he is in the driver seat. I asked him to start the vehicle and we both tried to make the vehicle come out of Park. We could not duplicate the condition. The vehicle could only be made to come out of Park by pressing the service brake pedal and pressing the gear selector lever release button at the same time.

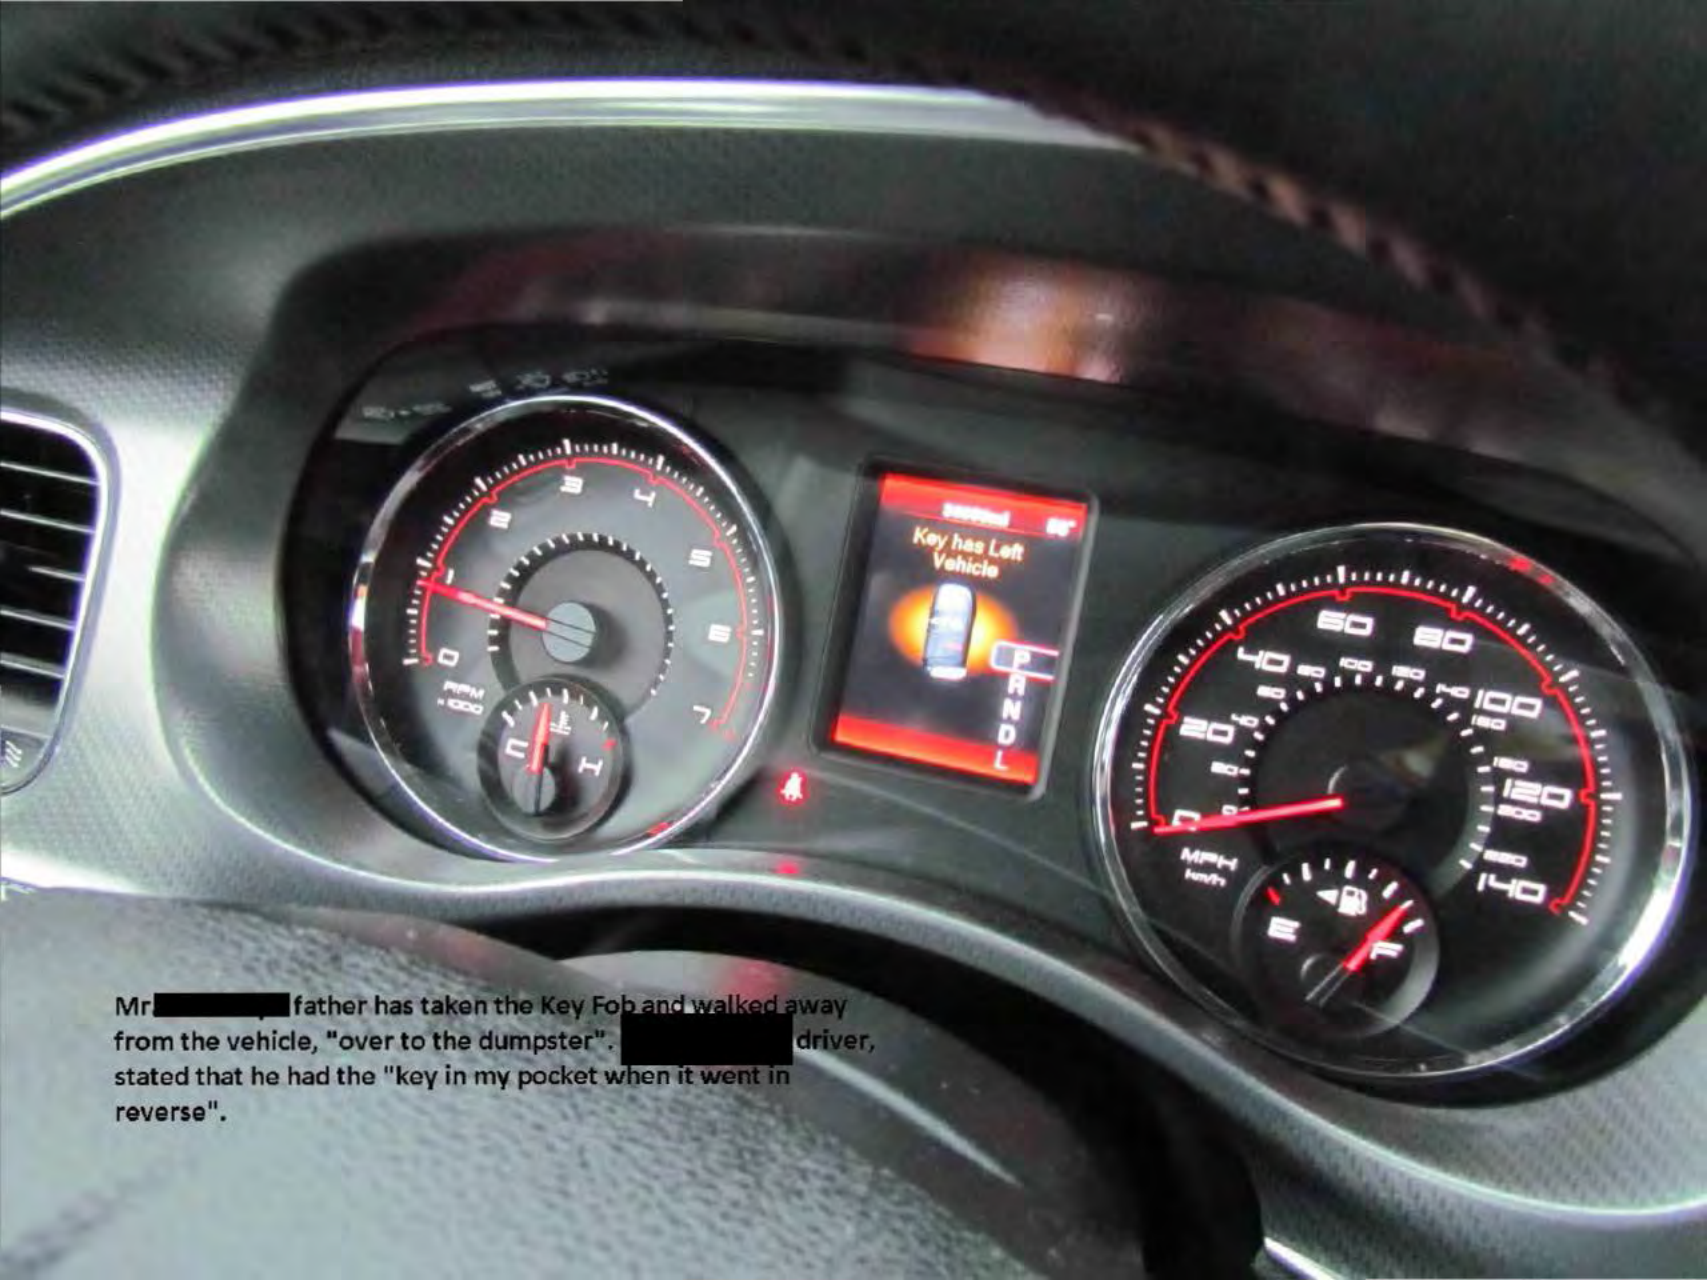
The vehicle has been shifted into Reverse and I asked Mr. [REDACTED] to release the service brake pedal. The vehicle did NOT move rearward, it sat stationary. The Parking brake was not applied, at this time.

Vehicle running in Reverse with no brakes applied, in the position where Parked at the Car Wash, vehicle not moving.

We waited for about one minute with the vehicle running in Reverse and the vehicle never moved. I attribute the lack of movement to the uneven surface the vehicle is Parked on in the car wash lot.
