EA16-002

FLAT CHRYSLER

ENCLOSURE 04

CAIR Backup

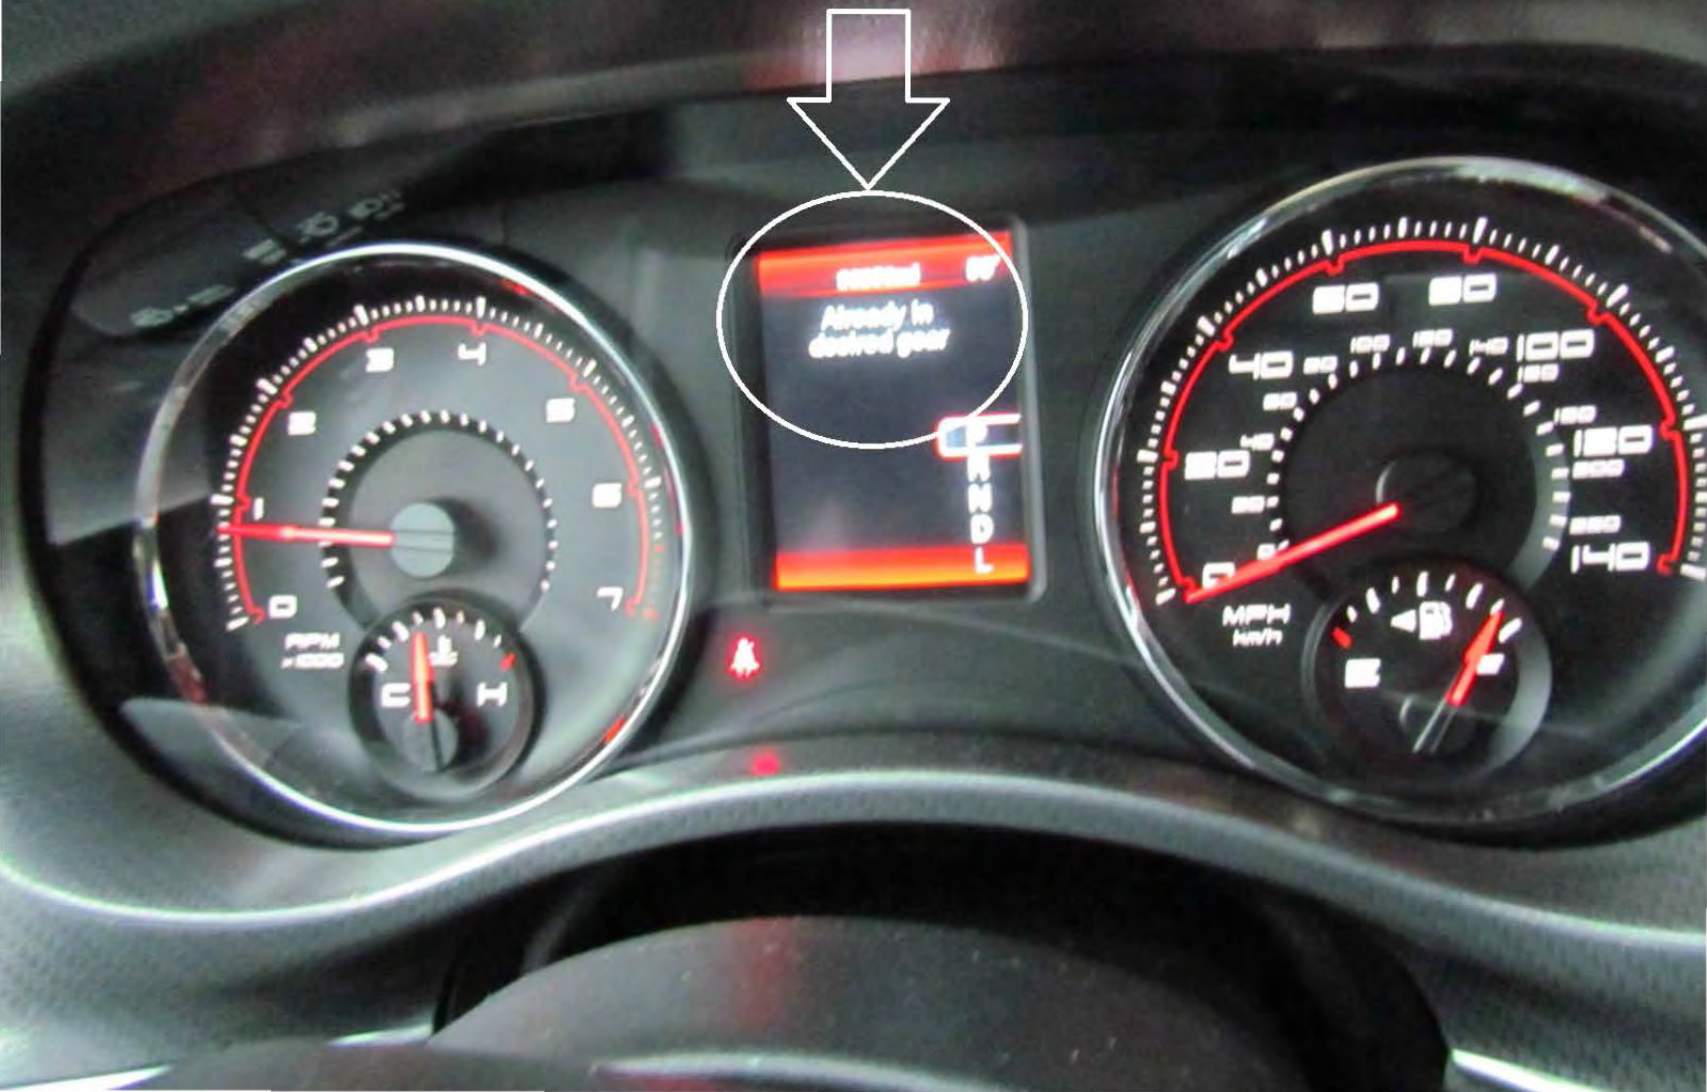
When attempting to shift out of Park without pressing the service brake pedal, this is the warning message displayed in the dash.
