PE16-008

FORD

Appendix G

Engineering Review

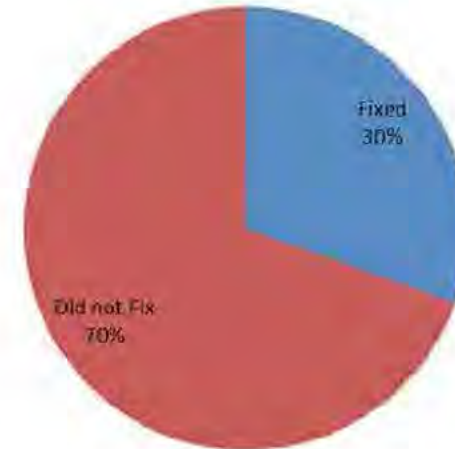
- All data provided by FCSD and is based on CQIS reports.
- According to CQIS reports provided – 23 Vehicles had the TSB actions.
- 7 vehicles showed elimination of the odor after the TSB actions were performed.
- 6 vehicles had the odor eliminated after extending the tail pipes 2". All 6 of these vehicles were located in the Middle East.

TSB Success Rate from FCSD Document 23 Claims for TSB

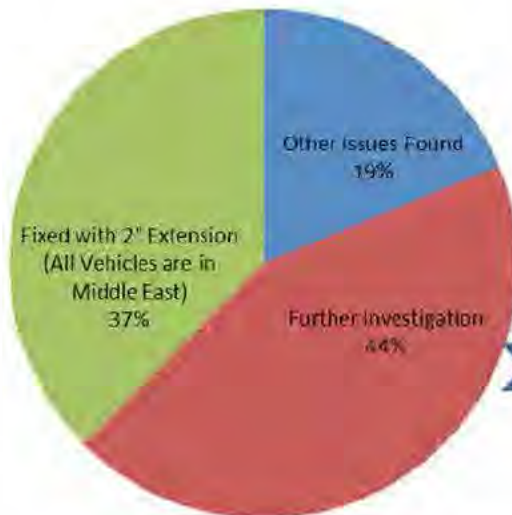
Breakdown of Vehicles Not Fixed with TSB Based on FCSD Document

- 6 - AWS indicates fix; but CQIS indicates it's still an issue
 - 3 vehicles from Middle East
 - 1 vehicle may have PTU leak but is under investigation. Odor on this vehicle is from vents and not from rear of vehicle.
 - 2 vehicle awaiting tech to verify TSB application.
- 1 - FSE cannot replicate the issue and customer insists it is still an issue. Complaint indicates that odor is much worse than typical.

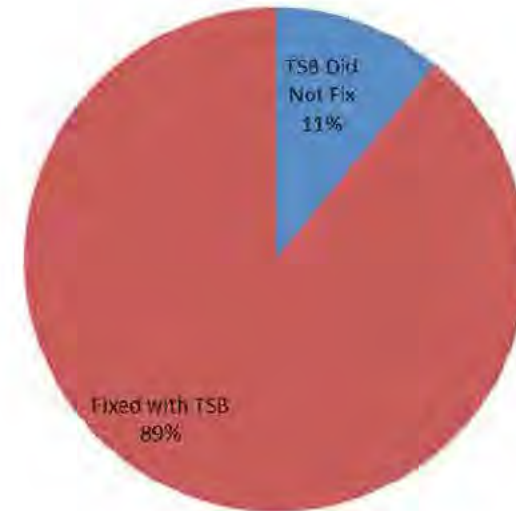
- AWS reports were run and these vehicles were added to those that were reported by FCSD.
- Duplicate VINS were removed.
- Overall – 183 vehicles had the TSB actions performed.
- 163 vehicles had odor eliminated after first attempt of TSB actions.
- Of the 20 remaining vehicles, 7 were found to have other issues that caused the odor. – Breakdown on next slide.

**All Vehicles with TSB Performed
AWS/CQIS**

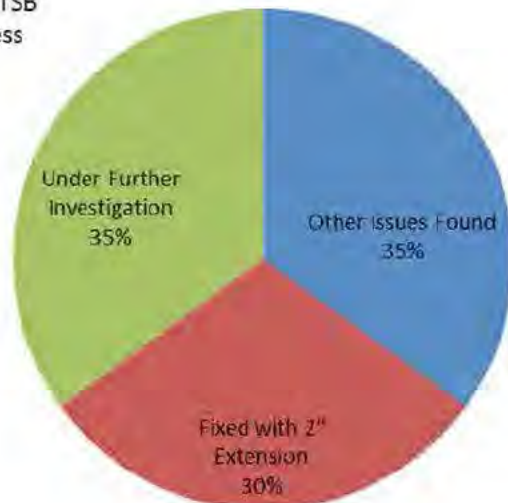
**Breakdown of All Vehicles Not Fixed With TSB
AWS/CQIS**

13 out of 183 = 7.1% TSB
Failure = 92.9% Success
Rate

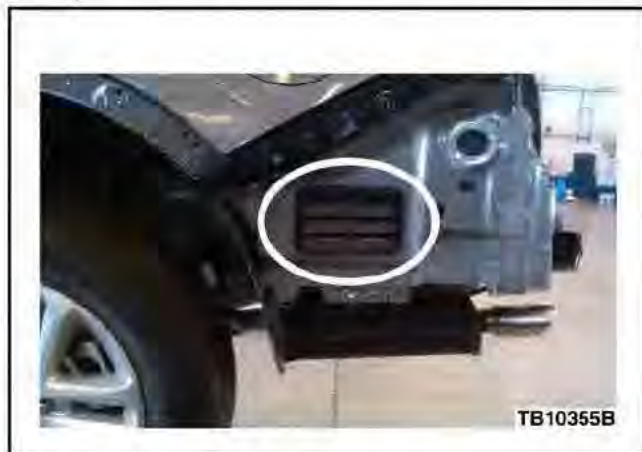
Figure 1 - Article 12-12-4

1. Remove the rear bumper cover. Refer to Workshop Manual (WSM), Section 501-19.
2. Replace the left side rear air extractor. (Figure 1)

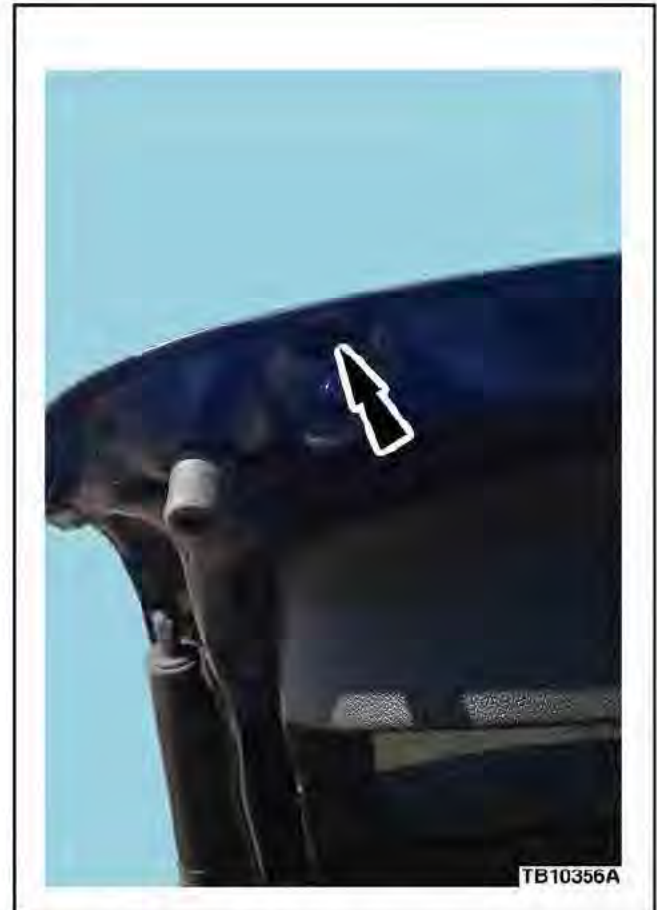
Figure 2 - Article 12-12-4

3. Open the liftgate and install a new drain valve in each of the two (2) drain holes on the left and right side of the liftgate. (Figure 2)

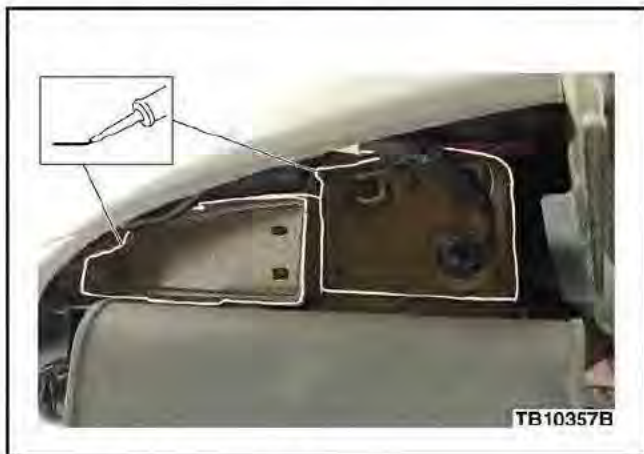
Figure 3 - Article 12-12-4

4. Raise vehicle on hoist. Refer to WSM, Section 100-02.
5. Lower and support rear section of the exhaust system.
6. Clean areas on underside of vehicle where seam sealer will be applied. (Figures 3-5)

7. Cover exhaust system and auxiliary climate control drain.
8. Apply generous amount of Motorcraft® Seam Sealer to rear horizontal sheet metal lap joints on left and right sides of the vehicle, and the rear sheet metal overlap flange across the rear of the vehicle. (Figures 3-5)

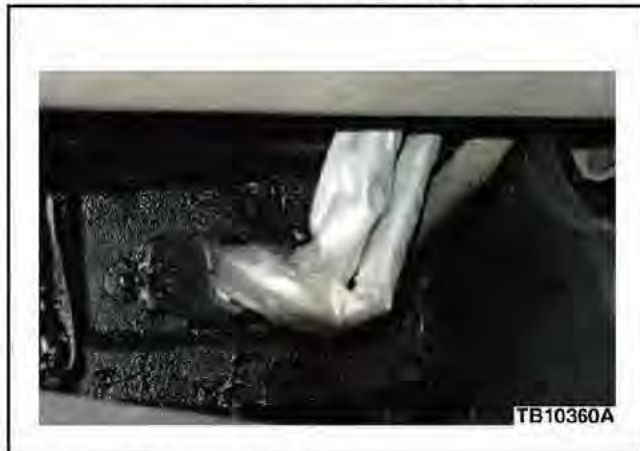
Figure 6 - Article 12-12-4

9. Spray generous amount of 3M™ Rubberized Undercoating around auxiliary air conditioning lines and seam sealer areas. (Figure 6)

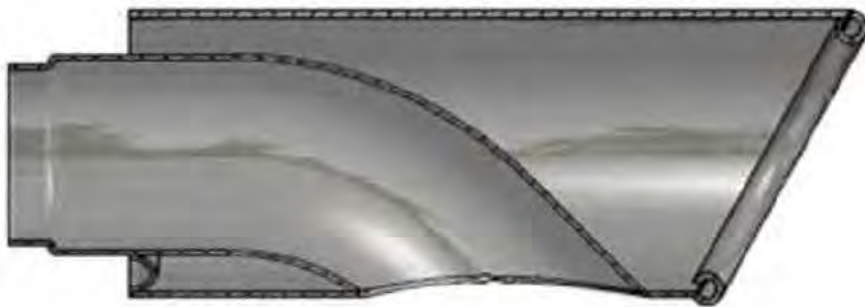
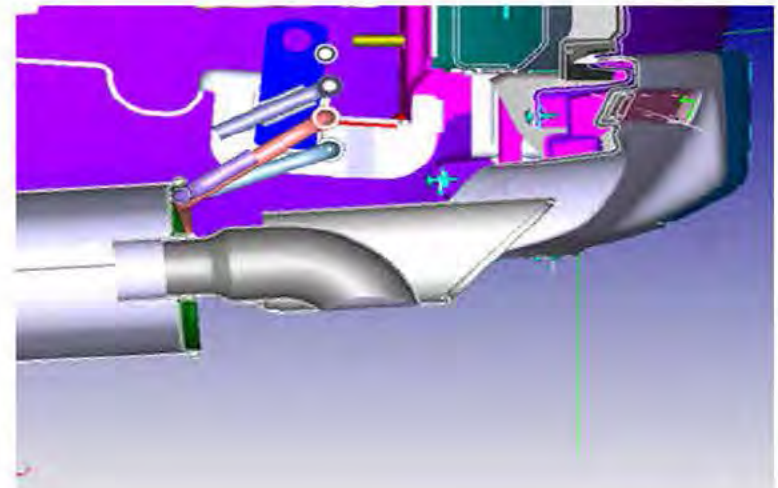
- Service TSB 14-16-NA release: Oct. 2014
 - TSB Actions:
 - Involves cut/weld local sourced downturn exhaust tip

- Next TSB release: May 2015
 - TSB Actions:
 - Involves cut/weld Tier1 sourced downturn exhaust tip
