Re: **EA16-001**  
**NEF-106kmb**

On behalf of the Volvo Group, I am responding to the questions in your letter dated August 9, 2017.

### Refuse Vehicle (#1052)

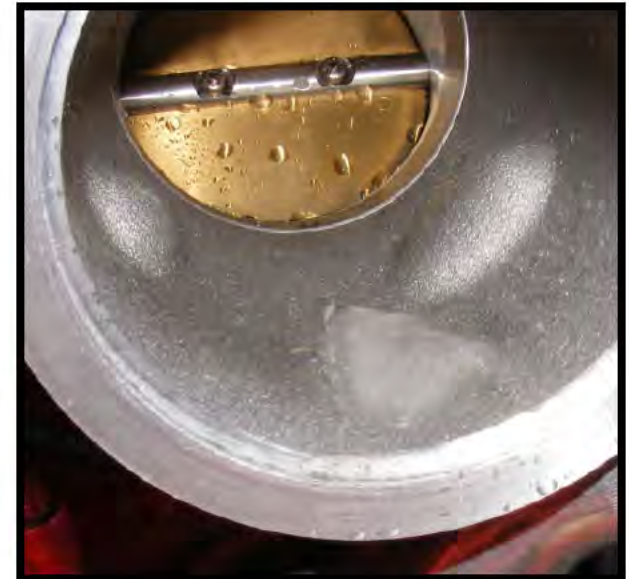
## Fault Codes 2758 & 2759

- Issue
  - Faults are caused by ice forming on and around the throttle plate
  - Moisture from charge air cooler (CAC) is forming the ice
- Solution
  - Block air flow across CAC using winter front or similar device
  - Warm intake air ahead of CAC

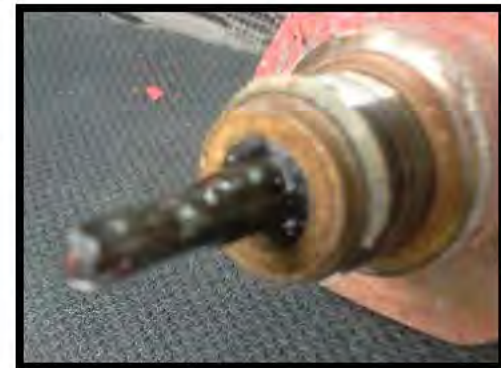
# Frozen Intake Manifold Pressure / Temperature Sensor Fault Codes 124 & 125

- Condensation collects on sensor and freezes while engine is not running
- Intake manifold pressure sensor is failed low (in range) and the ECM calculates low air flow
- Causes low power and fault codes

- Replace sensor or dry current sensor
- Block air flow across CAC using winter front or similar device
- Supply warm intake air ahead of CAC
- Prevent sensor freezing using a heater if parked over night
- Remove sensor from engine if heater not available

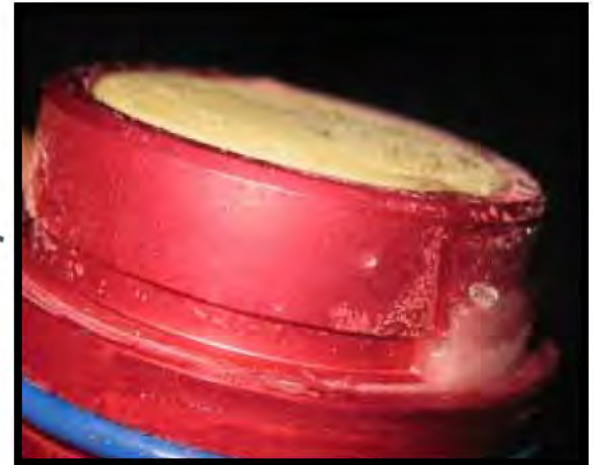
- Condensation from air flow collects in low pressure regulator and freezes
- Regulator can not adjust fuel pressure

- Block air flow across CAC using winter front or similar device
- Warm intake air ahead of CAC

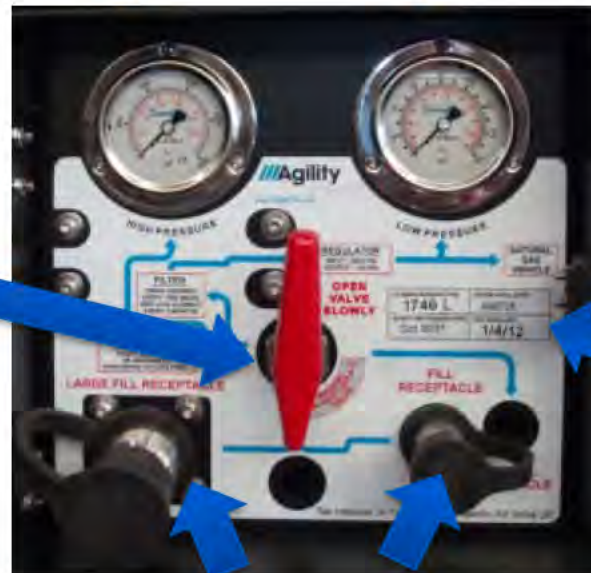
## ¼ turn Main Shut Off Valve

- Isolates components downstream including those enclosed inside the Fuel Management Module to manually shut off fuel supply to the engine and filter/regulator assembly components.

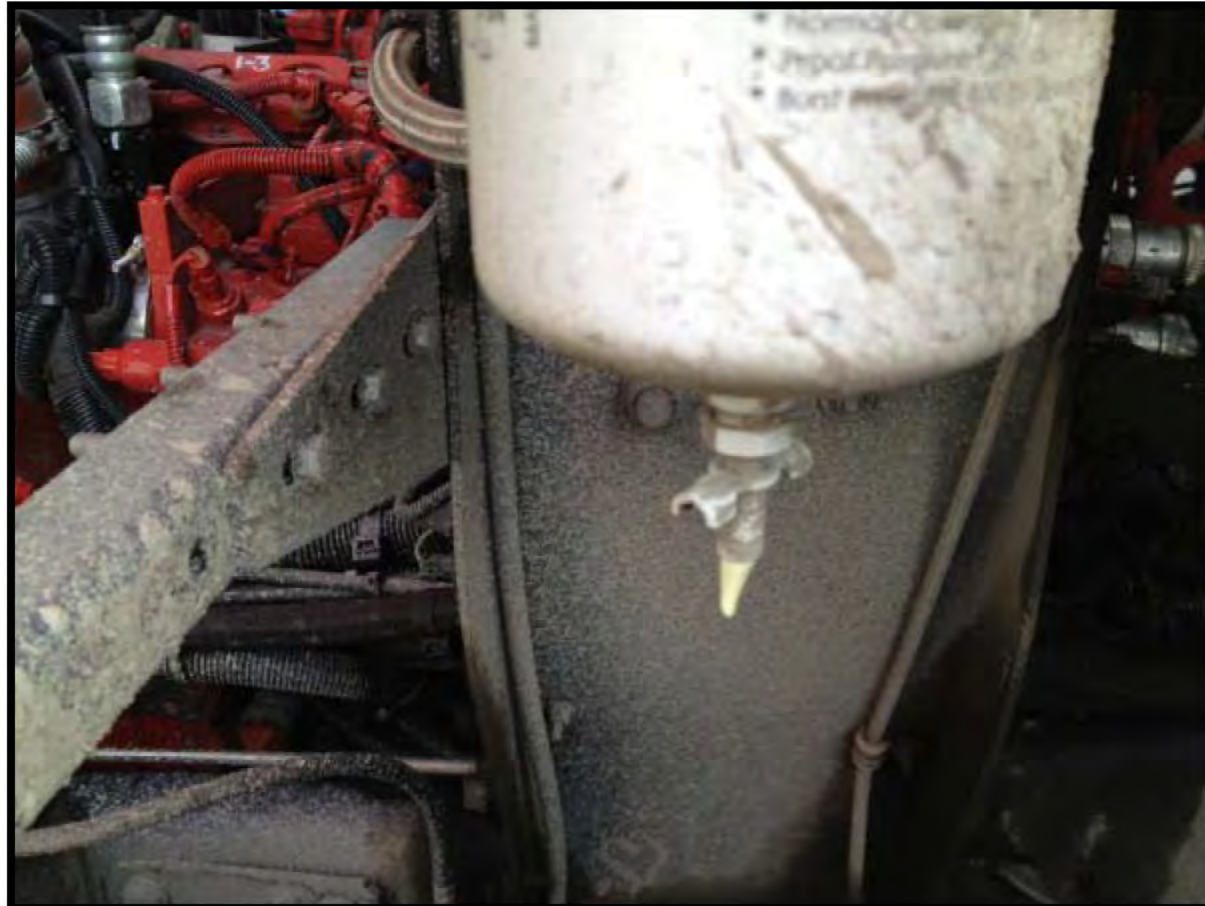
# Fuel Filter Draining Oil

- **No more than one ounce of oil in the fuel filter**

- Dry fuel is an important consideration for cold weather operation.
- **Water/oil captured in fuel filter can freeze and affect engine performance.**
- CNG filling stations should include a dryer to remove moisture from the natural gas.
- If daily fuel filter check drain reveals more than 1 ounce of water/oil, contact your fuel station provider.
