**NHTSA Safety Recall 17V-108**

**SUBJECT: Campaign #144 – LP Hose**

## INSTRUCTIONS TO PERFORM RECALL CAMPAIGN 144

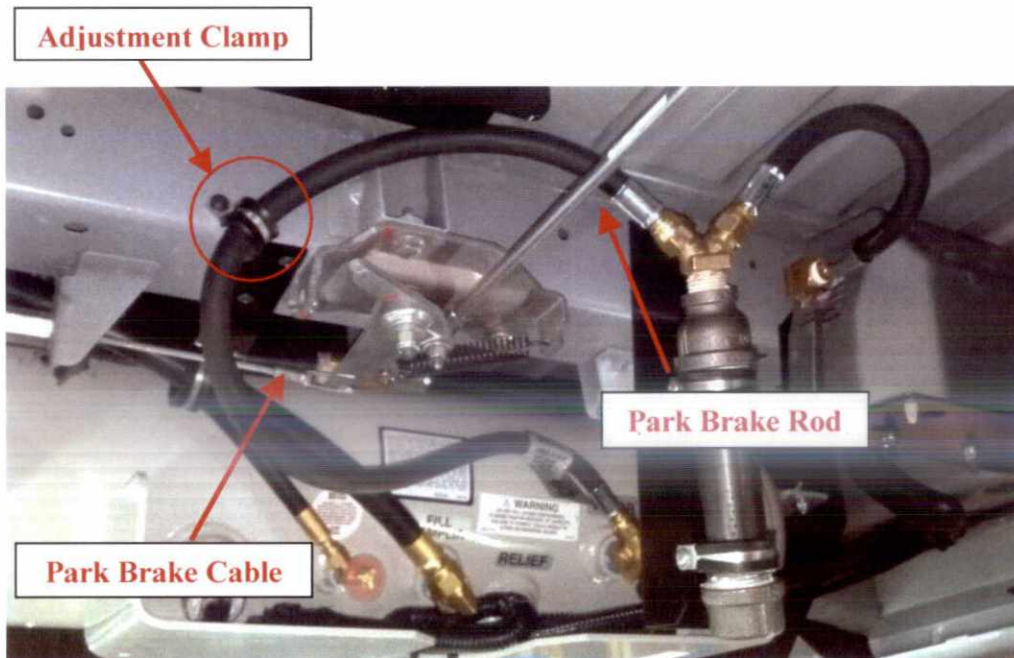
- Ensure there is adequate clearance between the park brake rod and park brake cable.

1. Visually inspect the LP hose for clearance. If adjustment is needed, loosen the adjustment clamp and move LP hose to ensure the hose is not coming in contact with the park brake rod and park brake cable. The hose should not touch anything other than the rubberized clamp.
2. Replace the LP hose if any damage is noticed. Contact Part Sales at 1-800-556-9670 to order a replacement LP hose.
