## **Introductory Remarks**

This letter represents an initial and partial response to the Information Request dated May 28, 2020 in relation to the above-captioned investigation on behalf of Volkswagen Group of America and Volkswagen AG (collectively referred to herein as “Volkswagen” or “VW”). We note that while the agency upgraded the investigation on July 3, 2018, after Volkswagen’s response to the Information Request associated with the Preliminary Evaluation, Volkswagen believed in good faith that ODI was reviewing and considering the information previously provided, as well as Volkswagen’s conclusion that the separation of the seat belt webbing that occurred in the \*MY 2018 NCAP tests was an artifact of the way in which the ADT cable was routed and does not reflect a potential unreasonable risk to motor vehicle safety in the real world. ODI reached out to VW in May 2020, met with the company on May 28, and issued the current Information Request that same day. Volkswagen has endeavored to provide as much information as possible at this time. Volkswagen will provide more complete information according to the dates agreed to with ODI and will, beyond that, supplement its respo

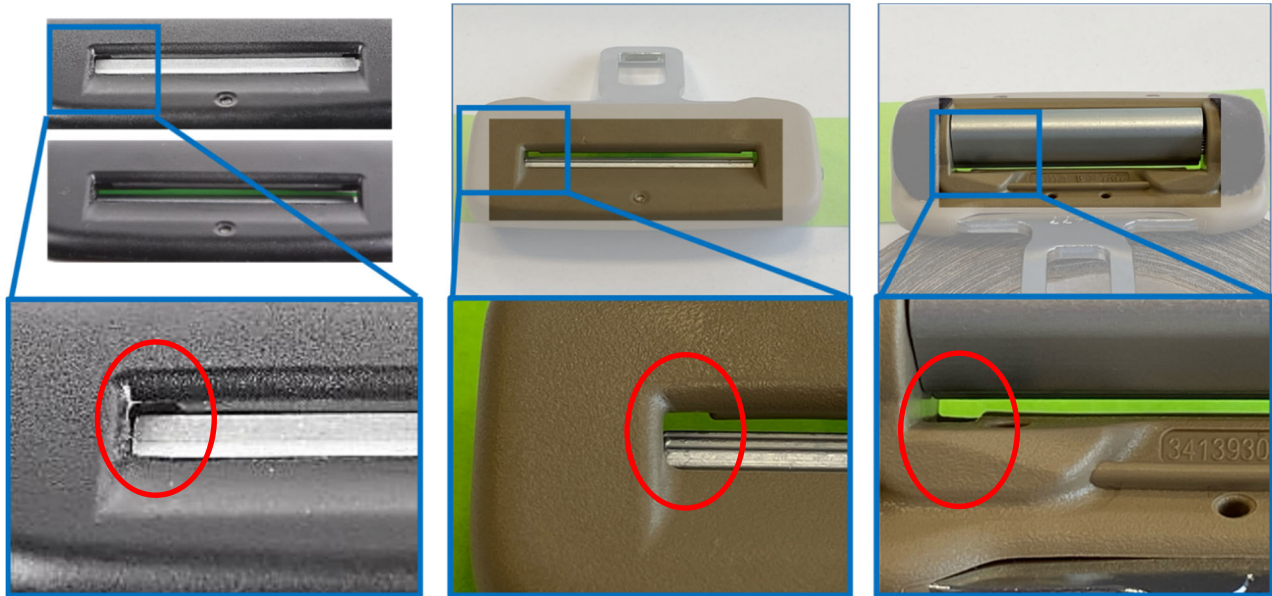
In the pictures below, when viewed from a different angle, the notches can be observed. The picture on the left was shared by NHTSA during the May, 28, 2020 meeting; corresponding photographs (middle, right) are provided of an exemplar replacement DLT-1 from ZF-TRW (for F-150 MY 2018) and the backside of the same exemplar, as well as magnifications of the notches.

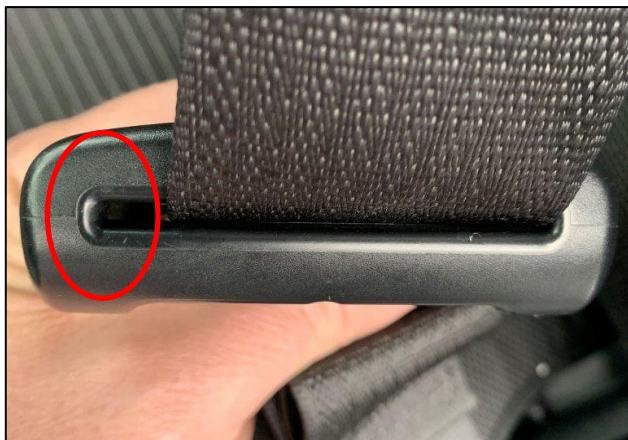
Figure 1. Autoliv CLT-R (original design)

VW understands ODI's concern about a less than complete clamping width to be that such a design could potentially provide more room for the webbing to bunch, thus increasing the potential for bunching. By providing the webbing with more space for insertion (reducing the clamp width, recesses in the housing), the design helps to reduce the load path concentrations.

The analysis of CLTs that are available in the market also indicate that Autoliv incorporated a wider opening at the outer side of the webbing slot, as can be seen in Figure 1 and Figure 2. (Which is used, for example, in GM, Daimler, FCA, BMW, Ford, Nissan, Subaru and Tesla vehicles of recent MYs.)

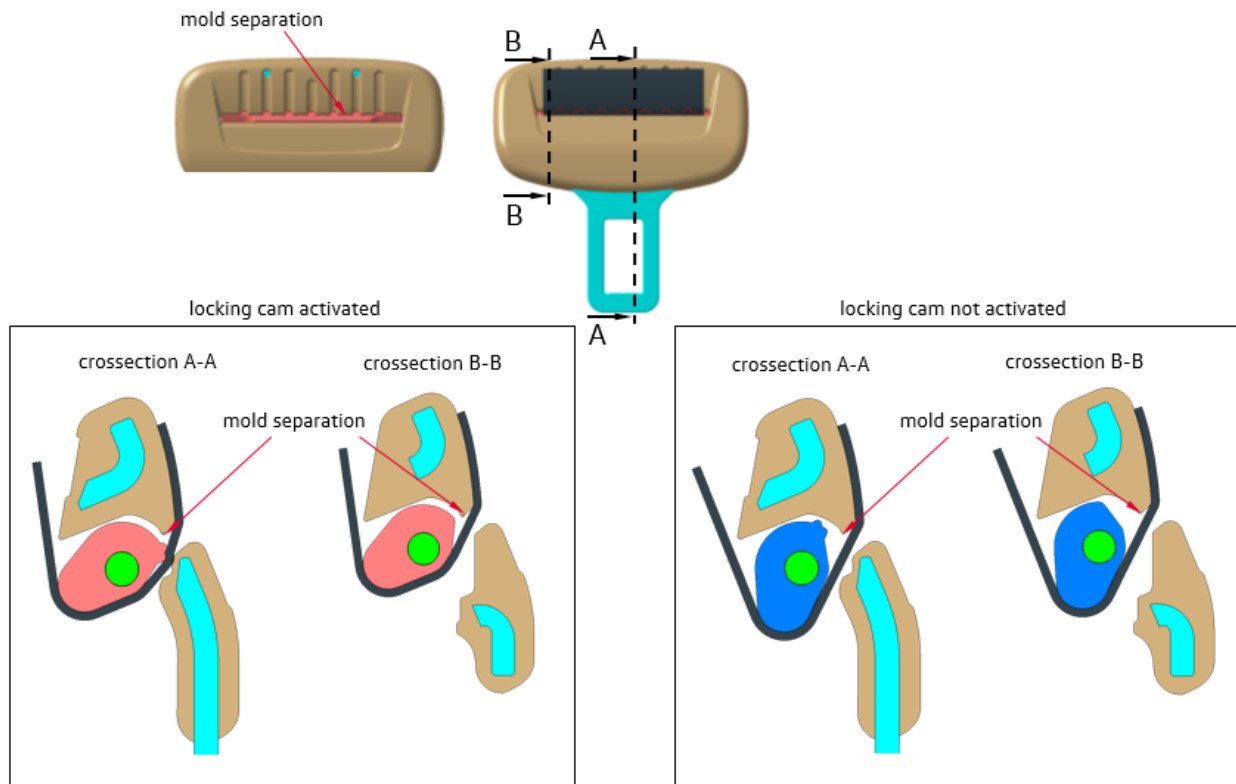
ODI observed that the separation line (ridge) from the molding tools of the VW DLT-1 provides a sharp edge which may have cut the webbing during the NCAP crashes. The webbing does not touch the mold separation ridge in any of the cam positions and the separation line is not a factor in belt performance:

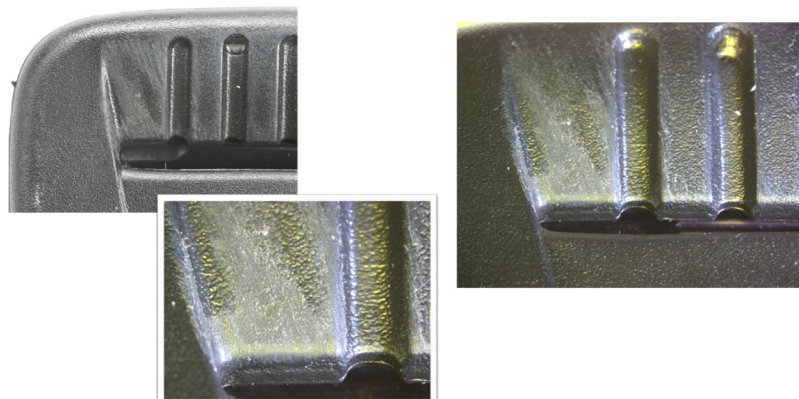
The polymer housing is not strong enough to damage the webbing. Photos from NHTSA's NCAP tests show abrasion and deformation on the working surface of the VW DLT-1 housing, not at the ridge.

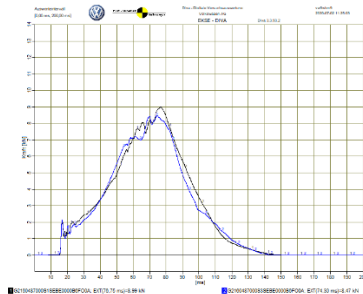
During this test there was no webbing damage or "bunching" (see figure 02). However, the pelvic forces were relatively low for an overload test (see figure 01: SP1: 8.99 kN / SP3: 8.47 kN), which does not meet the requirements of a worst case scenario. The pelvic force is an indicator of the load that has occurred on the belt system. Accordingly, it was decided to repeat the test with a synthetic pulse in order to put more strain on the belt system with increased load.

Figure 01: Pelvic forces < 10kN

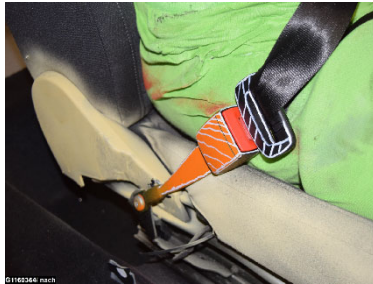
With the partially flexible buckle stalks, there was only minor "bunching" of the webbing on both seats. However, there was no damage observed to the belt system, including the seat belt webbing (see figures 03 and 04).

Figure 03: Belt position driver's side, minor bunching

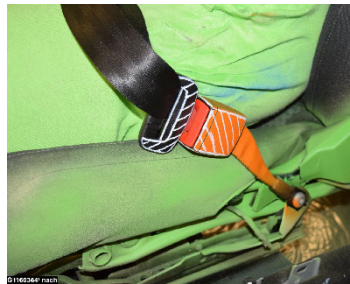
Figure 04: Seat belt position passenger side, minor bunching

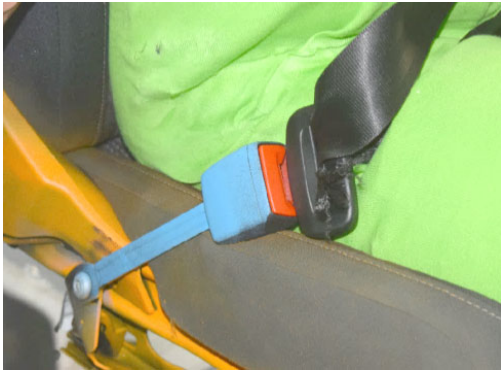
In this repeat test with solid buckle stalks, lap forces of 9.9 kN (driver's side [SP1]) and 10.58 kN (passenger side [SP3]) were achieved (similar to test #3). The test ended with damage to the belt on the driver's side. The webbing bunched into the upper end of the latch plate (see figure 06).

Figure 06: Strap position driver side, light bunching, Damage to the belt strap in the front area

In the end, the solid buckle stalks for the Tiguan LWB were not implemented.

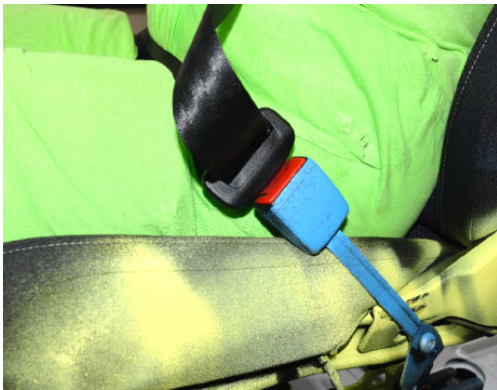
Figure 07: Seat belt position passenger side
