PE18-012

GM

SPRINNER DEALER PHOTO LOG

SPINNER DEALER INSPECTION PHOTOS

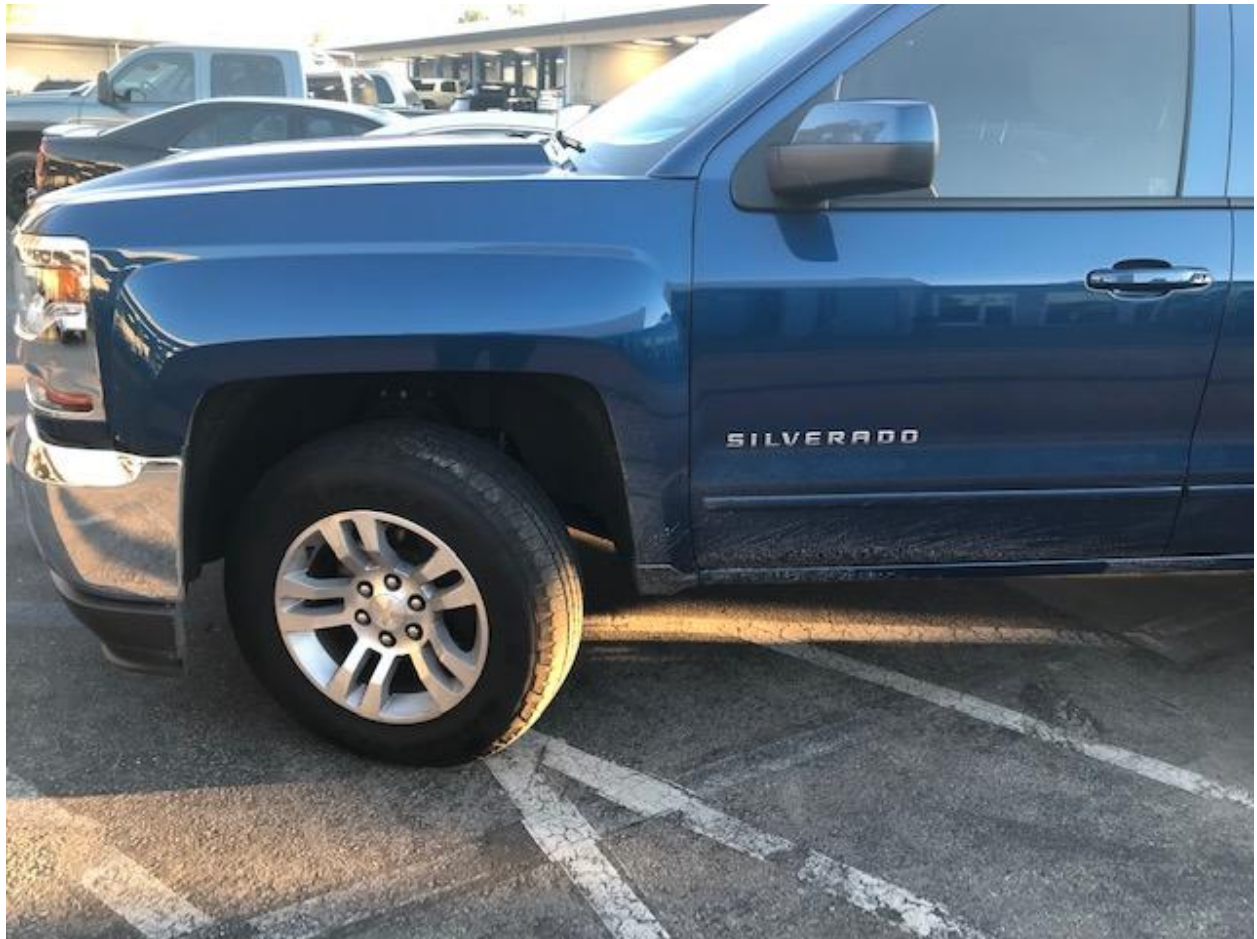
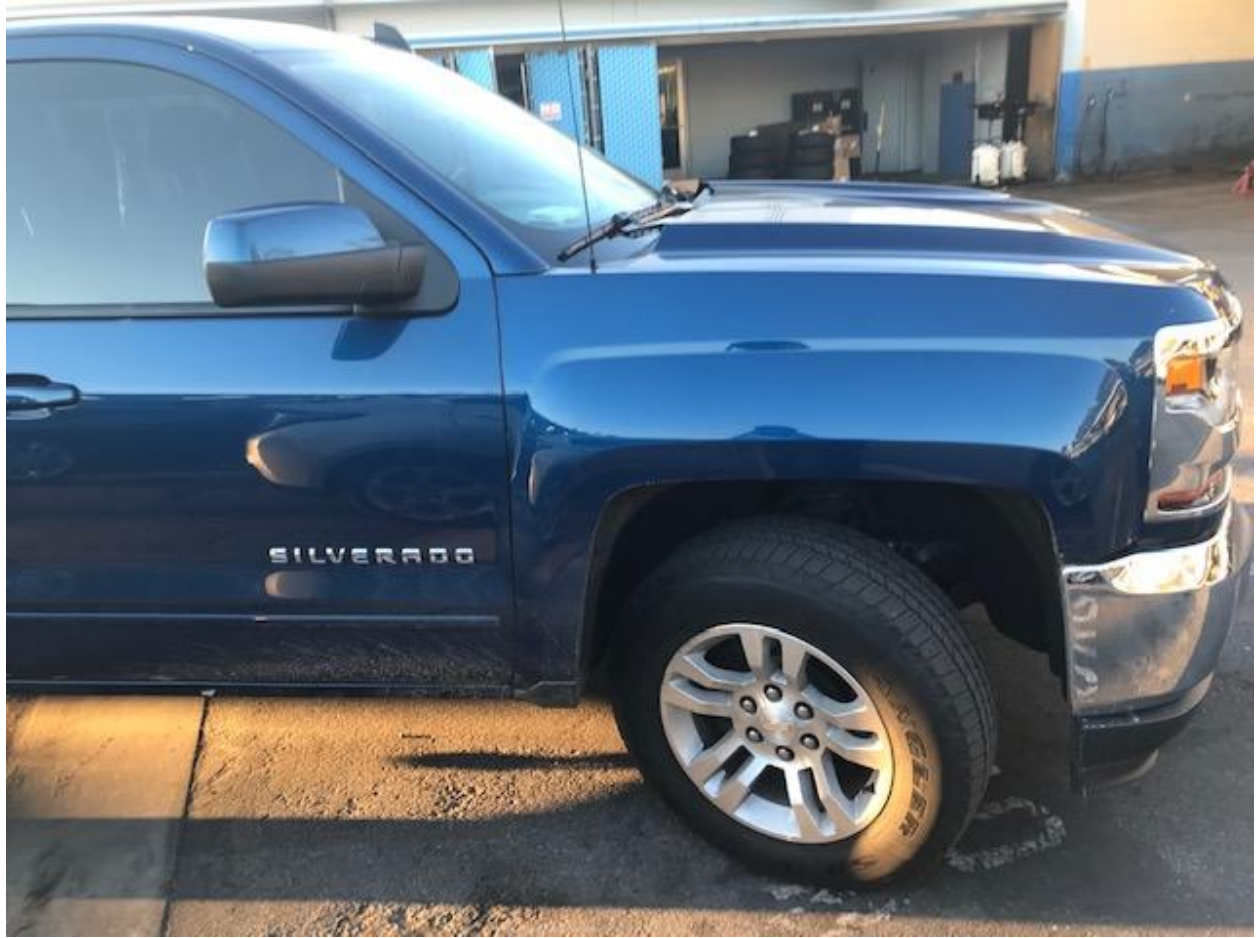
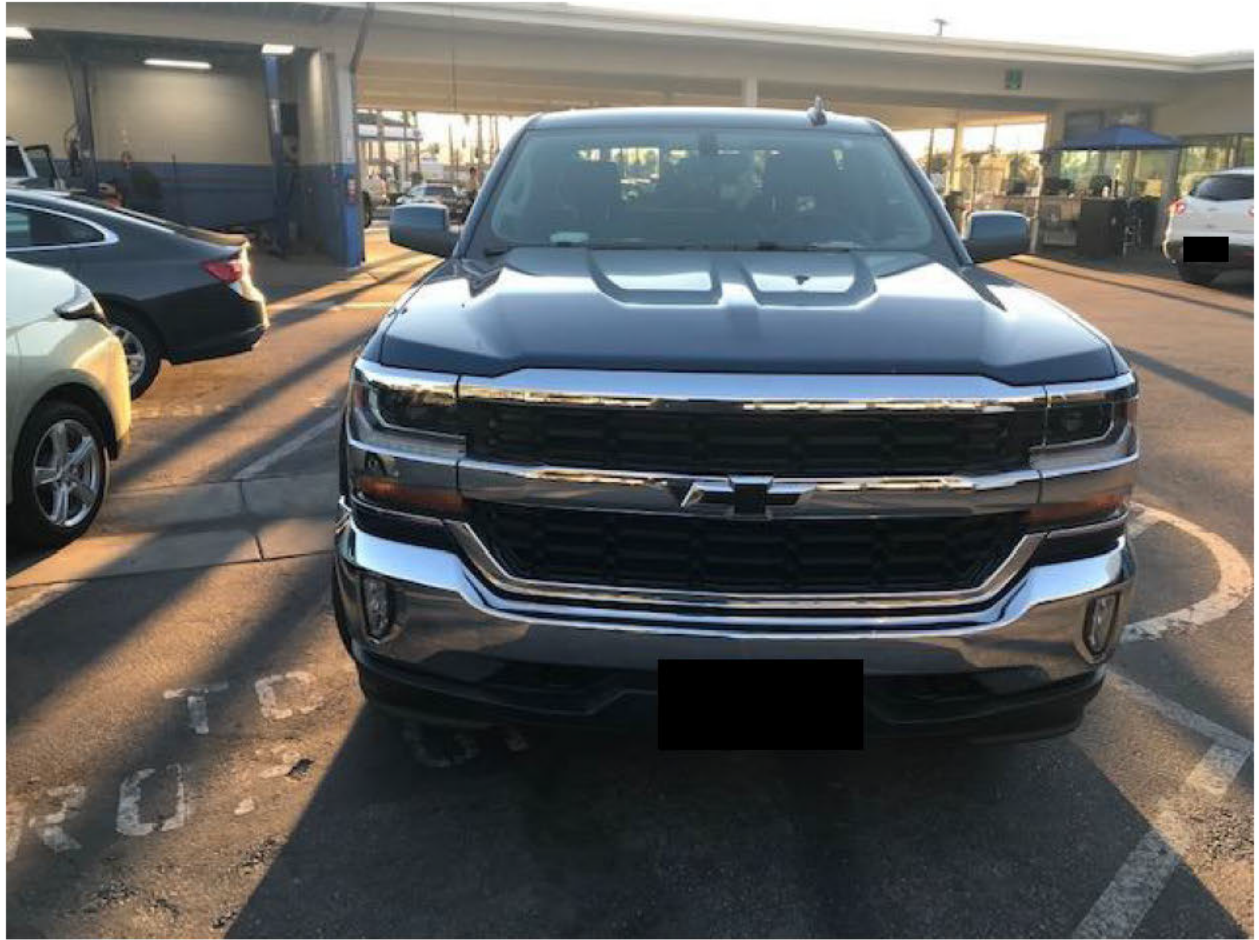
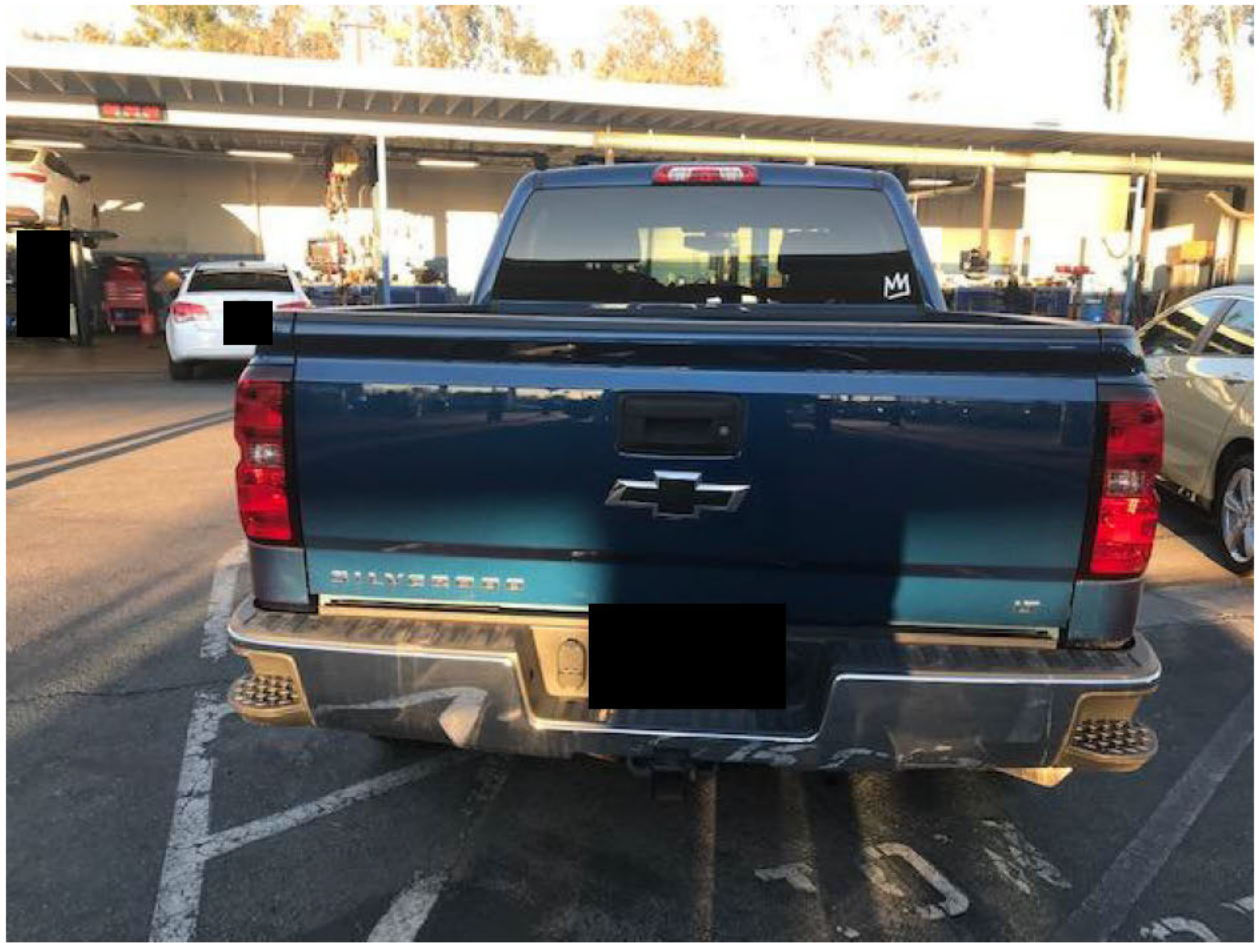
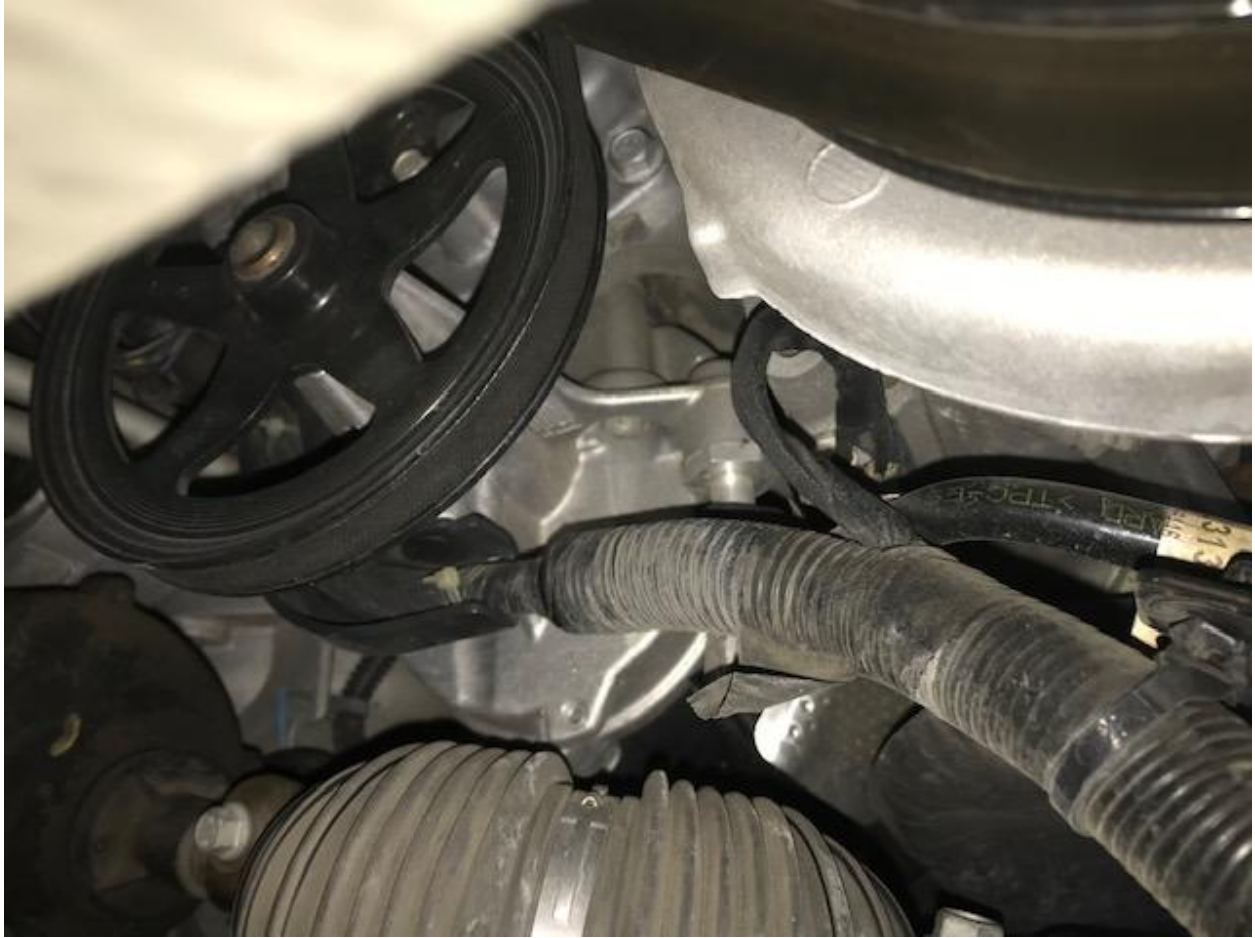
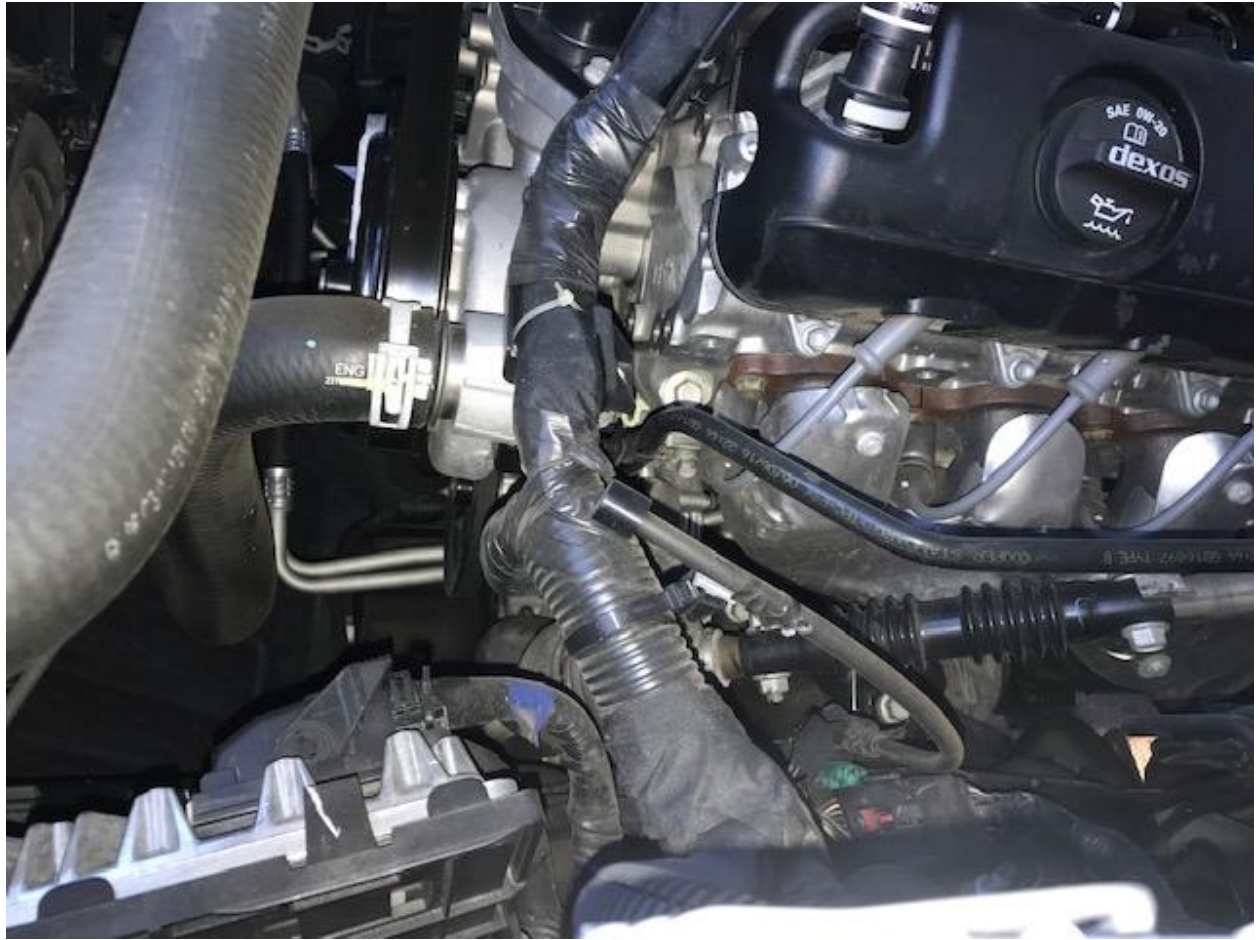
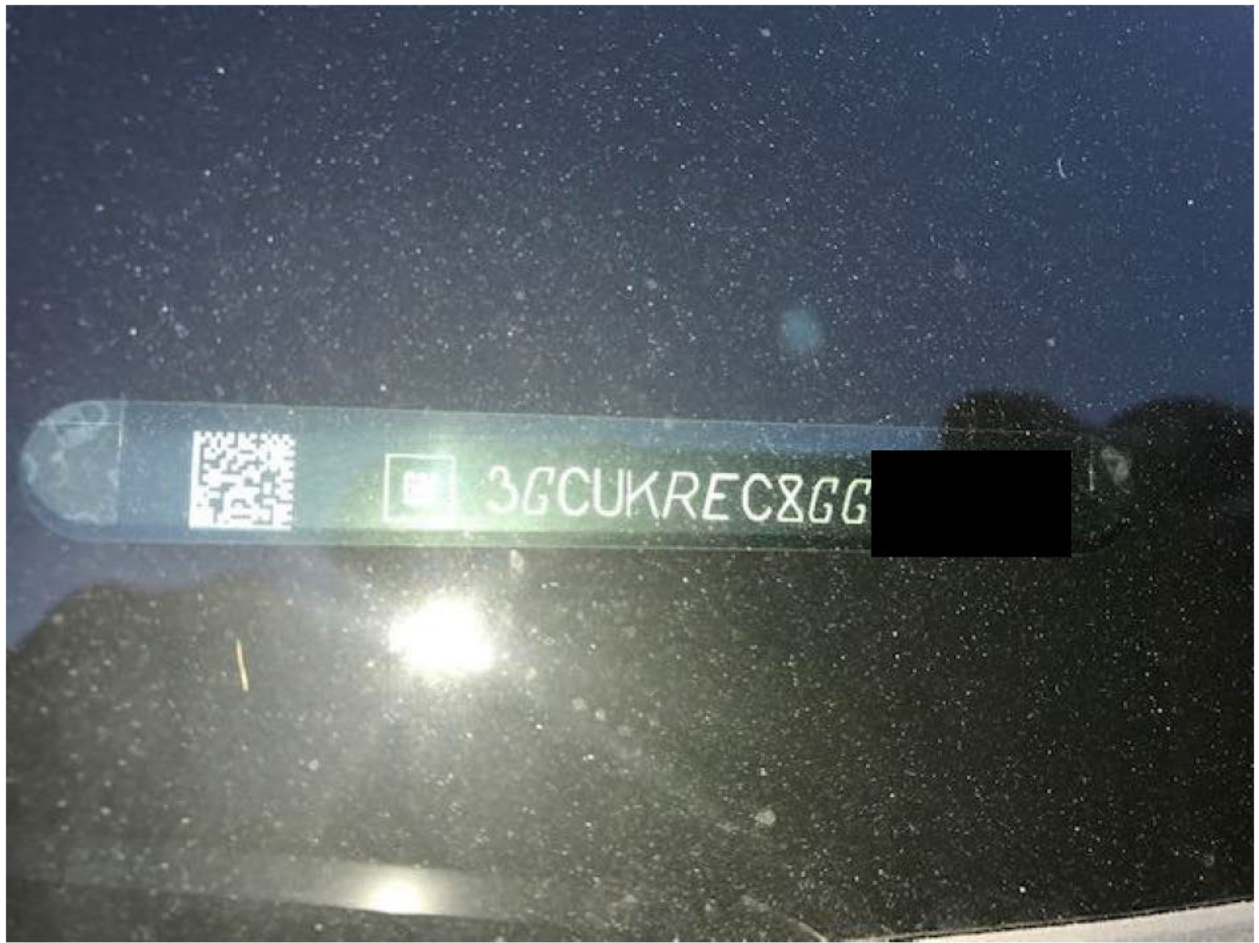
Monitor Brake Booster Pressure Sensor Found When Braking Felt Loose of Brake Assist. Brake Booster Vacuum sensor -0.9 PSI

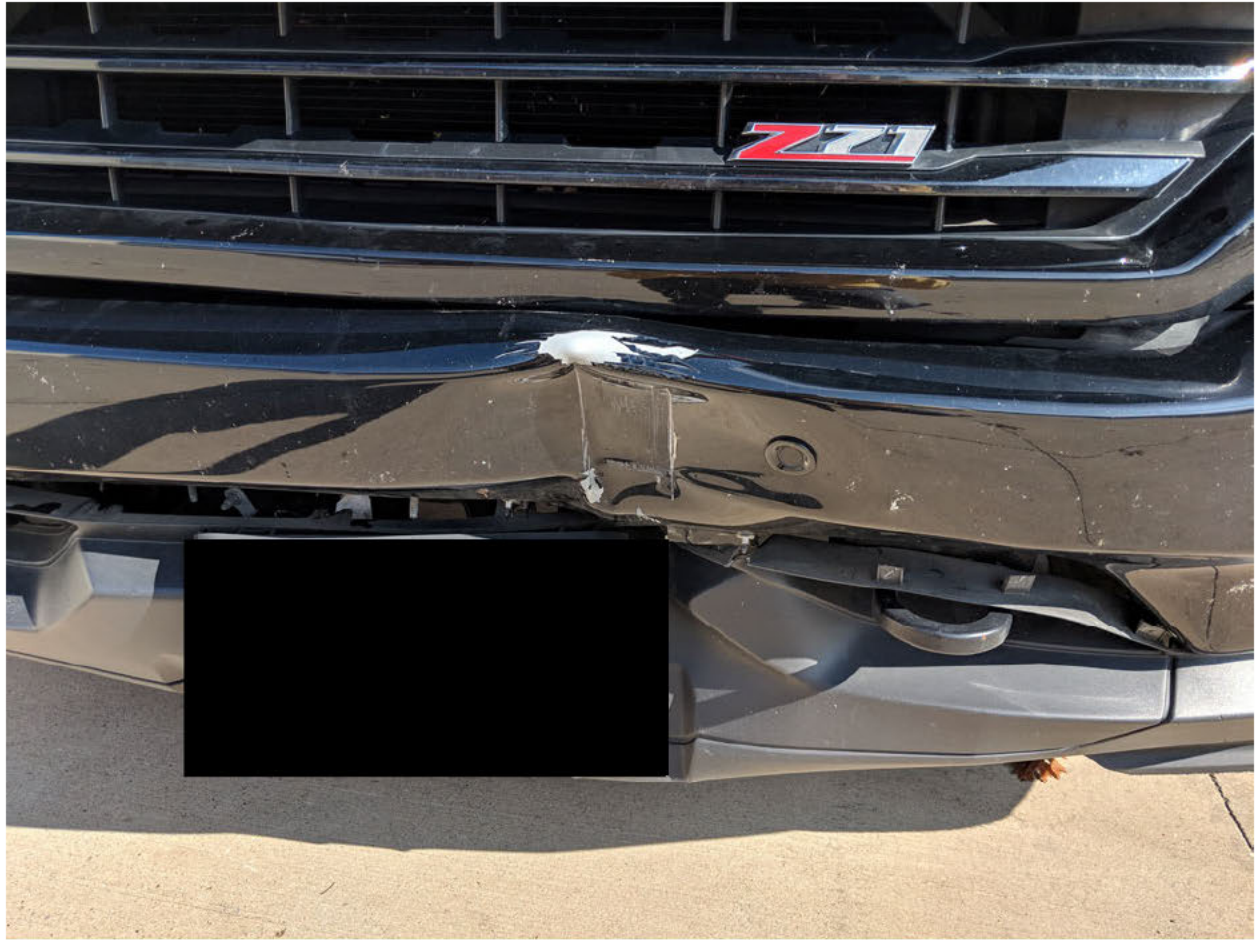
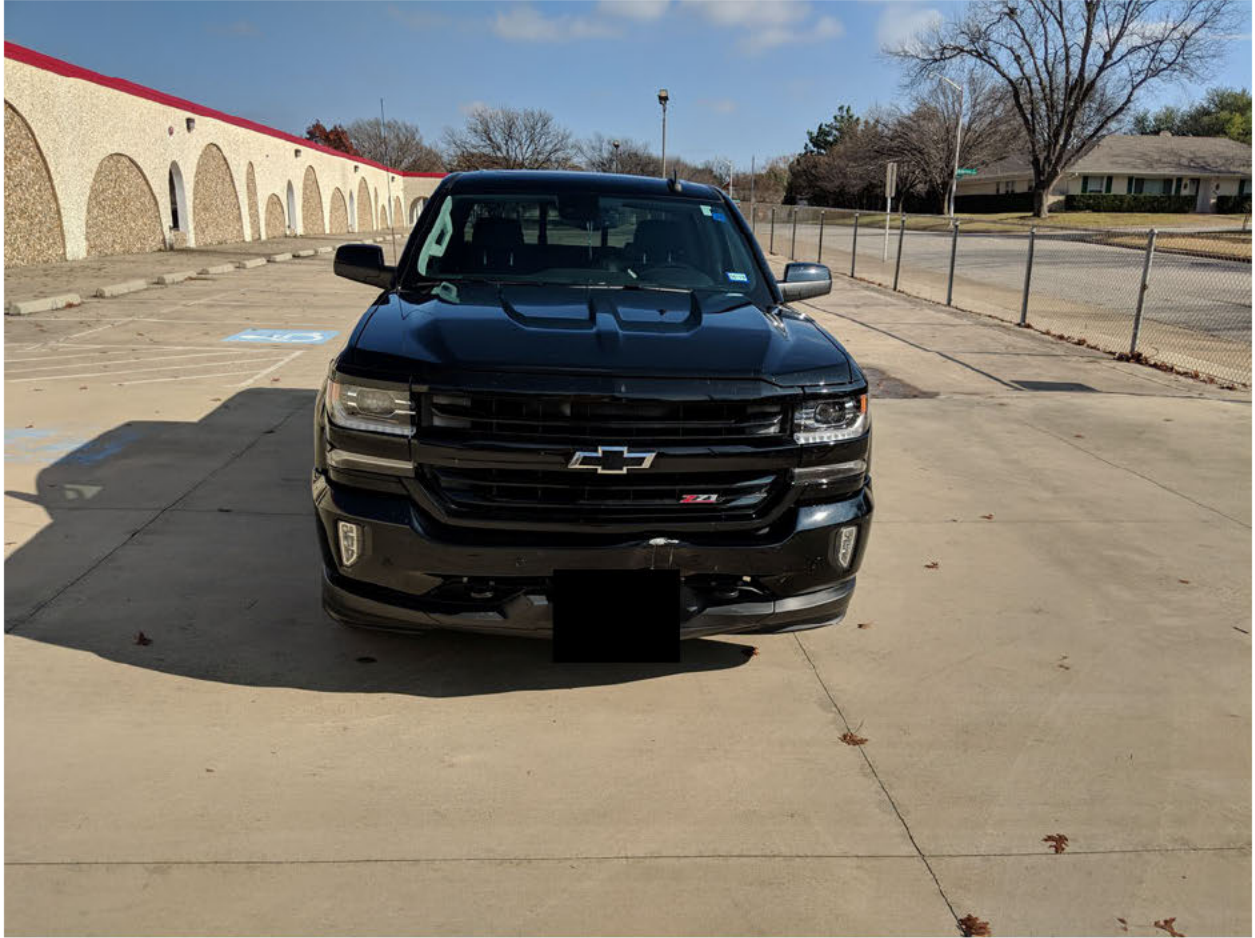
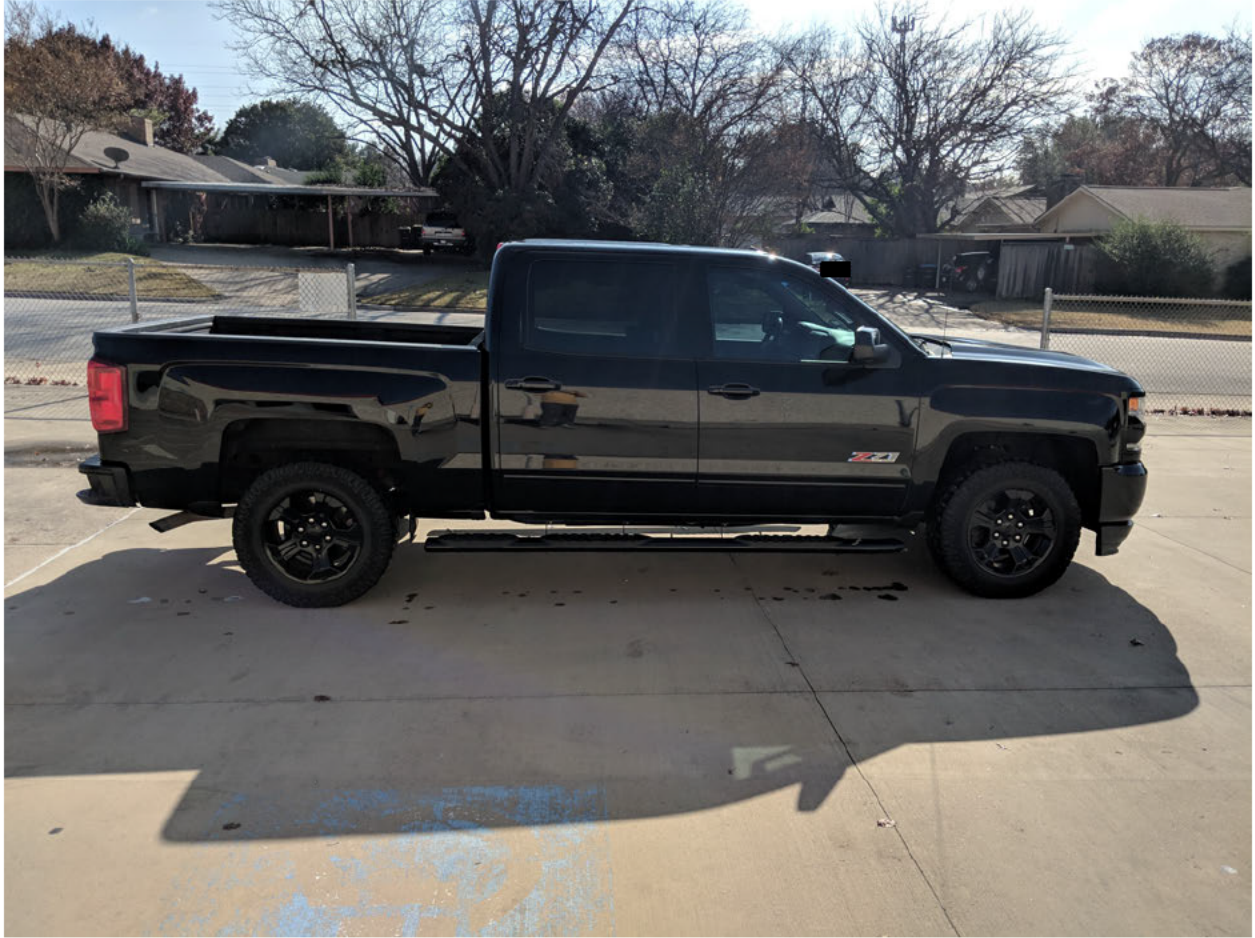
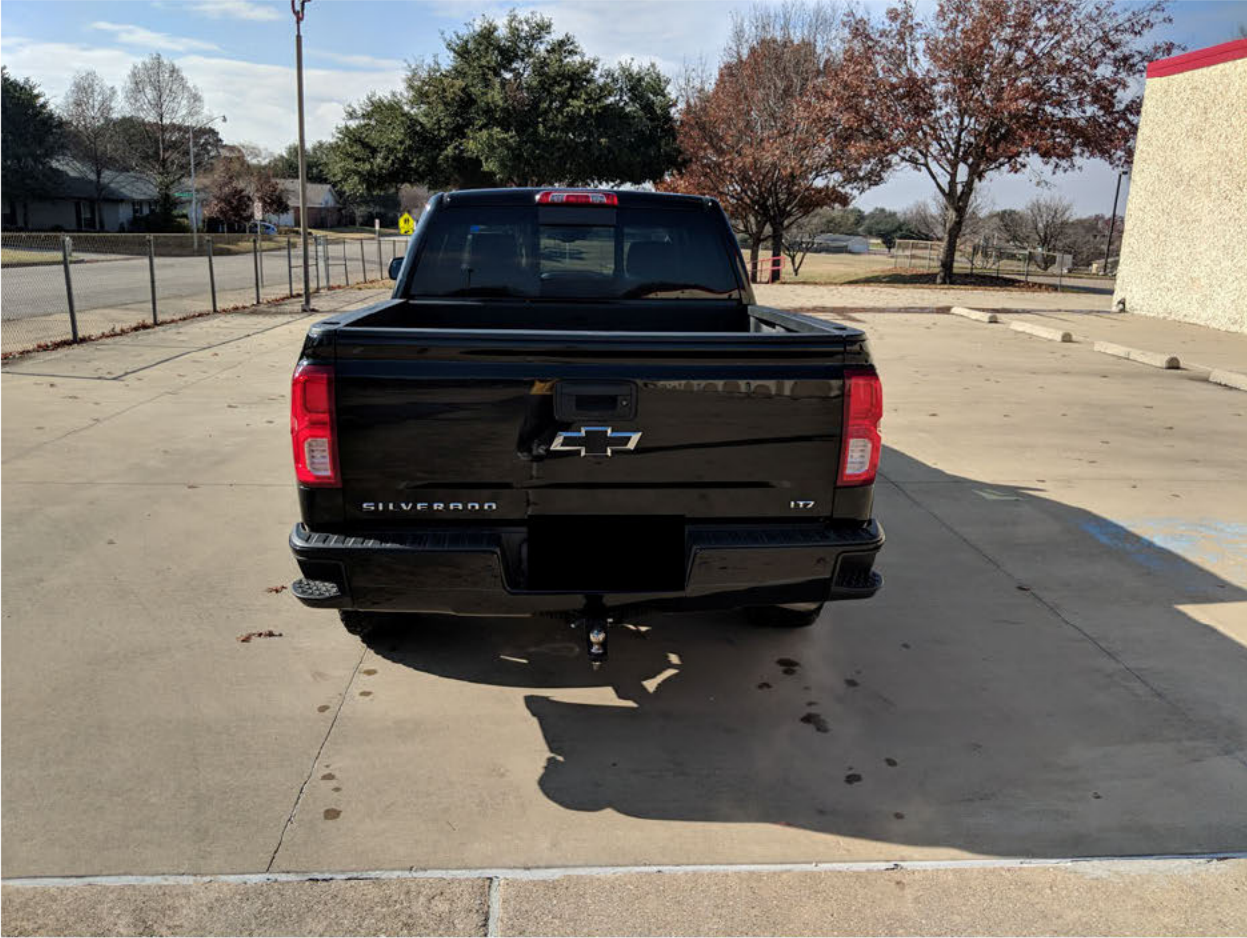
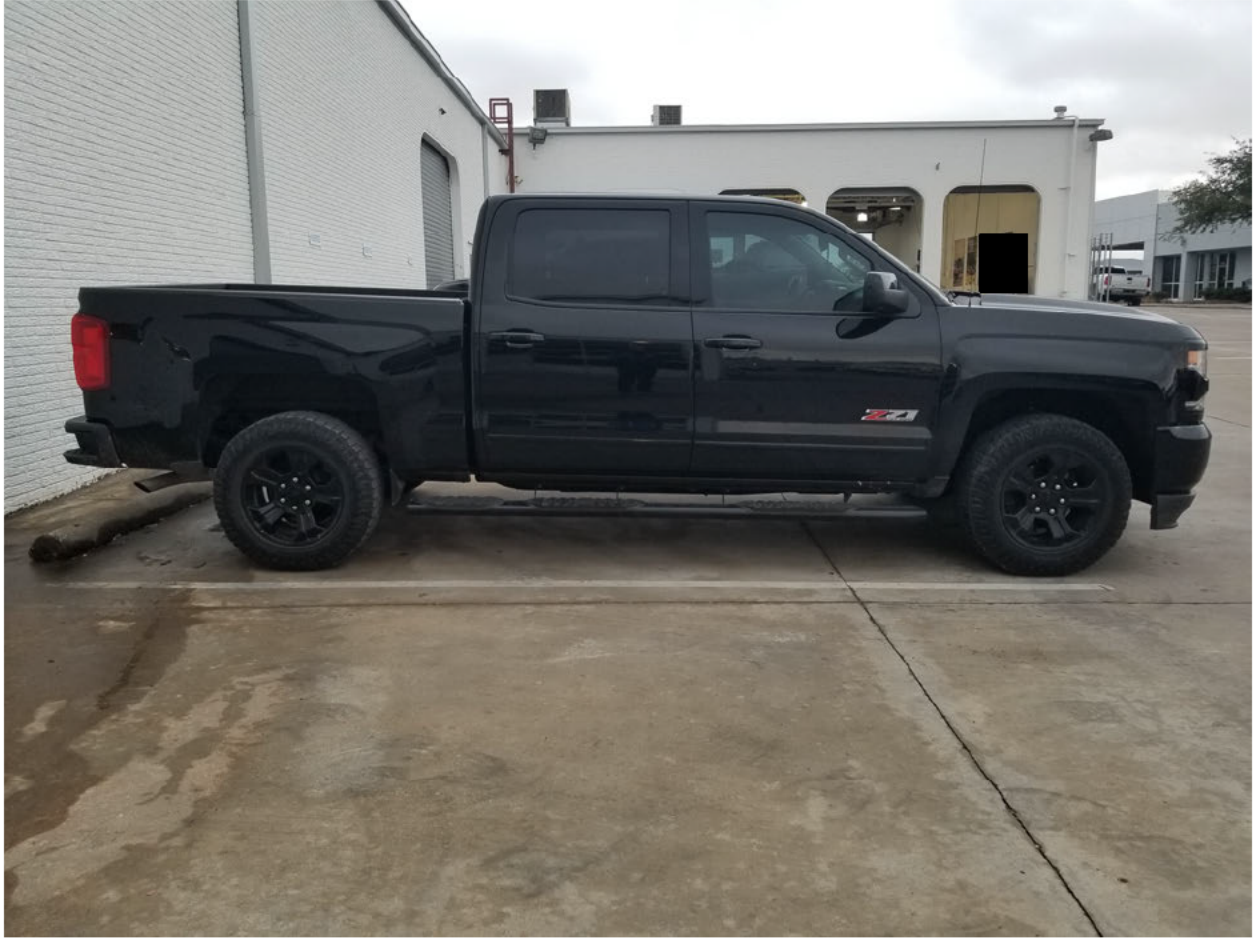
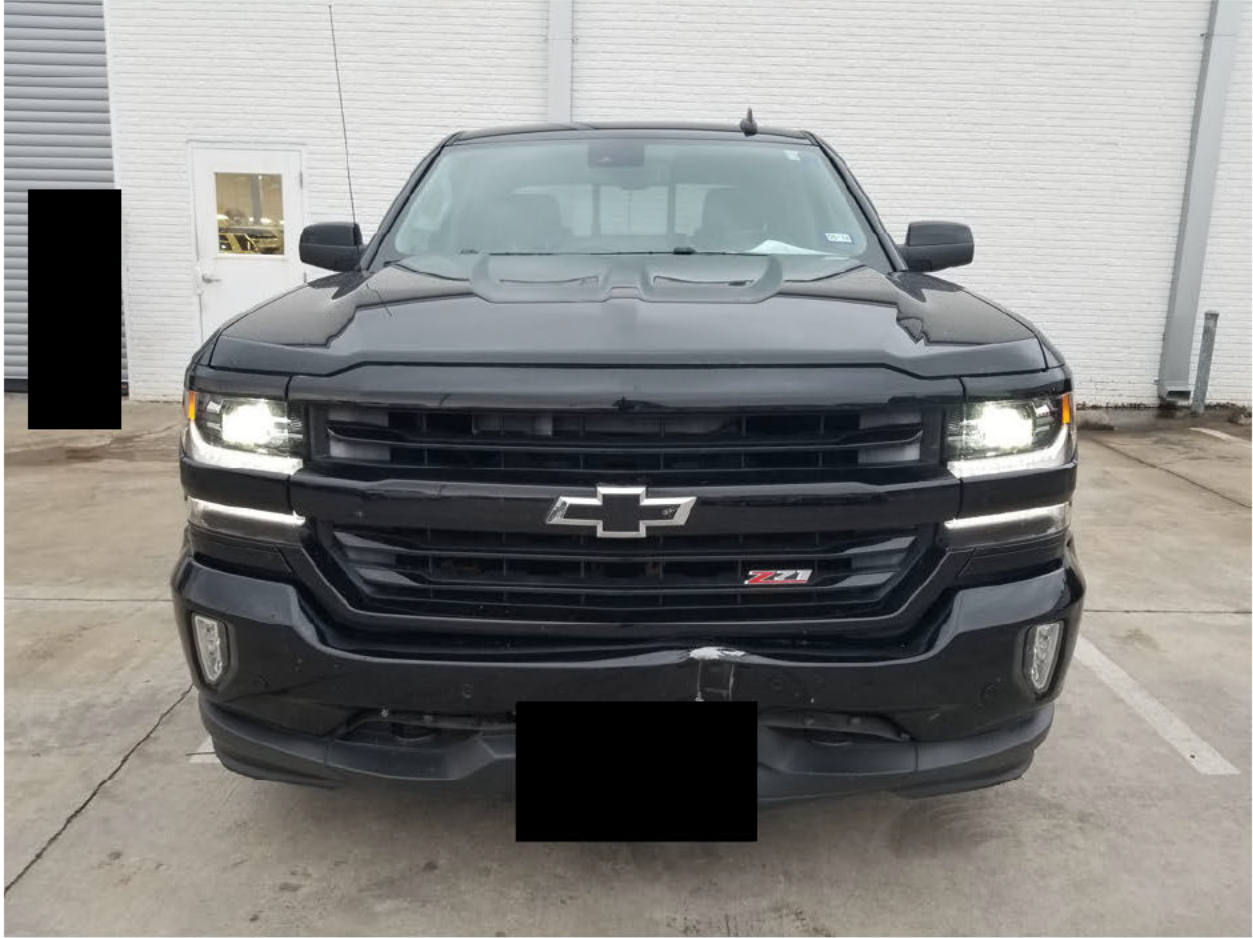
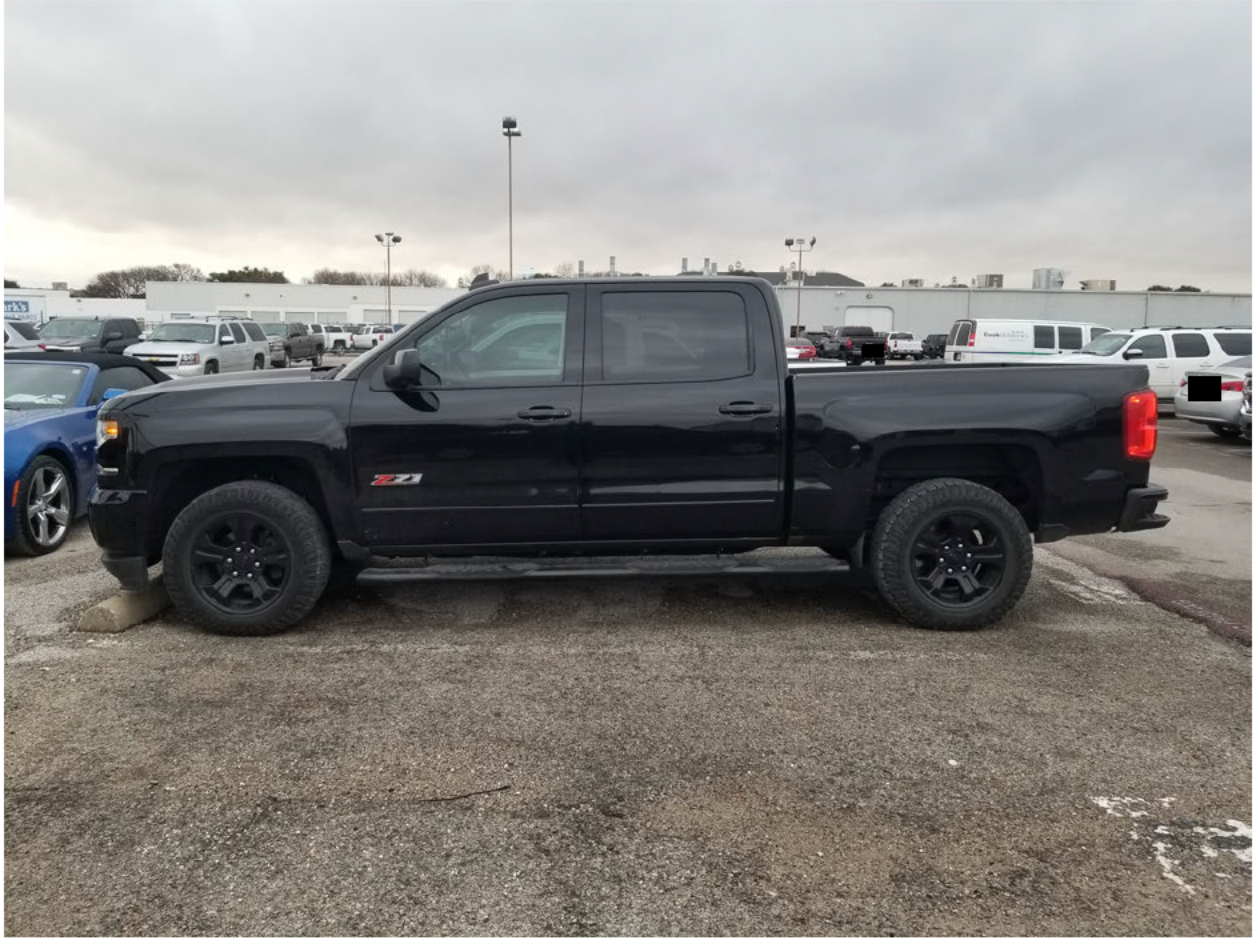
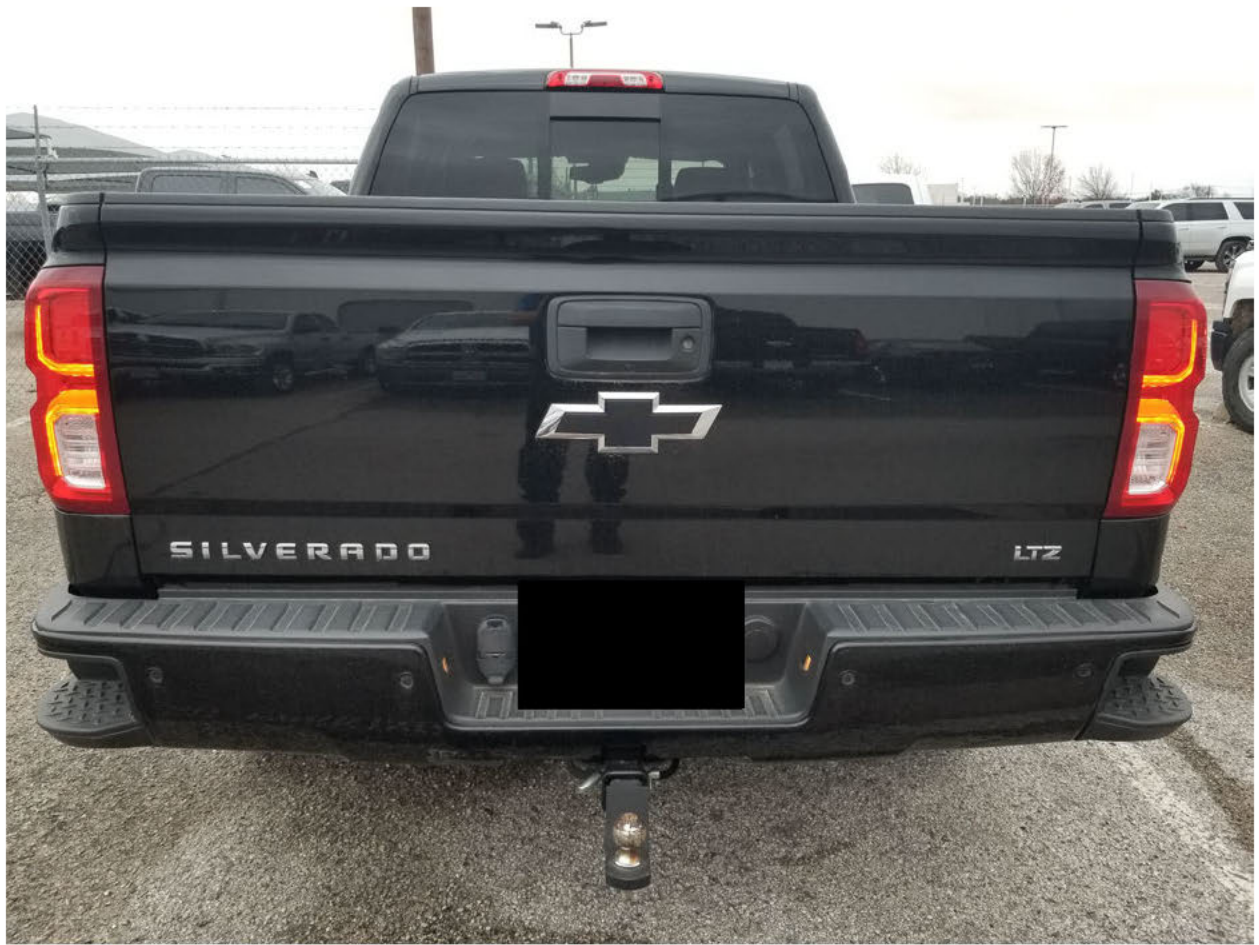
NO LEAKS FOUND

| Describe: | Only minor surface rust/corrosion |
| Describe: | Normal rust at rotor/hub mating surfaces |

| Any lining corrosion evident? | <input checked="" type="checkbox"/> Yes <input type="checkbox"/> No | Describe: Normal minor rust at pad to pad clip contact points |

Performed complete vehicle DTC check. No current codes or dash lights or messages after vehicle self test. No aftermarket components, brake fluid leaks, brake components or tire concerns found. Brake fluid condition and level normal. No excessive brake component corrosion. ABS working as designed.
