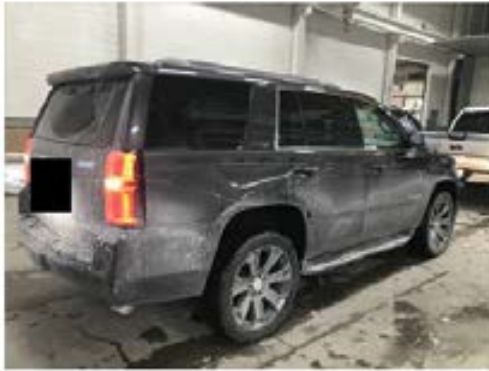
1/30/2018 E01  
 Comments:

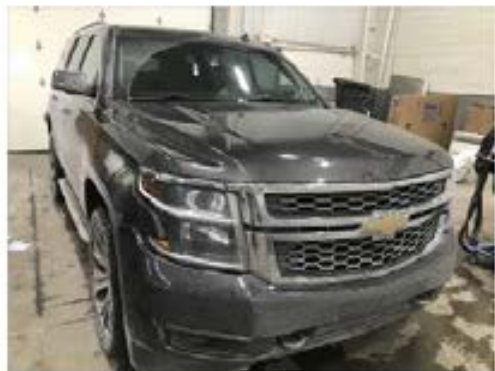
1/30/2018 E01  
 Comments:

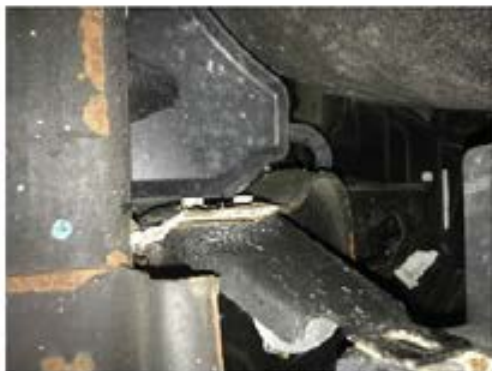
1/30/2018 E01  
Comments:
