NUMBER: 02-006-16

GROUP: Front Suspension

Toe Adjustment - Recirculating Ball Steering System

2013 - 2017	(D2)	Ram 3500 Pickup
2014 - 2017	(DJ)	Ram 2500 Pickup
2014 - 2017	(DD)	Ram 3500 Cab Chassis
2014 - 2017	(DX)	Ram Truck (Mexico) (Heavy Duty Trucks)

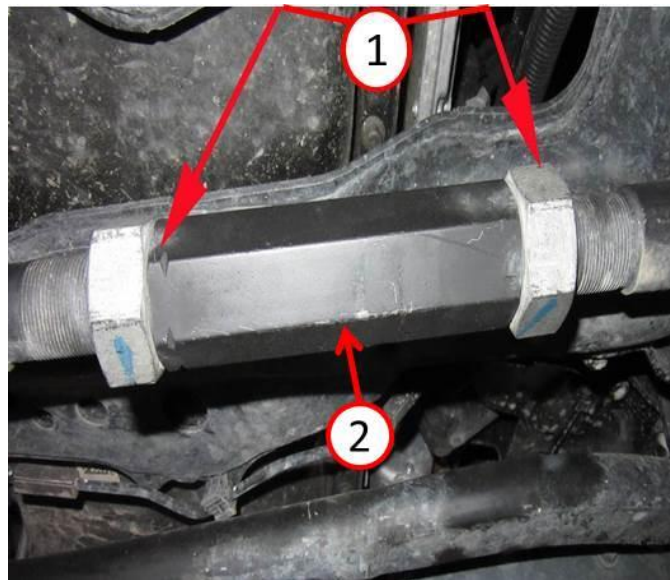
Fig. 1 Adjuster

The vehicles identified above have a drag link with an adjustment sleeve and jam nuts (Fig. 1), which differs from the previous clamp and bolt style.

1 - Jam Nuts

2 - Adjuster

NOTE: When tightening the drag link jam nuts ([Fig. 1](#)), the adjuster sleeve must always be held secure with a wrench/tool.
