STATE OF CALIFORNIA  
 DEPARTMENT OF CALIFORNIA HIGHWAY PATROL  
**MULTIDISCIPLINARY ACCIDENT INVESTIGATION TEAM NARRATIVE/DIAGRAM**  
 CHP 558D (Rev. 9-08) OPI 065 (MAIT use only)

**IL-030-18**

**MAIT SUPPLEMENTAL**

***ANALYSIS AND OPINION – AIRBAG CONTROL MODULE ANALYSIS***

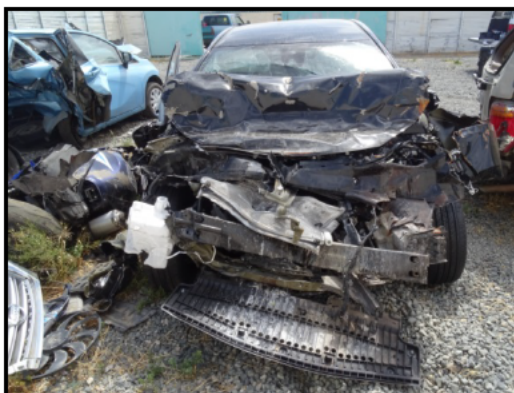
Figure 1. Front of the Toyota.

- The Toyota sustained significant frontal damage consistent with an underride impact (Figure 1 and Figure 2). The intrusion above the front bumper was deeper than that at the bumper level.
- The tires mounted on the vehicle were the original size,<sup>1</sup> as noted on the tire and loading information label on the base of the left B-pillar.
- None of the supplemental restraints had deployed.
- There were obvious signs of safety belt use observed on the components of the driver and right-front passenger seatbelts. Additionally, Sergeant Parent arrived at the collision scene moments after it occurred and observed both occupants utilizing their respective seatbelt.

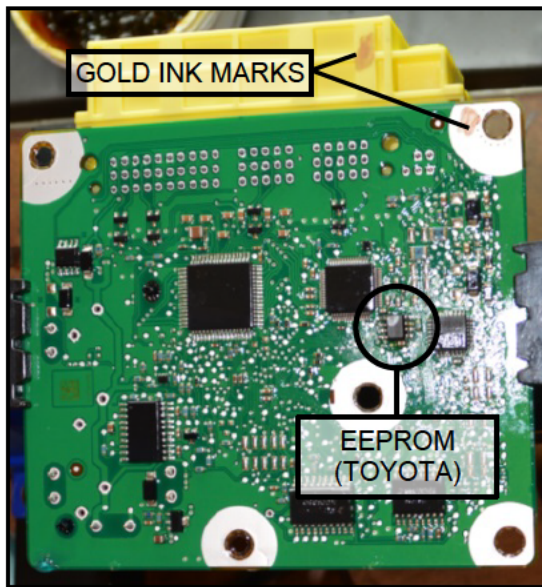
The circuit boards and EEPROMs of both ACMs were distinctly marked. The circuit board (Figure 3) and EEPROM (Figure 4) of the surrogate ACM were marked with gold ink. The circuit board (Figure 4) and EEPROM (Figure 3) of the ACM removed from the Toyota were marked with gray ink. Once marked, Investigator Snider removed both EEPROMs from their respective circuit boards. The EEPROM from the circuit board of the ACM removed from the Toyota was transplanted onto the circuit board of the surrogate ACM (Figure 3). The EEPROM from the circuit board of the surrogate ACM was transplanted onto the circuit board of the ACM removed from the Toyota (Figure 4).

*Figure 3.* Circuit board of the surrogate ACM with the transplanted EEPROM from the ACM installed in the Toyota.

With both EEPROMs transplanted, the ACMs were imaged by connecting a CDR system interface module directly to each ACM in accordance with CDR system guidelines. The surrogate ACM (with the EEPROM from the ACM installed in the Toyota) was successfully imaged. Availability of a report (Annex B) in the CDR system software indicated a valid image was copied from the ACM. Investigator Seruga attempted to image the ACM from the Toyota with the transplanted EEPROM from the surrogate ACM; however, he was unable to establish communication with the ACM. This suggested a fault with the circuit board of the ACM removed from the Toyota.

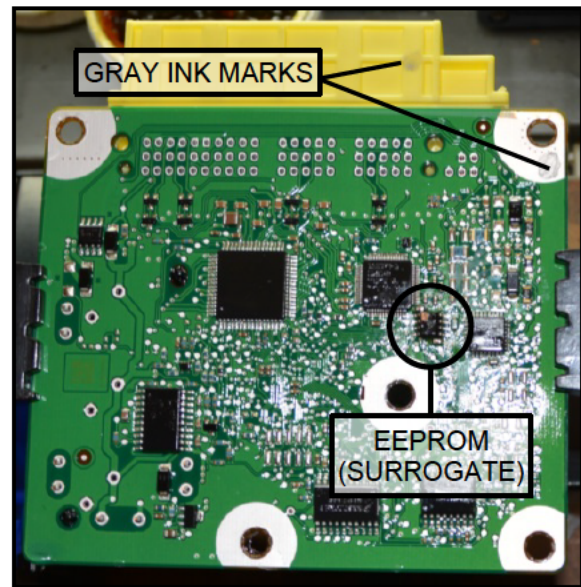
*Figure 4.* Circuit board of the ACM removed from the Toyota with transplanted EEPROM from the surrogate ACM.

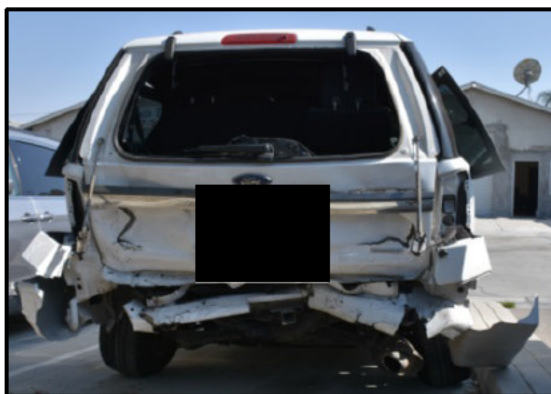
Figure 6. Rear of the Ford.

- The Ford sustained significant rear damage consistent with an underride impact (Figure 6 and Figure 7). The majority of the intrusion to the rear occurred below the license plate.
- The tires mounted on the vehicle were the original size,<sup>2</sup> as noted on the tire and loading information label on the base of the left B-pillar.
- None of the supplemental restraints had deployed.

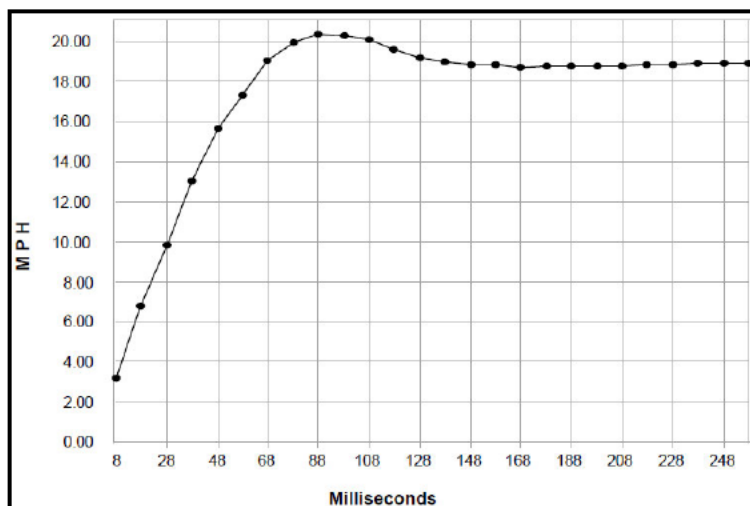
A graph of the longitudinal change in velocity was reported in the CDR report (Figure 12).

Figure 12. Longitudinal change in velocity graph.

Although not inclusive of all data reported in the longitudinal change in velocity graph, the following information was noted:

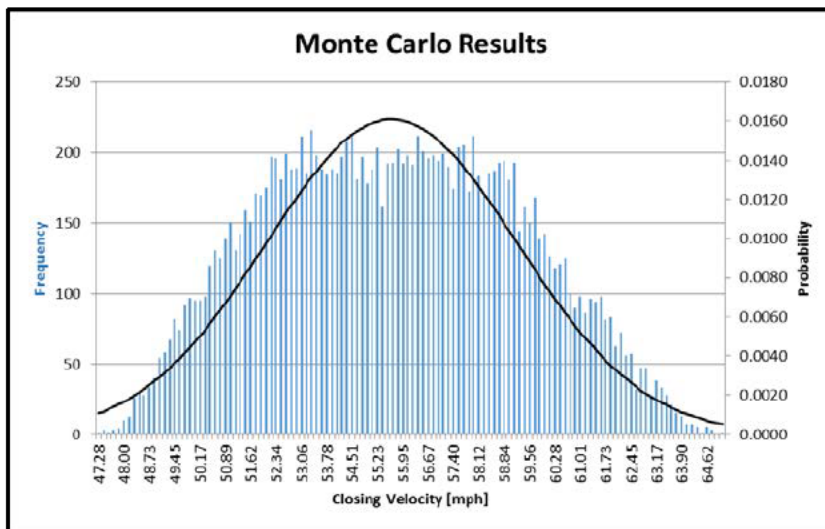
Based upon 15,000 calculated values for the closing velocity between the Toyota and the Ford, the following frequency distribution (Figure 13) and cumulative probability (Figure 14) was developed:

Figure 13. Frequency distribution for the closing velocity between the Toyota and Ford.

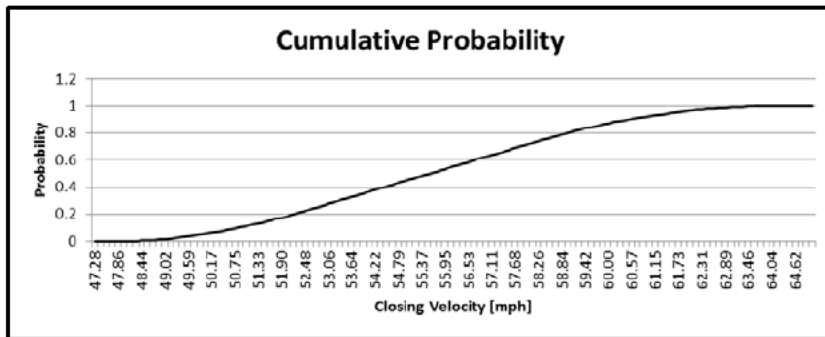
Figure 14. Cumulative probability for the closing velocity between the Toyota and Ford.

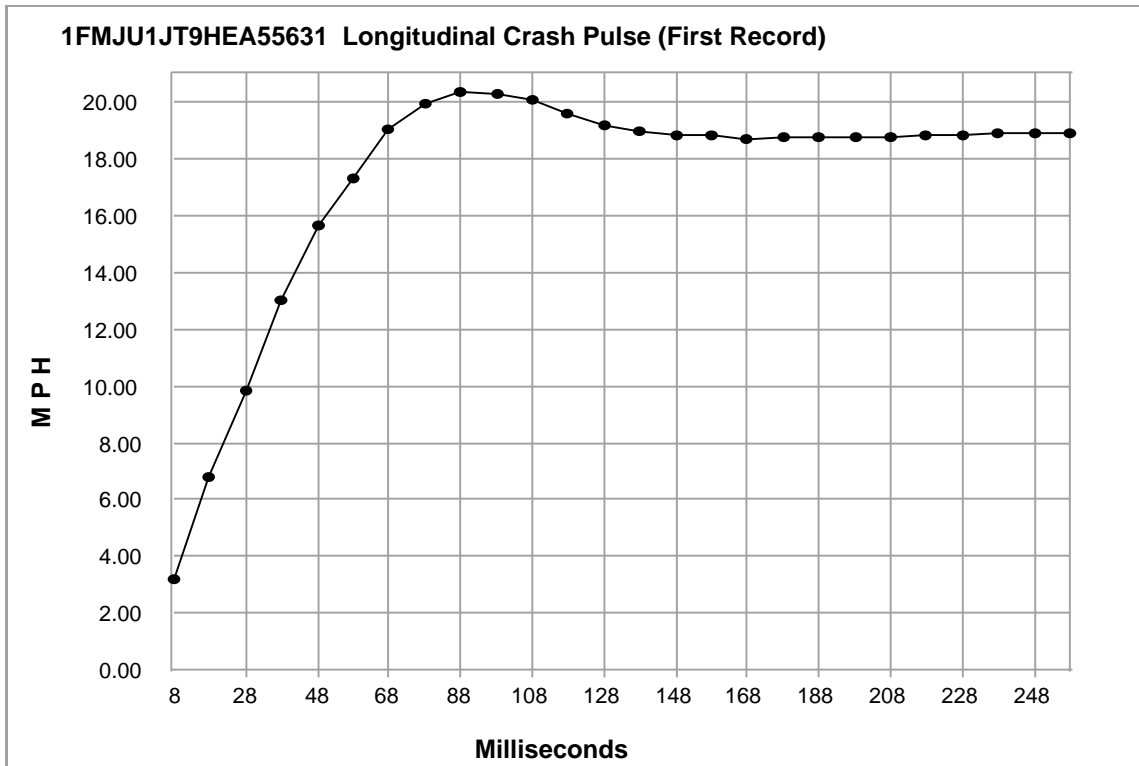
**Longitudinal Crash Pulse (First Record)**

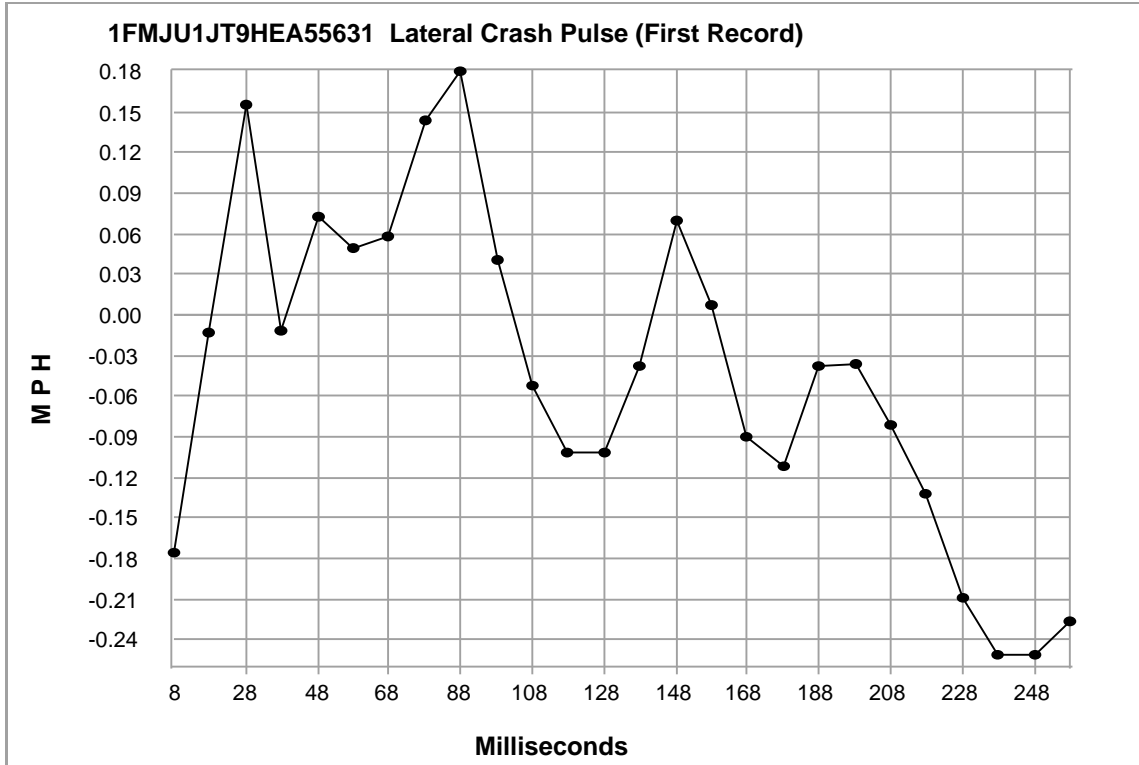
**Lateral Crash Pulse (First Record)**

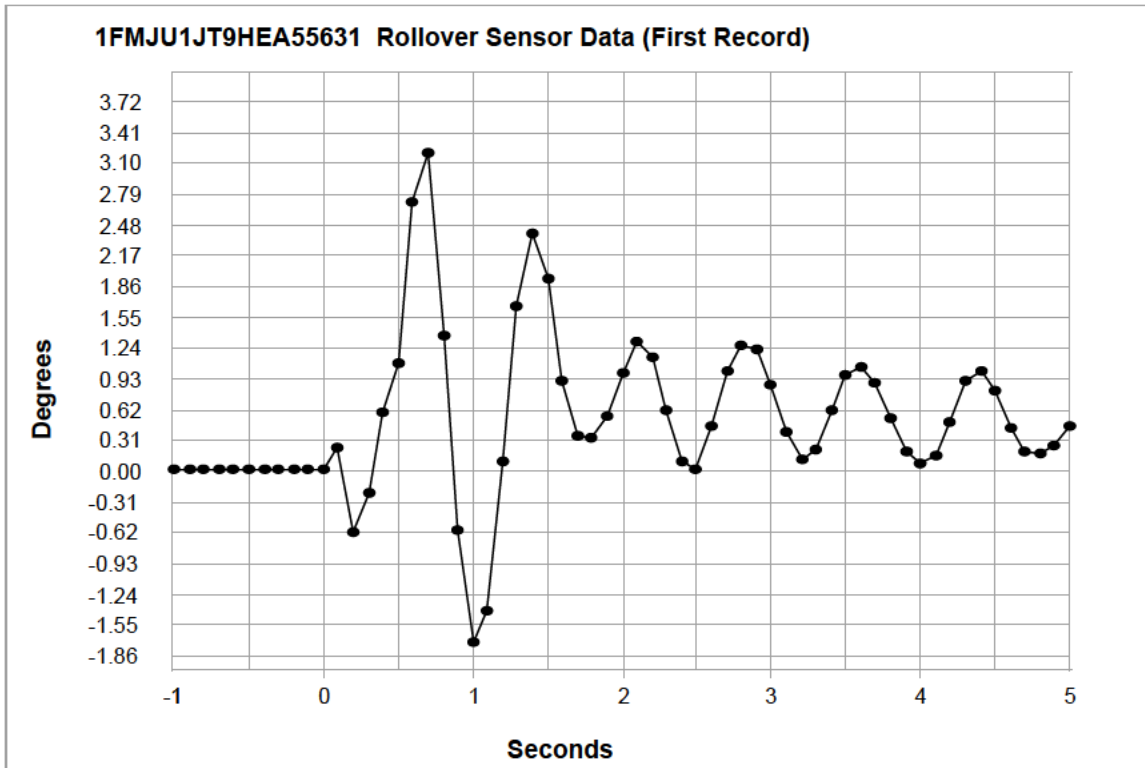
**Rollover Sensor Data (First Record)**
