EA19-001

FCA

ALLEGED DEFECT NOT RULED
OUT

CONFIDENTIAL - Prior Approval Required Before Duplicating
Preliminary Vehicle Investigation Report(PVIR)

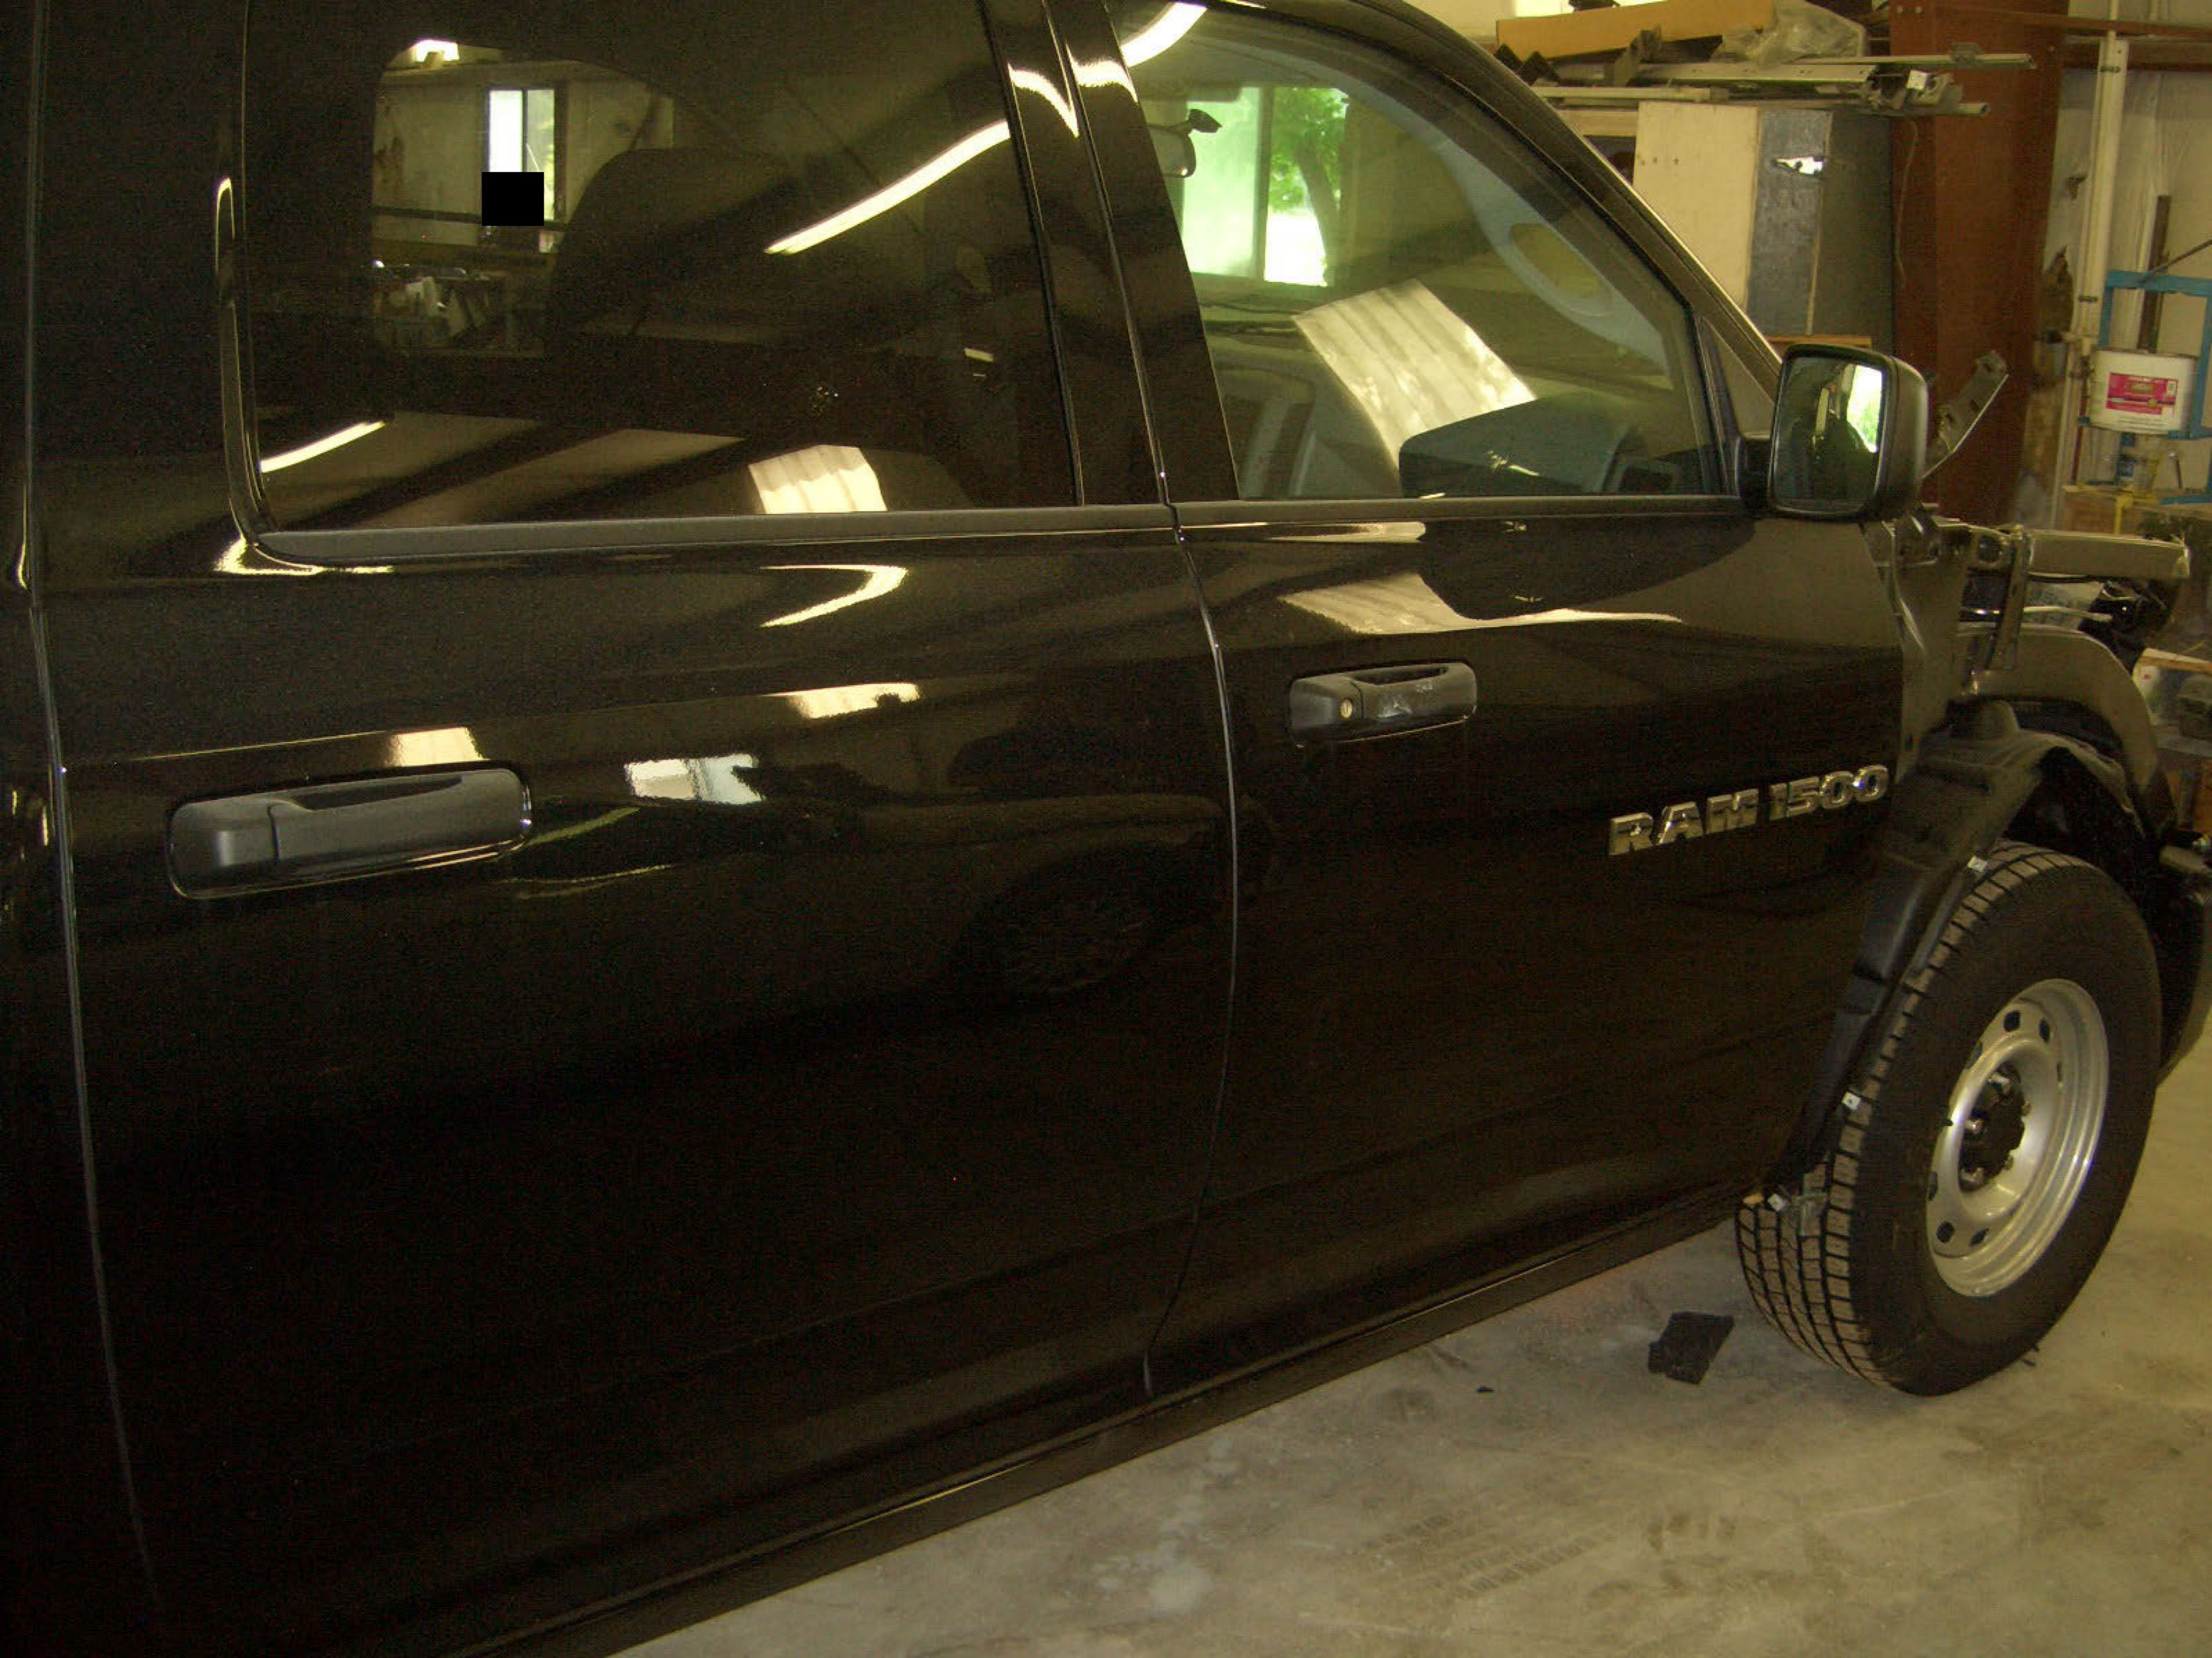
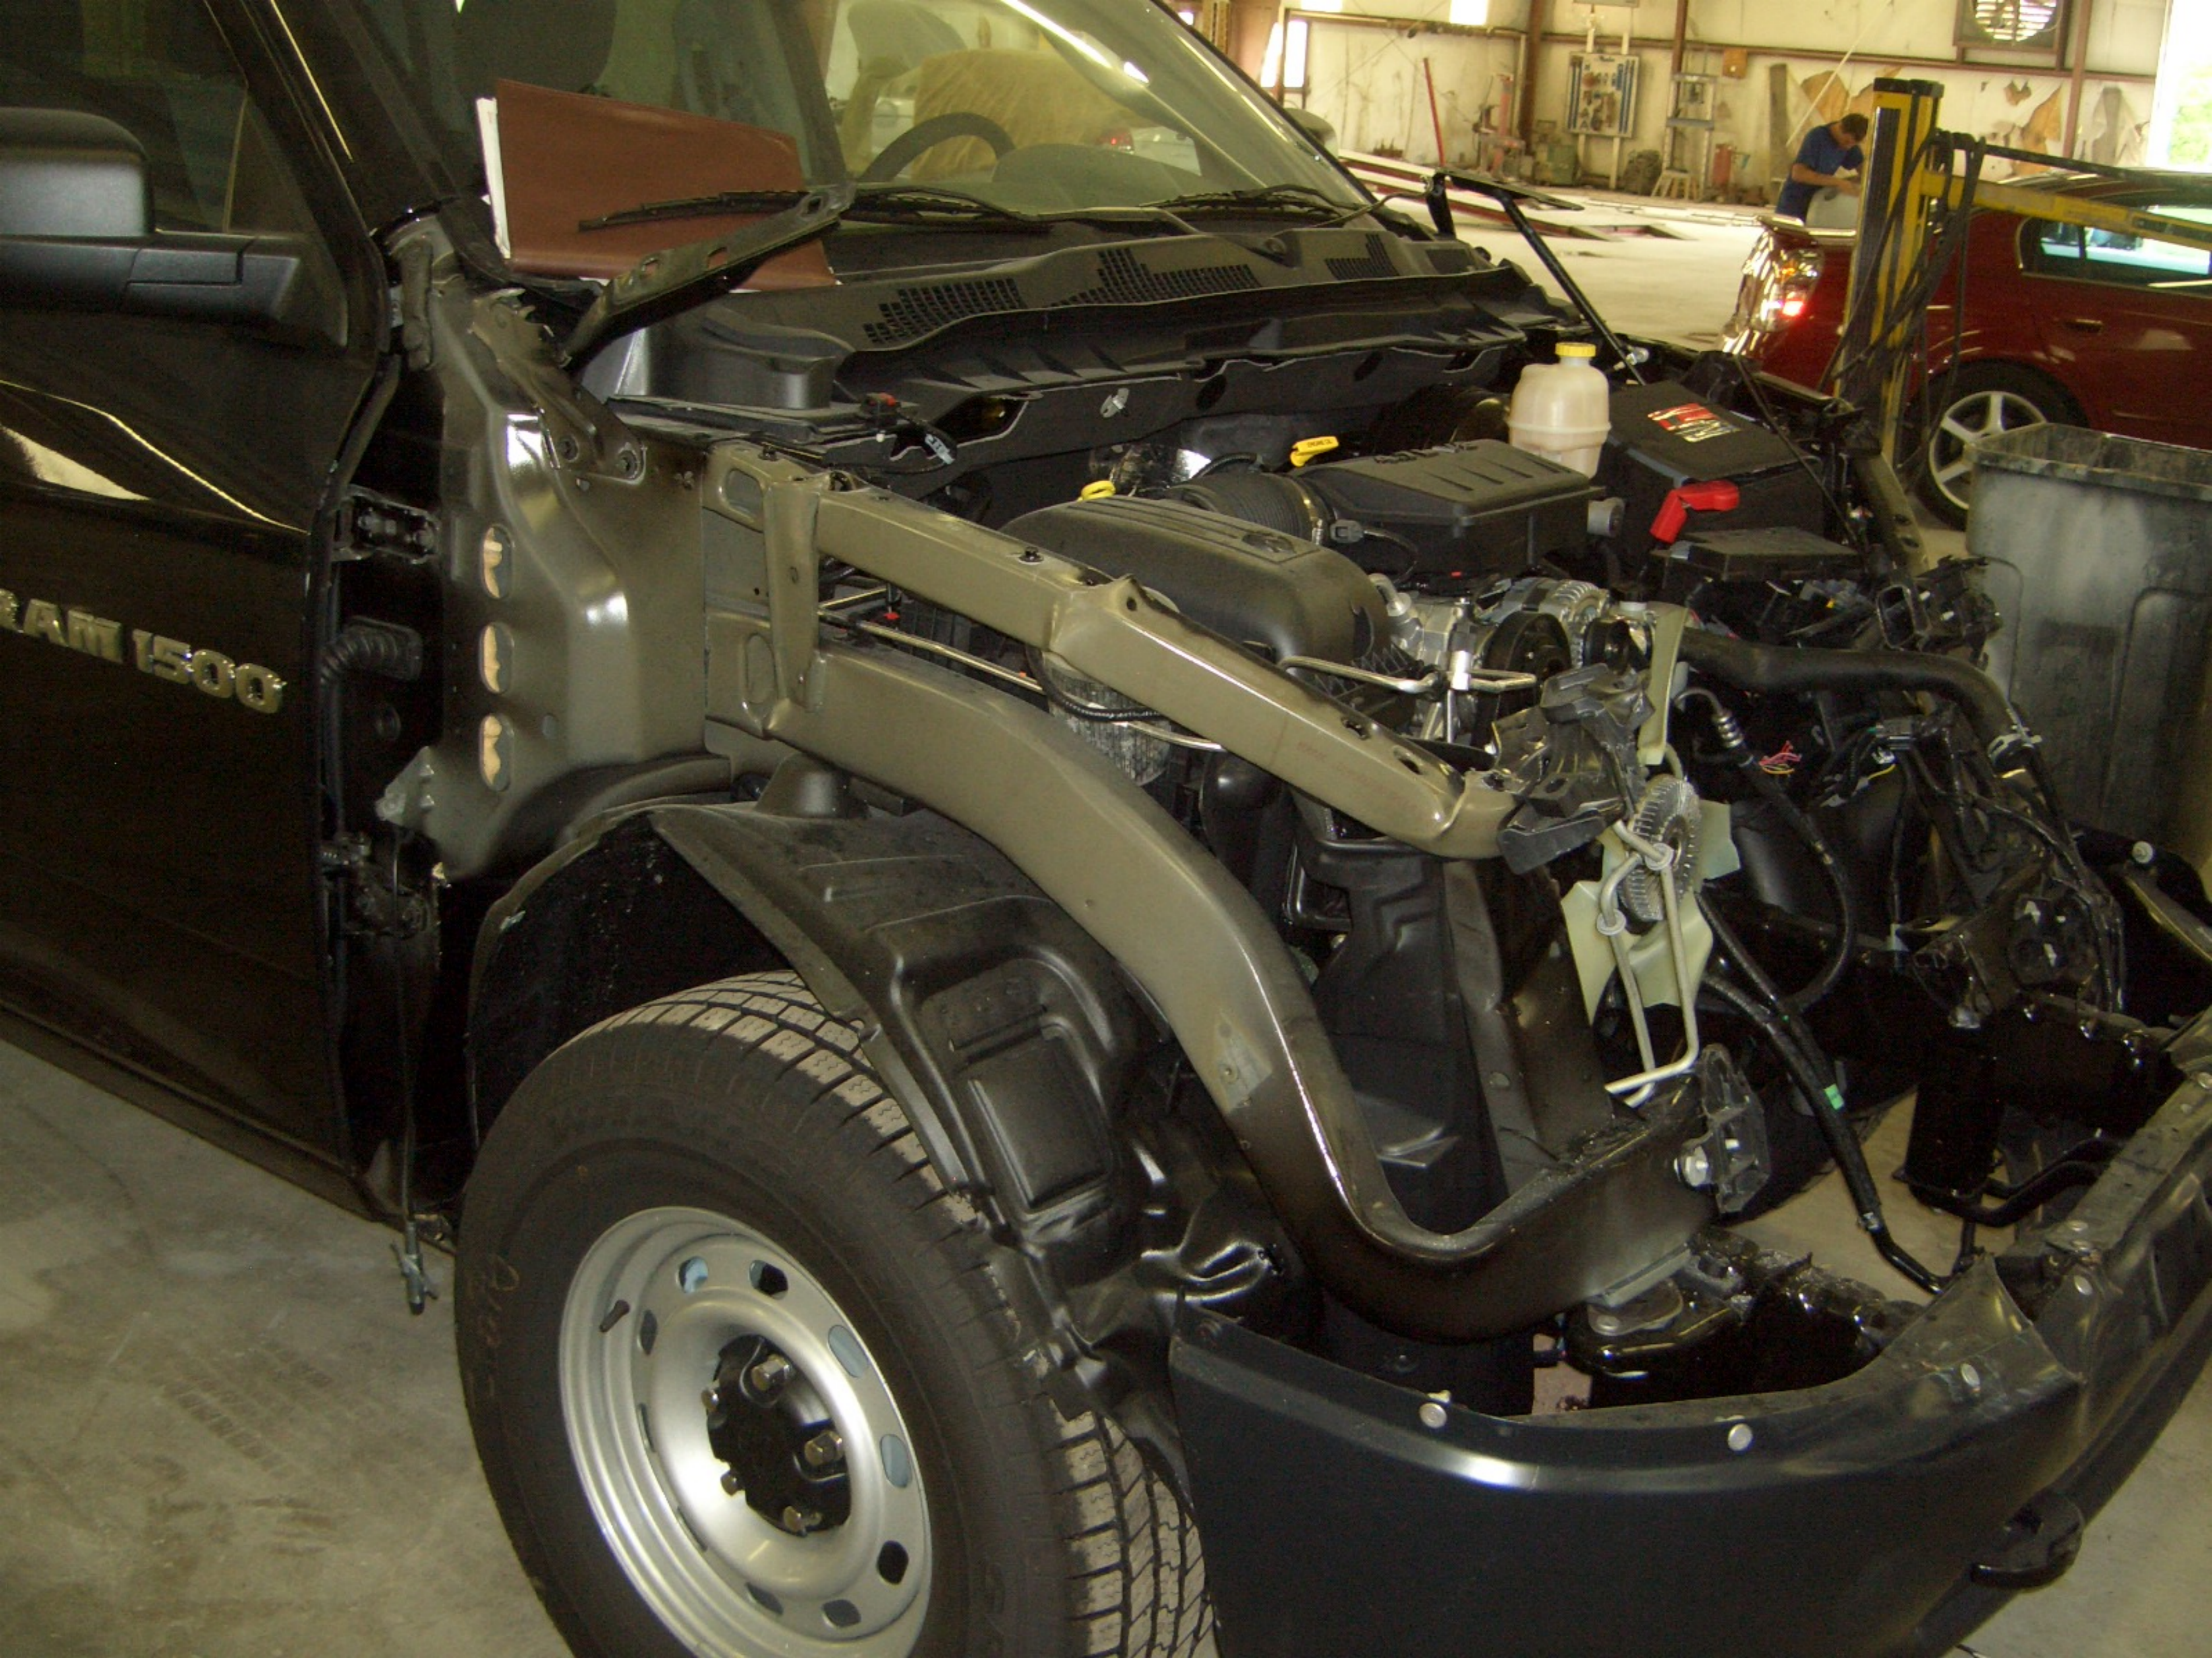
- REQUIRED PHOTOGRAPHS:** The vehicle was impacted in the front end above the front bumper. The windshield was broken in the lower left where the hood came back into the windshield. Both front fenders were pushed back, the hood was pushed back and up. The grill, radiator, condensor was pushed back into the engine. The head lights were broken out. The drivers door was slightly miss aligned. [REDACTED] did not report any injuries to the driver or passenger.
- WINDSHIELD
 - ALL AREAS OF DAMAGE MARKINGS ON INTERIOR AND EXTERIOR
 - CLOSE UPS OF STAINS, SKIN, HAIR, CLOTH
 - EXTERIOR AND INTERIOR DAMAGE INCLUDING UNDERCARRIAGE
- INFORMATION:**
- DESCRIBE ANY INJURIES TO DRIVER AND/OR OTHER OCCUPANTS
 - SEE SEAT BELT/SEATS SECTION IF APPLICABLE
-
-

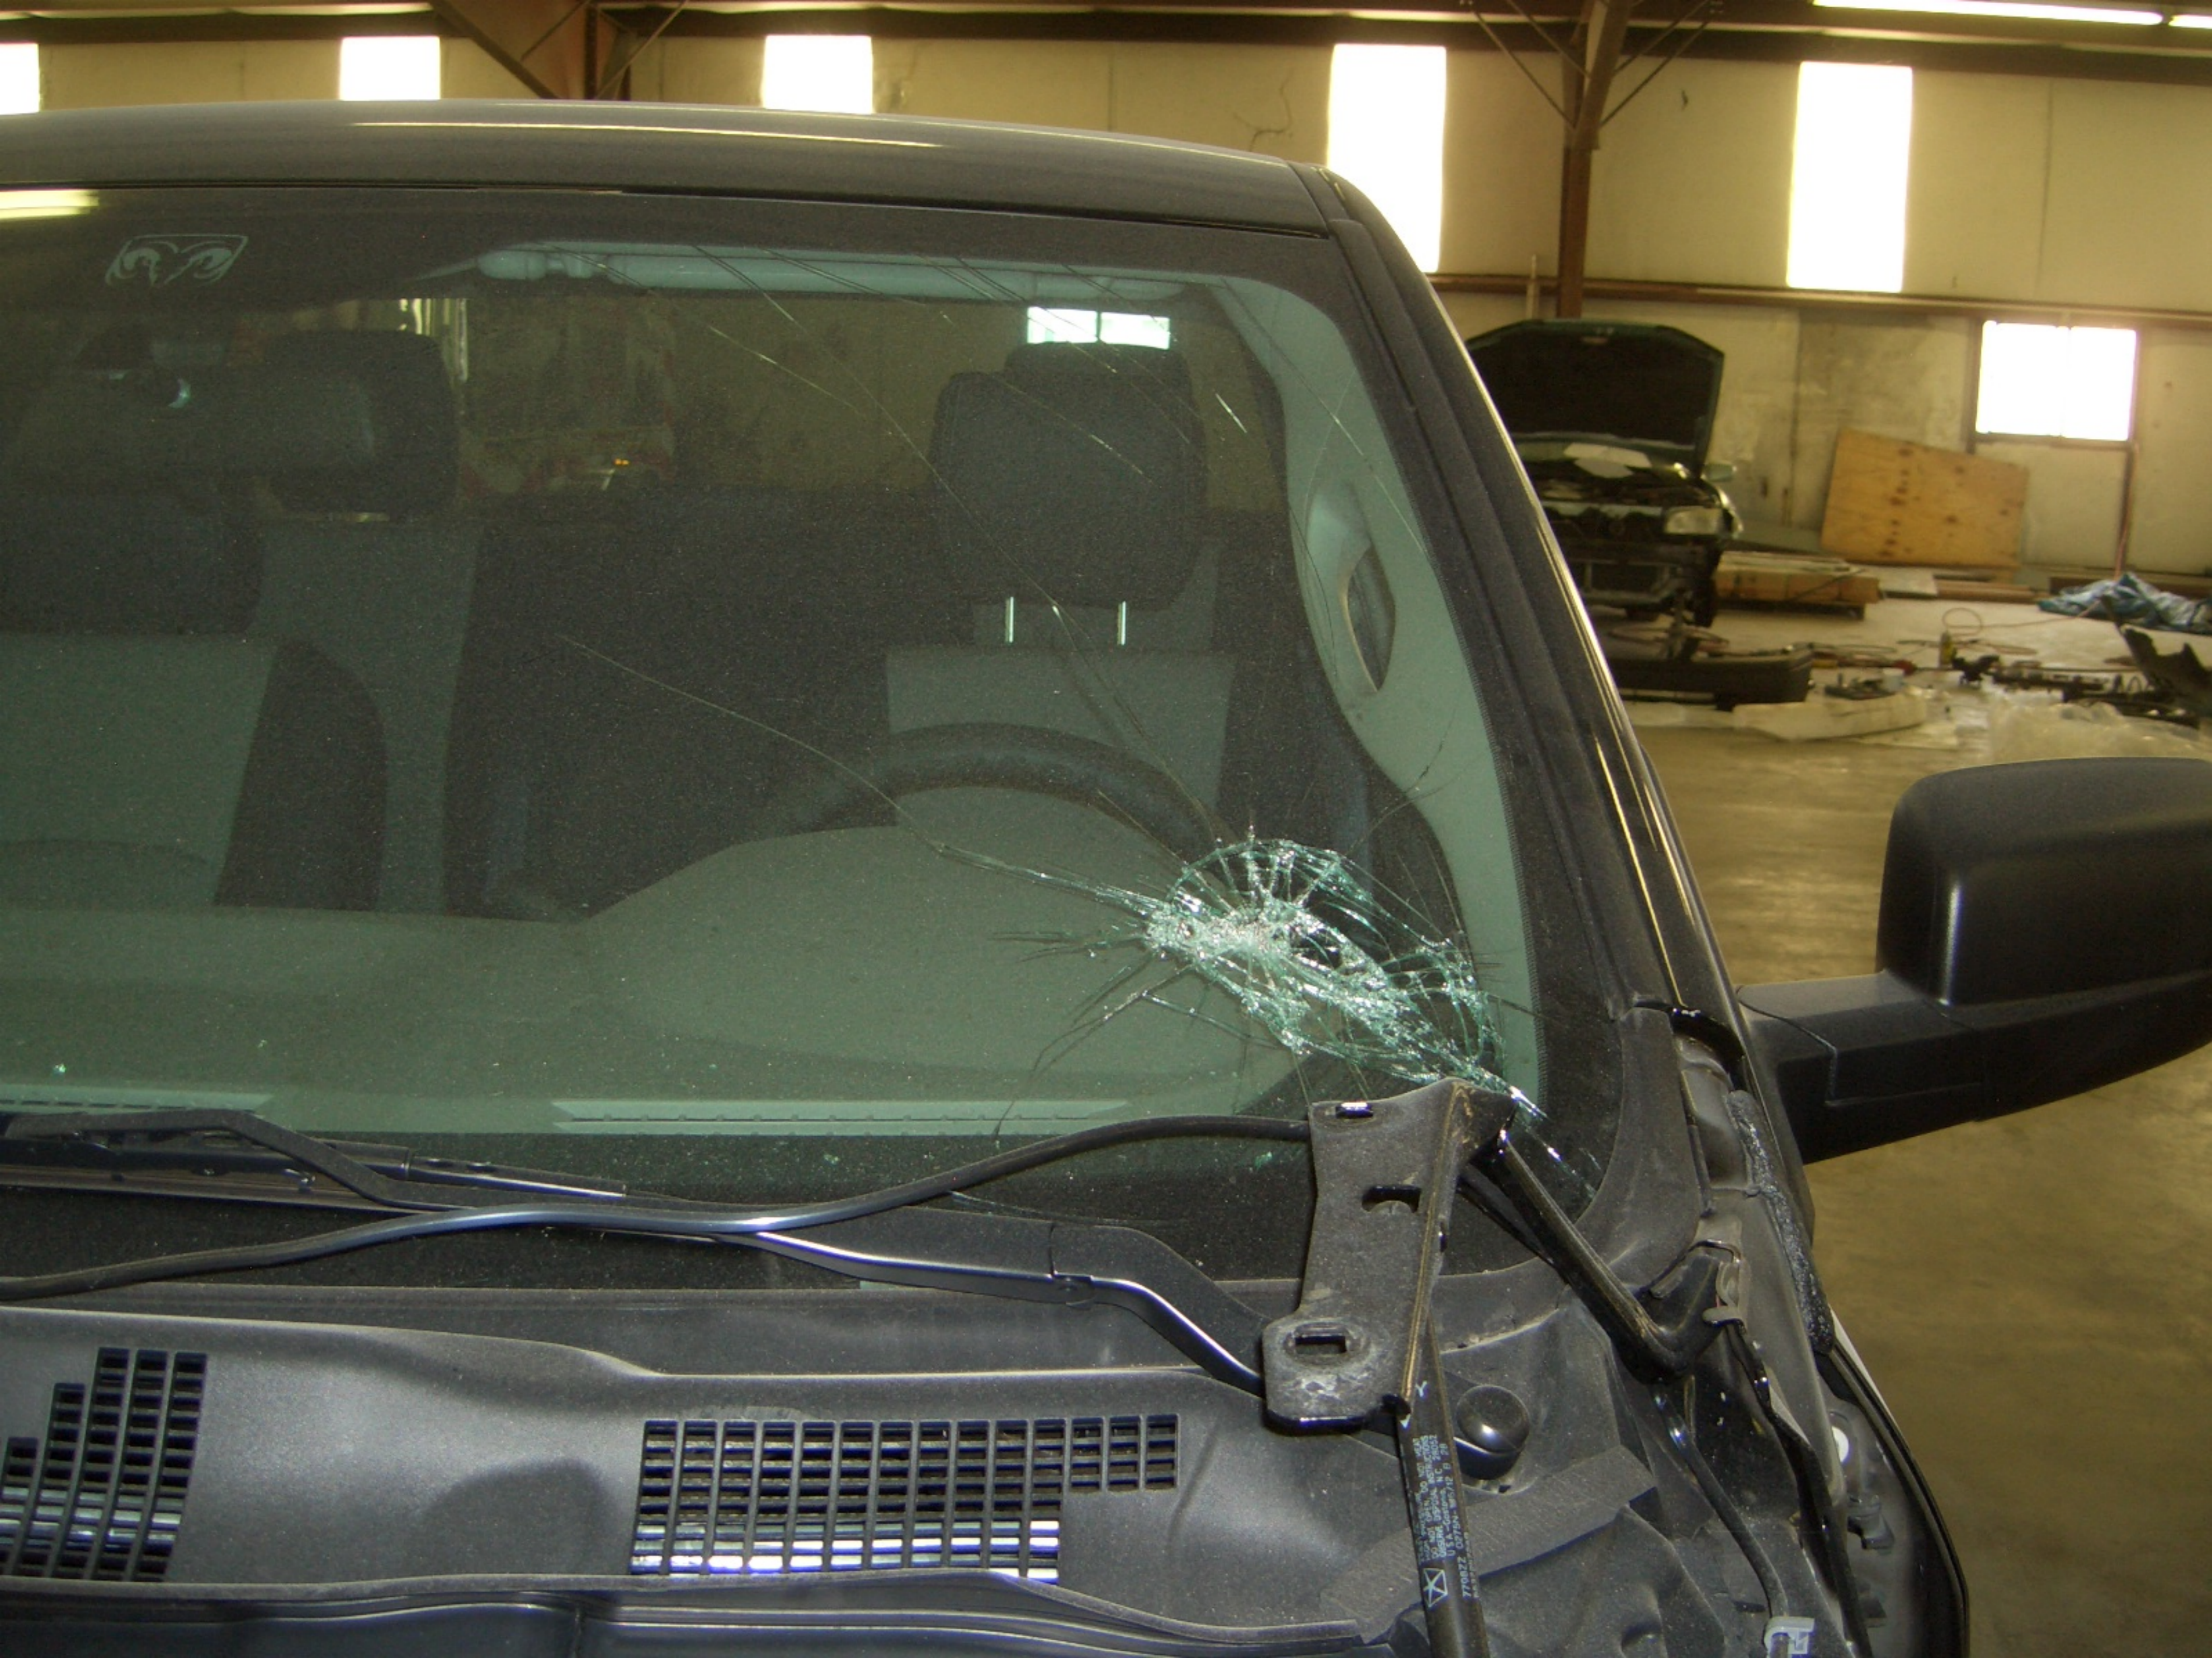
770827
U 03799-8051/R 8 28

MFD BY CHRYSLER GROUP LLC

DATE OF MFR (BUILT): JUN 12

GWR: 3085 KG 6800 LB

GAWR FRONT: 1770 KG 3900 LB WITH P265/70R17 TIRES
17X7.0 RIMS AT 276 KPA (40 PSI) COLD

GAWR REAR: 1770 KG 3900 LB WITH P265/70R17 TIRES
17X7.0 RIMS AT 276 KPA (40 PSI) COLD

VIN: [REDACTED] TYPE: TRUCK NDH: 062910 656AA
VEHICLE MADE IN U.S.A. PAINT: PX8 TRIM: TXV3

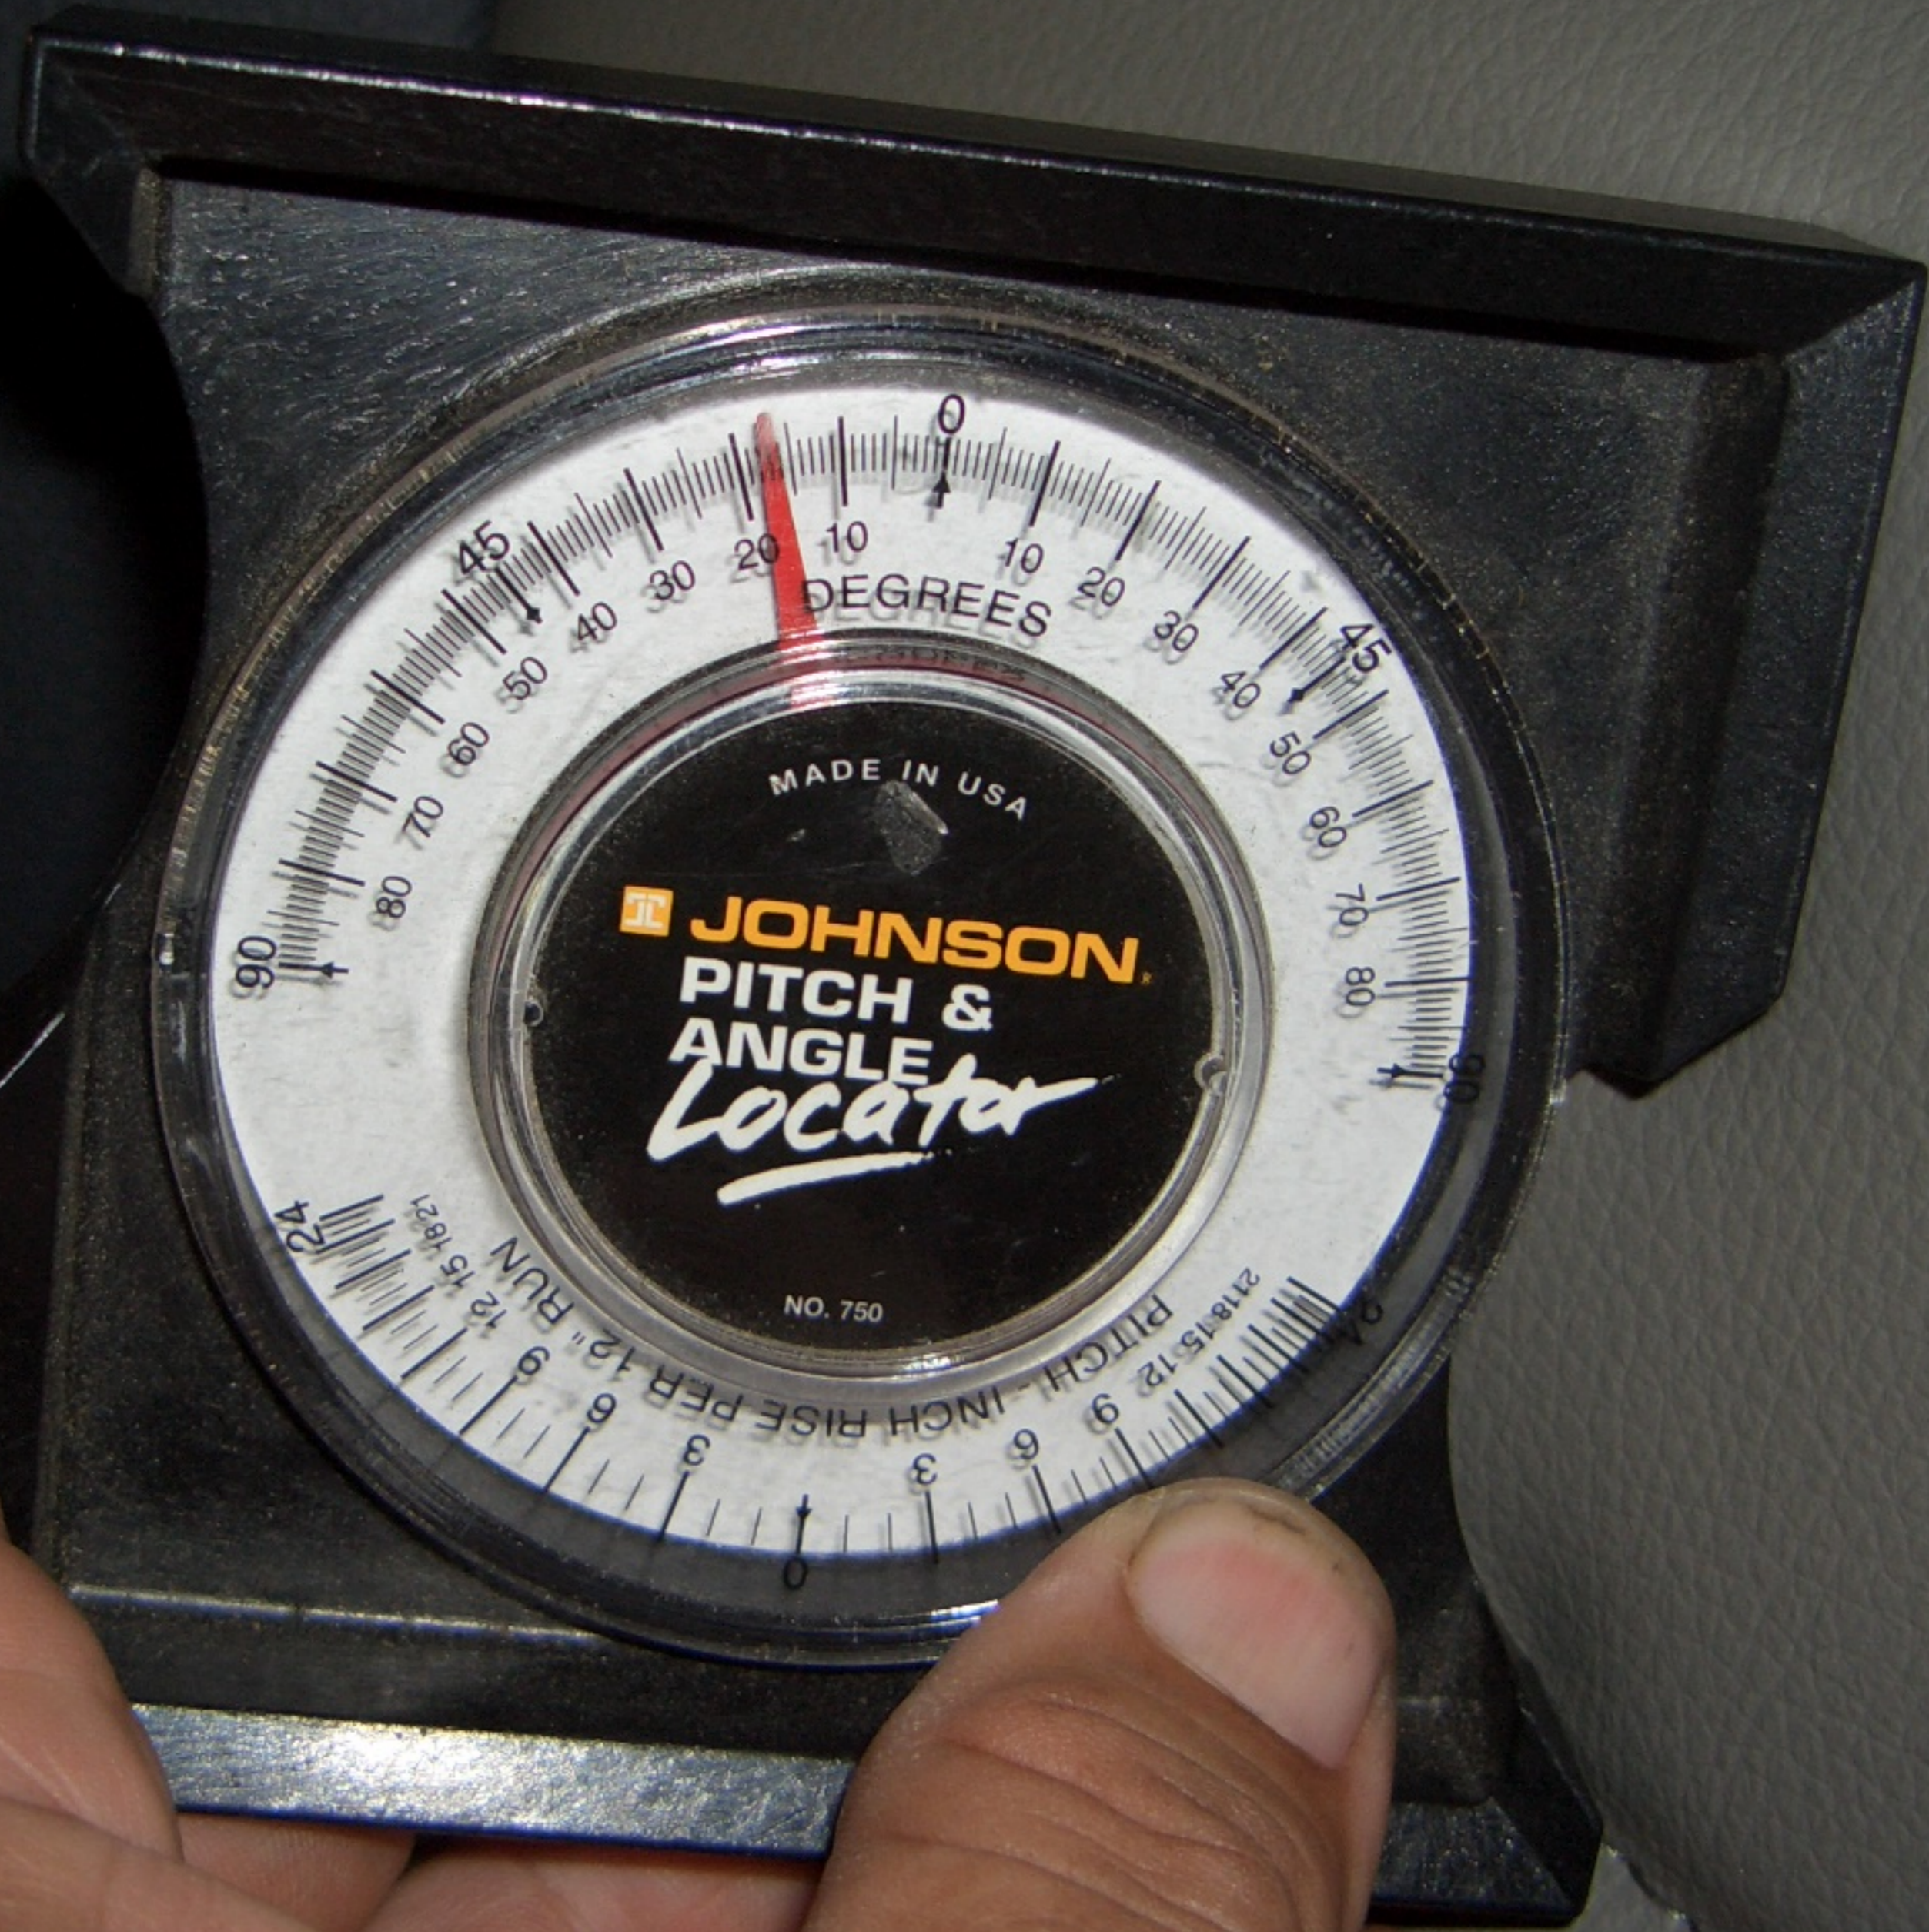
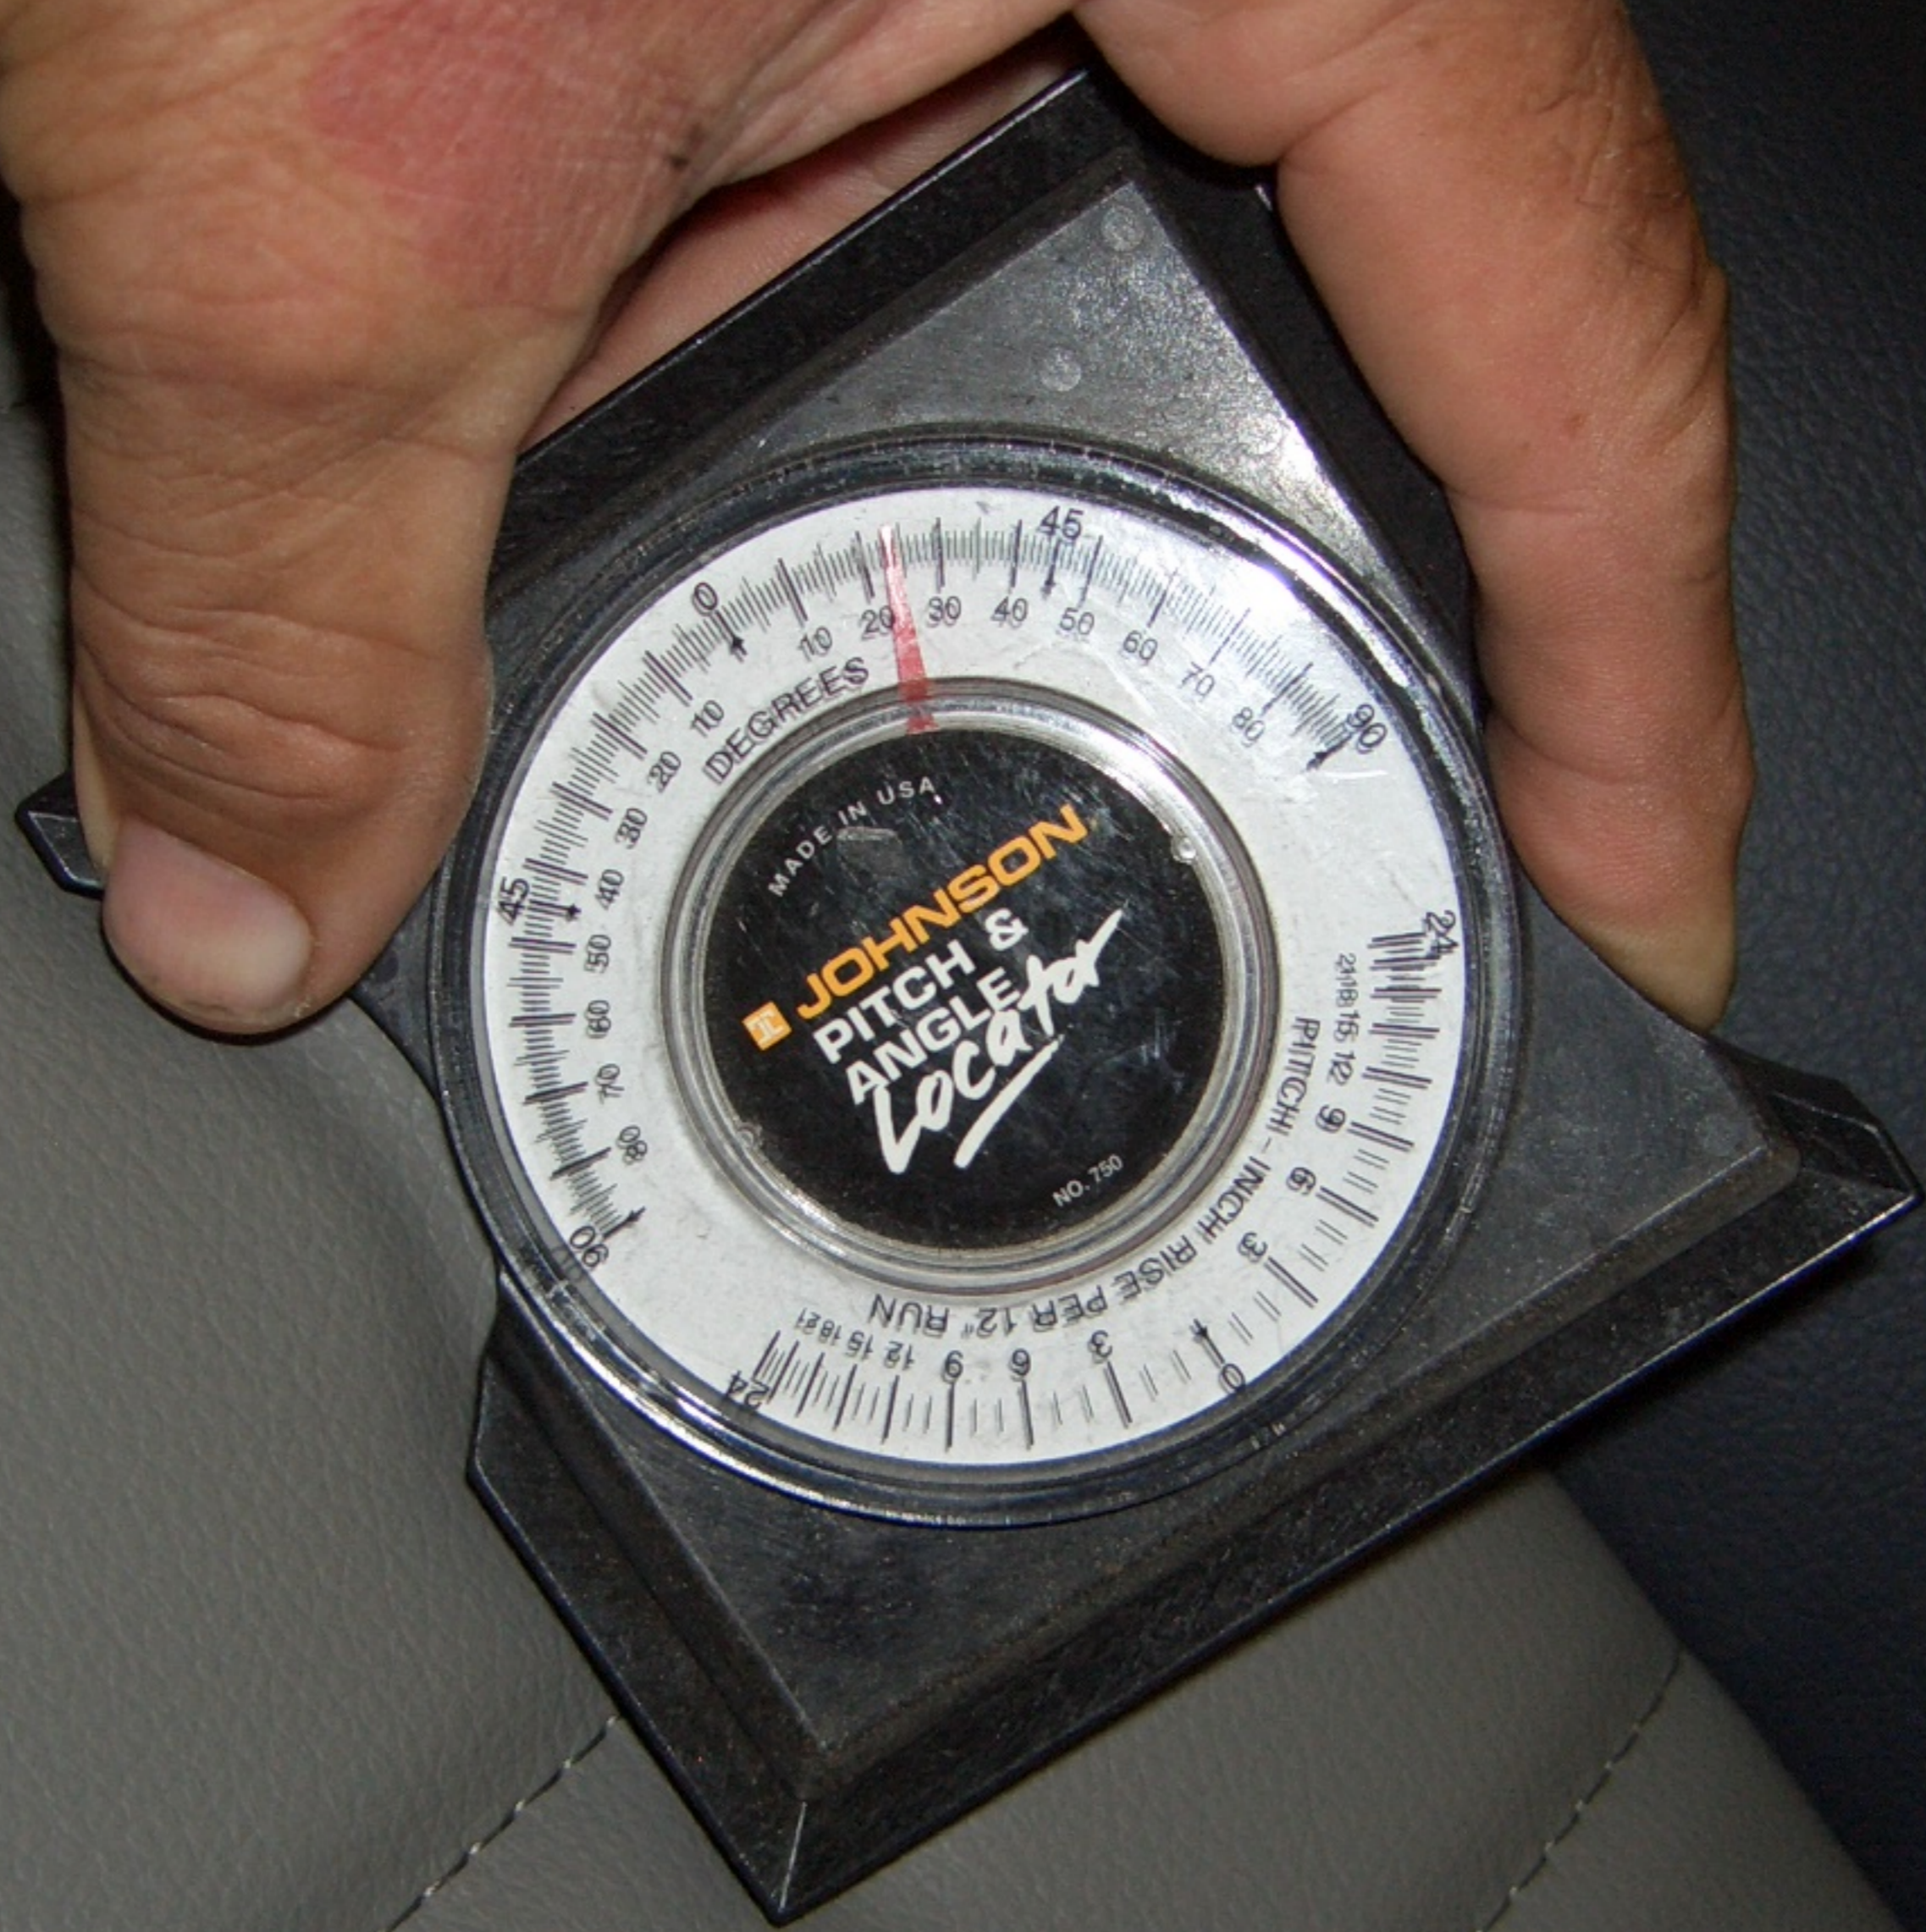
- EXISTING LOCATION OF RECLINER - DESCRIBE THE LOCATION AND PICTURE OF SEAT BACK WITH B PILLOR AS REFERENCE AND INCLINOMETER READING

15 degrees D 20 degrees P

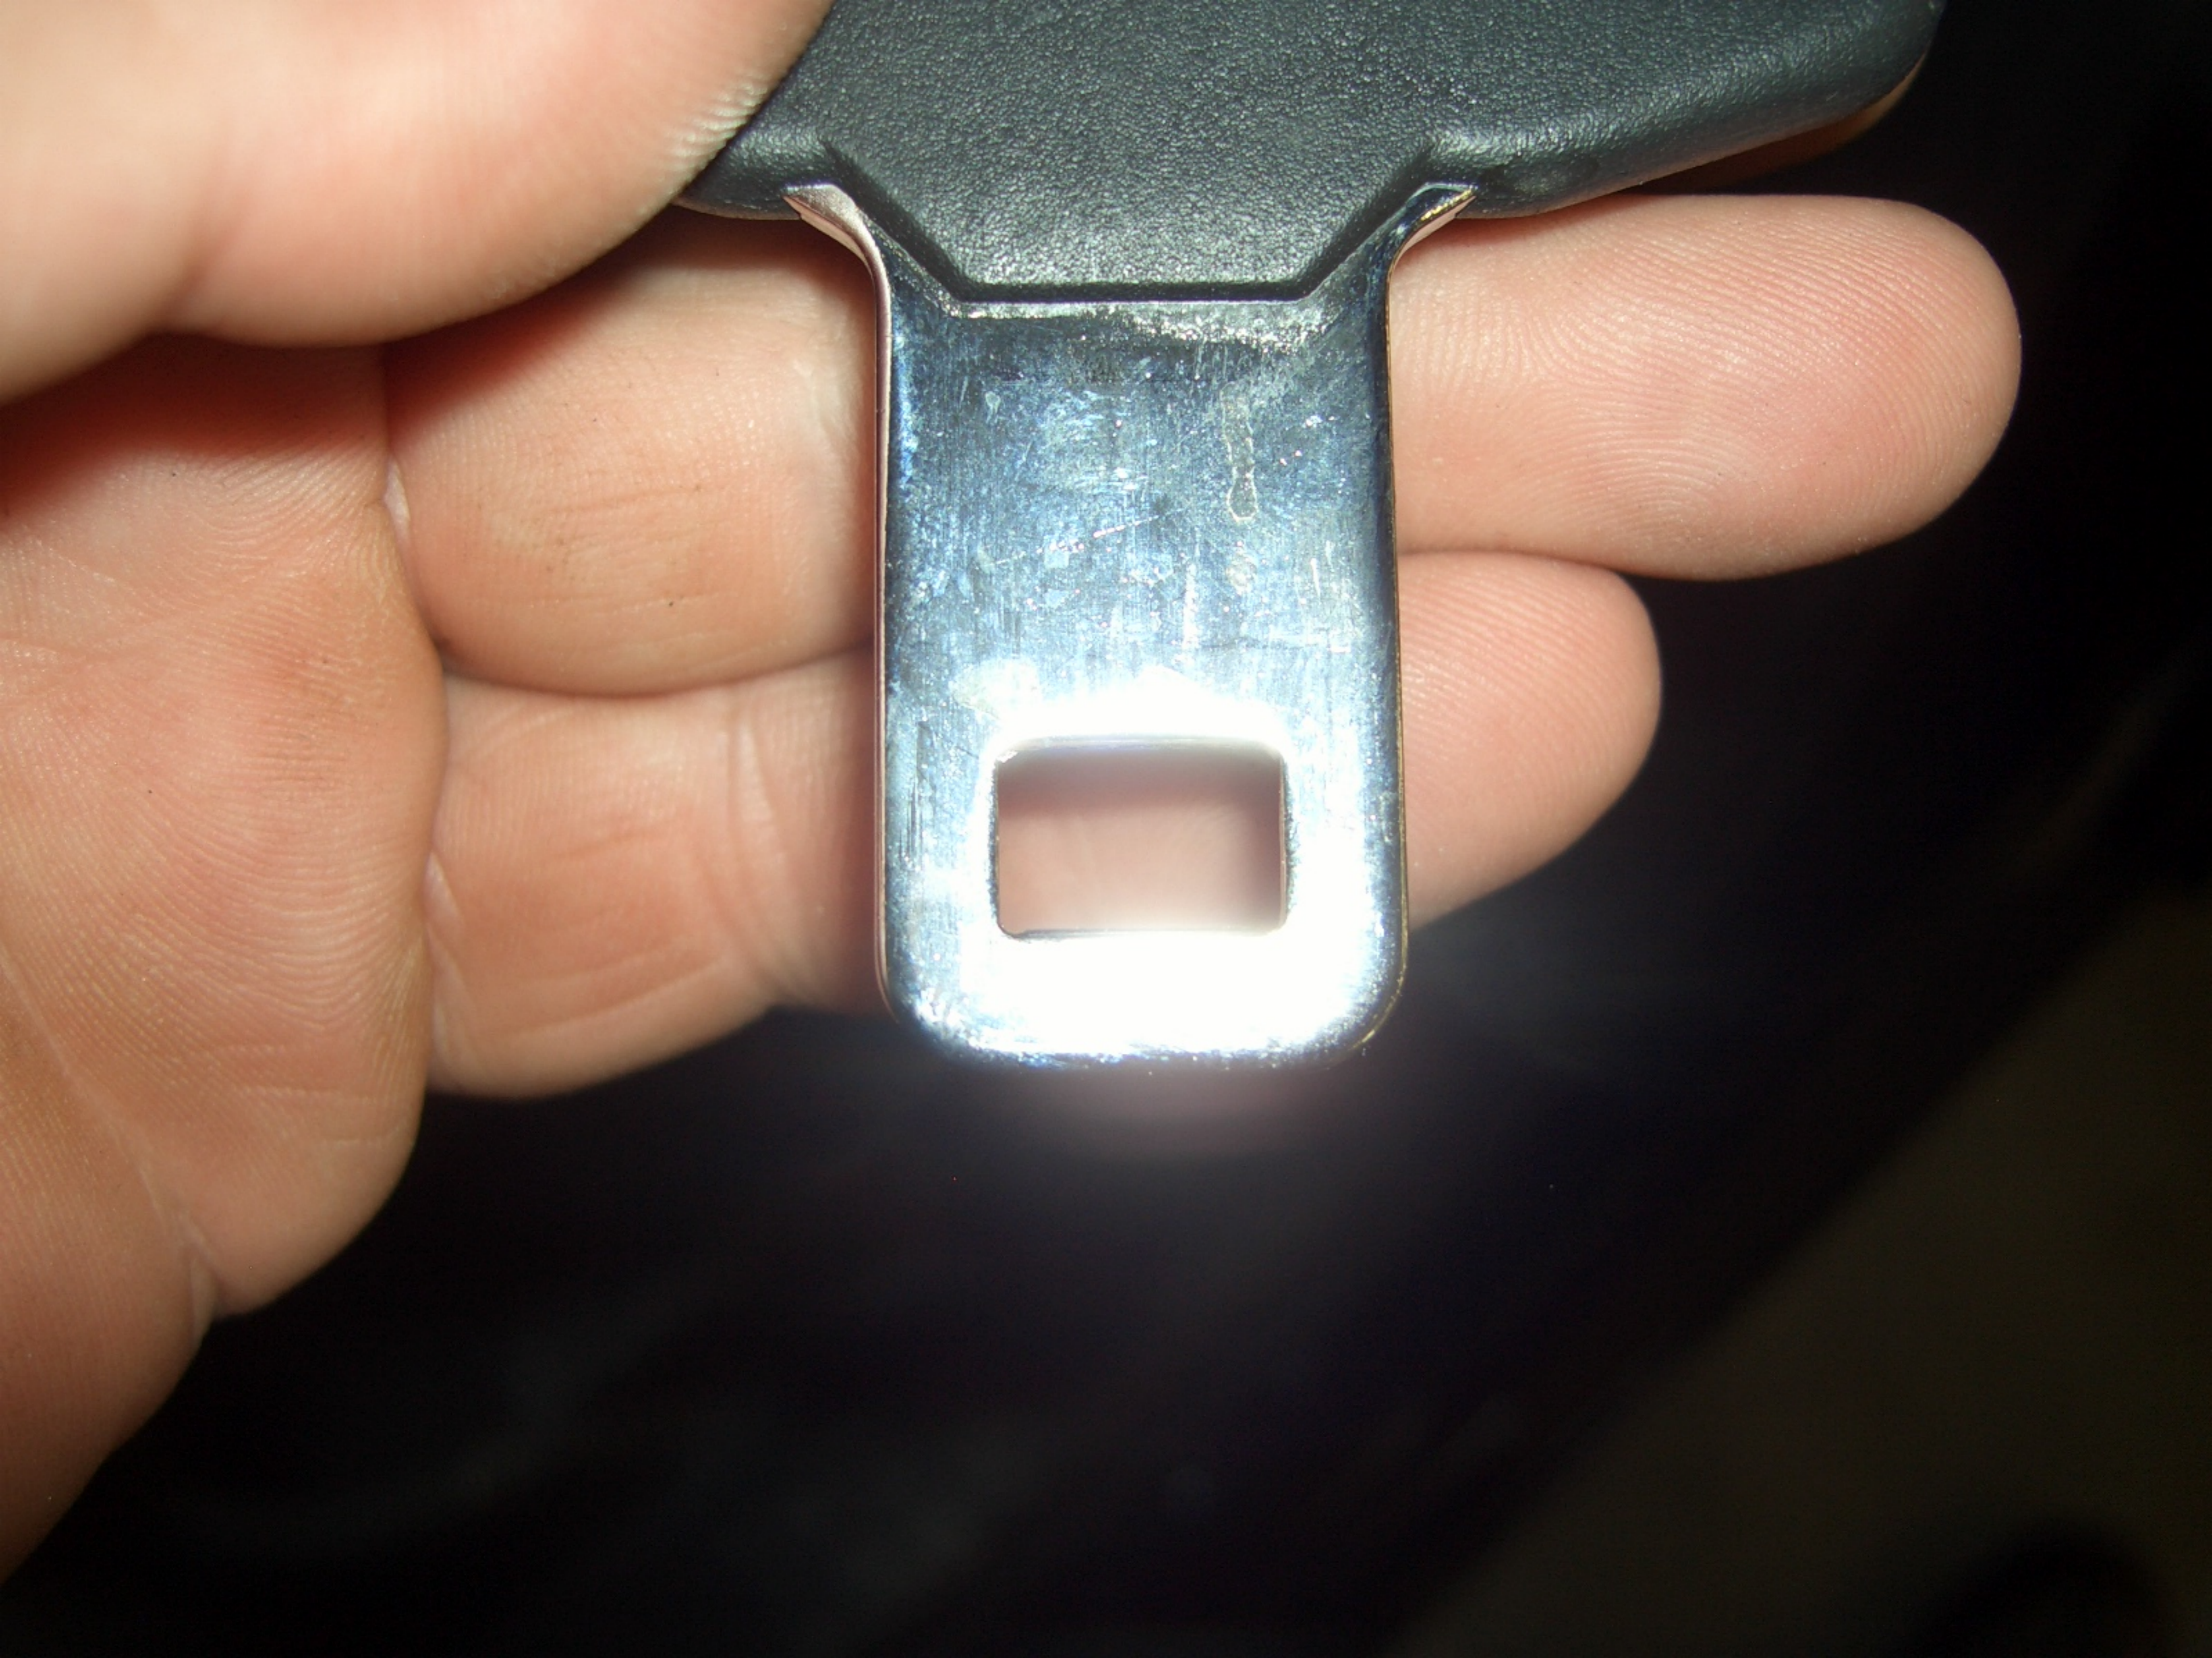
Driver TC082C Pass 2014

TRW

24076951

TC082A
