PE19-004

KIA

DEFECT B

**ORIGIN AND CAUSE INVESTIGATION:**

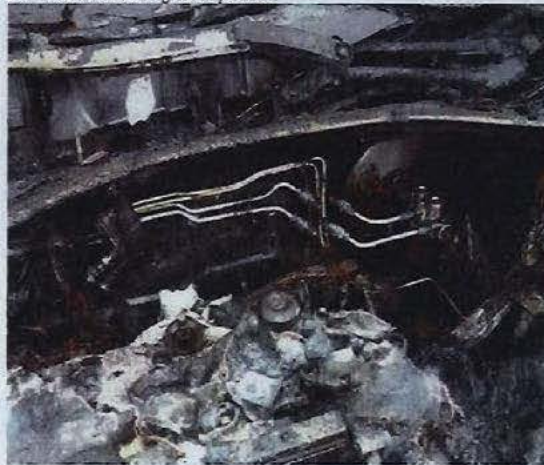
The inspection continues and is focused to the rear of the engine compartment where in the left rear factory wiring harnesses reveal wrapping charred and color coded wiring insulation still remaining. Factory rubber grommet to the left of the brake booster is also still basically intact. The examination of the right or passenger side reveals exposure fire damage to the ABS module and associated wiring. The wiring harness traveling along the rear of the engine compartment in the center is void of insulation. Further, the silencer pad material at the bulkhead in the center has been consumed. Consumption of air conditioning hoses, combustible brake hoses from the fittings within this area is noted. The examination reveals the heater hose connections with the remains of the hoses and clamps in place and the hoses partially consumed.

26. View of the rear engine compartment.

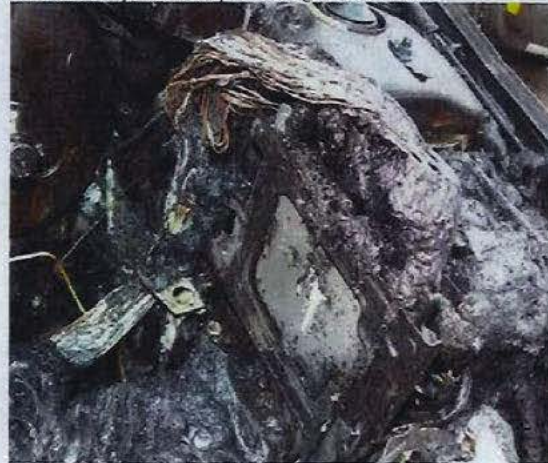
The inspection is focused to the electrical system on the left or driver side where exposure fire damage is noted to the fuse box, powertrain computer and battery. Plastic casing remains surrounding the fuse box and wiring traveling to same reveals color coded wiring insulation still intact. Wiring traveling to the power train computer inboard the fuse box reveals charred wrapping, charred wiring insulation and wires with color coded insulation still present and no

27. View of the engine compartment fuse box and wiring, driver's side.

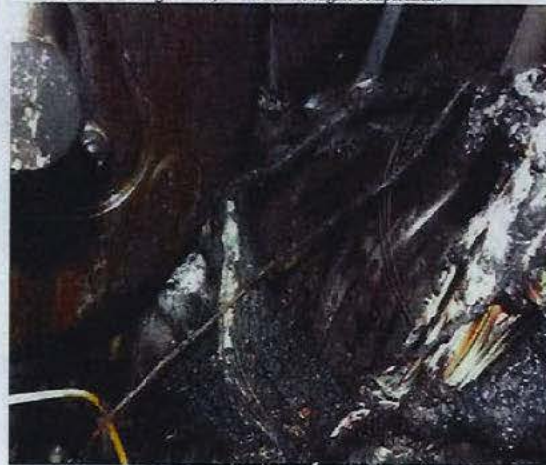
Further examination reveals foam padding with the Hyundai cover assy. imprint noted which is at this time lying in the area of the exhaust manifold and rear of the engine compartment. The inspection of same reveals an odor familiar to this Investigator as gasoline on the remains of the padding.

51. View of the rear of the engine to include the exhaust and foam padding.

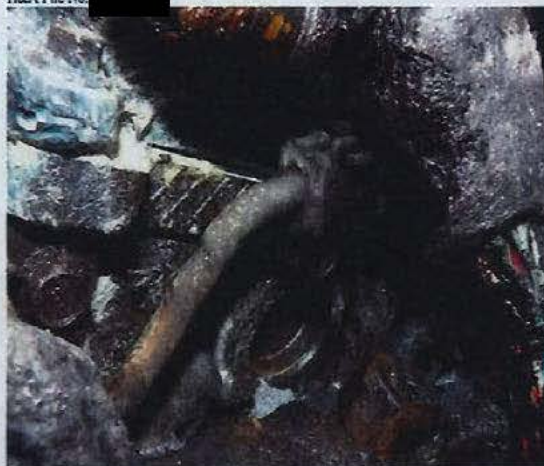
61. View of the routing of the metal fuel line along the left cylinder head toward the high pressure fuel pump.

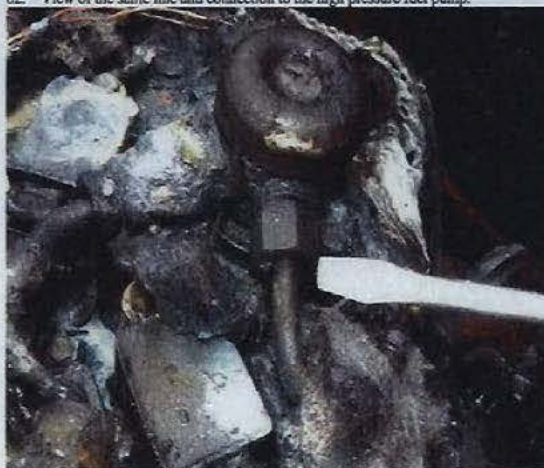
62. View of the same line and connection to the high pressure fuel pump.

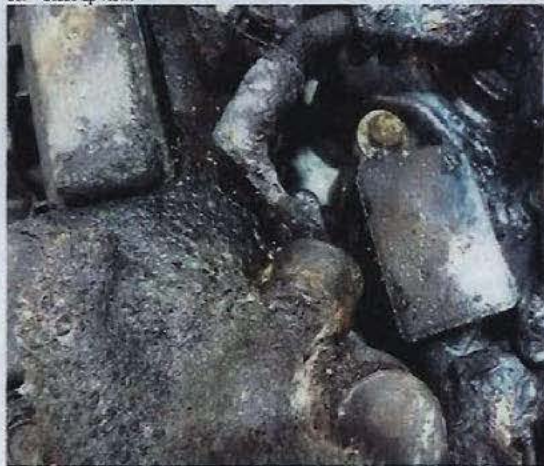
68. Close up view.

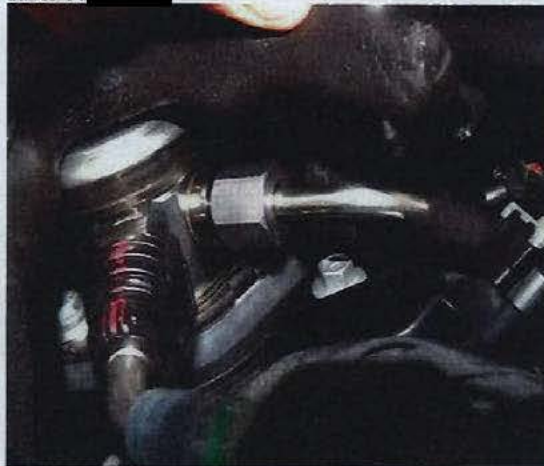
99. View of the fuel line which travels from the pump to the fuel rail.

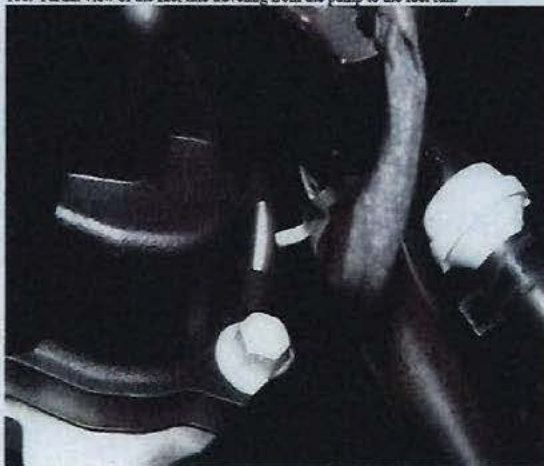
100. Partial view of the fuel line traveling from the pump to the fuel rail.
