PE19-004

KIA

OPTIMA

**ORIGIN AND CAUSE INVESTIGATION:**

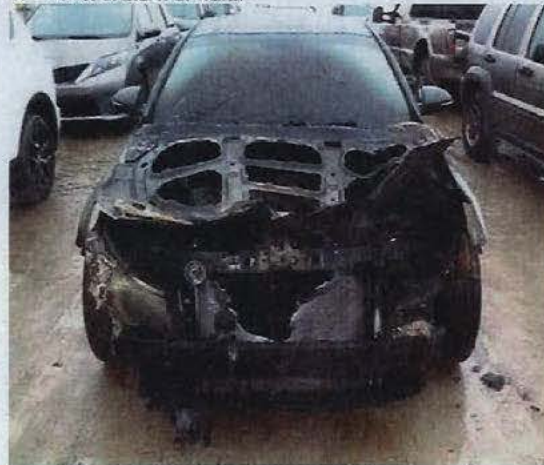
2. View of the front of the vehicle.

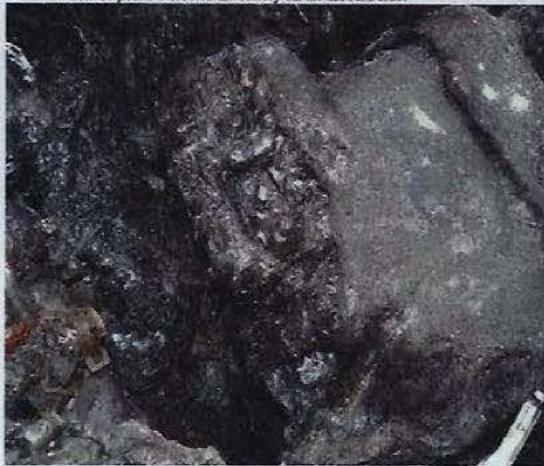
30. View of the positive side of the battery on the inboard side.

evidence of any fire origin. Inspection of the battery and the left front reveals exposure fire damage with plastic casing and a heat protector on the sides of the battery. The negative battery post on the outboard side is broken off and the cable is void of insulation. Combustibles surround the positive cable connection on the inboard side. Upon examining the battery cable wiring, the positive cable which travels to the starter at the front of the engine and alternator cable in the right front of the engine have made contact with a hose bracket in the area of the engine and transmission connection with electrical activity and fusing noted and the metal bracket melted in two. Further, branch wiring traveling over the top of the engine within this area reveals electrical activity present.

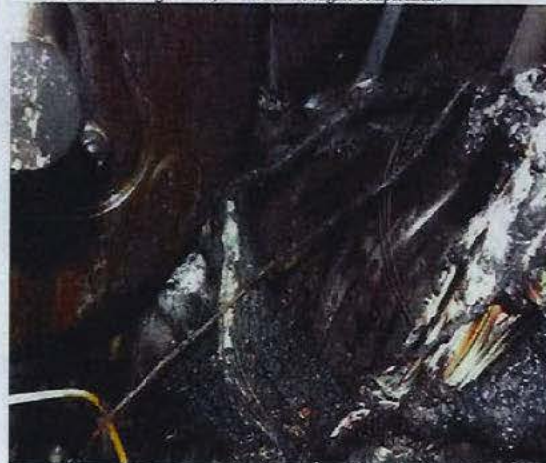
50. View of the wiring harness, left rear of the engine compartment.

The inspection continues and is focused to the rear of the engine compartment where in the left rear factory wiring harnesses reveal wrapping charred and color coded wiring insulation still remaining. Factory rubber grommet to the left of the brake booster is also still basically intact. The examination of the right or passenger side reveals exposure fire damage to the ABS module and associated wiring. The wiring harness traveling along the rear of the engine compartment in the center is void of insulation. Further, the silencer pad material at the bulkhead in the center has been consumed. Consumption of air conditioning hoses, combustible brake hoses from the fittings within this area is noted. The examination reveals the heater hose connections with the remains of the hoses and clamps in place and the hoses partially consumed.

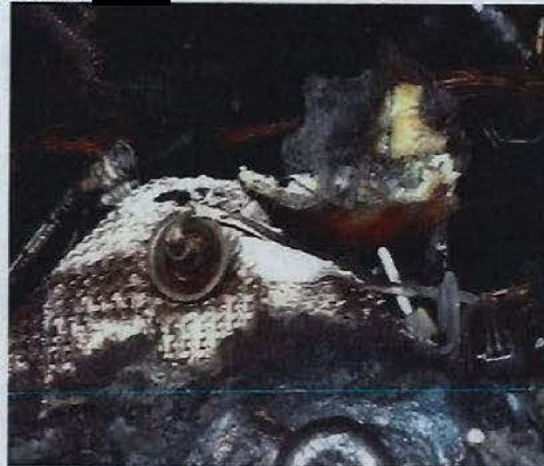
51. View of the rear of the engine to include the exhaust and foam padding.

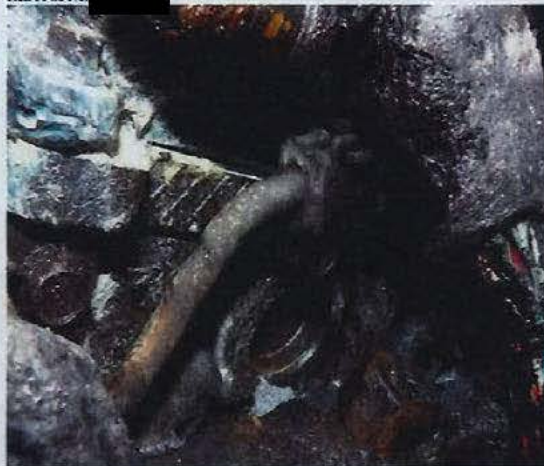
61. View of the routing of the metal fuel line along the left cylinder head toward the high pressure fuel pump.

The investigation is now focused to the top of the engine where there is the remains of fiberglass material covering the valve cover on the passenger side where the oil fill cap is still in place. The examination reveals the fire damage to the engine is most pronounced on the left or driver side as indicated by the lack of fiberglass material covering areas of the driver side of the valve cover and top of the engine and melting to the aluminum heat shielding for the exhaust manifold and catalytic converter at the rear of the engine. The examination is focused to the fuel system where the combustible fuel line at the bulkhead to the left of the exhaust has melted off and been

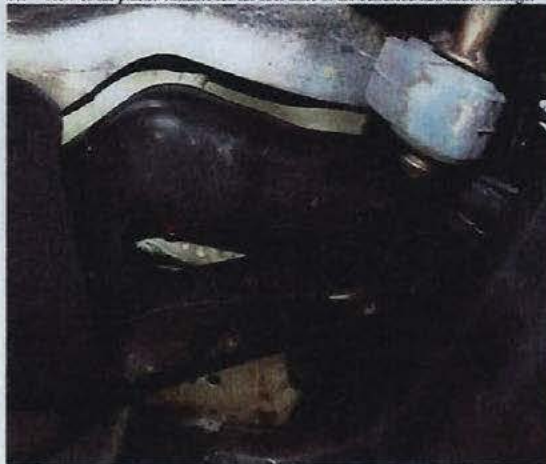
80. View of the plastic channel for the fuel lines at the bulkhead and undercarriage.

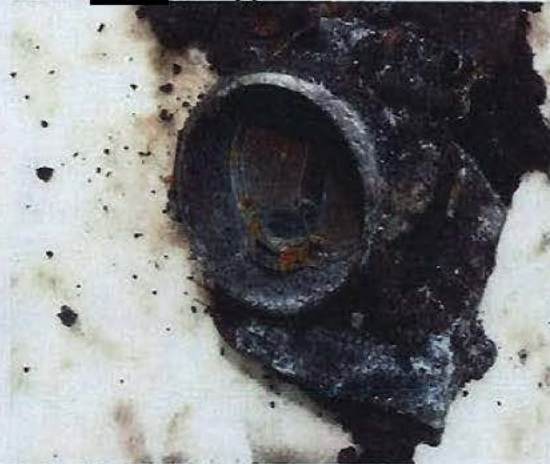
5. View of the throttle body.

On January 27, 2017 vehicle parts were retrieved from the fire scene; [REDACTED] Hillsdale, MI. Located at the scene were: a light bulb assembly, the cooling fan motor and wiring and the throttle body. Inspection of these items reveal exposure fire damage and no evidence of fire origin. Further, the items were placed in the vehicle at Copart on January 31, 2017. (See enclosed photographs)

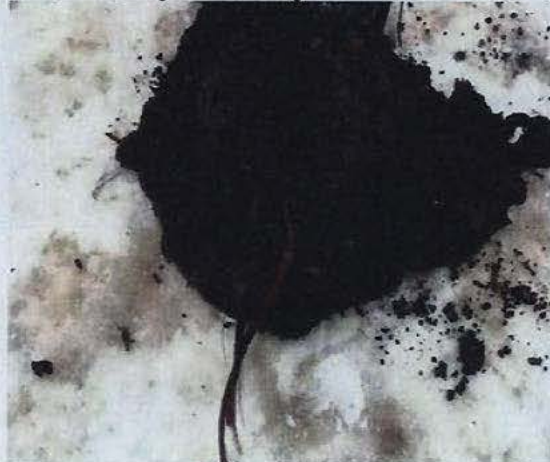
6. View of the cooling fan motor and wiring.
