PE19-004

KIA

OPTIMA

**ORIGIN AND CAUSE INVESTIGATION:**

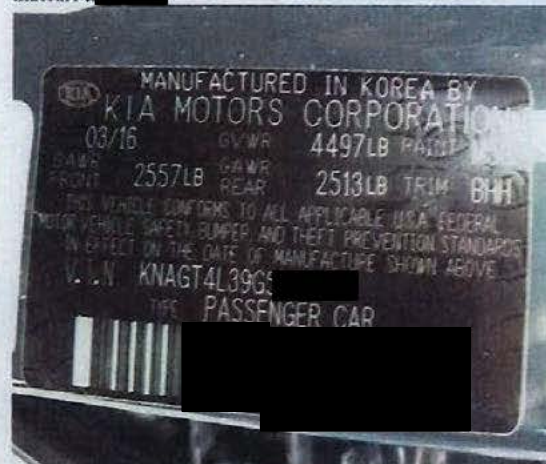
1. View of the Federal Manufacturers Label secured to the driver B-pillar.

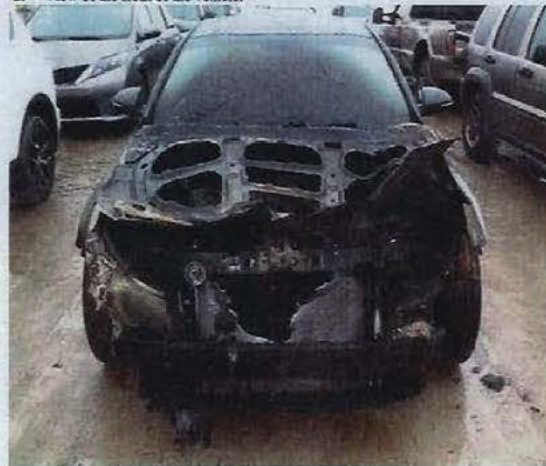
2. View of the front of the vehicle.

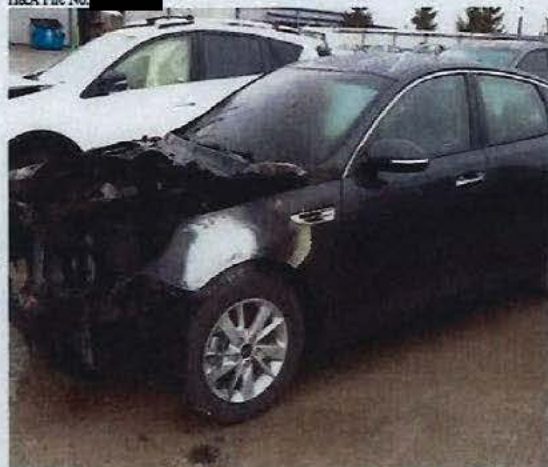
3. View of the left front and driver's side.

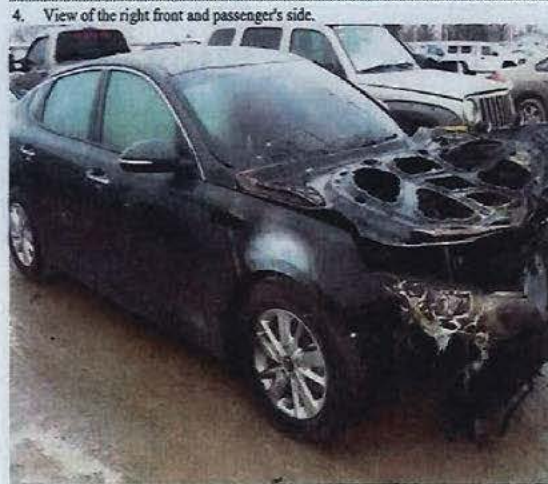
4. View of the right front and passenger's side.

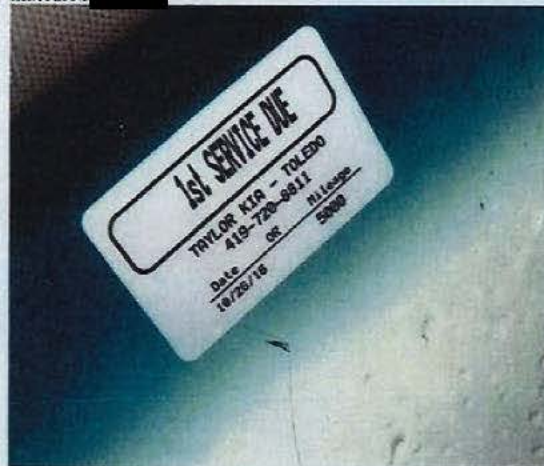
9. View of the oil change sticker.

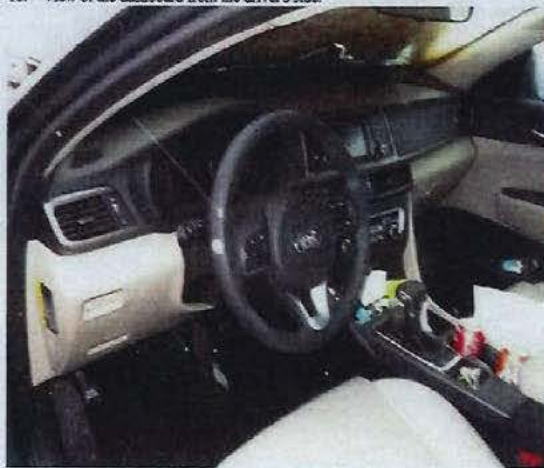
10. View of the dashboard from the driver's side.

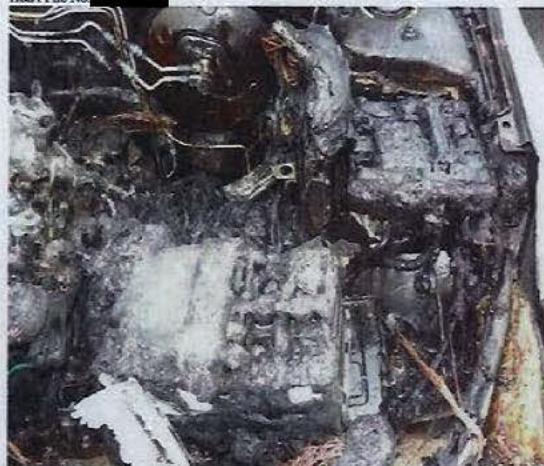
21. View of the driver's side engine compartment from the front.

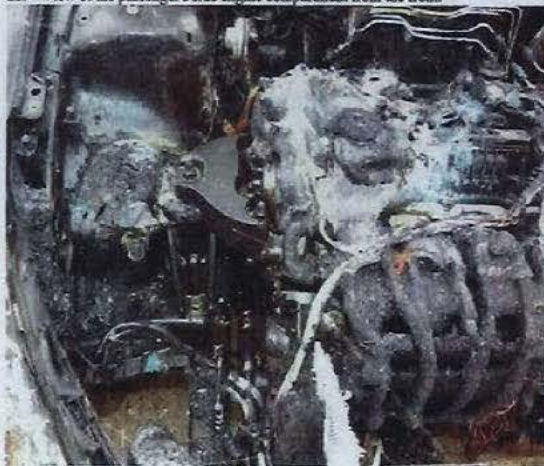
22. View of the passenger's side engine compartment from the front.

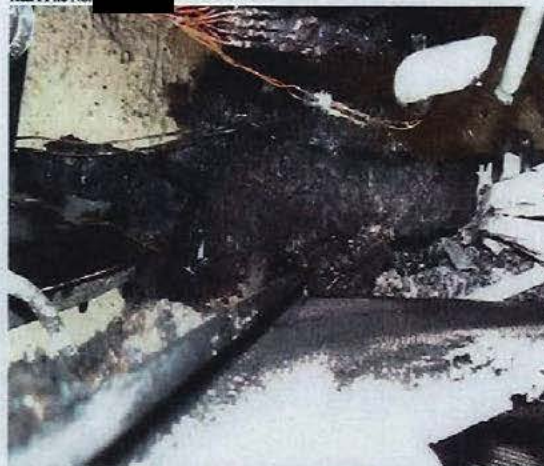
43. View of the lower radiator hose connection, right side of the radiator.

The examination is focused to the front of the engine compartment where melting is present to center of the aluminum air conditioning condenser and radiator. The lower radiator hose is still connected to the radiator on the passenger side and much of the upper radiator hose is still present on the left side of the engine. The examination continues and the cooling fan motor is not located at this time, wiring on the left or driver side reveals it is void of insulation but no evidence of any electrical activity is found. The examination further reveals the oil filter secured at the front of the engine with the hoses traveling to the oil cooler partially consumed with the hose clamps still in place.

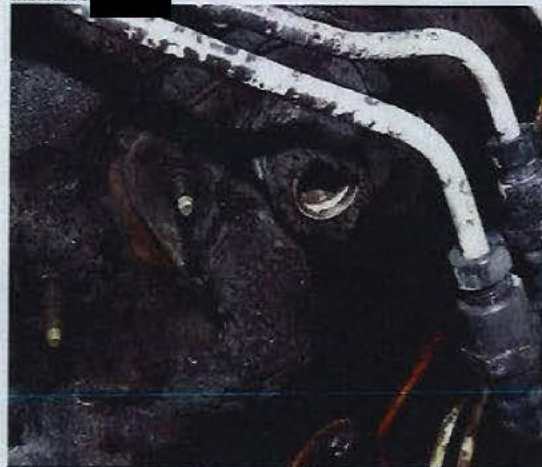
49. View of the heater hoses connections at the bulkhead.

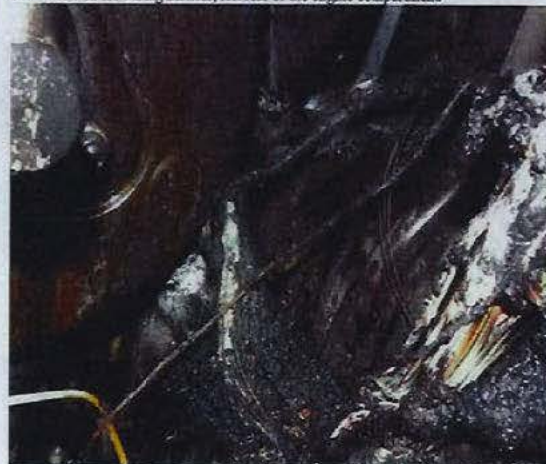
50. View of the wiring harness, left rear of the engine compartment.

The inspection continues and is focused to the rear of the engine compartment where in the left rear factory wiring harnesses reveal wrapping charred and color coded wiring insulation still remaining. Factory rubber grommet to the left of the brake booster is also still basically intact. The examination of the right or passenger side reveals exposure fire damage to the ABS module and associated wiring. The wiring harness traveling along the rear of the engine compartment in the center is void of insulation. Further, the silencer pad material at the bulkhead in the center has been consumed. Consumption of air conditioning hoses, combustible brake hoses from the fittings within this area is noted. The examination reveals the heater hose connections with the remains of the hoses and clamps in place and the hoses partially consumed.

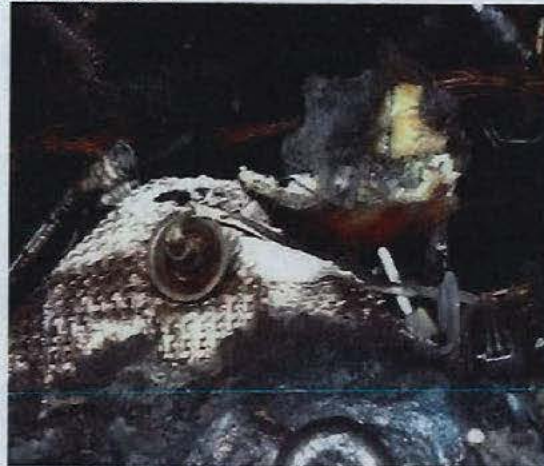
51. View of the rear of the engine to include the exhaust and foam padding.

Further examination reveals foam padding with the Hyundai cover assy. imprint noted which is at this time lying in the area of the exhaust manifold and rear of the engine compartment. The inspection of same reveals an odor familiar to this Investigator as gasoline on the remains of the padding.

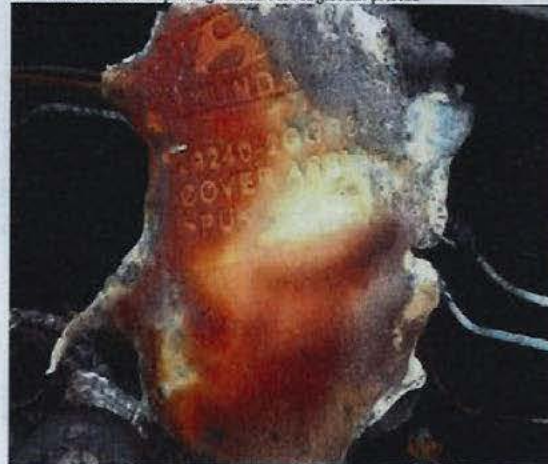
52. View of said foam padding with an odor of gasoline present.

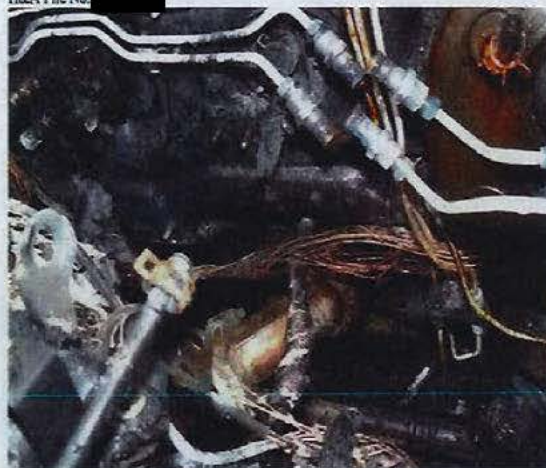
53. View of the center of the bulkhead.

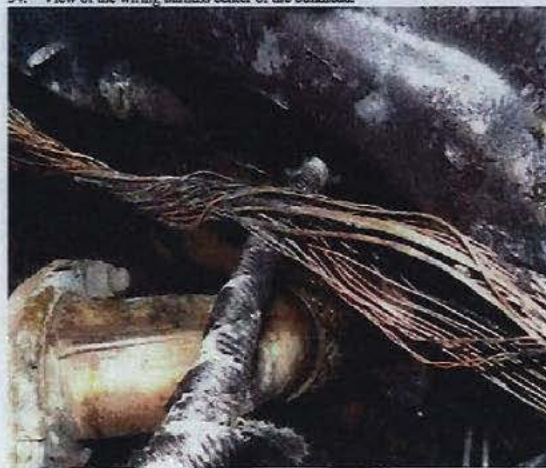
54. View of the wiring harness center of the bulkhead.

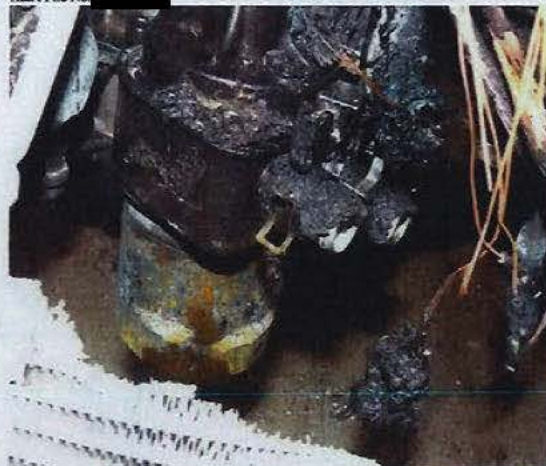
55. View of the oil filter, front of engine.

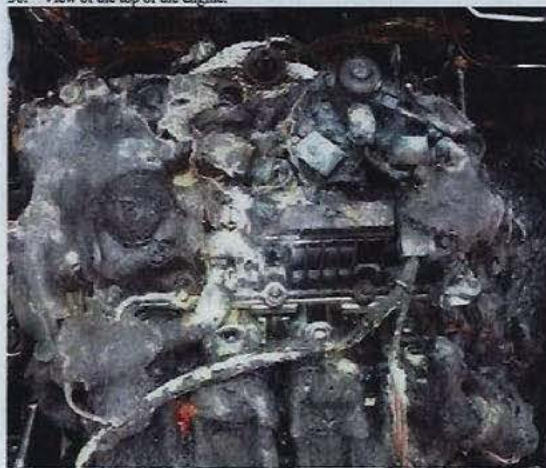
56. View of the top of the engine.

The investigation is now focused to the top of the engine where there is the remains of fiberglass material covering the valve cover on the passenger side where the oil fill cap is still in place. The examination reveals the fire damage to the engine is most pronounced on the left or driver side as indicated by the lack of fiberglass material covering areas of the driver side of the valve cover and top of the engine and melting to the aluminum heat shielding for the exhaust manifold and catalytic converter at the rear of the engine. The examination is focused to the fuel system where the combustible fuel line at the bulkhead to the left of the exhaust has melted off and been

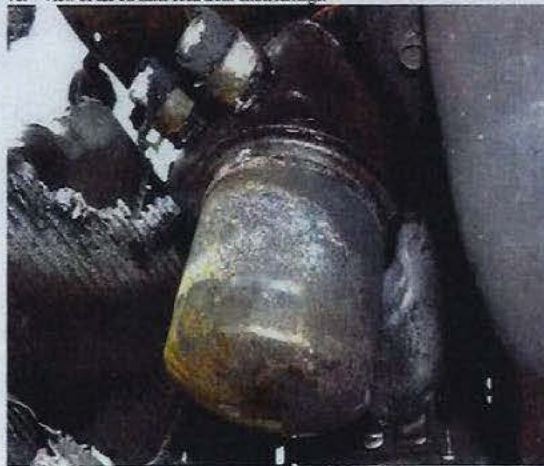
78. View of the oil filter seen from underneath.

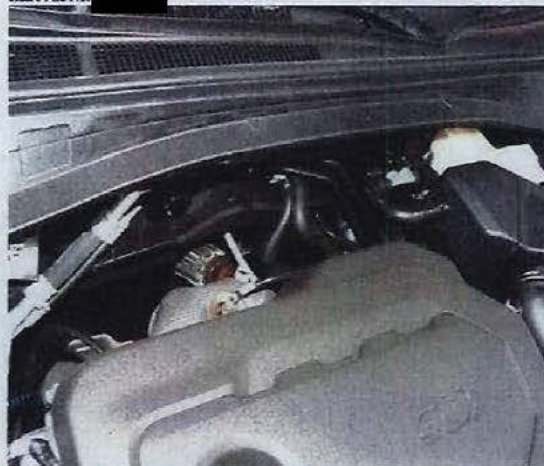
91. View of the rear of the engine compartment.

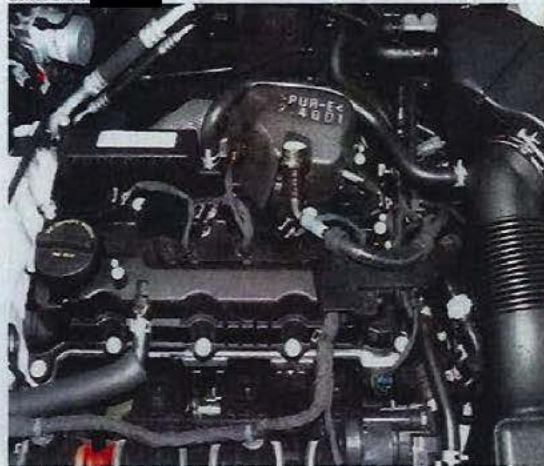
95. View of the top of the engine with the engine cover off.

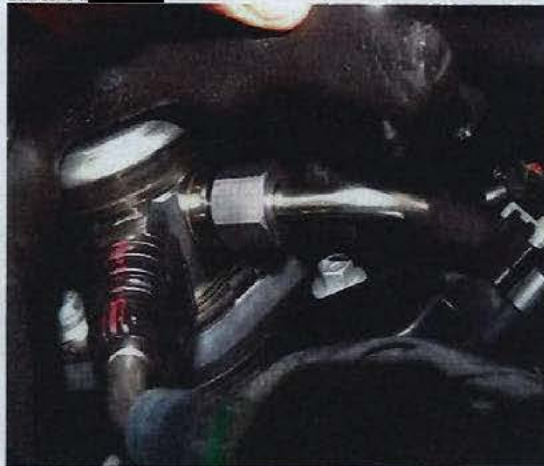
99. View of the fuel line which travels from the pump to the fuel rail.

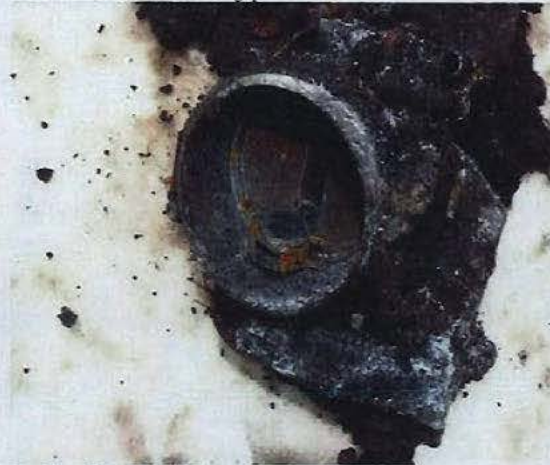
5. View of the throttle body.

On January 27, 2017 vehicle parts were retrieved from the fire scene; [REDACTED] Hillsdale, MI. Located at the scene were: a light bulb assembly, the cooling fan motor and wiring and the throttle body. Inspection of these items reveal exposure fire damage and no evidence of fire origin. Further, the items were placed in the vehicle at Copart on January 31, 2017. (See enclosed photographs)

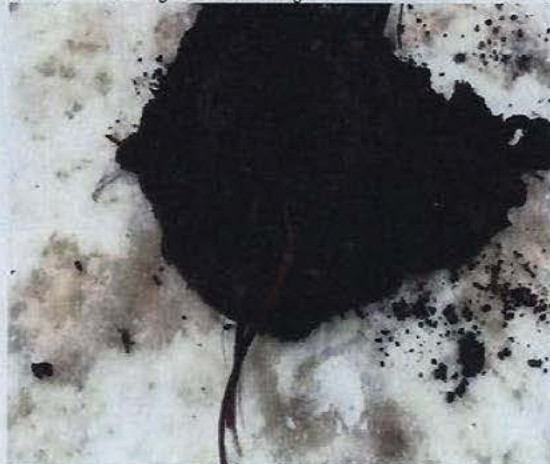
6. View of the cooling fan motor and wiring.
