DUTEAU
Driven by you.

TERMS	VEHICLE ID NO. JF2SJADC4G	YEAR/MAKE/MODEL 16/SUBARU/FORESTER/4DR 2.5I PREM AT	PRODUCTION DATE	STOCK NO.	LICENSE NO. TMI818
CASH <input type="checkbox"/>	[REDACTED]	[REDACTED]	[REDACTED]	[REDACTED]	[REDACTED]
CREDIT CARD <input type="checkbox"/>	[REDACTED]	[REDACTED]	[REDACTED]	[REDACTED]	[REDACTED]
CHCK <input type="checkbox"/>	[REDACTED]	[REDACTED]	[REDACTED]	[REDACTED]	[REDACTED]
PRIOR APPROVAL <input type="checkbox"/>	[REDACTED]	[REDACTED]	[REDACTED]	[REDACTED]	[REDACTED]
OTHER <input type="checkbox"/>	LINCOLN, NE [REDACTED]	[REDACTED]	[REDACTED]	[REDACTED]	[REDACTED]
CALL WHEN READY <input type="checkbox"/> YES <input type="checkbox"/> NO	[REDACTED]	[REDACTED]	[REDACTED]	[REDACTED]	[REDACTED]
SAVE REMOVED PARTS FOR CUSTOMER <input type="checkbox"/> YES <input type="checkbox"/> NO	[REDACTED]	[REDACTED]	[REDACTED]	[REDACTED]	[REDACTED]
APPOINTMENT <input type="checkbox"/> YES <input checked="" type="checkbox"/> NO	04:31pm	05/02/17	06:15pm	PRIORITY	LABOR RATE 114.00

1 W*26CVZ1TRIM INT/EXT TRIM
 INSTALL PASSENGER SEAT BOTTOM PER PREVIOUS DIAGNOSIS.

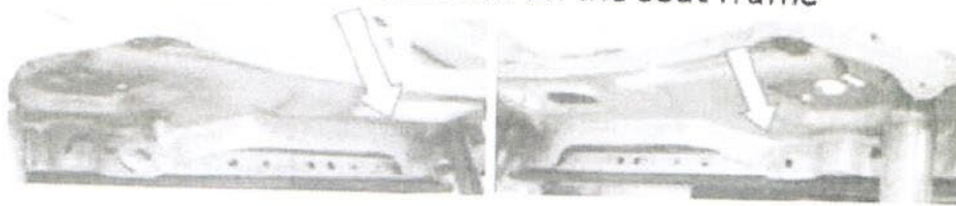
Evidence of rust seen on the seat frame

Replaced seat vented operation.

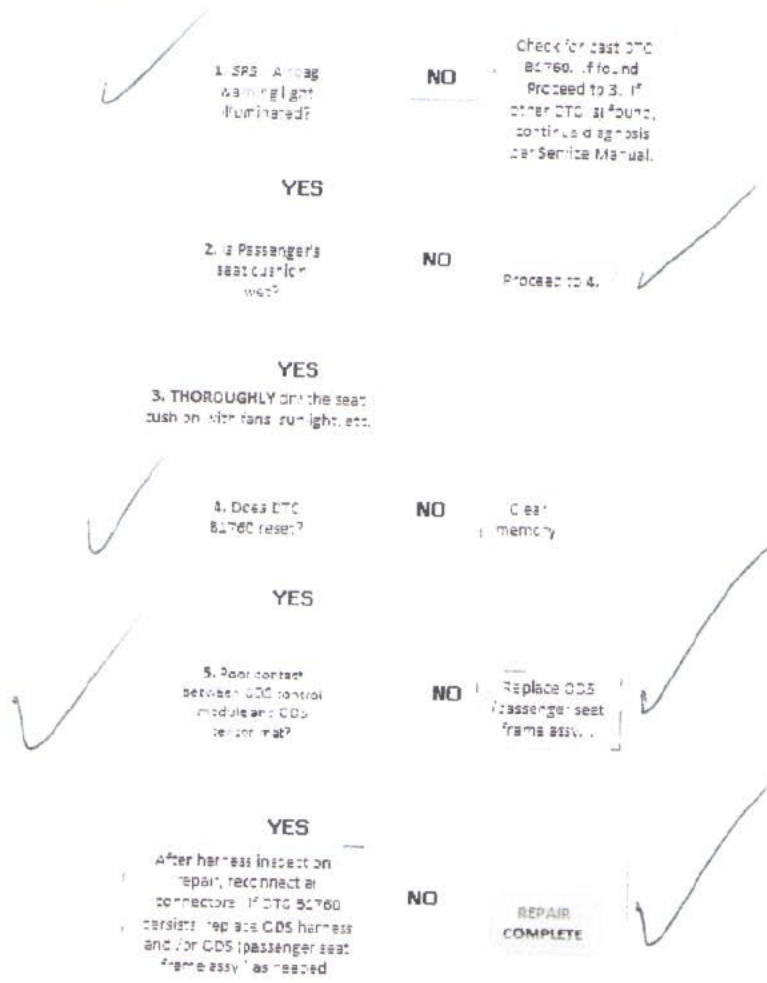
B1760 FLOW CHART

BIT60 code present and would reset.
 Nothing was found wet and all connectors tested ok. TSB 07-08-16 flow chart attached.
