Condition	General Motors has decided that a defect, which relates to motor vehicle safety, exists in 2014-2016 model year Chevrolet Caprice Police Pursuit Vehicles (PPVs) and Chevrolet SS vehicles. The flexible steel cable that connects the safety belt to the vehicle at the outside of the front driver seat can fatigue and separate over time if the driver's movement into the seat repeatedly bends the steel seat belt cable down against the seat edge. In a crash, a fatigued cable could break, reducing the effectiveness of the vehicle's safety belts and increasing the risk of injury to the occupant.
Correction	Dealers will replace the driver side front seat cushion outer finish cover, install a driver side front seat belt anchor plate tensioner bracket and inspect the vehicle to determine if the front seat belt anchor plate tensioner assembly is worn, and also requires replacement.

Product Safety Recall
31340 Seatbelt Lap Anchor Tensioner Cable

SAFETY BELT CABLE SLEEVE INSPECTION PROCEDURE FOR RECALL 31340

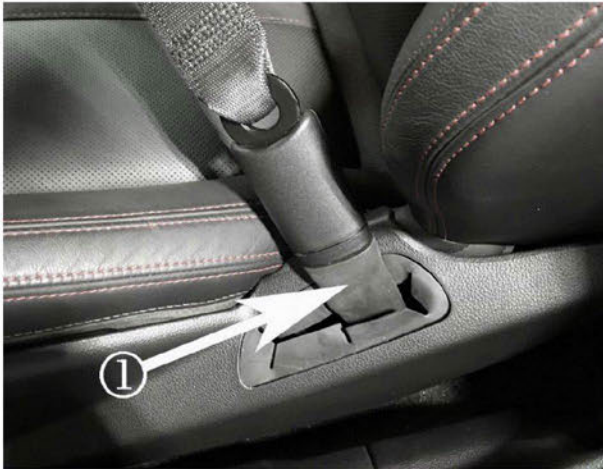
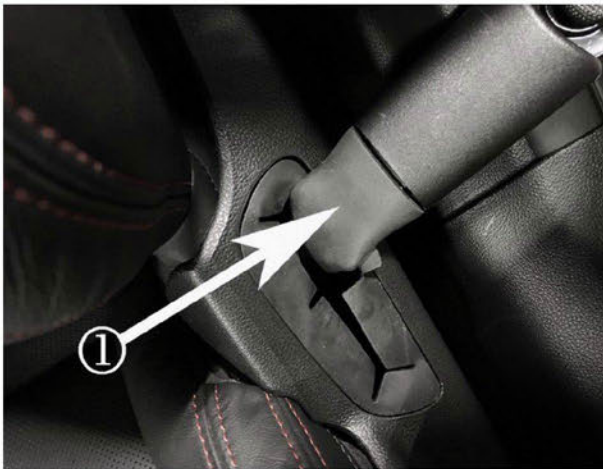
4593189

1. Using the seat adjustment switch, move the driver seat as far rearward and downward as possible. The front safety belt cable sleeve (hereinafter, "sleeve") covers the flexible steel cable that connects the safety belt to the vehicle at the front outside seating position. The sleeve is covered by the seat trim and comes out of the slot on the side of the front seat.

2. Inspect the sleeve for any cuts or cracks. Bend the cable toward the inside and outside of the vehicle and inspect the area near arrows (1) above.

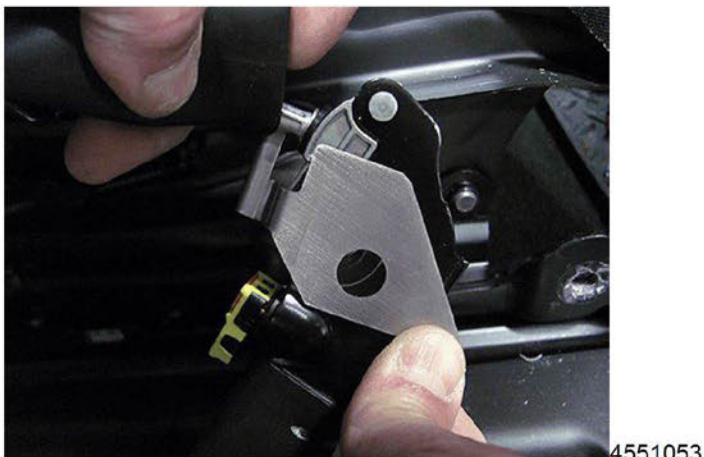
1. Disable the SIR. Refer to *SIR Disabling and Enabling* in SI.
2. Using a Torx bit along with a ratcheting box end wrench, remove the anchor plate tensioner mounting bolt. The retaining washer can be discarded, it does not need to be reinstalled. Refer to *Front Seat Belt Anchor Plate Tensioner Replacement* in SI.

3. Install the service bracket as shown.

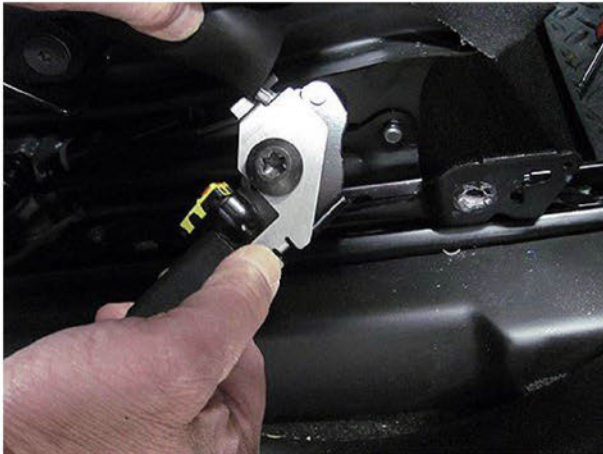
4551062

5. Assemble the tensioner assembly, service bracket and bolt.

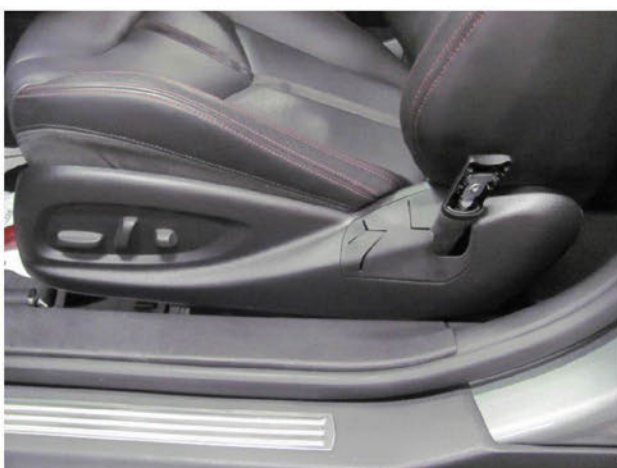
4593195

10. Complete the installation of the seat belt anchor plate tensioner cover, new redesigned seat cushion outer finish cover and anchor plate to seat belt bolt assembly. Refer to *Front Seat Belt Anchor Plate Tensioner Replacement* in SI.
11. Enable the SIR. Refer to *SIR Disabling and Enabling* in SI.

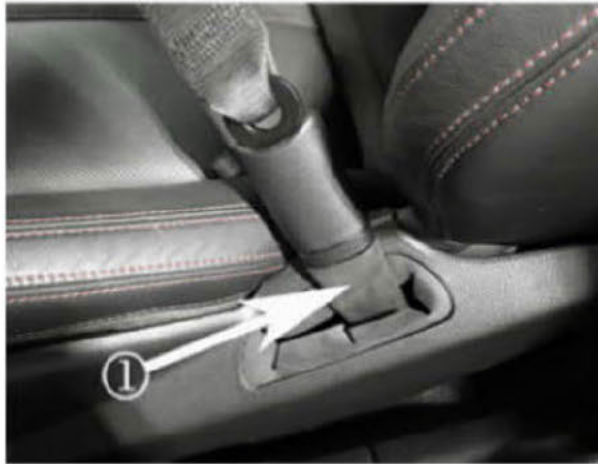
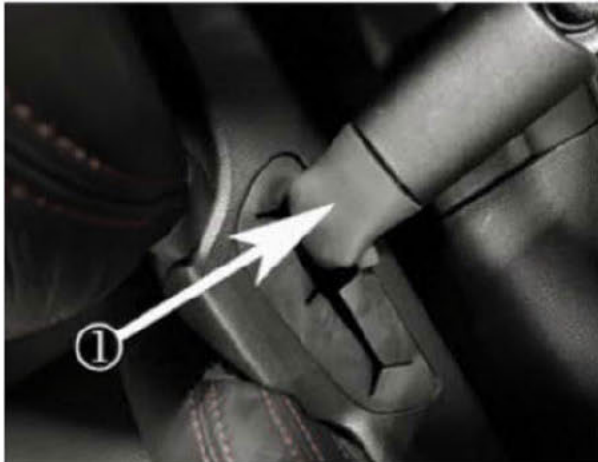
1. Using the seat adjustment switch, move the driver seat as far rearward and downward as possible. The front safety belt cable sleeve (hereinafter, "sleeve") covers the flexible steel cable that connects the safety belt to the vehicle at the front outside seating position. The sleeve is covered by the seat trim and comes out of the slot on the side of the front seat.

2. Inspect the sleeve for any cuts or cracks. Bend the cable toward the inside and outside of the vehicle and inspect the area near arrows (1) above.

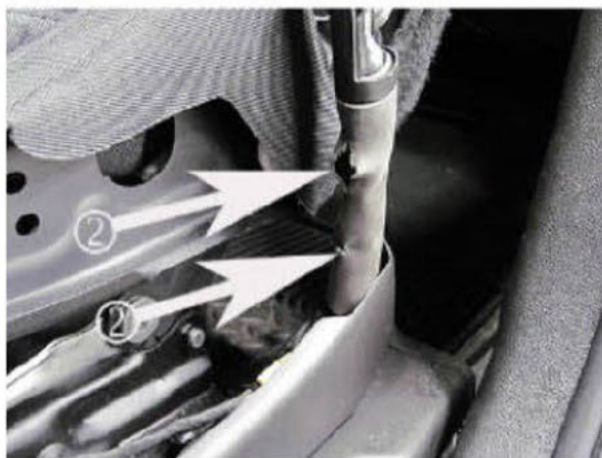
This damage will be in the form of holes (1) or splitting (2).

- If **any damage** is found, replace the tensioner with the revised tensioner and seat trim listed above. The tensioner bracket is not required. Refer to *Front Seat Belt Anchor Plate Tensioner Replacement* in SI.
- If no damage is found, install the seat tensioner bracket using the existing tensioner. Follow the steps in the Bracket Installation section below.

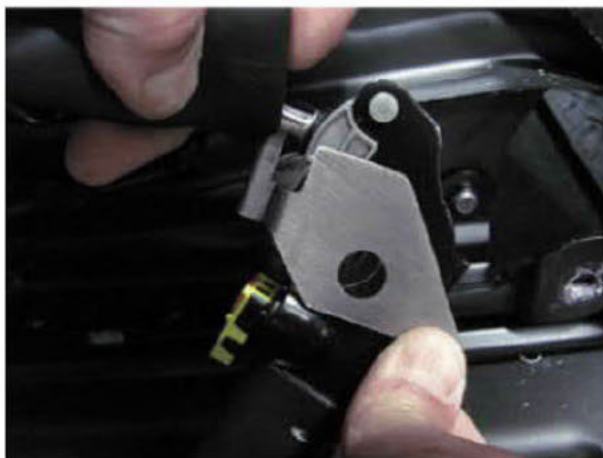
3. Install the service bracket as shown.

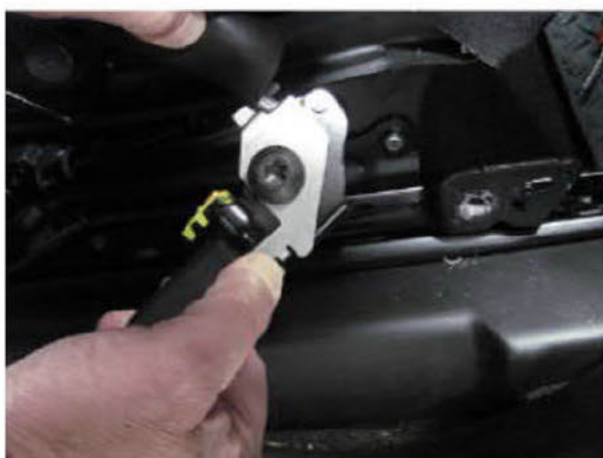
- Assemble the tensioner assembly, service bracket and bolt

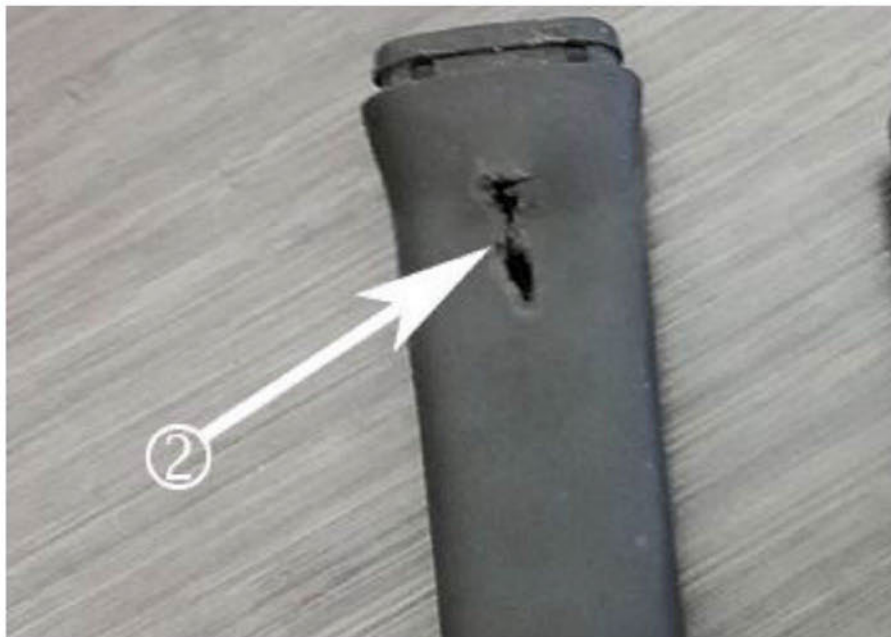
1. Using the seat adjustment switch, move the driver seat as far rearward and downward as possible. The front safety belt cable sleeve (hereinafter, "sleeve") covers the flexible steel cable that connects the safety belt to the vehicle at the front outside seating position. The sleeve is covered by the seat trim and comes out of the slot on the side of the front seat.
2. Inspect the sleeve for any cuts or cracks. Bend the cable toward the inside and outside of the vehicle and inspect the area near arrows (1) above. The sleeve shown below (2) requires replacement as a hole has worn through the sleeve.

- If the driver sleeve shows any cuts, cracks or wear through, please stop driving your vehicle and immediately contact your GM dealer. Your dealer will arrange for your vehicle to be towed to the dealership at no charge and provide you with a free loaner vehicle while the damaged safety belt assembly is replaced. **Note that this replacement is a temporary repair and your vehicle will still need to be serviced when parts are available.**
- If the driver sleeve shows no visible cuts or cracks, no further action is required until you receive a second letter from GM asking you to take your vehicle to your dealer for the permanent repair.
