CARFAX Vehicle History Report for this 2015 CHEVROLET SS: 6G3F15RW9FL

**Product Safety Recall**  
N202312100 Seat Belt Cable Separation – US Only

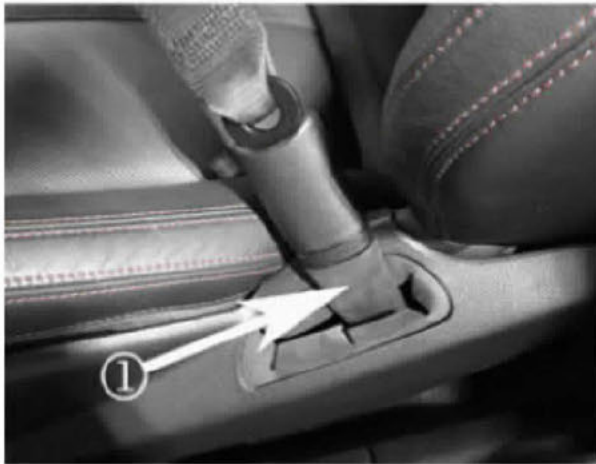
1. Using the seat adjustment switch, move the driver seat as far rearward and downward as possible. The front safety belt cable sleeve (hereinafter, "sleeve") covers the flexible steel cable that connects the safety belt to the vehicle at the front outside seating position. The sleeve is covered by the seat trim and comes out of the slot on the side of the front seat.

2. Inspect the sleeve for any cuts or cracks. Bend the cable toward the inside and outside of the vehicle and inspect the area near arrows (1) above.

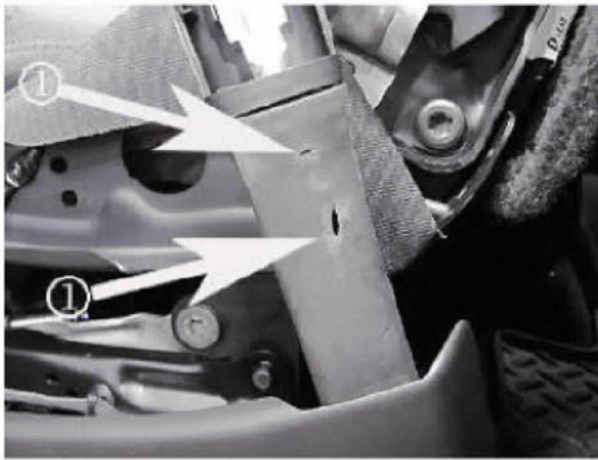
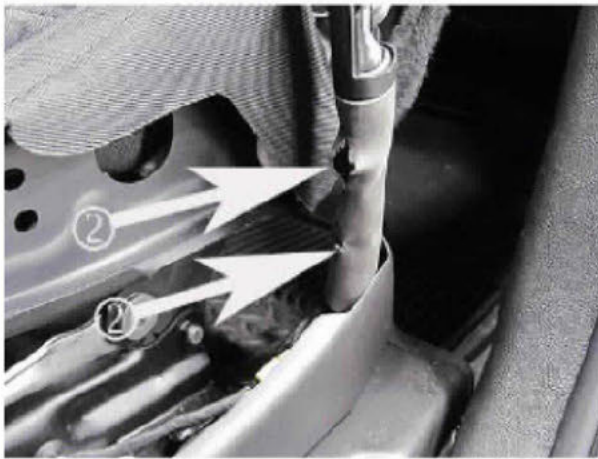
This damage will be in the form of holes (1) or splitting (2).

- If **any damage** is found, replace the tensioner with the revised tensioner and seat trim listed above. The tensioner bracket is not required. Refer to *Front Seat Belt Anchor Plate Tensioner Replacement* in SI.
- If no damage is found, install the seat tensioner bracket using the existing tensioner. Follow the steps in the Bracket Installation section below.

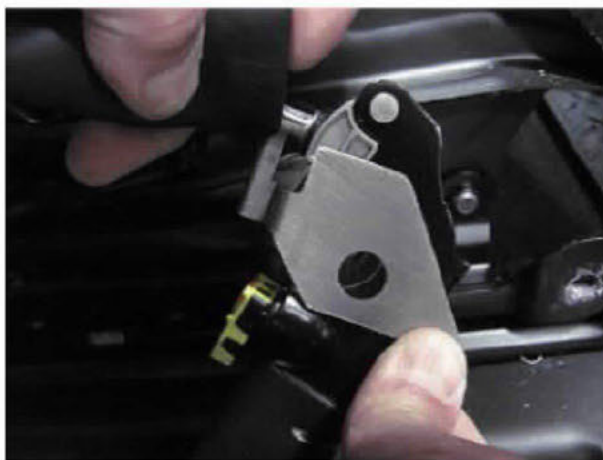
1. Disable the SIR. Refer to *SIR Disabling and Enabling* in SI.
2. Using a Torx bit along with a ratcheting box end wrench, remove the anchor plate tensioner mounting bolt. The retaining washer can be discarded, it does not need to be reinstalled. Refer to *Front Seat Belt Anchor Plate Tensioner Replacement* in SI.

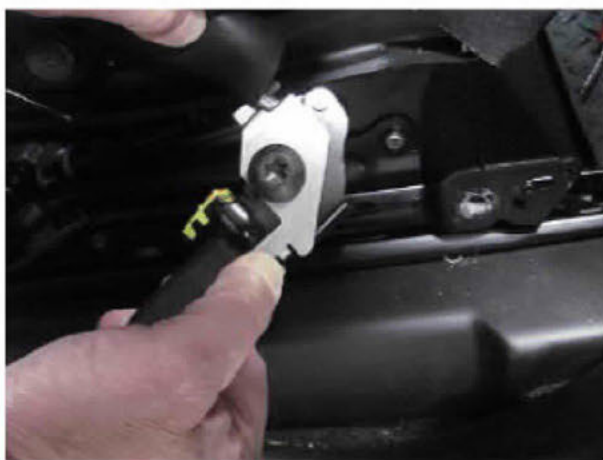
4. Insure the tensioner cable is positioned on the outside of the tab on the bracket.

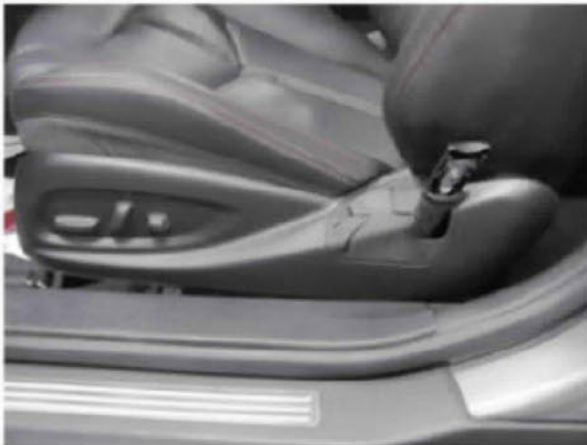
6. Start the bolt and insure the lower tab on the bracket is correctly positioned in the notch on the seat track.
7. Verify the bolt is seated properly (1), the cable position is correct (2) and the lower tab is correctly positioned (3).
8. Tighten the mounting bolt: **Tighten** 42 Nm (31 lb ft).
9. Transfer the power seat switch assembly from the existing seat cushion outer finish cover. Refer to *Front Seat Cushion Outer Finish Cover Replacement* in SI.

10. Complete the installation of the seat belt anchor plate tensioner cover, new redesigned seat cushion outer finish cover and anchor plate to seat belt bolt assembly. Refer to *Front Seat Belt Anchor Plate Tensioner Replacement* in SI.
11. Enable the SIR. Refer to *SIR Disabling and Enabling* in SI.

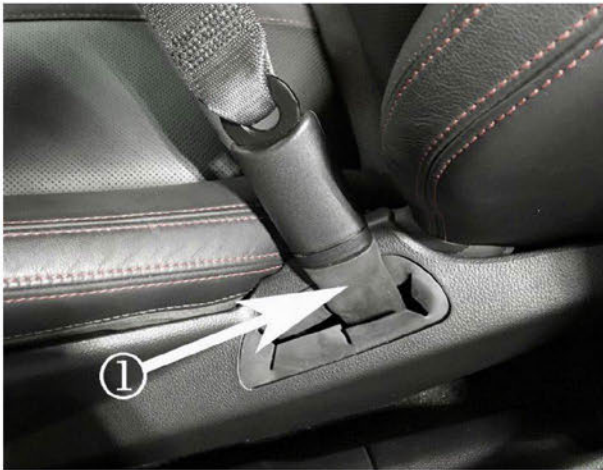
4593189

1. Using the seat adjustment switch, move the driver seat as far rearward and downward as possible. The front safety belt cable sleeve (hereinafter, “sleeve”) covers the flexible steel cable that connects the safety belt to the vehicle at the front outside seating position. The sleeve is covered by the seat trim and comes out of the slot on the side of the front seat.

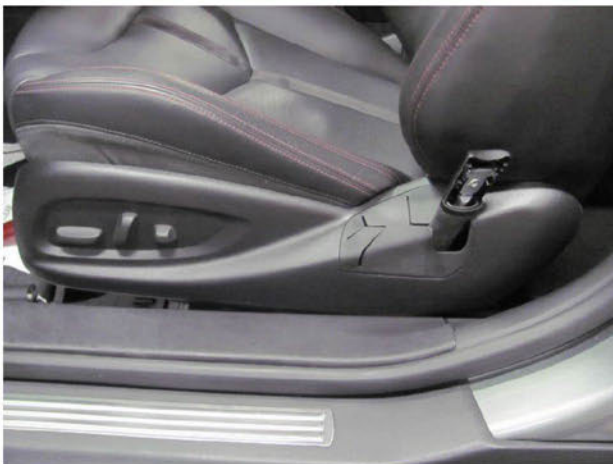
4593195

**SEAT CUSHION OUTER FINISH COVER INSTALLATION**

Transfer the power seat switch assembly from the existing seat cushion outer finish cover and install the revised seat cushion outer finish cover. Refer to *Front Seat Cushion Outer Finish Cover Replacement* in SI.
