Front brake caliper leaking

LOW PRESSURE LEAKAGE FRONT BRAKE CALIPER HAYES. ROOT CAUSE AND MEASURE

This Service Information bulletin provides technical, diagnostic and repair-related information.

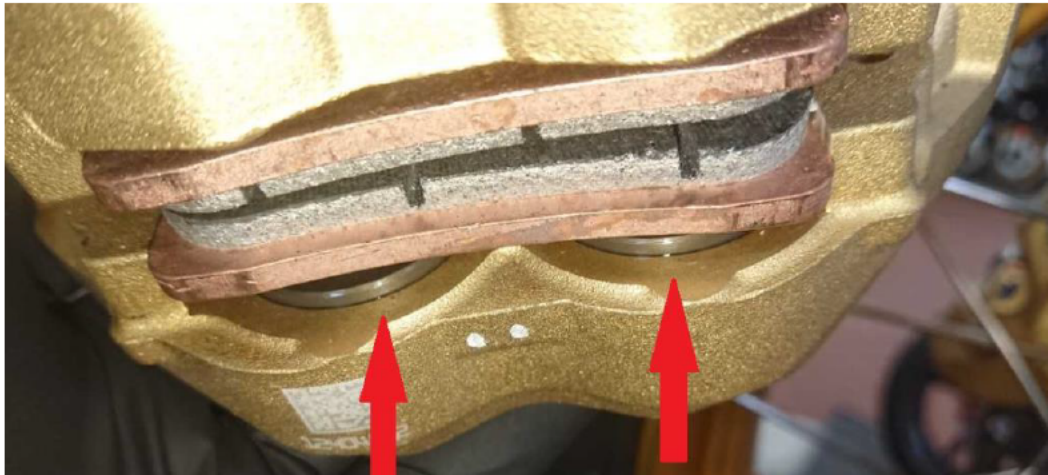
LOW PRESSURE WEEPING FRONT BRAKE CALIPER HAYES. ROOT CAUSE AND MEASURE

Capillary effect between caliper body and primary seal due to too high finish roughness before launching the vehicle.

1. housing end : variation of finish roughness in the groove caused by the anodizing process
2. seal end : finish roughness due to production process (grinding)

- **Corrective actions in vehicle production:**

Sept. 02nd 2019: conditioning of the brake calipers before vehicle assembly (simulation of driving cycles; brake in process); → work off the rough tops
