# Vehicle Fire Investigation Report(VFIR)

| 2015 | CHRYSLER TOWN & COUNTRY TOURING | 2C4RC1BG2 | 10/24/2014 |

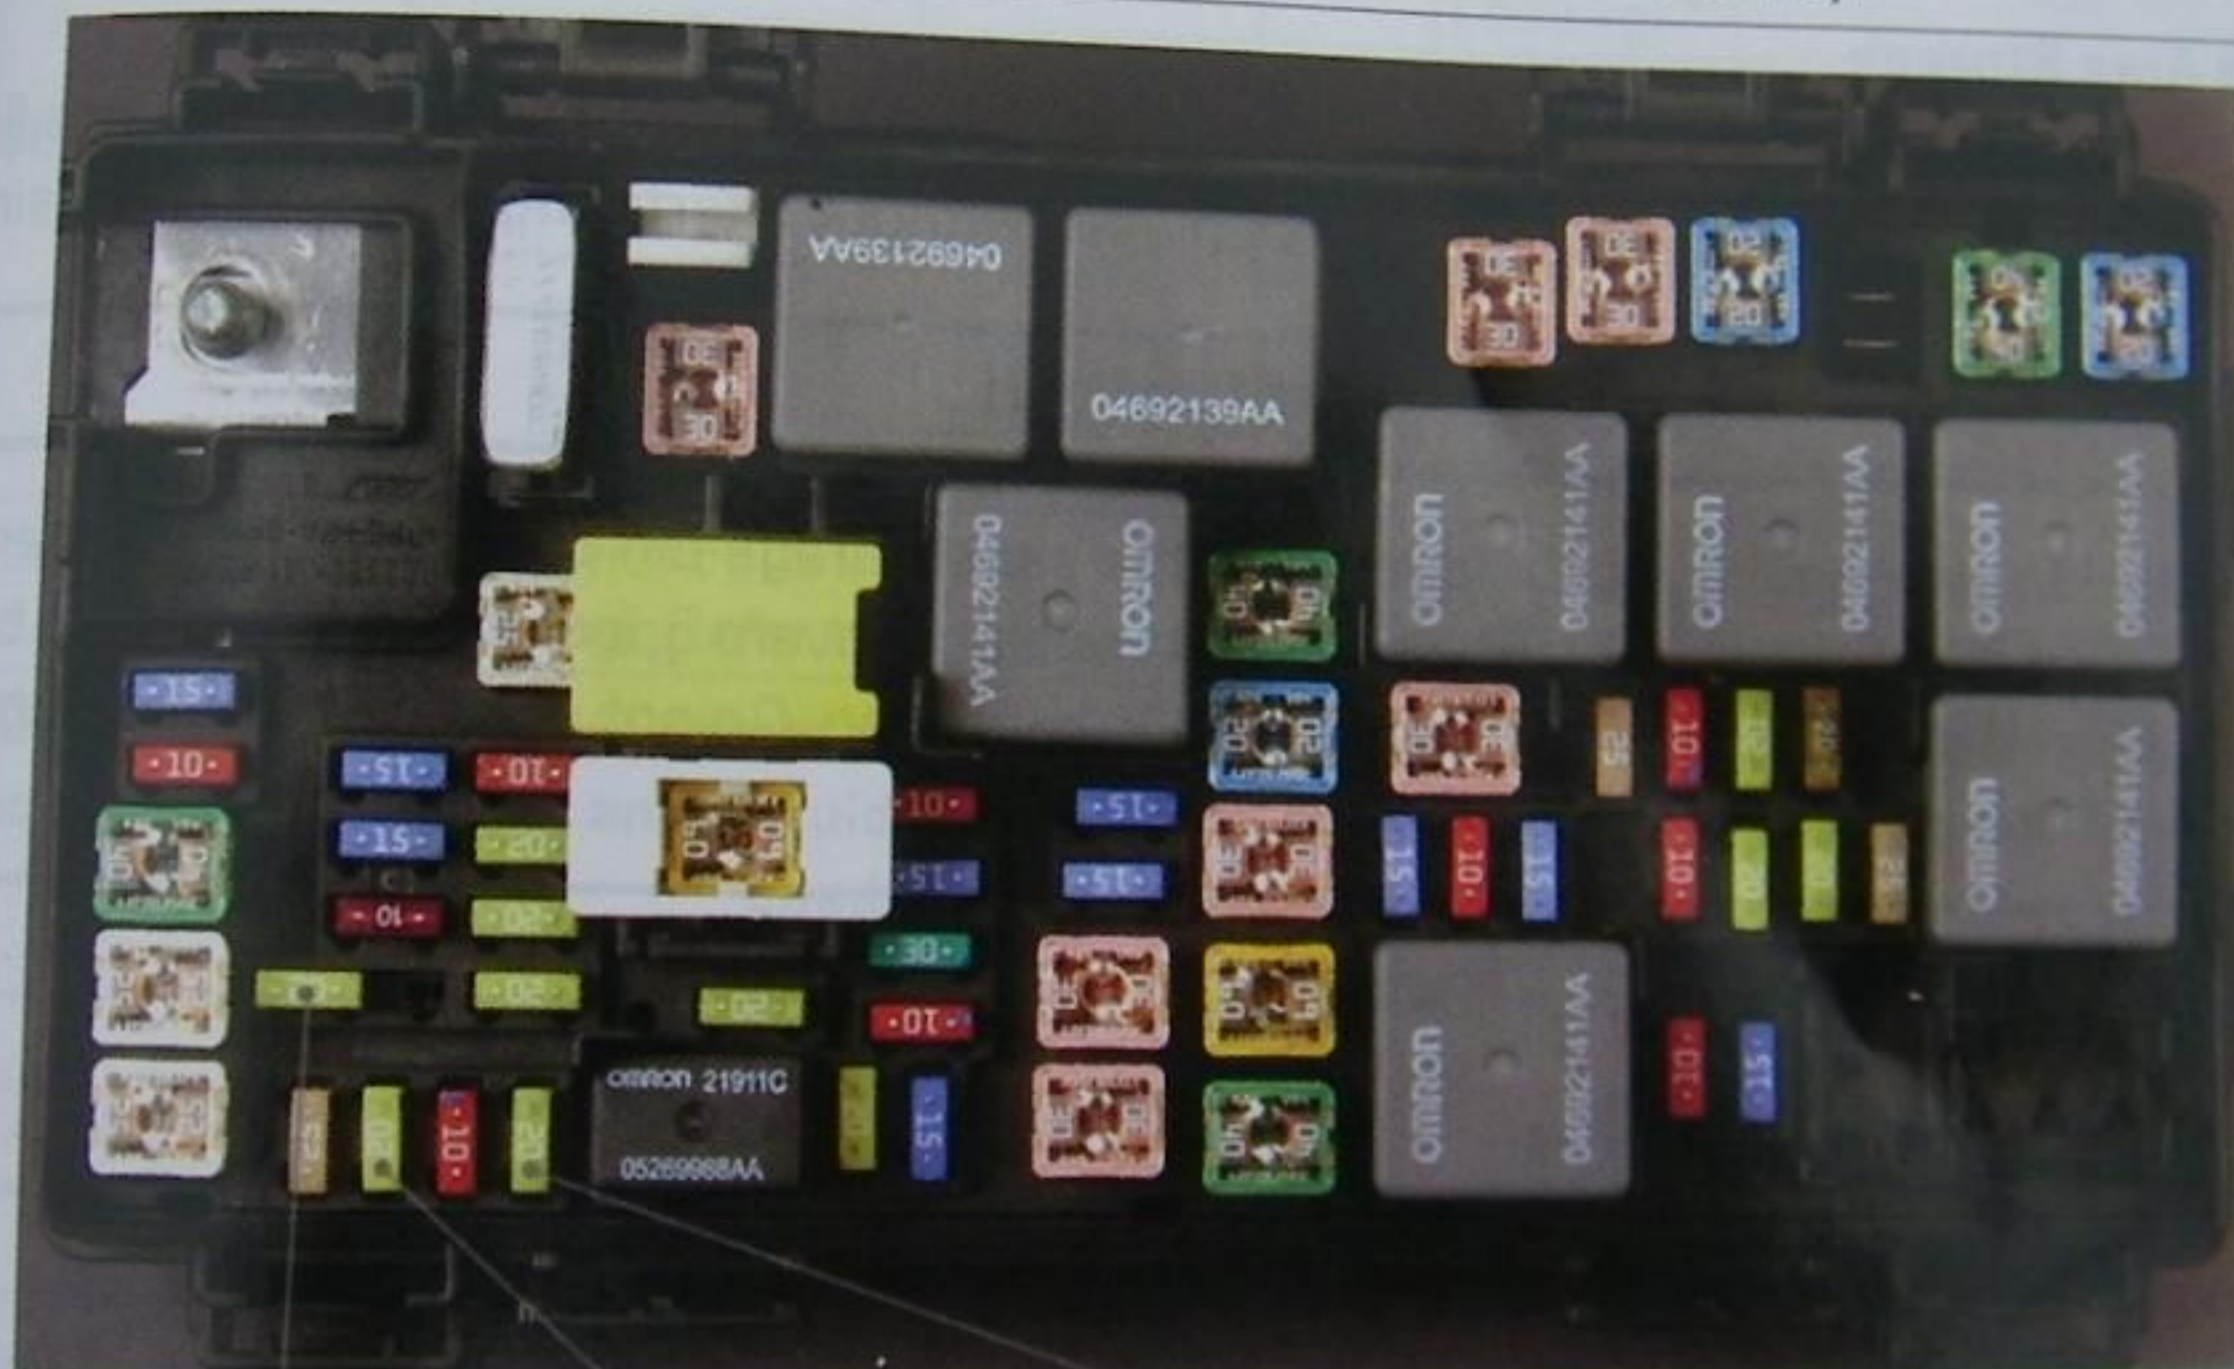
M7 Fuse 20 Amp  
Yellow – Power Outlet  
Left of Second Row  
Passenger Seat

M6 Fuse 20 Amp  
Yellow – Cigar  
Lighter/Power Outlet  
Instrument Panel

M36 Fuse 20 Amp  
Yellow – Power Outlet  
Instrument Panel & in  
Console – If Equipped
