LOCATING LEAKS IN FRONT OF CAB

FL545 RECALL CAMPAIGN

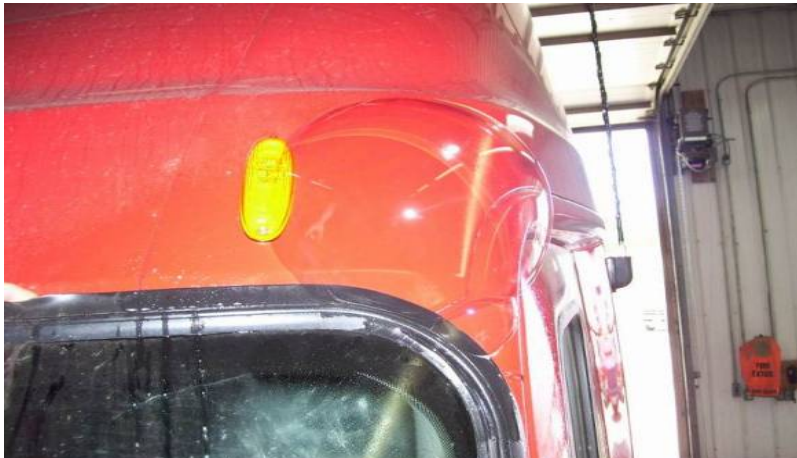
Likely leak between seal and cab OR
between roof-cap and cab

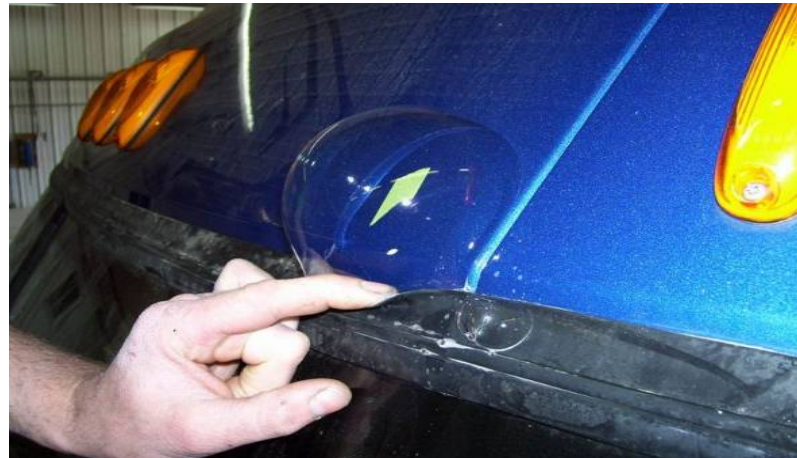
Likely leak between windshield seal and cab
