**HYUNDAI** | NEW THINKING.  
NEW POSSIBILITIES.

## Technical Service Bulletin

GROUP	NUMBER
RECALL	15-01-048
DATE	MODEL(S)
DECEMBER, 2015	2011-2012MY SONATA (YF)

**SUBJECT:** SONATA GDI ENGINE INSPECTION / REPLACEMENT  
(RECALL CAMPAIGN 132)

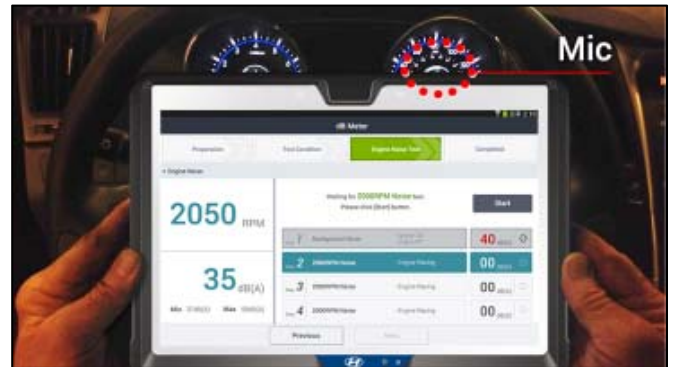
5. Position the GDS Mobile Tablet for inspection:

- Rotate the GDS Mobile Tablet, so that the microphone (installed at the bottom of the GDS Mobile Tablet) points up towards the windshield and headliner.
- Align the GDS Mobile Tablet so that it is centered to the steering wheel, but not touching it.

**Inspect the GDS Mobile Tablet to verify that the microphone location is not partially shrouded by the cover due to misalignment.**

**If necessary, remove the cover from the GDS Mobile Tablet and then enlarge the hole with a 3mm drill to prevent the microphone from being shrouded.**

OK:  
MICROPHONE  
IS CENTERED  
TO COVER  
AND NOT  
SHROUDED

Not OK:  
COVER IS NOT CENTERED.  
THE MICROPHONE IS SHROUDED.

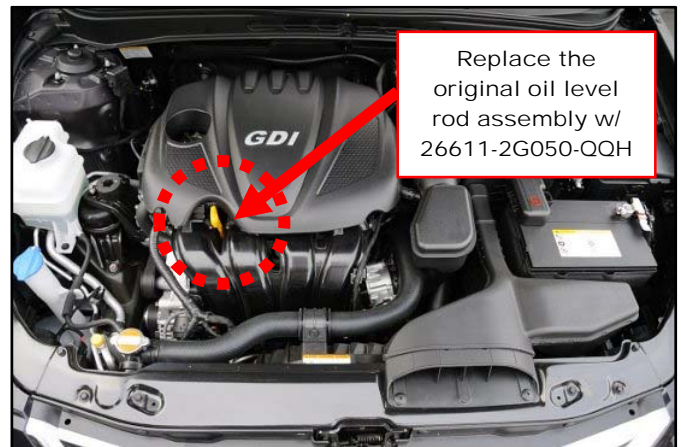
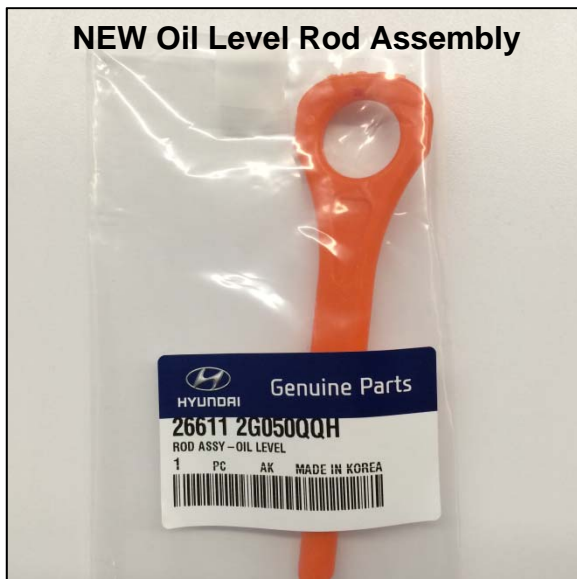
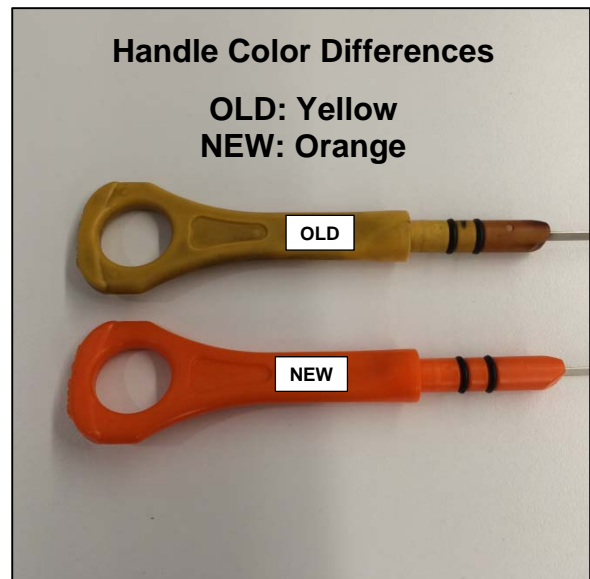
- Replace the oil level rod assembly (engine oil dipstick) with the new campaign part.
- Adjust the engine oil level to near FULL mark.

2. Replace the current Oil Level Rod Assembly with the new campaign part.
- Remove and discard the existing Oil Level Rod Assembly.
  - Install new ORANGE handle Oil Level Rod Assembly (P/N 26611-2G050-QQH)

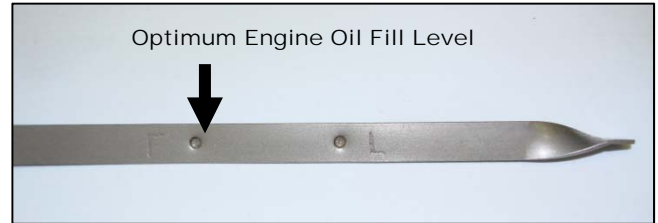
3. Adjust the engine oil level to near the “F” mark as shown in the picture.
- Use Quaker State 5W-30 conventional type engine oil to complete this step.
  - Add 0.42 quarts or more, as required.
  - Do not overfill.

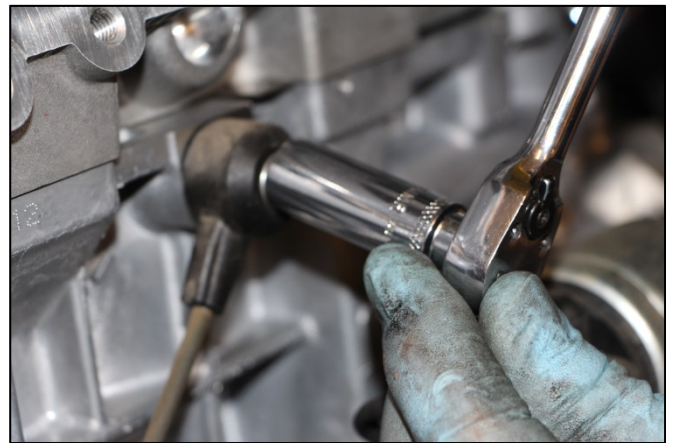
**5. Remove and reinstall the engine Knock Sensor from the existing engine to the new engine.**

**(Knock Sensor Fastener)**

Tightening torque: 21Nm (15.5lb-ft)

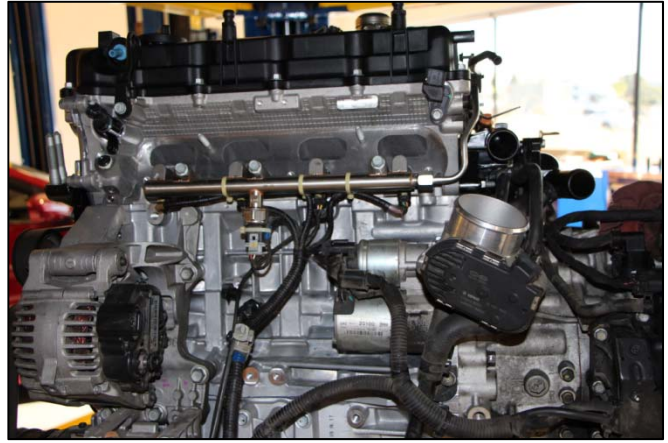
7. Reconnect and reinstall the engine front harness as shown.
- Be sure to properly route the opposite end of the harness end down towards the front of the engine.

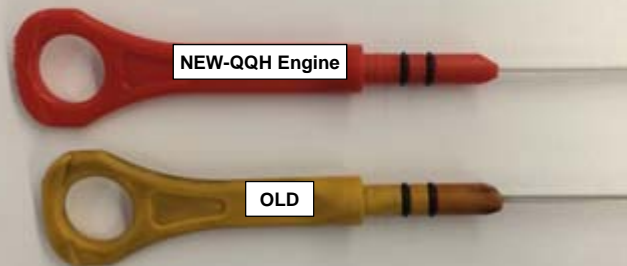
#### Handle Color Differences

8. Install newly supplied Oil Level Guide and Oil Level Rod Assemblies to the new engine.
- Be sure to install the NEW Oil Level Guide (Dipstick Tube) to the NEW engine.
  - Install the NEW Oil Level Rod Assembly (Dipstick) to the NEW engine.

NEW-QQH Engine: Red  
 OLD: Yellow

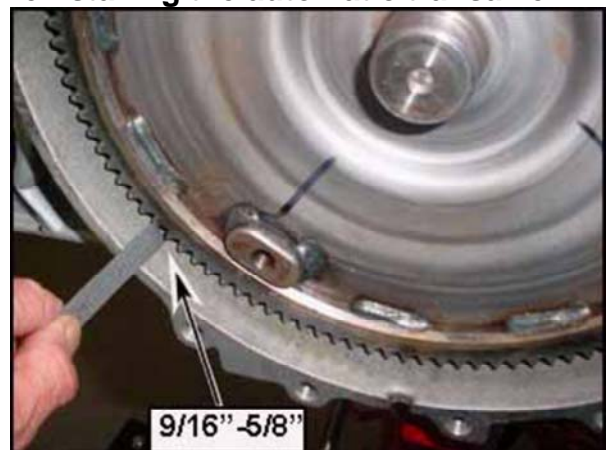
If the torque converter has moved from the fully inserted position, carefully push inward and rotate the torque converter until the converter is recessed approximately 9/16 - 5/8" (14 -16 mm) into the transaxle case when reinstalling the automatic transaxle.

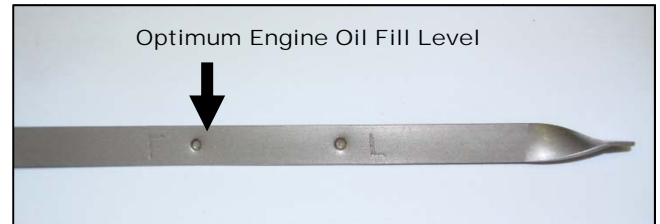
12. Start the engine to warm up the engine and begin the cooling system air bleed process.
- During this time, check for any leaks.
  - After the engine has warmed up to normal operating temperature, wait a few minutes after turning the engine OFF, then adjust the engine oil level to near the "F" mark as shown in the picture.
