<b>HYUNDAI</b> <b>Technical Service Bulletin</b>	GROUP <b>RECALL</b>	NUMBER <b>17-01-046</b>
	DATE <b>JUNE 2017</b>	MODEL(S) <b>2011-2012MY SONATA (YF)</b>
<b>SUBJECT: SONATA GDI ENGINE INSPECTION / REPLACEMENT (RECALL CAMPAIGN 132)</b>

**This TSB supersedes TSB# 15-01-048 and modifies the inspection procedure.**

**Description:** Certain 2011-2012 model year Sonata (YF) vehicles equipped with 2.4L and 2.0T GDI engines require an inspection to confirm normal operation. The inspection procedure will help indicate if the engine is operating normally or if an excessive connecting rod bearing wear condition in the engine crankcase may be present. If the vehicle continues to be driven with a worn connecting rod bearing, the bearing can fail and the vehicle could stall.

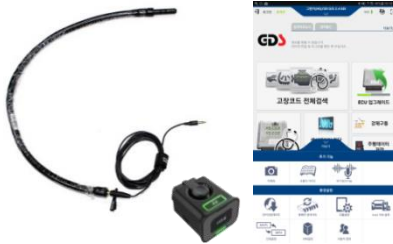
Description	Tool Part #	Image	Comment
Engine Noise Inspection Tool	G1XTD-CP001

For noise inspection
Torque Wrench Socket	09314-3Q100		Only needed if engine replacement required.
Injector Combustion Seal Ring Installer	09353-2B000		Refer to TSB 10-FL-019 for the detailed usage instructions

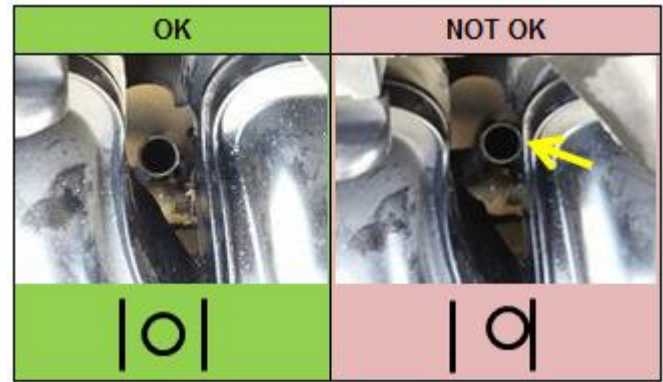
4. Prepare the vehicle and Engine Noise Inspection Tool as follows:
- Remove the oil level rod assy (engine oil dipstick).
  - Check for interference between the dipstick tube and the intake manifold.

Adjust the dipstick tube to create clearance between the tube and manifold if necessary.

- Insert the adapter (A) into the oil level gauge tube (dipstick tube).
- Attach the clip (B) to the hood latch.
- Connect the stereo jack (C) to the GDS Mobile headphone jack.
- Feed the inspection tool through the open driver's front window.

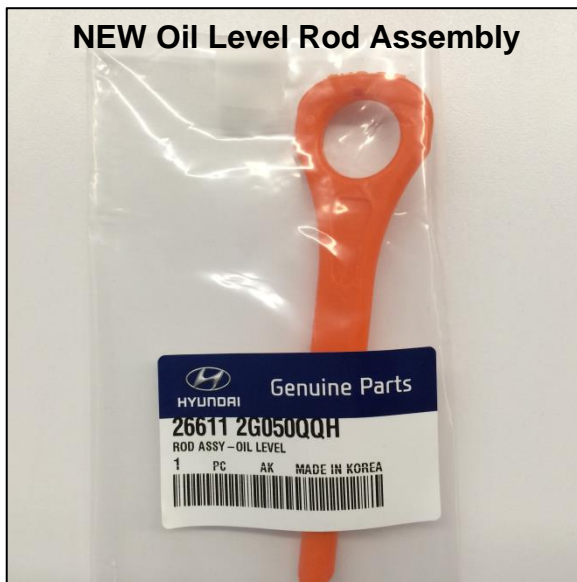
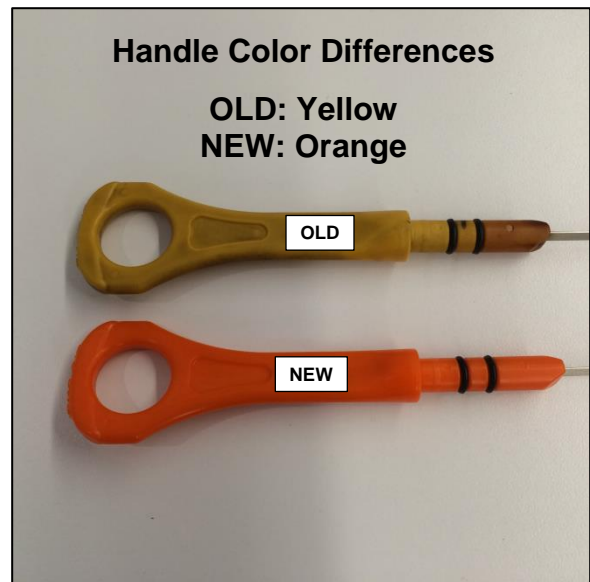
2. Replace the engine oil (4.8 quarts) and oil filter.
3. Replace the current Oil Level Rod Assembly with the new campaign part.
  - Remove and discard the existing Oil Level Rod Assembly (engine oil dipstick).
  - Install new ORANGE handle Oil Level Rod Assembly (P/N 26611-2G050QQH)

Note: Replace the dipstick only if the current dipstick's handle is yellow.

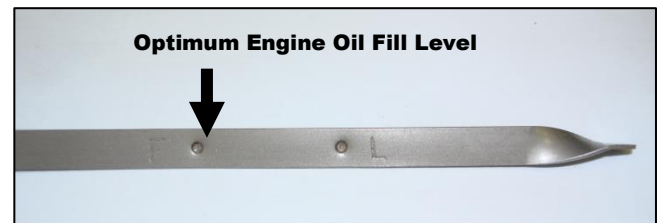
4. Start the engine and allow it to run for 10 seconds. Then adjust the engine oil level to near the "F" mark as shown in the picture.
  - Use Quaker State 5W-30 conventional type engine oil to complete this step.
  - Do not overfill.

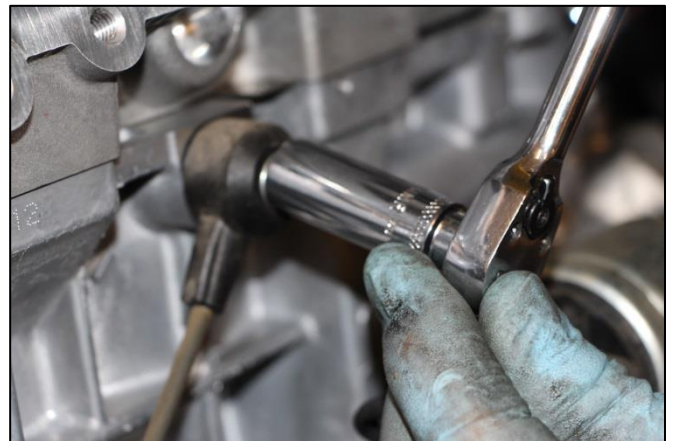
**(Knock Sensor Fastener)**

5. Remove and reinstall the engine Knock Sensor from the existing engine to the new engine.

Tightening torque: 21Nm (15.5lb-ft)

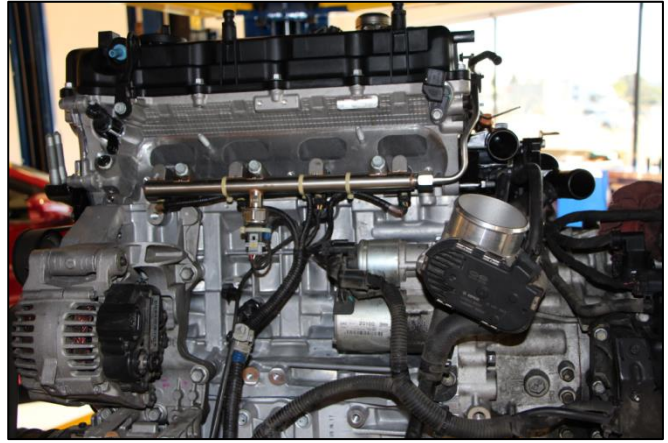
7. Reconnect and reinstall the engine front harness as shown.
- Be sure to properly route the opposite end of the harness end down towards the front of the engine.

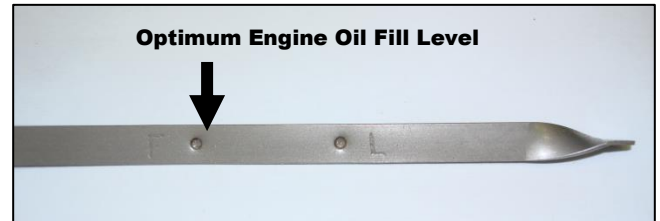
12. Start the engine to warm it up and begin the cooling system air bleeding process.
  - During this time, check for any leaks.
  - After the engine has warmed up to normal operating temperature, turn the engine off, wait a few minutes, and then adjust the engine oil level to near the “F” mark as shown in the picture.
