HYUNDAI Technical Service Bulletin	GROUP RECALL	NUMBER 19-01-011H
	DATE APRIL 2019	MODEL(S) 2011-2012MY SONATA (YF)
SUBJECT: SONATA GDI ENGINE INSPECTION / REPLACEMENT (RECALL CAMPAIGN 132)

Description: Certain 2011-2012 model year Sonata (YF) vehicles equipped with 2.4L and 2.0T GDI engines require an inspection to confirm normal operation. The inspection procedure will help indicate if the engine is operating normally or if an excessive connecting rod bearing wear condition in the engine crankcase may be present. If the vehicle continues to be driven with a worn connecting rod bearing, the bearing can fail and the vehicle could stall.

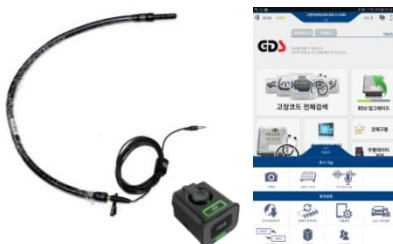
Description	Tool Part #	Image	Comment
Engine Noise Inspection Tool	G1XTD-CP005

For noise inspection
Torque Wrench Socket	09314-3Q100-01		Only needed if engine replacement required.
Injector Combustion Seal Ring Installer	09353-2B000		Refer to TSB 19-FL-001H for detailed usage instructions. Order replacements through Bosch at 1-866-539-4248.

DO NOT disassemble or modify any components of the engine inspection tool. If any part of the tool is damaged, a new one should be ordered. Individual components of the tool cannot be ordered.

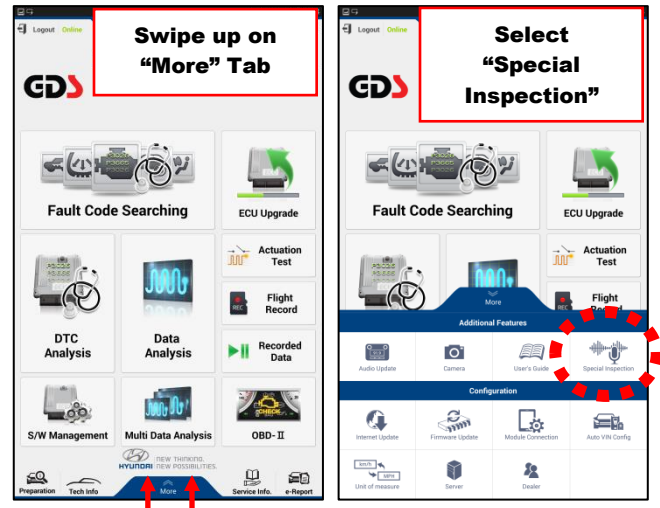
1. The Inspection Procedure will consist of preparing the vehicle and then performing an inspection using the “Special Inspection” function of the GDS Mobile application.

- Obtain the latest GDS Mobile update daily. The GDS Mobile must be connected to the internet via WiFi daily to confirm the latest software update is installed or the application will not function.
- Connect the GDS VCI to vehicle DLC.
- VCI should be updated with latest version and paired with GDS Mobile.
- Open the GDS Mobile App.
- Swipe up on the “More” tab at the bottom of the screen.
- Select the “Special Inspection” function.

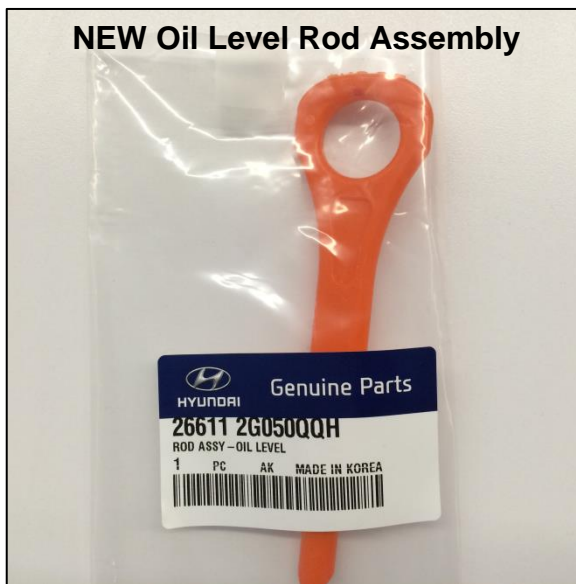
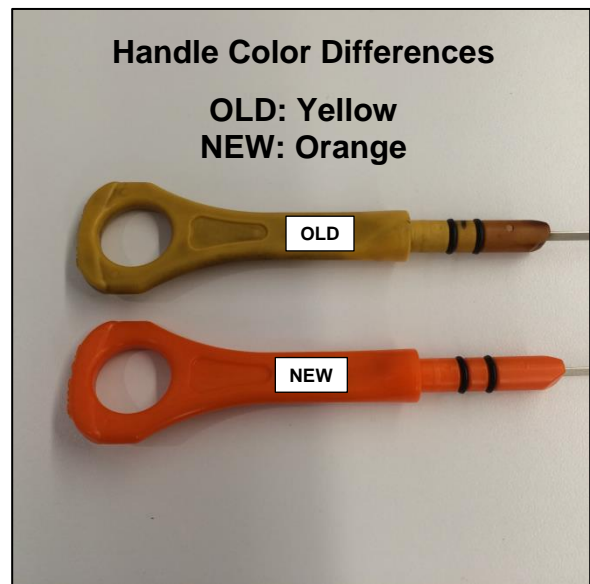
2. Replace the engine oil (4.8 quarts), oil filter, and drain plug gasket.
3. Replace the current Oil Level Rod Assembly with the new campaign part.
 - Remove and discard the existing Oil Level Rod Assembly (engine oil dipstick).
 - Install new ORANGE handle Oil Level Rod Assembly (P/N 26611-2G050QQH)

Note: Replace the dipstick ONLY if the current dipstick's handle is yellow. Do not replace if it's red.

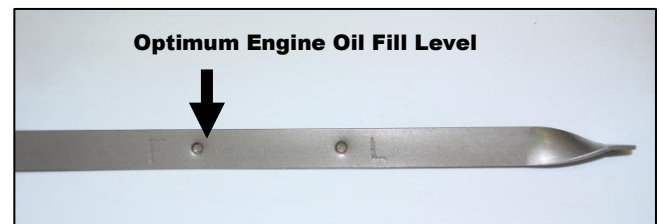
4. Start the engine and allow it to run for 10 seconds. Turn off the engine and after a few minutes adjust the engine oil level to near the "F" mark as shown in the picture.
 - Use Quaker State 5W-30 viscosity engine oil or other brand if not available (conventional type with API SM / ILSAC GF-4 or higher grade).
 - Do not overfill.

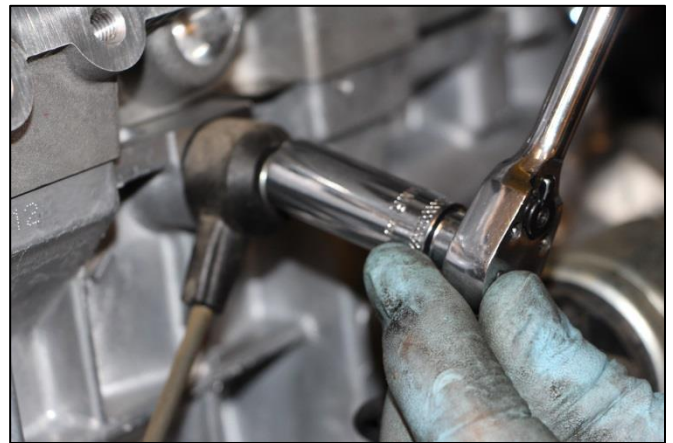
5. Remove and reinstall the engine Knock Sensor from the old engine to the new engine.

(Knock Sensor Fastener)
Tightening torque: 21Nm (15.5lb-ft)

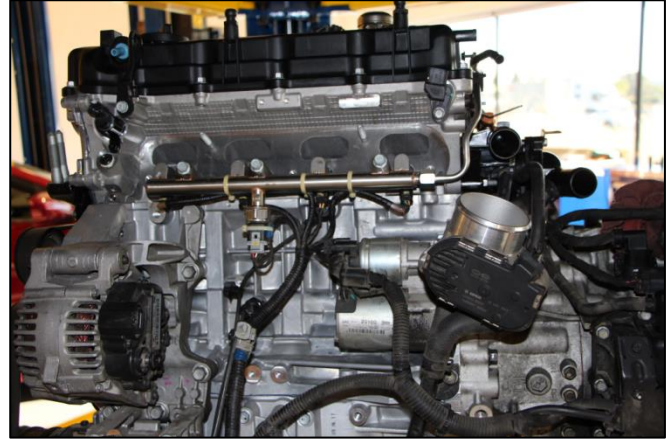
7. Install new oil cooler hoses.
8. Reconnect and reinstall the engine front harness as shown.
 - Be sure to properly route the opposite end of the harness end down towards the front of the engine.
9. Install newly supplied Oil Level Guide and Oil Level Rod Assemblies to the new engine.
 - Be sure to install the NEW Oil Level Guide (dipstick tube) to the NEW engine.
 - Install the NEW Oil Level Rod Assembly (dipstick) to the NEW engine.

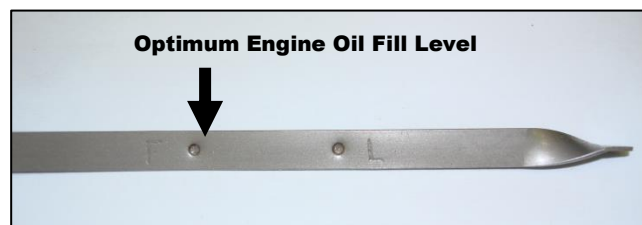
13. Start the engine to warm it up and begin the cooling system air bleeding process.
- During this time, check for any leaks.
 - After the engine has warmed up to normal operating temperature, turn the engine off, wait a few minutes, and then adjust the engine oil level to near the "F" mark as shown in the picture.
