**HYUNDAI**  
**Technical Service Bulletin**

GROUP <b>RECALL</b>	NUMBER <b>17-01-047</b>
DATE <b>JUNE 2017</b>	MODEL(S) <b>2013-2014MY SONATA (YF) SANTA FE SPORT (AN)</b>

**SUBJECT:** SONATA / SANTA FE SPORT GDI ENGINE INSPECTION  
/ REPLACEMENT (RECALL CAMPAIGN 162)

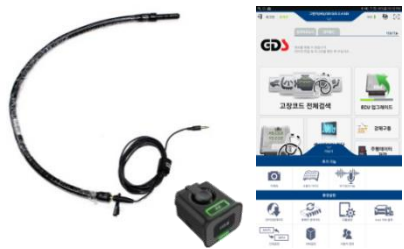
Description	Tool Part #	Image	Comment
Engine Noise Inspection Tool	G1XTD-CP001

For noise inspection
Torque Wrench Socket	09314-3Q100		Only needed if engine replacement required.
Injector Combustion Seal Ring Installer	09353-2B000		Refer to TSB 10-FL-019 for the detailed usage instructions

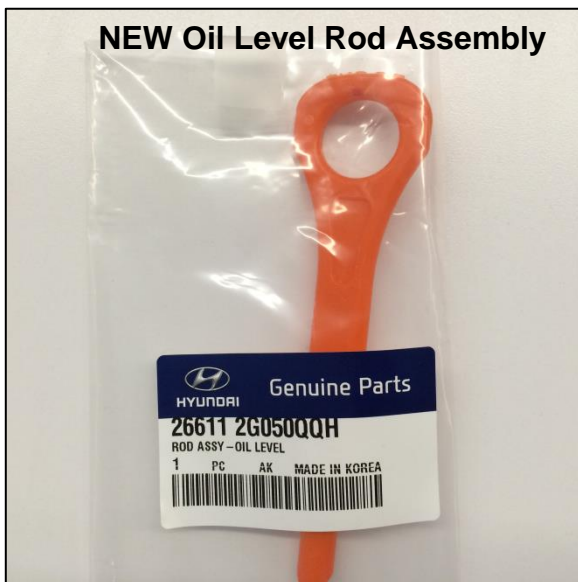
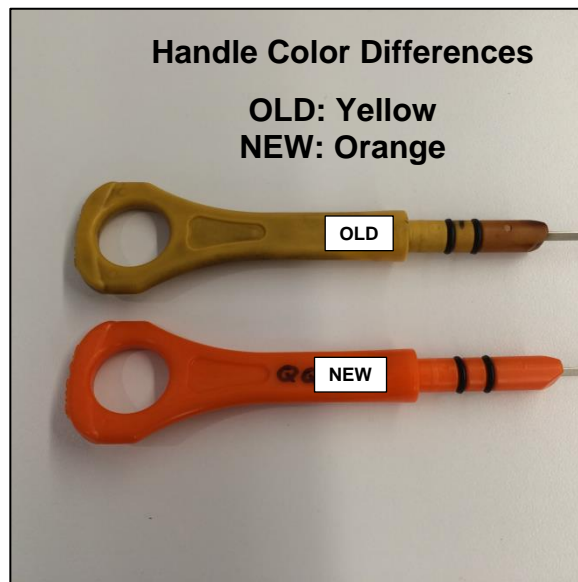
2. Replace the engine oil (4.8 quarts) and oil filter.
3. Replace the current Oil Level Rod Assembly with the new campaign part.
  - Remove and discard the existing Oil Level Rod Assembly (engine oil dipstick).
  - Install new ORANGE handle Oil Level Rod Assembly (P/N 26611-2G050QQH)

Note: Replace the dipstick only if the current dipstick's handle is yellow.

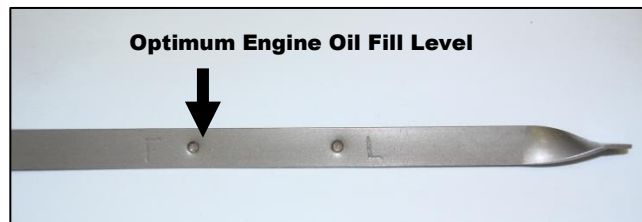
4. Start the engine and allow it to run for 10 seconds. Then adjust the engine oil level to near the "F" mark as shown in the picture.
  - Use Quaker State 5W-30 conventional type engine oil to complete this step.
  - Do not overfill.

12. Start the engine to warm it up and begin the cooling system air bleeding process.
  - During this time, check for any leaks.
  - After the engine has warmed up to normal operating temperature, turn the engine off, wait a few minutes, and then adjust the engine oil level to near the “F” mark as shown in the picture.

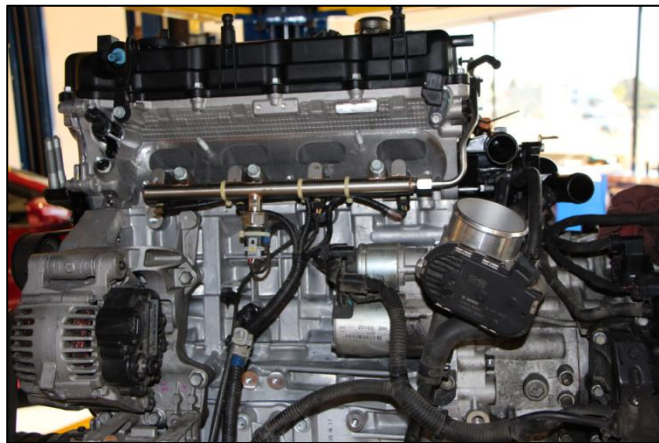
7. Reconnect and reinstall the engine front harness as shown.
- Be sure to properly route the opposite end of the harness end down towards the front of the engine.
