HYUNDAI Technical Service Bulletin	GROUP RECALL	NUMBER 18-01-007
	DATE JANUARY, 2018	MODEL(S) 2013-2014MY SONATA (YF) SANTA FE SPORT (AN)
	SUBJECT: SONATA / SANTA FE SPORT GDI ENGINE INSPECTION / REPLACEMENT (RECALL CAMPAIGN 162)

This TSB supersedes TSB# 17-01-047-1 and modifies the Parts Information and Service Procedure sections.

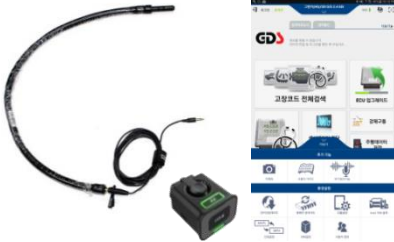
Description	Tool Part #	Image	Comment
Engine Noise Inspection Tool	G1XTD-CP005

For noise inspection
Torque Wrench Socket	09314-3Q100		Only needed if engine replacement required.
Injector Combustion Seal Ring Installer	09353-2B000		Refer to TSB 10-FL-019 for the detailed usage instructions

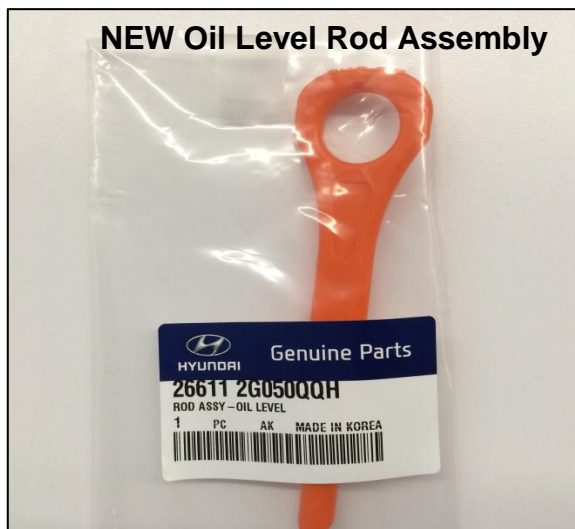
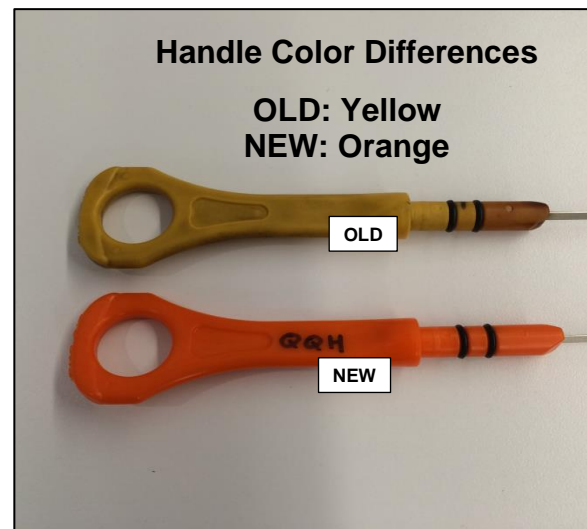
2. Replace the engine oil (4.8 quarts), oil filter, and drain plug gasket.
3. Replace the current Oil Level Rod Assembly with the new campaign part.
 - Remove and discard the existing Oil Level Rod Assembly (engine oil dipstick).
 - Install new ORANGE handle Oil Level Rod Assembly (P/N 26611-2G050QQH)

Note: Replace the dipstick ONLY if the current dipstick's handle is yellow. Do not replace if it's red.

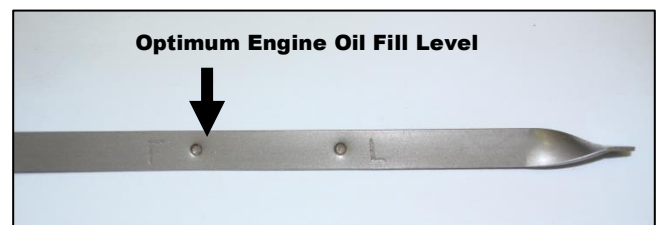
13. Start the engine to warm it up and begin the cooling system air bleeding process.
- During this time, check for any leaks.
 - After the engine has warmed up to normal operating temperature, turn the engine off, wait a few minutes, and then adjust the engine oil level to near the "F" mark as shown in the picture.
