<b>HYUNDAI</b> <b>Technical Service Bulletin</b>	GROUP <b>RECALL</b>	NUMBER <b>18-01-007-1</b>
	DATE	MODEL(S)
	<b>JUNE, 2018</b>	<b>2013-2014MY SONATA (YF) SANTA FE SPORT (AN)</b>
<b>SUBJECT: SONATA / SANTA FE SPORT GDI ENGINE INSPECTION / REPLACEMENT (RECALL CAMPAIGN 162)</b>

**This TSB supersedes TSB# 18-01-007 and modifies the Parts Information and Warranty Information sections.**

**Description:** Certain 2013-2014 model year Sonata (YF) and 2013-2014 model year Santa Fe Sport (AN) vehicles equipped with 2.4L and 2.0T GDI engines require an inspection to confirm normal operation. The inspection procedure will help indicate if the engine is operating normally or if an excessive connecting rod bearing wear condition in the engine crankcase may be present. If the vehicle continues to be driven with a worn connecting rod bearing, the bearing can fail and the vehicle could stall.

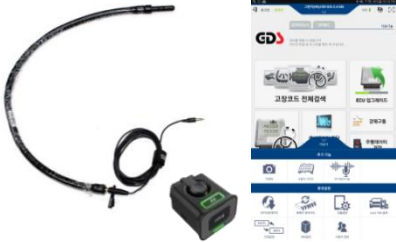
Description	Tool Part #	Image	Comment
Engine Noise Inspection Tool	G1XTD-CP005

For noise inspection
Torque Wrench Socket	09314-3Q100		Only needed if engine replacement required.
Injector Combustion Seal Ring Installer	09353-2B000		Refer to TSB 10-FL-019 for the detailed usage instructions

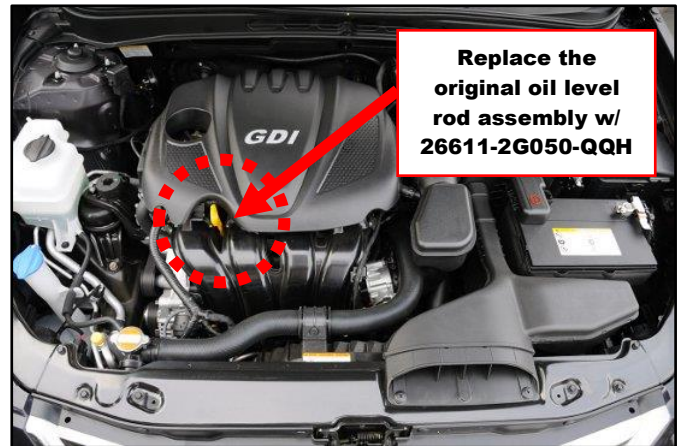
2. Replace the engine oil (4.8 quarts), oil filter, and drain plug gasket.
3. Replace the current Oil Level Rod Assembly with the new campaign part.
  - Remove and discard the existing Oil Level Rod Assembly (engine oil dipstick).
  - Install new ORANGE handle Oil Level Rod Assembly (P/N 26611-2G050QQH)

**Note: Replace the dipstick ONLY if the current dipstick's handle is yellow. Do not replace if it's red.**

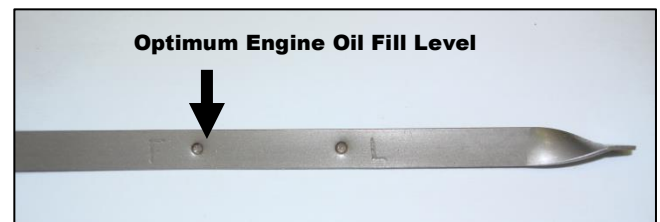
4. Start the engine and allow it to run for 10 seconds. Turn off the engine and after a few minutes adjust the engine oil level to near the "F" mark as shown in the picture.
  - Use Quaker State 5W-30 viscosity engine oil or other brand if not available (conventional type with API SM / ILSAC GF-4 or higher grade).
  - Do not overfill.

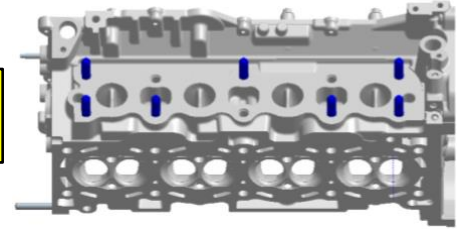
**SULEV /  
CAL Spec**

4. **For 2.4L with ULEV / FED emissions only**  
All 2.4L engines with part numbers in the Parts Information section are produced with the exhaust manifold studs configured for SULEV / CAL emissions package.

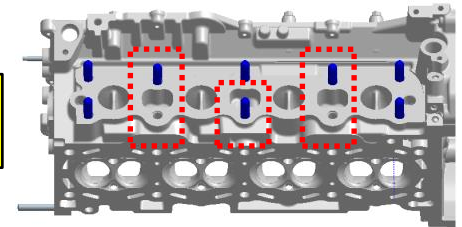
**ULEV /  
FED Spec**

**Exhaust Stud Position Relocation Information**

2.4L vehicles with a ULEV / FED emissions package require 2 exhaust studs to be relocated on the new engine and 1 exhaust stud transferred over from the old engine.

- Use a commercially available stud removal tool or use the double-nut technique to complete this step.

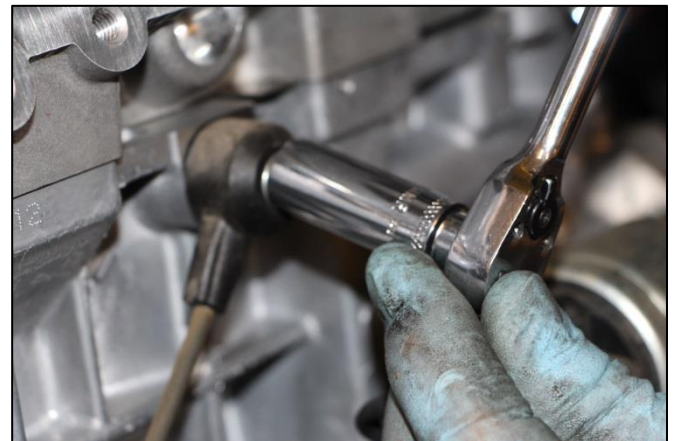
5. Remove and reinstall the engine Knock Sensor from the old engine to the new engine.

**(Knock Sensor Fastener)**  
**Tightening torque: 21Nm (15.5lb-ft)**

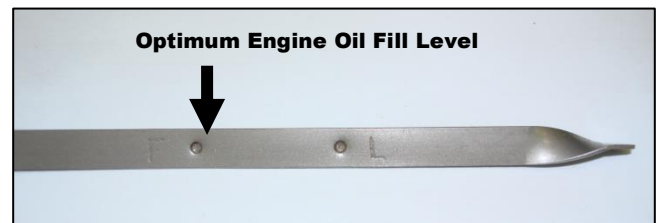
13. Start the engine to warm it up and begin the cooling system air bleeding process.
- During this time, check for any leaks.
  - After the engine has warmed up to normal operating temperature, turn the engine off, wait a few minutes, and then adjust the engine oil level to near the "F" mark as shown in the picture.
