<b>HYUNDAI</b> <b>Technical Service Bulletin</b>	GROUP <b>RECALL</b>	NUMBER <b>21-01-022H-1</b>
	DATE <b>DECEMBER 2021</b>	MODEL(S) <b>APPLICABLE VEHICLES BELOW</b>
<b>SUBJECT:</b> ENGINE INSPECTION / REPLACEMENT (RECALL CAMPAIGN 198)

This TSB supersedes TSB# 21-01-022H to revise the Warranty Information and Service Procedure.

ENGINE INSPECTION / REPLACEMENT (RECALL CAMPAIGN 198)

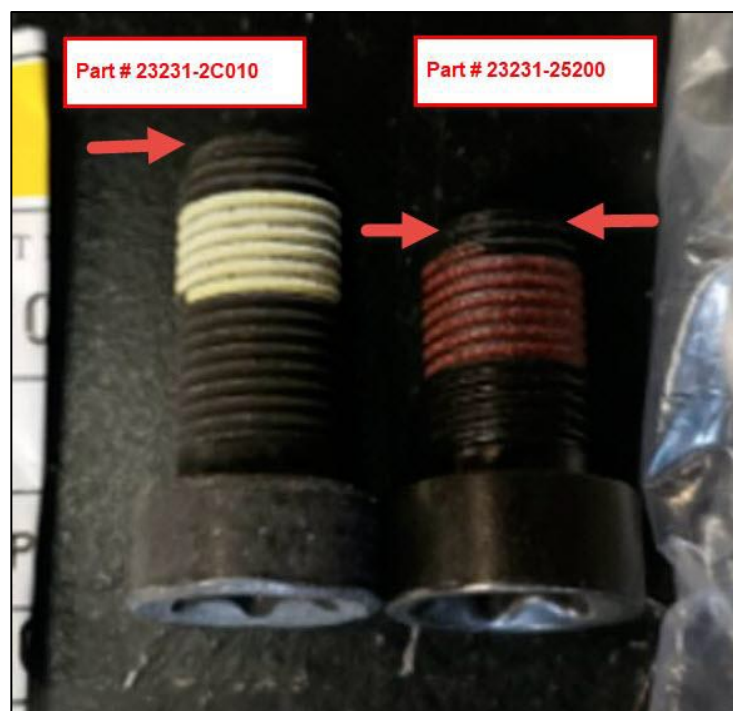
For 11-12MY Sonata Hybrid (YF HEV):

When installing a new engine, the drive plate bolts must be replaced with P/N 23231-25200.

- ❖ Due to changes to the crankshaft design, the existing bolts are ~2mm too long and will result in improperly fastened drive plate if reused.
- ❖ The 13-15MY version drive plate bolts (P/N 23231-25200) are correct length for the new engine and will provide proper fastening during engine installation.

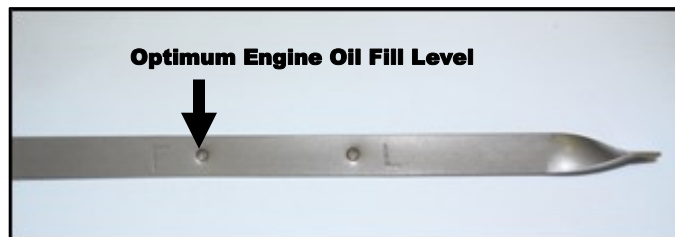
- Check for any leaks during this time.
  - After the engine has warmed up to normal operating temperature, turn the engine off, wait a few minutes, and then **adjust the engine oil level up the “F” mark as shown.**
