<b>HYUNDAI</b> <b>Technical Service Bulletin</b>	GROUP <b>RECALL</b>	NUMBER <b>21-01-073H</b>
	DATE <b>DECEMBER 2021</b>	MODEL(S) <b>APPLICABLE VEHICLES BELOW</b>
<b>SUBJECT:</b> ENGINE INSPECTION / REPLACEMENT (RECALL CAMPAIGN 209)

**Description:** Certain applicable vehicles may have engines produced with conditions that can cause premature wear of the connecting rod bearings. A worn connecting rod bearing could result in abnormal knocking noise from the engine and/or illumination of the oil pressure warning light. Follow the procedure to inspect the vehicle to determine the applicable repair procedure based on the inspection results.

Certain 2017 MY Sonata Hybrid (LF HEV) vehicles with Nu 2.0L GDI Hybrid engines  
 Certain 2017 MY Tucson (TL) vehicles with Nu 2.0L GDI engines

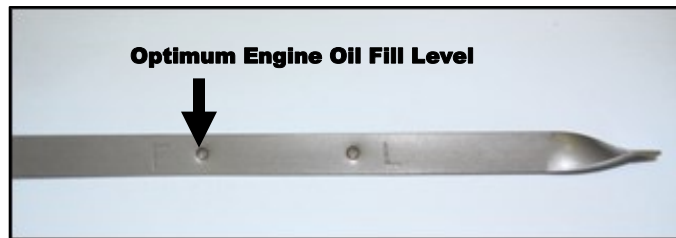
- Check for any leaks during this time.
    - After the engine has warmed up to normal operating temperature, turn the engine off, wait a few minutes, and then **adjust the engine oil level up the “F” mark as shown.**
