# Service Campaign T6G DTC P1326 - ENGINE BEARING INSPECTION / ENGINE REPLACEMENT- Dealer Best Practice (TSB 22-01-023H-1)

**April 28, 2022**

Certain vehicles that have completed Service Campaign 966 may experience the Check Engine warning lamp illuminated with DTC P1326 and/or an engine concern/noise related to connecting rod bearing wear or damage. Follow the procedure to inspect the vehicle and replace the engine and/or update the engine ECU software (if new ROM is available) based on the inspection results.

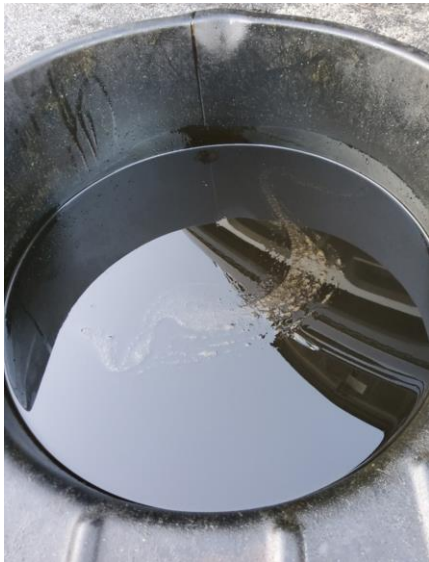
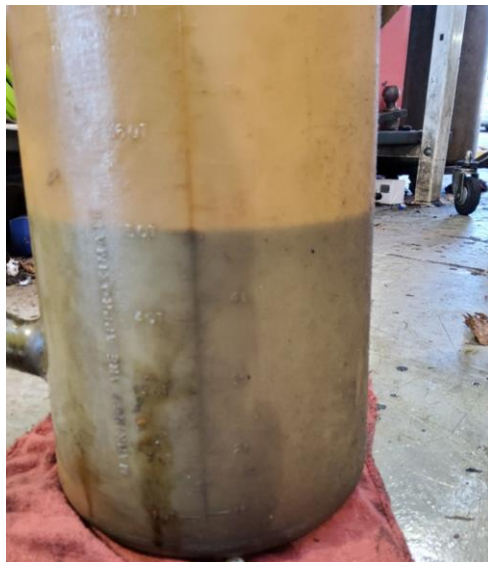
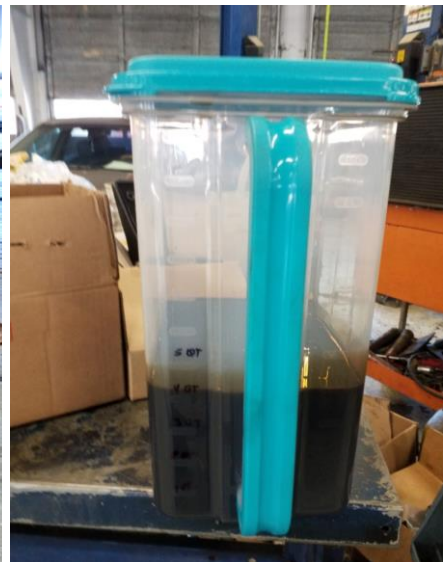
**Bad Oil Drain Photo (see below)**

Example 1

Example 2

Example 3

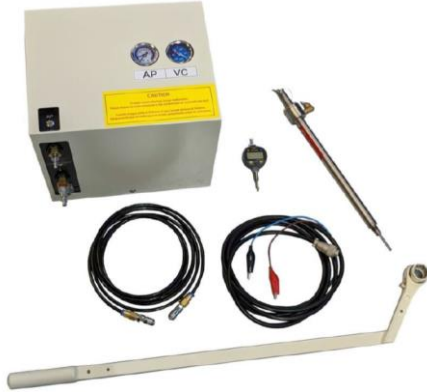
- Engine Bearing Clearance Tester set (bearing tool)

- **Note:** the bearing tool must be accurately calibrated prior to performing the engine inspection procedure outlined in the T6G TSB. Refer to TSB 21-GI-009H (or latest revision) for the calibration procedure as needed.
