HYUNDAI Technical Service Bulletin	GROUP CAMPAIGN	NUMBER 22-01-033H
	DATE APRIL 2022	MODEL(S) APPLICABLE VEHICLES BELOW
SUBJECT: THETA GDI ENGINE DTC P1326 - ENGINE BEARING INSPECTION / REPLACEMENT (SERVICE CAMPAIGN T3G)

This TSB supersedes TSB 21-01-066H to update the Service Procedure Flowchart and Service Procedure contents to reflect various process revisions.

Description: Applicable vehicles with 2.0L T-GDI and 2.4L GDI engines may experience the Check Engine warning lamp illuminated with DTC P1326 and/or engine may exhibit Abnormal Noise or No Crank/No Start condition. Follow the procedure to inspect the vehicle and replace the engine or update the engine ECU software based on the inspection results.

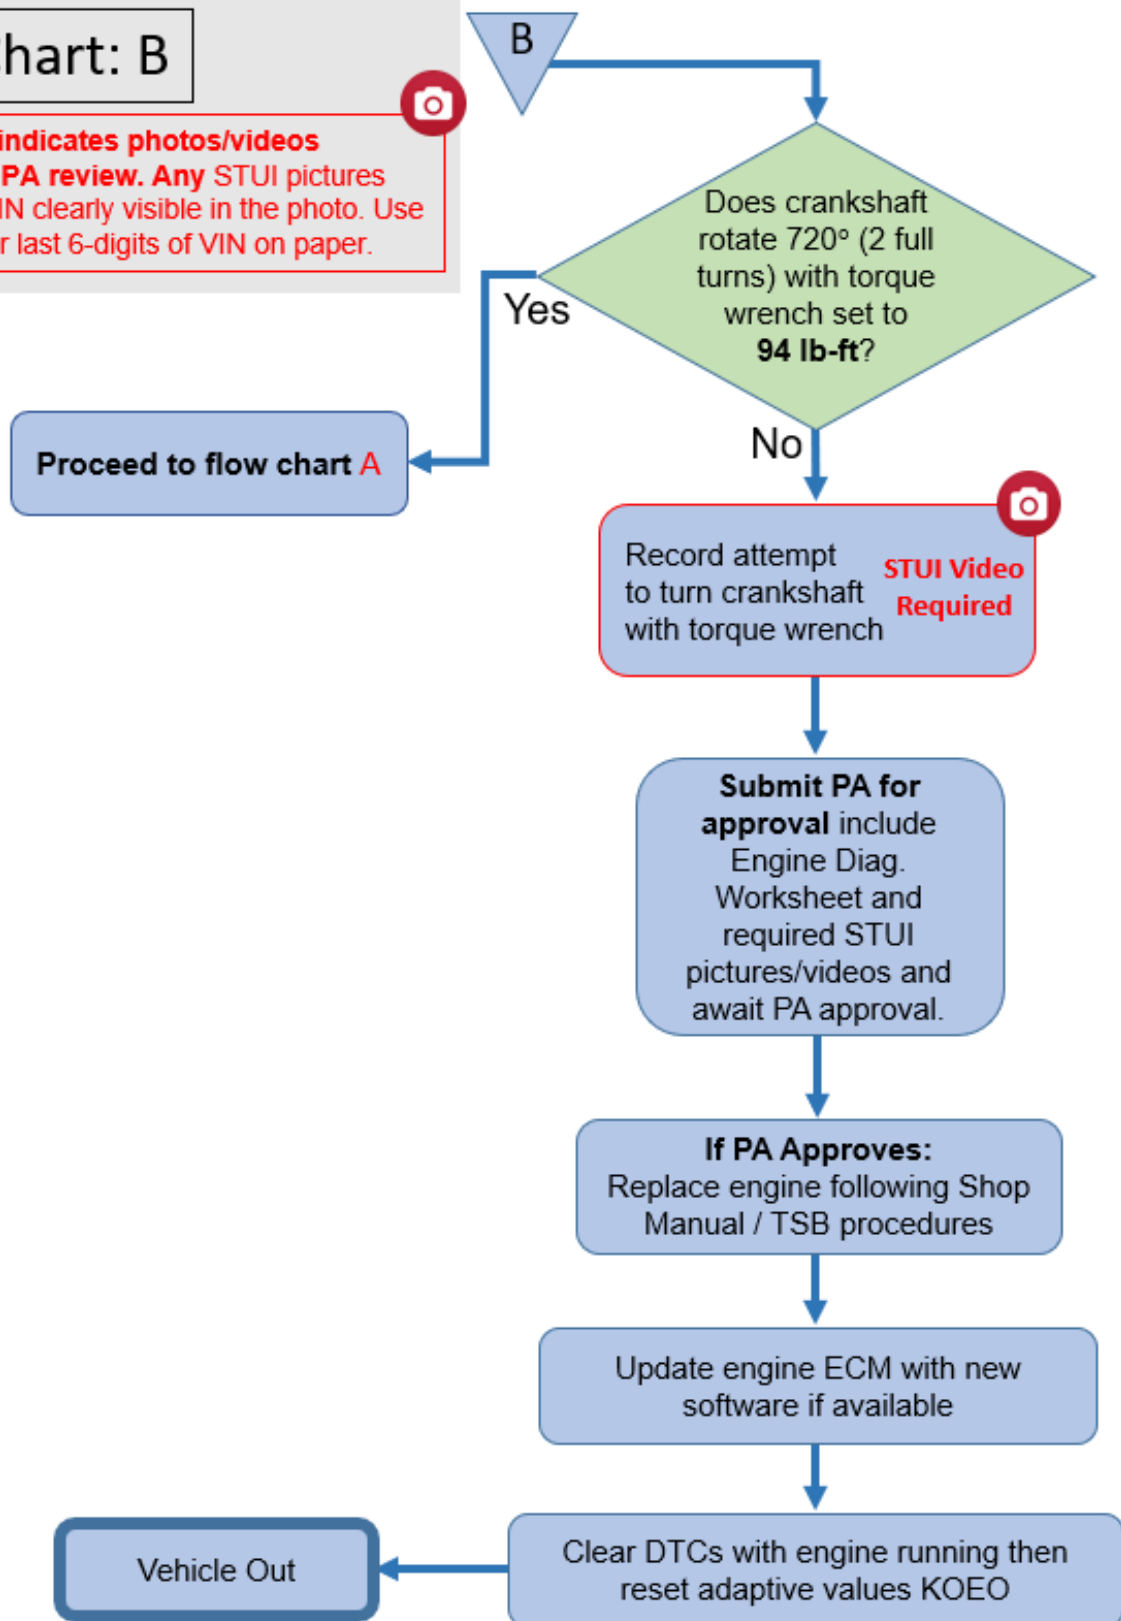
Flow Chart: B

NOTE: Icon indicates photos/videos required for PA review. Any STUI pictures require the VIN clearly visible in the photo. Use copy of RO or last 6-digits of VIN on paper.

1. Rotate the crankshaft with the crank rotator SST.
 - If the crankshaft cannot be turned with a moderate force, then measure the force required to turn the crankshaft with a torque wrench.
 - If the SST or shop tools do not fit the specific vehicle type, remove the front passenger wheel, and wheel liner or underbody tray as needed to rotate the crankshaft.
 - ❖ **If the crankshaft normally rotates up to 2 full turns (720°):**
 - Proceed to Bearing Inspection in the following page and follow the procedure sequence in **Flow Chart A**.
 - ❖ **If the force required for rotating the crankshaft is greater than 94 lb-ft., documentation through STUI video is required.**
 - Follow the procedure sequence in **Flow Chart B** to complete the crank rotation inspection.

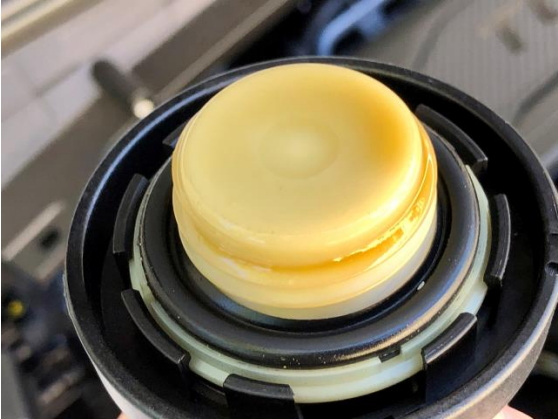
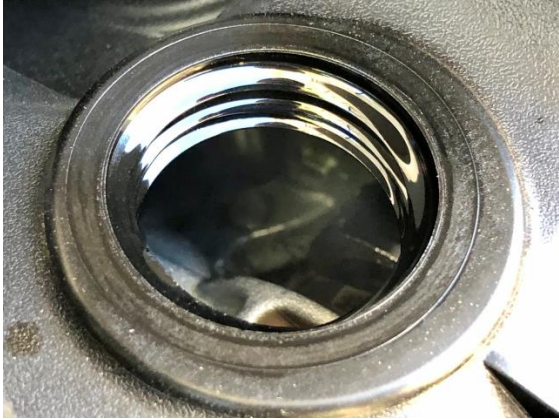
1. Check ROM ID to take a screenshot and scan for DTC P1326 using the GDS.
 - If DTC P1326 (or any other code) is present, take screenshot of Freeze Frame data for PA using GDS screen capture if any DTCs are present and proceed to Step 2.
2. Take pictures of the dipstick, engine oil filler cap, and inside the valve cover oil filler opening.
 - Using STUI on the GDS, take and submit pictures of the following with the VIN in the background of the photo (RO or last 6 digits written on paper). **VIN must be legible.**

Oil filler cap: Clear view of cap underside	Oil filler opening: Clear view inside opening.

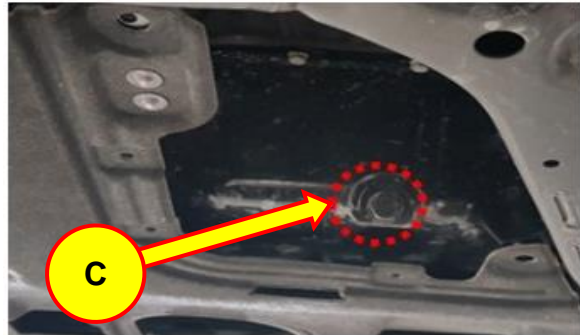
2. Lift up the vehicle and remove the oil drain plug (C).

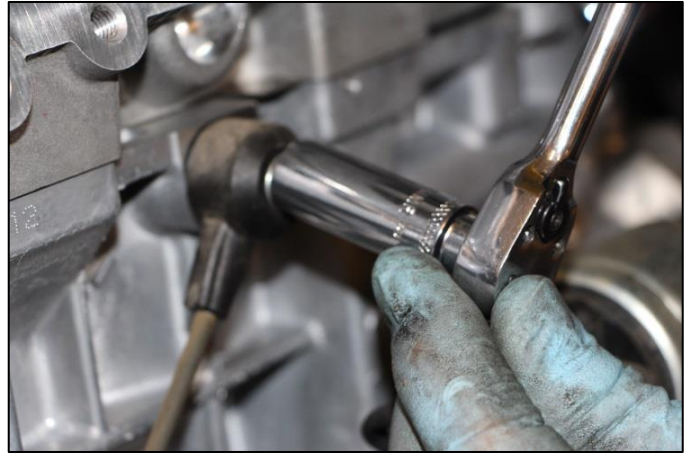
5. Remove and reinstall the engine knock sensor from the old engine to the new engine.

Knock Sensor Fastener Tightening torque:
21Nm (15.5lb-ft)

Ensure the knock sensor is torqued to specification using a torque wrench.

- ❖ Improper installation can result in DTC codes.

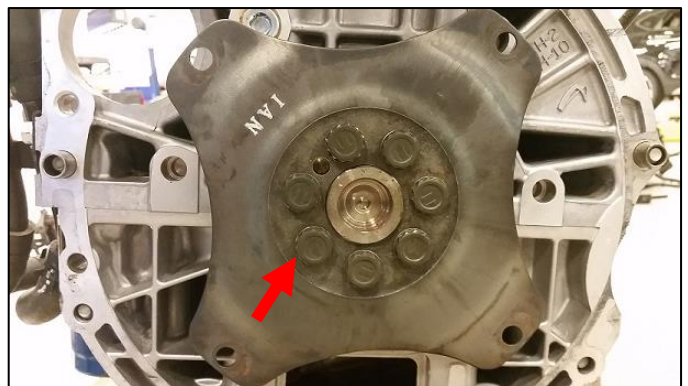
If the crankshaft has drill-through type drive plate mounting holes, then thread-locking sealant must be used to prevent any oil seepage through the (7) drive plate bolts.

- Apply on all threads a low/medium strength thread-locking adhesive that seals fasteners and are tolerant to engine oil.

- Be sure to lightly brush all the bolt threads free of debris/residue and clean off any oil prior to applying the thread-locking sealant for installation.

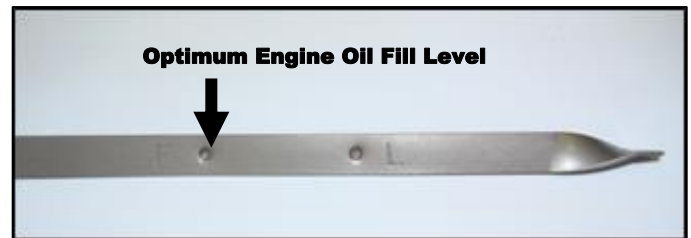
- ❖ Check for any leaks during this time.
- ❖ After the engine has warmed up to normal operating temperature, turn the engine off, wait a few minutes, and then **adjust the engine oil level to near the “F” mark as shown.**
