## Service Campaign T6G Dealer Best Practice

**Subject:** Service Campaign T6G: DTC P1326 – Engine Inspection / Replacement (TSB #21-01-024H)

Certain vehicles listed below may experience the Check Engine warning lamp illuminated with DTC P1326. Follow the procedure to inspect the vehicle and replace the engine and/or update the engine ECU software (if new ROM is available) based on the inspection results.

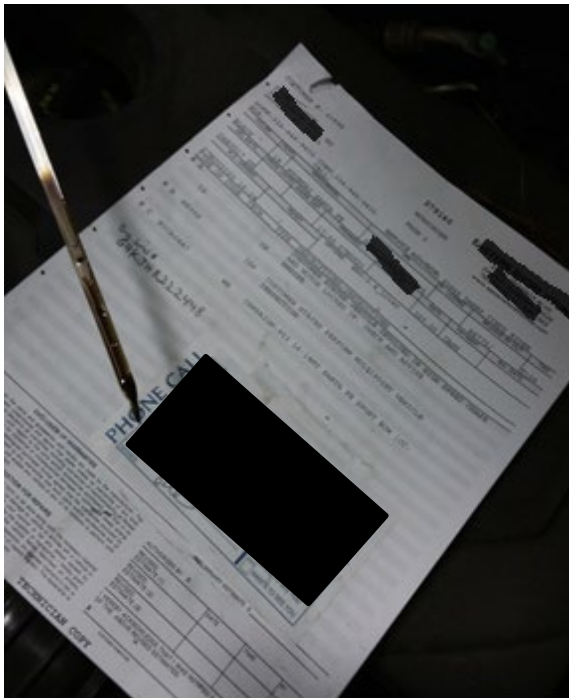
#### Good Dipstick Photo (see below)

- VIN in view when photo is taken of the item in question. **(Windshield or doorjamb VIN Plate)**
  - **Exception:** For oil Measurement photo, a Repair Order in photo will suffice.
- Photo taken with clear focus, showing the item being presented.
- BCT Connection Calibration Test - show connections and gauges clearly (up to two photos)
- Crank Rotation Video and Engine Noise Video - start at the Windshield VIN Plate and move to the front of the engine showing no crankshaft movement or noise (as applicable) in a continuous video beginning to end.
  - \*\*\*Returned engines may be inspected by WTC for a seized condition\*\*\*

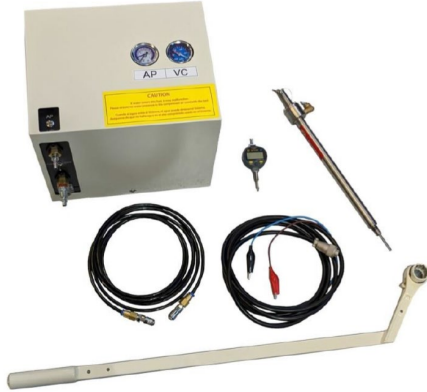
- Engine Bearing Clearance Tester set (bearing tool)

- Note: the bearing tool must be accurately calibrated prior to performing the engine inspection procedure outlined in the T6G TSB. Refer to TSB 20-GI-009H (or latest version) for the calibration procedure as needed.

- Ensure your dealer's shop is configured properly to use SST bearing clearance tester (bearing tool).
- Confirm the following pressures meet requirements. The correct ranges for VC/AP air pressures are also indicated with red/blue decals on the gauges:
- Shop air supply: 0.36MPa (50psi) minimum
  - AP: 0.1 ~ 0.11 MPa

- **Bearing Tool SST Power Check**
  - Supply 12 volts (or an alternate external AC/DC 13.8 volt power supply with at least ~2 amp output to the power cable connected to the bearing tool SST.
