Service Campaign T3G & Warranty Extensions TXXC/TXXI - ENGINE BEARING INSPECTION / ENGINE REPLACEMENT- Dealer Best Practice

Revised publication April 15, 2022

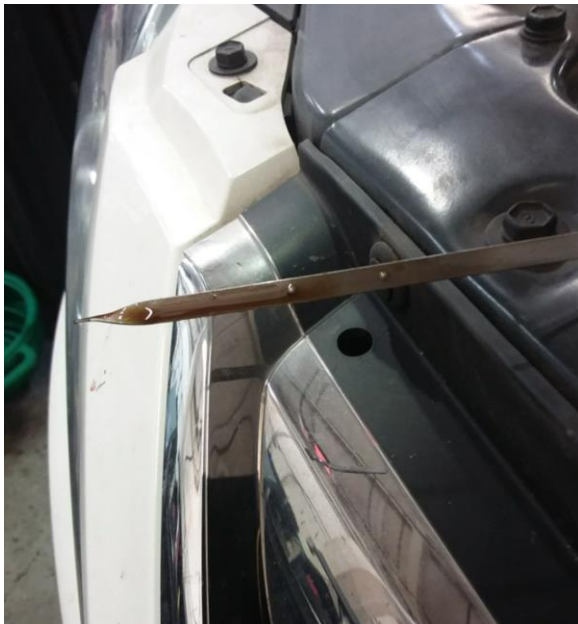
Bad Dipstick Photo (see below)

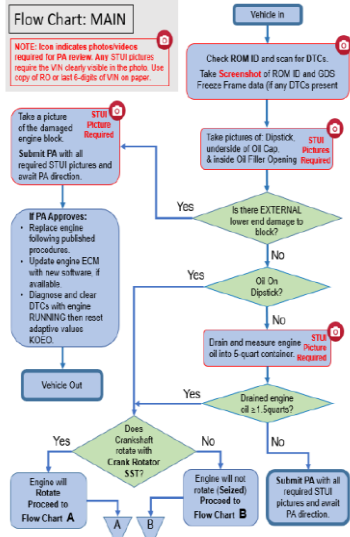
Service Procedure Flowchart:

- Follow the **Service Procedure Flowchart** found in the latest TSB and update the Engine ECM if new version is available (Campaign T3G).

- Important: If a vehicle passes the bearing inspection test, but DTC P1326 comes back on after the code is cleared, contact Techline for further assistance on diagnosing the vehicle.**
- Use the **Service Process Results Worksheet** (reference latest repair TSB) as a guide to help diagnose the vehicle. This should be used as a tool to assist.

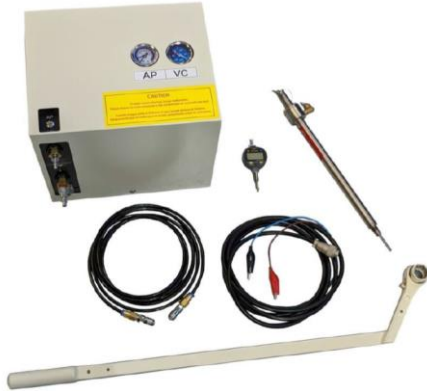
- Engine Bearing Clearance Tester set (bearing tool)

- Note: the bearing tool must be accurately calibrated prior to performing the engine inspection procedure outlined in the T3G TSB. Refer to TSB 21-GI-009H (or latest revision) for the calibration procedure as needed.
