| <br><br><b>Technical Service Bulletin</b> | <b>GROUP</b><br><br><b>RECALL</b> | <b>NUMBER</b><br><br><b>22-01-017G</b> |
| <b>SUBJECT:</b> | <b>FRONT SEAT BELT PRETENSIONER REPLACEMENT<br/>(RECALL 009G)</b> | |

**Description:** The front seat pretensioner may deploy abnormally in the vehicles described below, causing the MMG (Micro Gas Generator) to detach from the assembly. This bulletin describes the procedure to replace the front seatbelt pretensioner to resolve the condition.

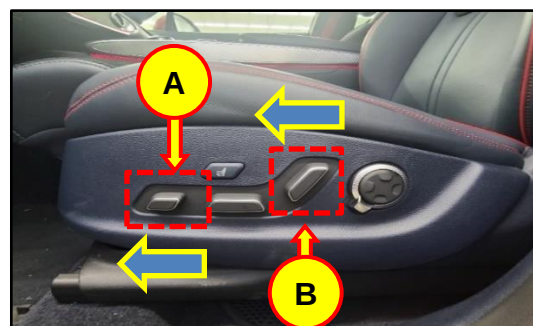
1. Move the seat as far forward as possible by using the front/rear switch (A) and seat back switch (B).

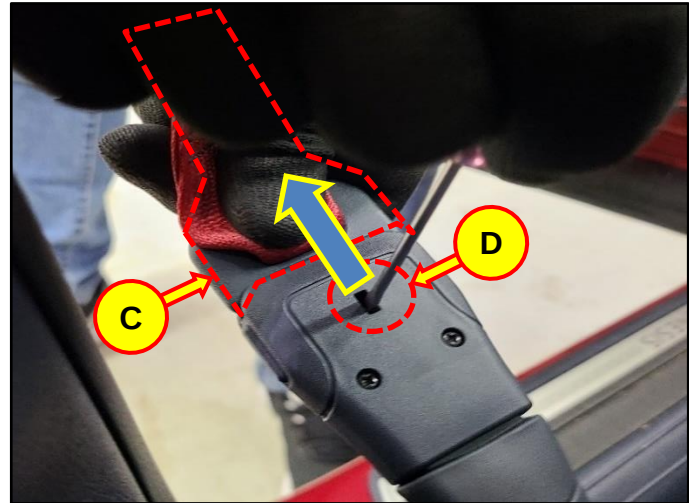
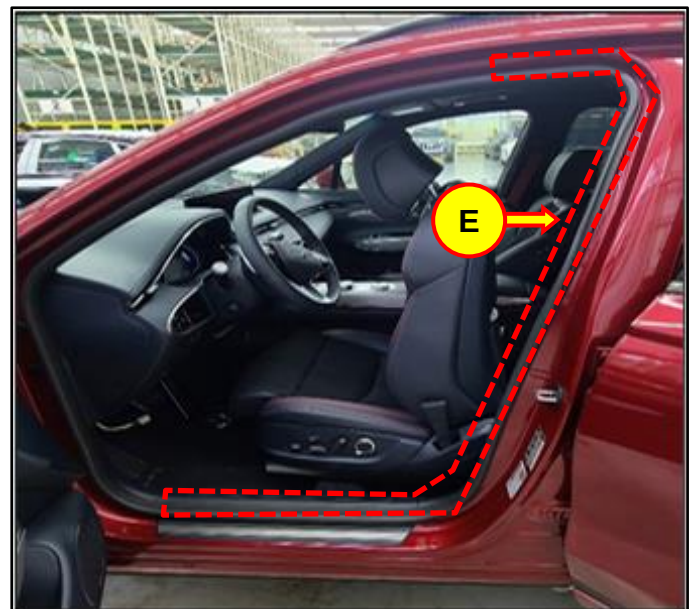
2. Record radio presets and disconnect the vehicle's negative (-) battery terminal.
3. Turn off the vehicle's ignition key before continuing.
4. Remove the front anchor seat belt (C).

Push the front anchor seat belt inward, towards the seat. Insert a flat tip screwdriver into the point of insertion (D) and pry it away from the seat to remove the front anchor seat belt.

Do not scratch the anchor cover while inserting the screwdriver into the point of insertion.

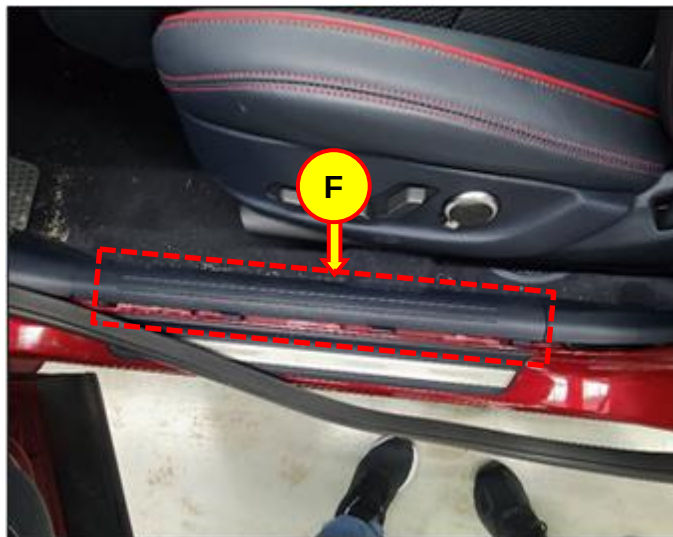
6. Remove the front door scuff trim (F) using a flat head screwdriver or plastic trim remover tool.

If using a screwdriver, be sure to wrap protective tape around the tip to prevent damage on the trim and panels.

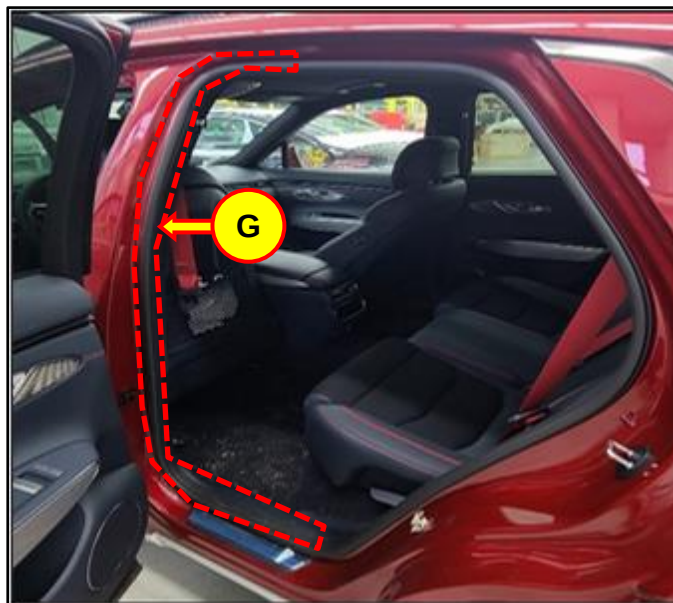
7. Partially remove the rear door body side weather strip (G).

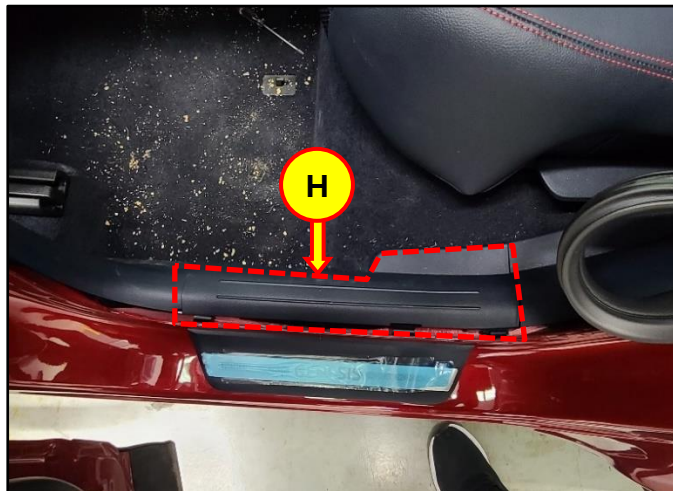
8. Remove the rear door scuff (H) using a flat head screwdriver or plastic trim remover tool.

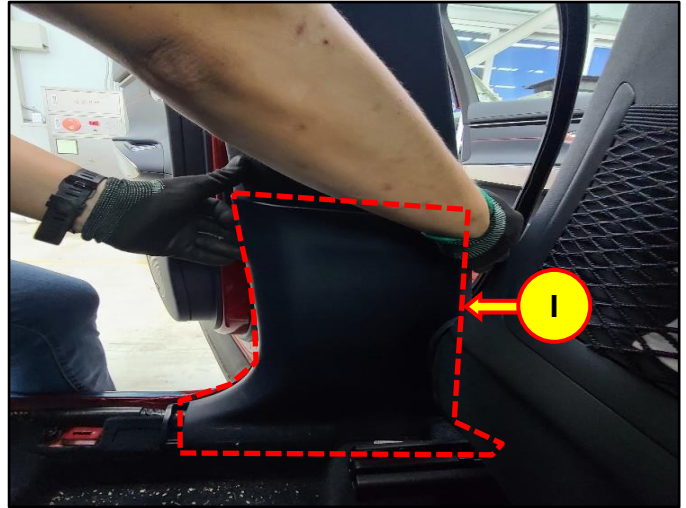
9. Remove the center pillar lower trim (I). Be careful to not damage the plastic fasteners.

**Replace existing fasteners with new ones.**

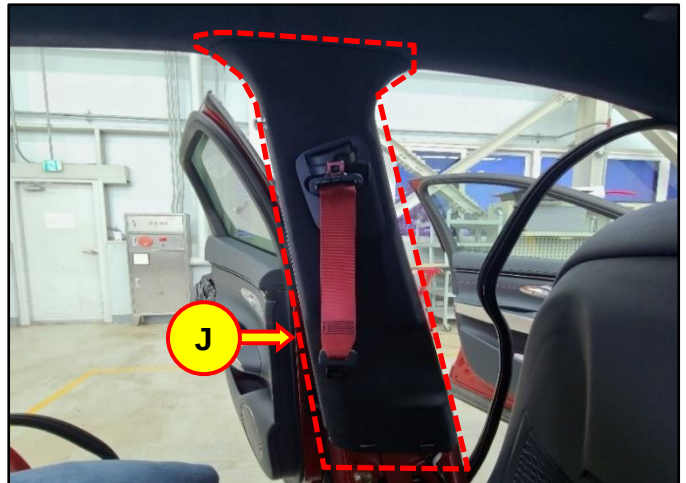
10. Remove the center pillar upper trim (J).

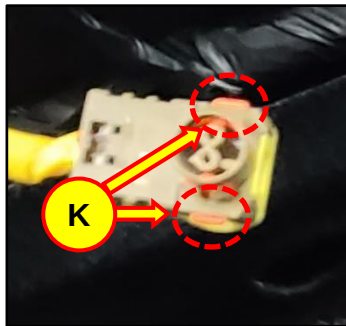
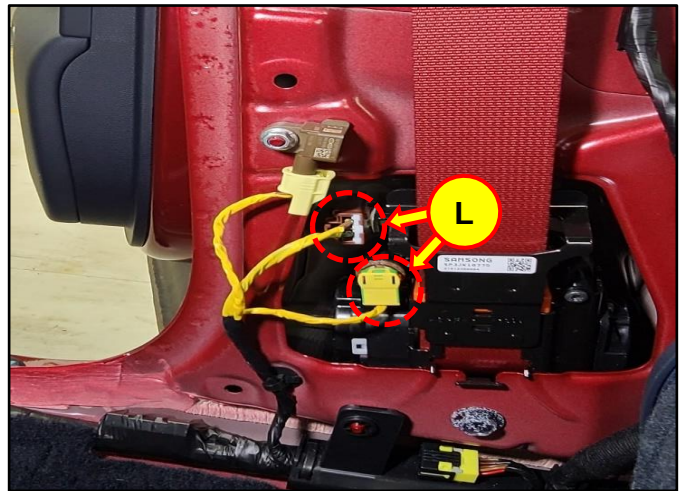
11. Press in the tabs for the locking pin (K) to disconnect the front seatbelt pretensioner connector and free active seatbelt connector (L).

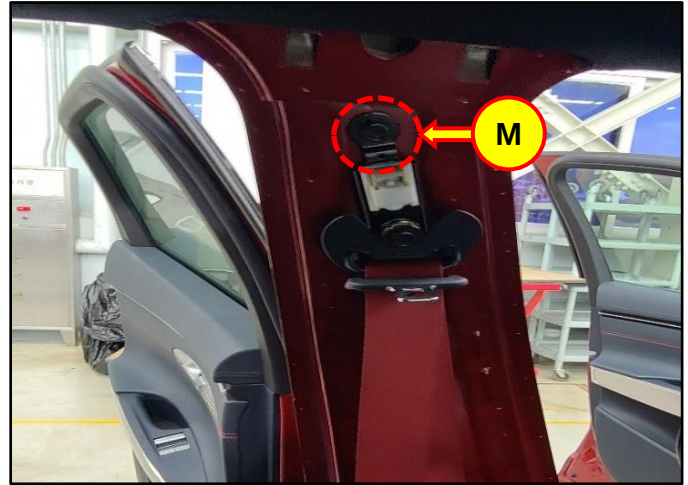
12. Loosen the front seat upper anchor mounting bolt (M) and remove the front seat belt upper anchor.

28.9 – 39.8 lb-ft (39.2 – 53.9 Nm)

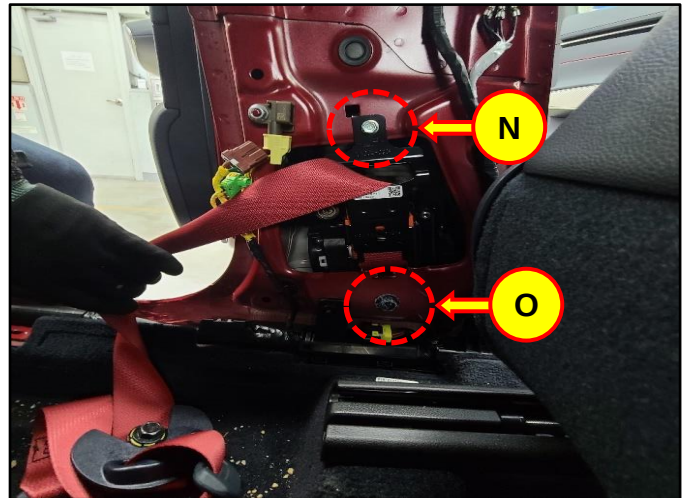
13. Loosen mounting bolts (N) and (O) and remove the front seat belt pretensioner.

M: 5.8 – 8.7 lb-ft (7.7 – 11.8 Nm)

N: 28.9 – 39.8 lb-ft (39.2 – 53.9 Nm)

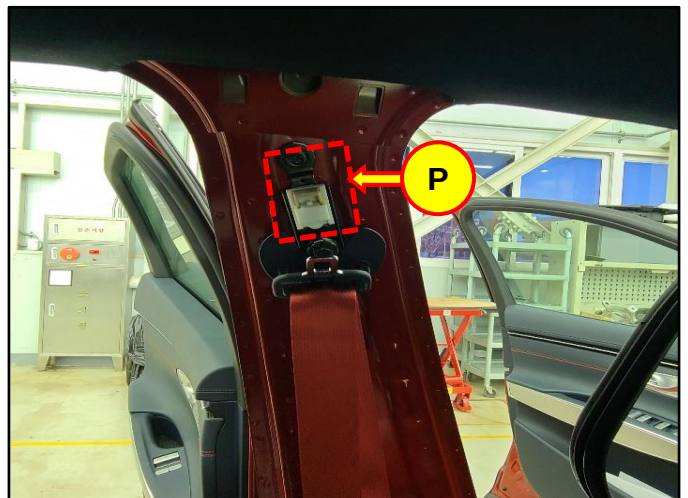
14. Install the newly supplied front seatbelt pretensioner.
15. Reinstall parts in reverse order of removal. Make sure to replace existing fasteners with new ones.

Move the height adjuster lever (P) to the highest point before reinstalling the upper center pillar trim.
