| | Safety Recall Campaign | 2021-2022MY<br>Sorento HEV (MQ4 HEV)<br>2022MY Sorento PHEV (MQ4 PHEV) |
| | SC241 | July 2022 |

## SAFETY RECALL CAMPAIGN

### SEAT BELT PRETENSIONER MGG PROTECTION CAP INSTALLATION (SC241)

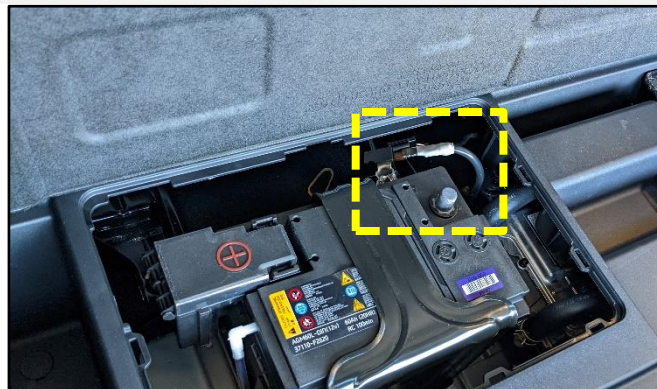
- 1a. Open the rear door.
- 1b. Open the tool box cover to access battery.
- 1c. Disconnect the negative (-) battery terminal.

Wait for at least 3 minutes before attempting to disconnect any electrical connections.

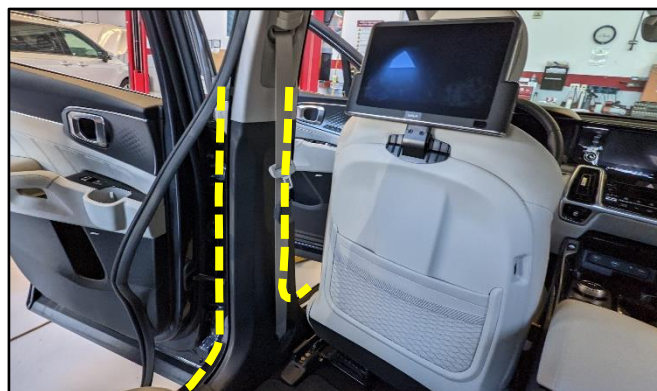
2. Partially detach the door rubber seal from both front and rear driver (left) doors, enough to clear the center pillar lower trim area.

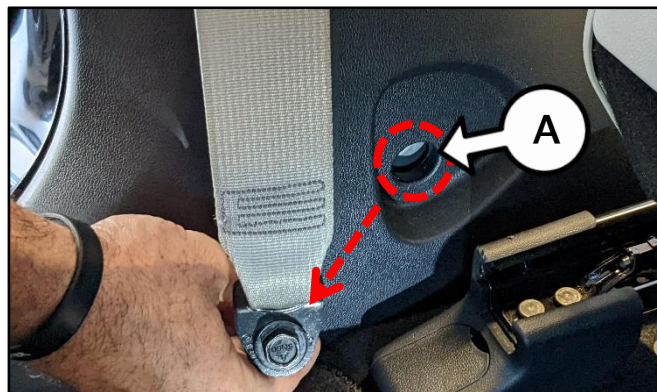
3. Remove the bottom seat belt retaining bolt (A).

Tightening torque for bolt (A):  
28.9 - 39.7 lb.ft (39.2 - 53.9 N.m)

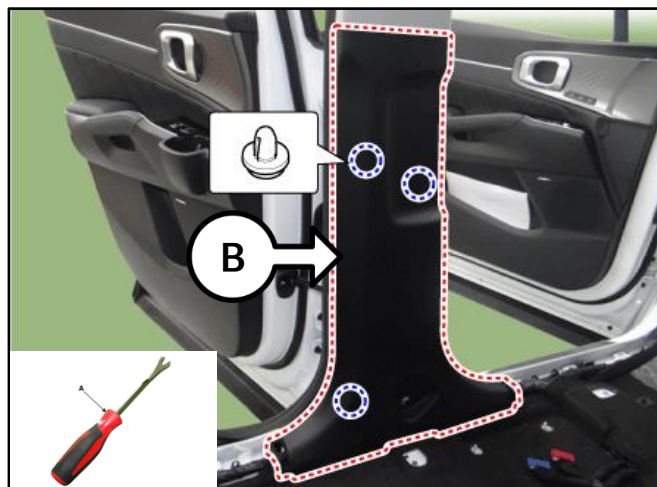
4. Carefully detach and remove the center pillar lower trim (B).

Replace any damaged fasteners during removal, P/N 82315 2P000.

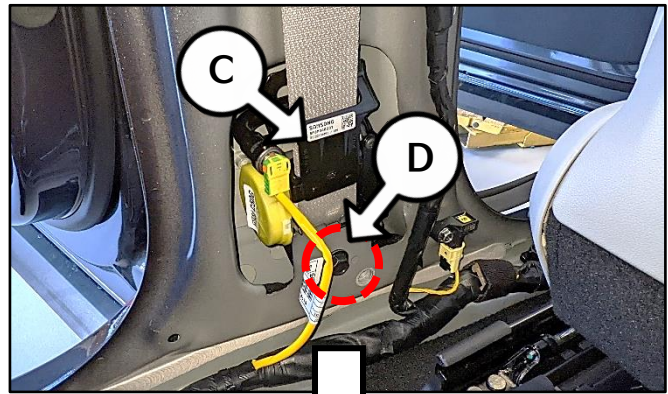
- 5a. Remove the seat belt pretensioner (C) retaining bolt (D).

**Tightening torque for bolt (D):**  
28.9 - 39.7 lb.ft (39.2 - 53.9 N.m)

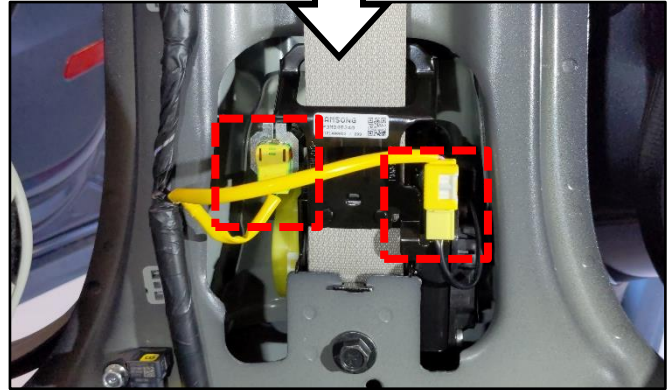
- 5b. Disconnect the two (2) connectors.

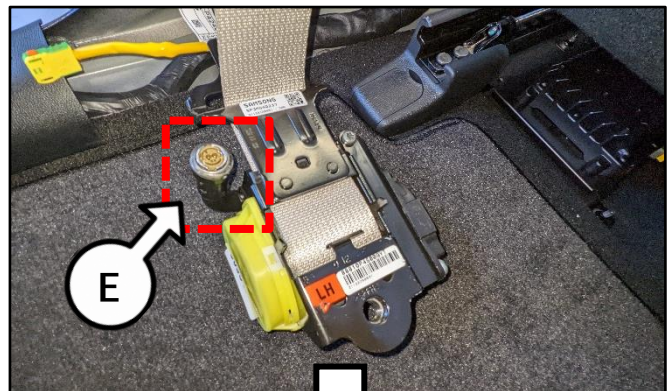
- 5c. Place the pretensioner down on the floor and locate the Micro Gas Generator (MGG) (E) installation area.

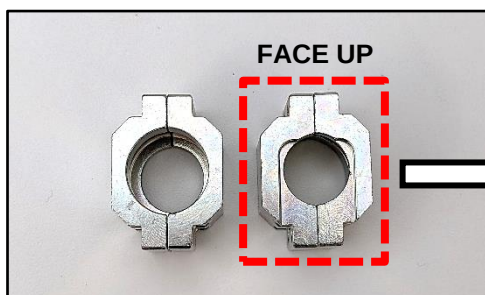
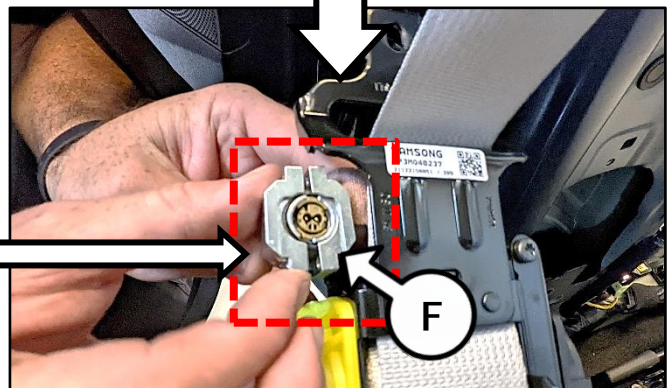
6. Install the MGG cap (F) in the direction shown.

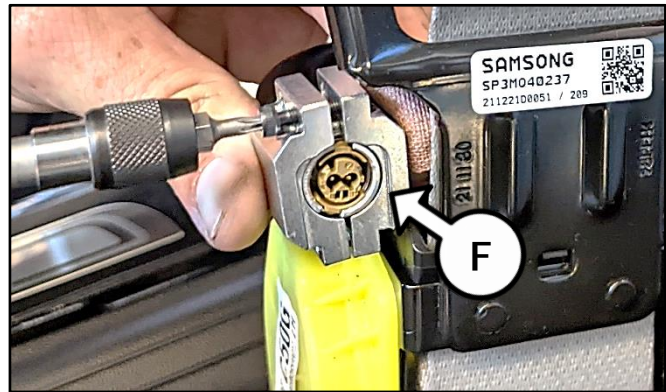
7. Install the four (4) MGG cap (F) retaining screws.

**Tightening torque for screws:**  
18 - 22 lb.in (2.1 - 2.6 N.m)

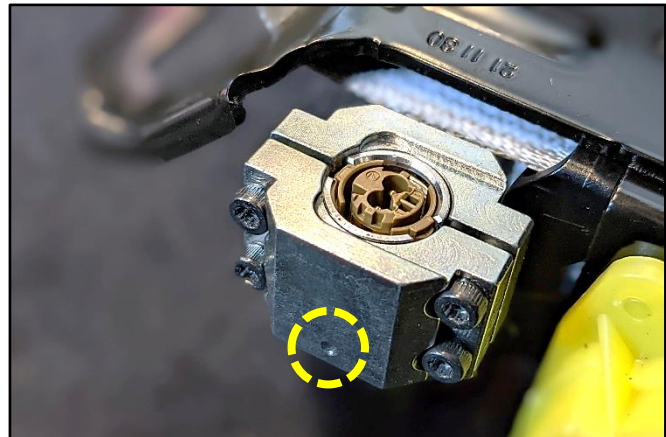
**Note:** Dimple dot marking on the surface of the outside (left) MGG cap.

Ensure to evenly space the gap between the opposite cap ends as screws are tightened. Uneven tightening of the cap screws can cause the cap end(s) to crack. DO NOT exceed the recommended torque specification.
