**July 6, 2023**

Version 1

## 2022–23 Civic EPS Gearbox Replacement

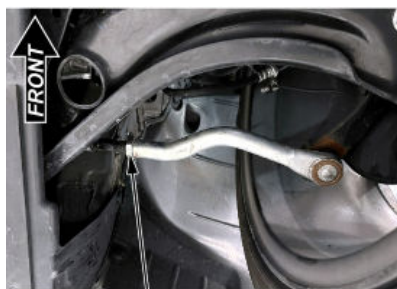
10. Loosen the outer tie-rod end nut (both sides).

OUTER TIE-ROD NUT

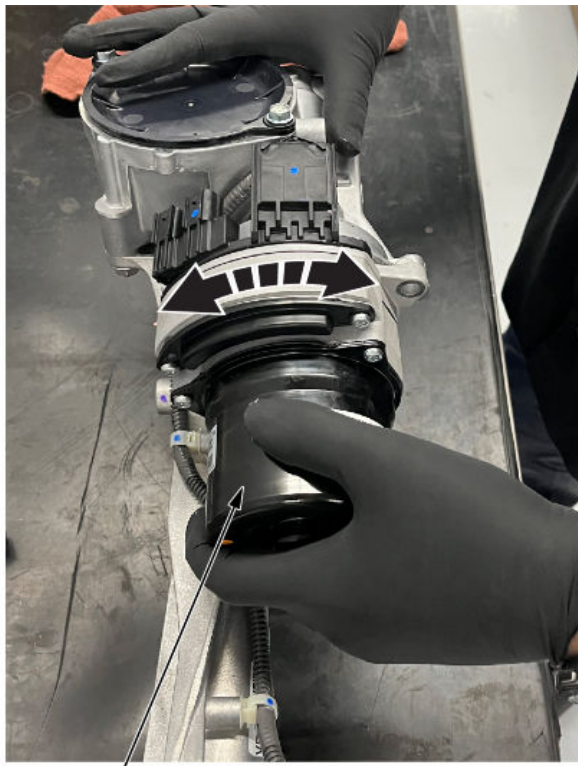
22. Turn the EPS motor/control unit **two or three times** to both the **left and right** in a **45° arc** as shown below.

**EPS MOTOR CONTROL UNIT**  
Turn unit two or three times to the right and left (about 45 degrees).

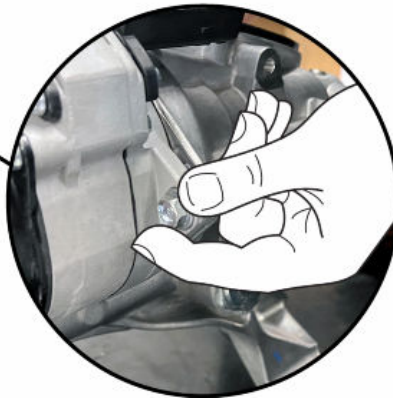
- To prevent damaging the motor and/or gearbox, **DO NOT** use power tools to install or tighten the bolts.
- Make sure the EPS motor/control unit is evenly seated on the P/S gearbox.

**EPS MOTOR/CONTROL UNIT**  
Make sure unit is evenly seated.

24. Torque the EPS motor/control unit mounting bolts to **20 N·m (15 lb-ft)**.
