**December 8, 2023**

Version 2

## Product Update: 2022–24 Civic EPS Gearbox Inspection (Service Parts)

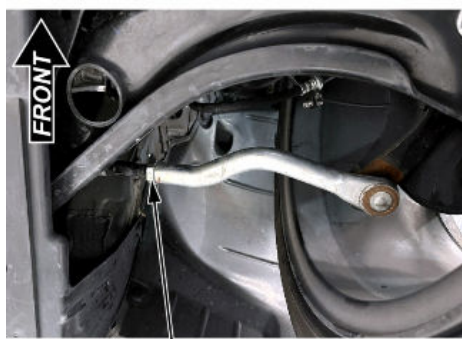
OUTER TIE-ROD NUT

10. Loosen the outer tie-rod end nuts and disconnect the tie-rod end ball joints (both sides).

NOTE: Always use a ball joint remover to disconnect a ball joint. Do not strike the housing or any other part of the ball joint connection to disconnect it.

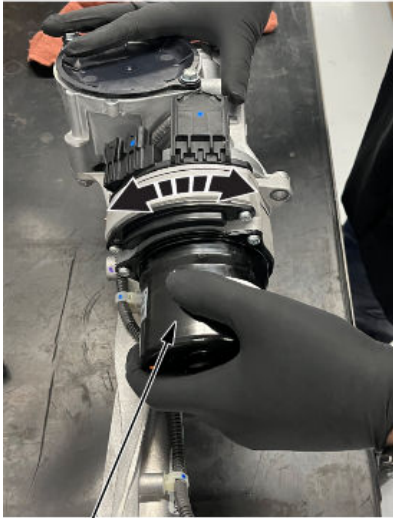
21. Install the EPS motor/control unit on the replacement rack with the barcode facing up, but do not install the mounting bolts.

**EPS MOTOR CONTROL UNIT**  
Turn unit two or three times to the right and left (about 45 degrees).

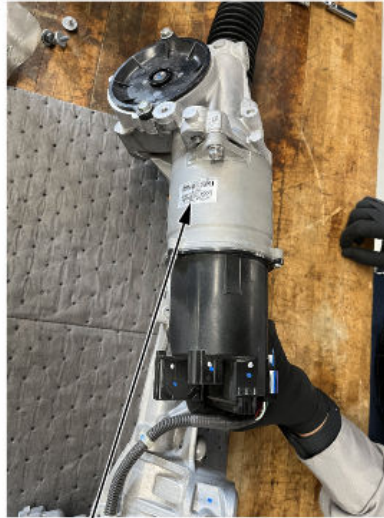
**BARCODE**  
Install with barcode facing up.

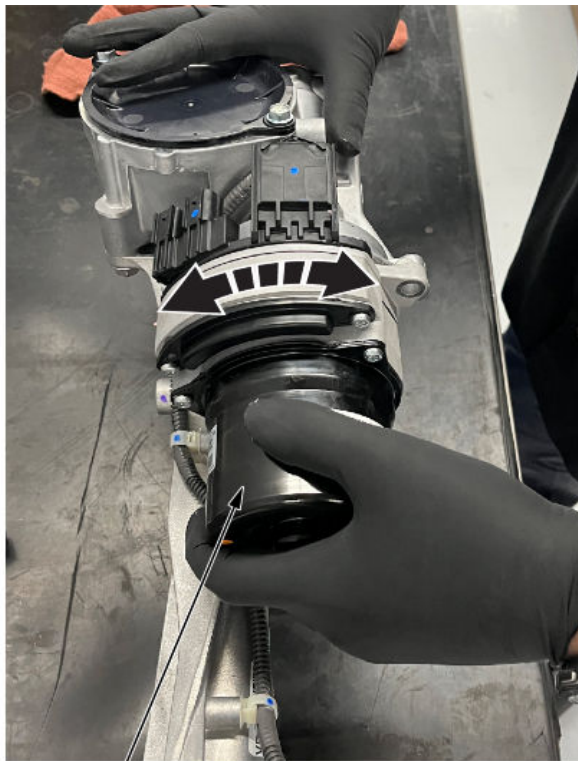
22. To seat the EPS motor/control unit turn it **two or three times** to both the **left and right** in a **45° arc**, as shown below.

**EPS MOTOR CONTROL UNIT**  
Turn unit two or three times to the right and left (about 45 degrees).
